# **FINAL INVESTIGATION REPORT**

**ACCIDENT OF SUNWAY AIR CARRIER (GEORGIA)**  
**IL-76TD AIRCRAFT REG # 4L-GNI AT KARACHI, PAKISTAN**  
**ON 27<sup>th</sup> NOVEMBER, 2010**

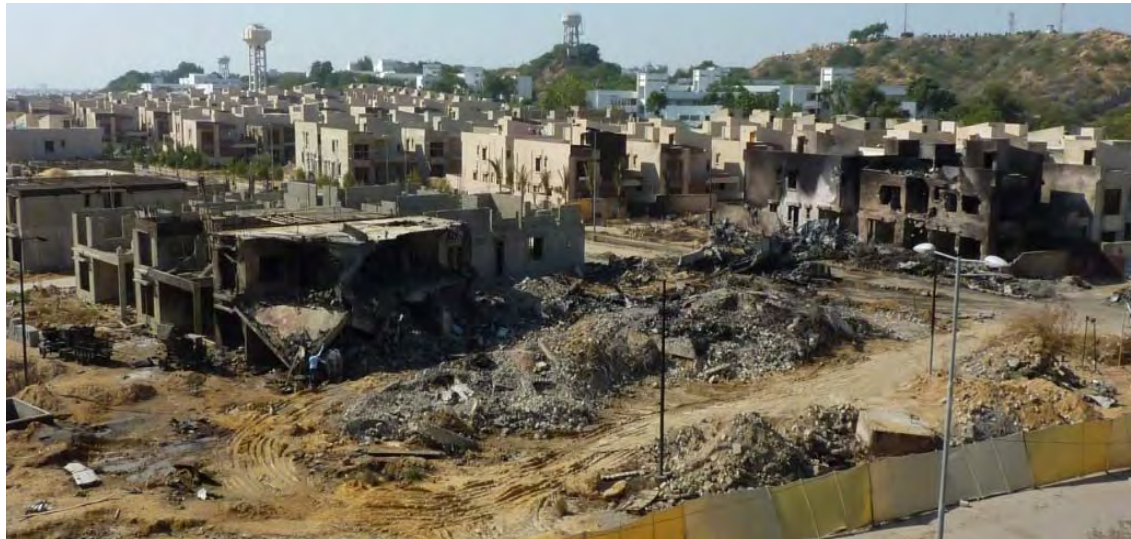
1.12. **Wreckage and Impact Information.** Most of the wreckage was located in an area approximately 150m (long) x 60m (wide). The aircraft crashed on under construction buildings and was in right bank before the impact. At the time of impact, aircraft heading was approximately 320-330 degrees. As a result of the aircraft's collision with the ground, under construction buildings and subsequent fire almost entire aircraft structure was destroyed. The following pictures explain location and condition of major parts as found after ground impact. The details are presented in the wreckage analysis report.

Aircraft crash site and wreckage

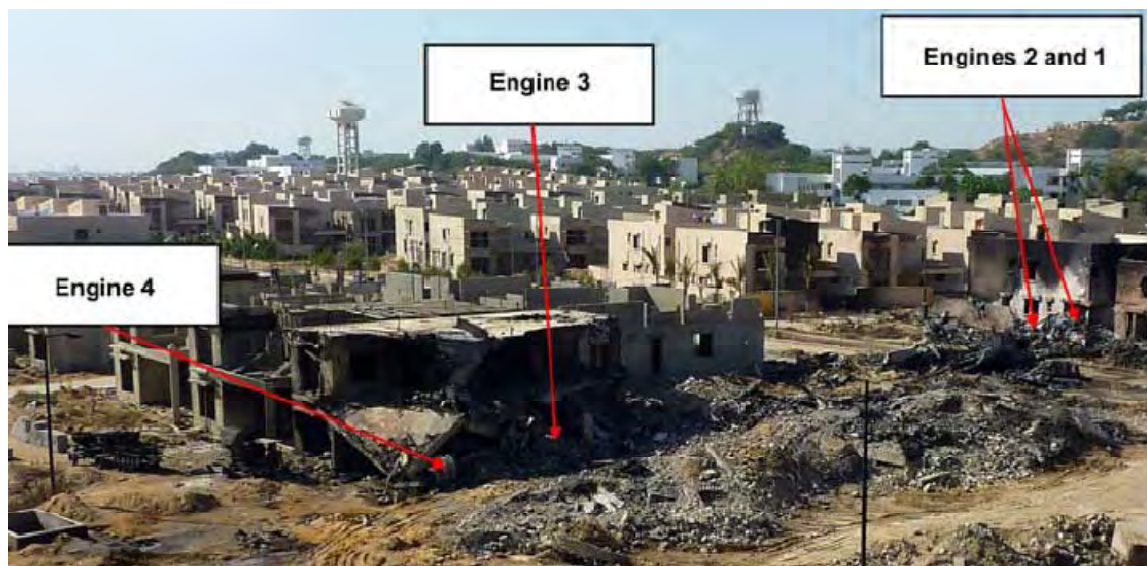
Location of engines

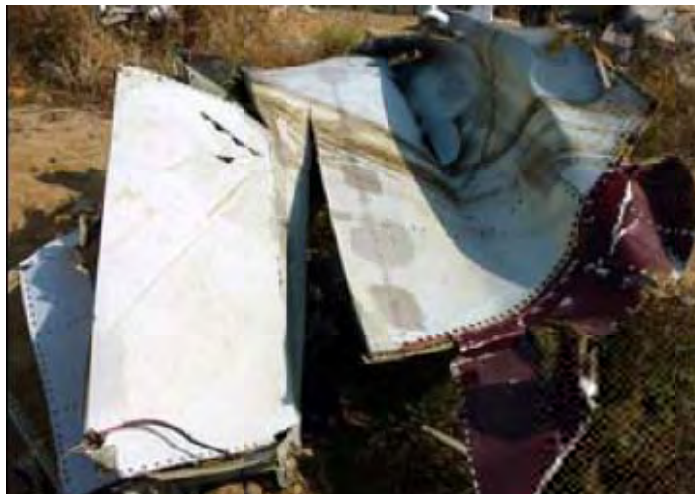
#1. Part of right outer wing

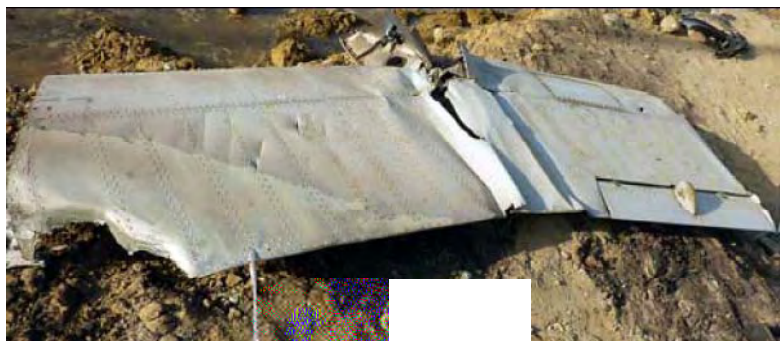
#2. Part of right aileron

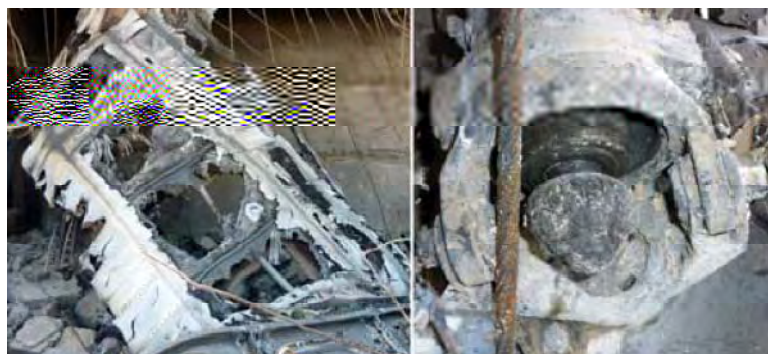
#5. Vertical  
Stabilizer  
panel

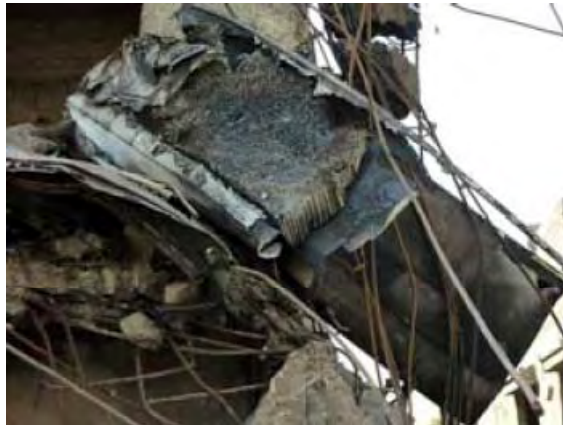
#6. Part of right  
flap with its  
track

#7. Right flap fragment

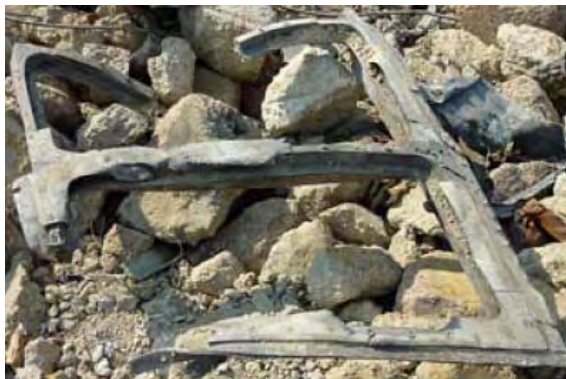
#8. Left side crew cabin transparency frame fragment

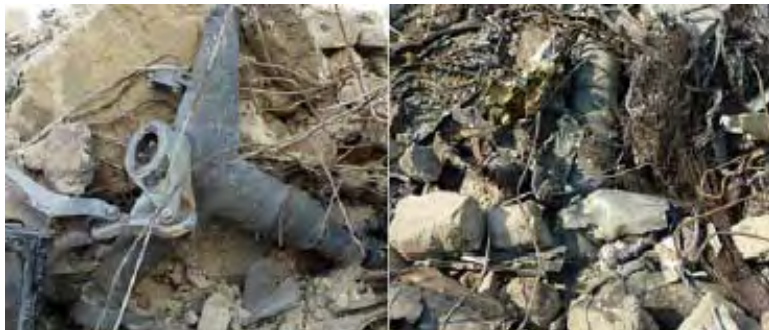
#9. Part of right middle wing with rear spar

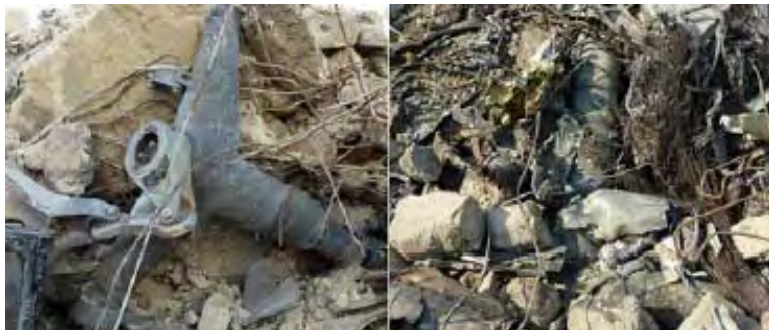
#10. Right main landing gear

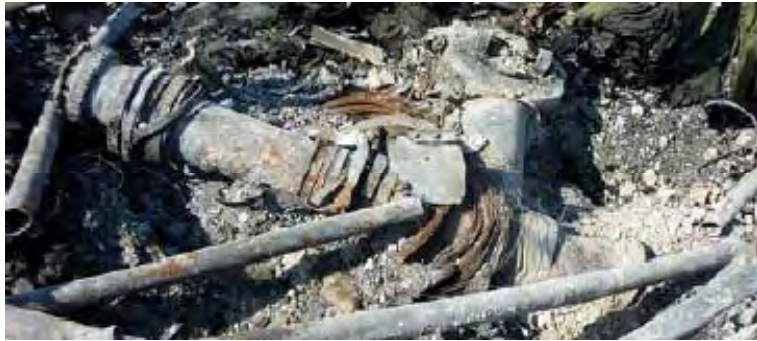
#11. Nose landing gear

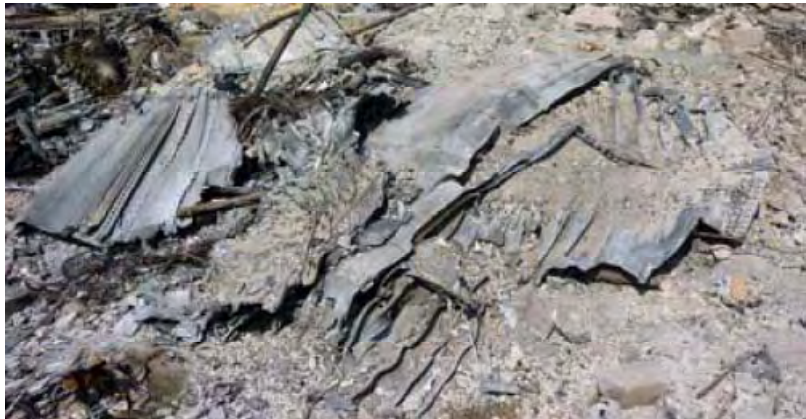
#12. Wing centre section  
lower panel from  
middle to the front  
spar

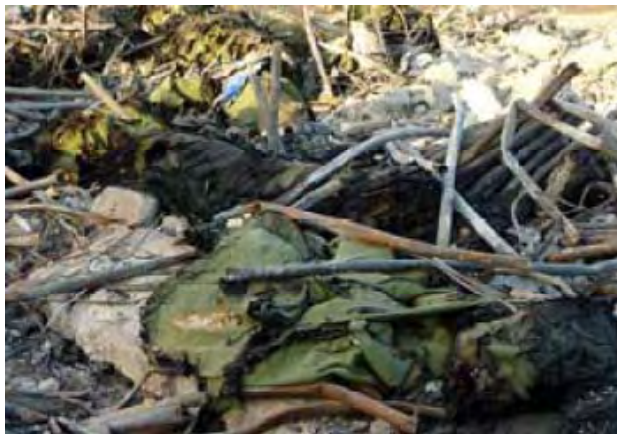
#13. Cargo (tents)

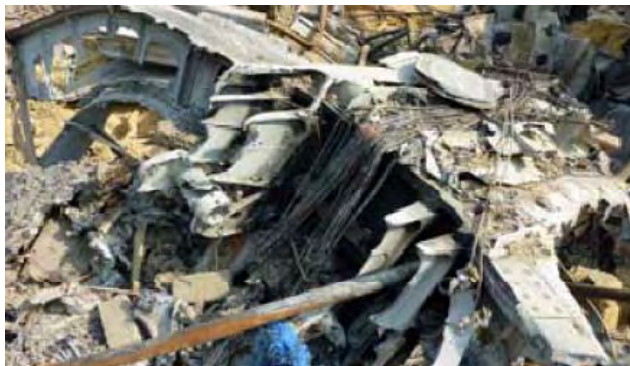
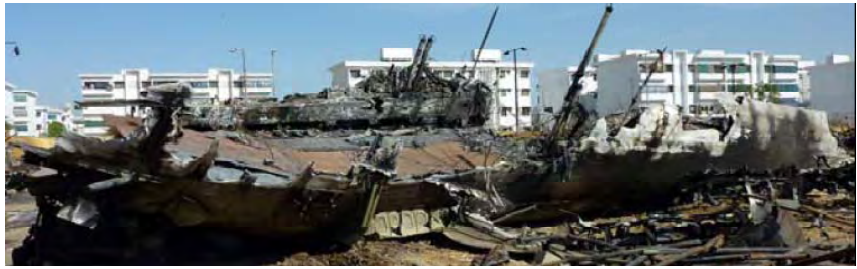
#14. Rear centre part of  
the stabilizer

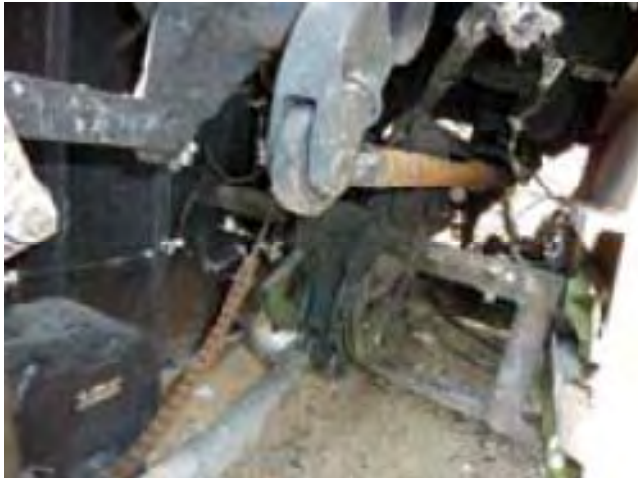
#15. Fuselage tail section with control rods

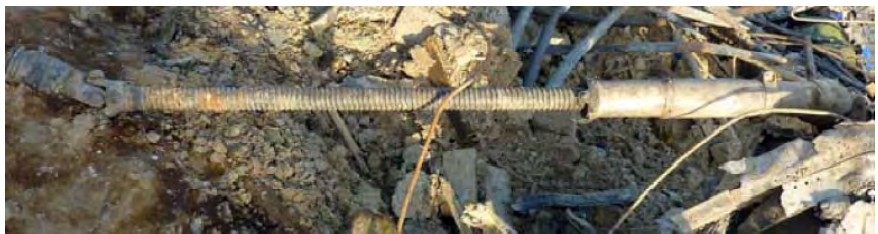
#16. Left main landing gear

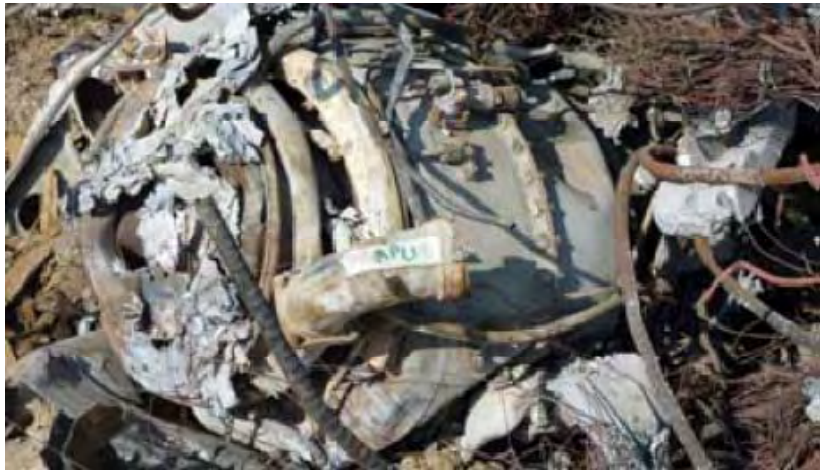
#17. Flap Track

#18. APU

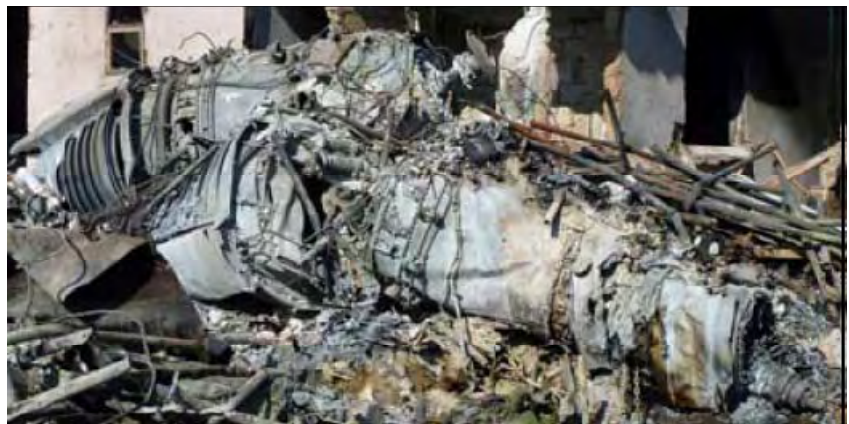
#19. Engine # 1 & 2

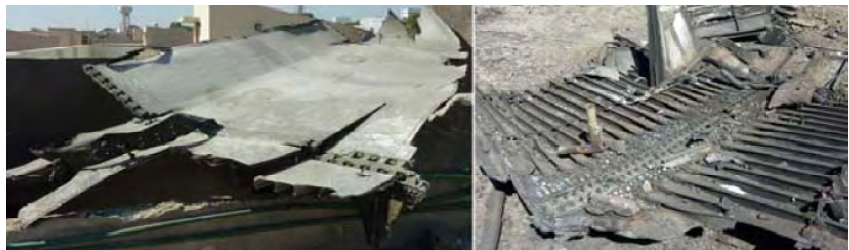
#20. Centre wing section  
upper and lower  
panels from the  
middle to the rear  
spar

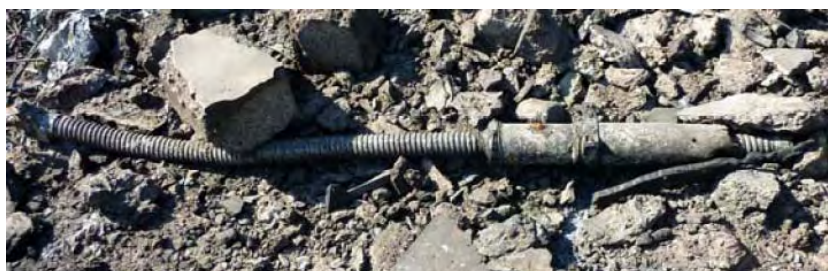
#21. Flap track

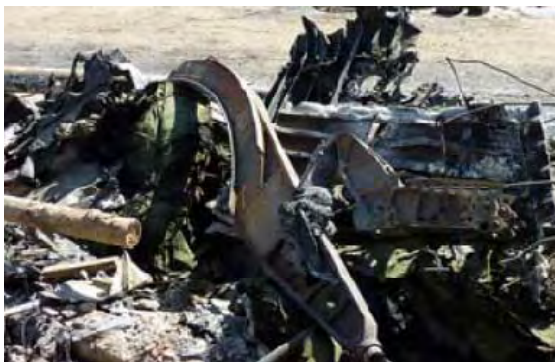
#22. Left wing fragments

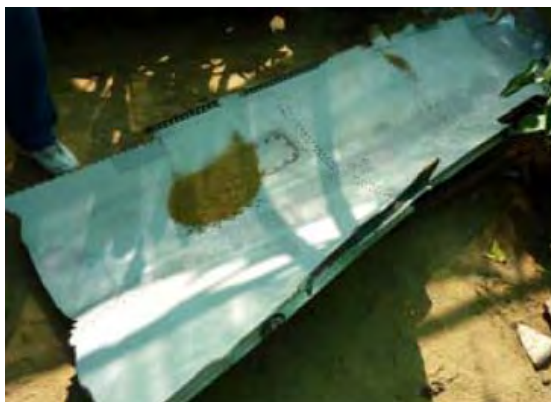
#23. Upper panel fragments  
of left outer wing

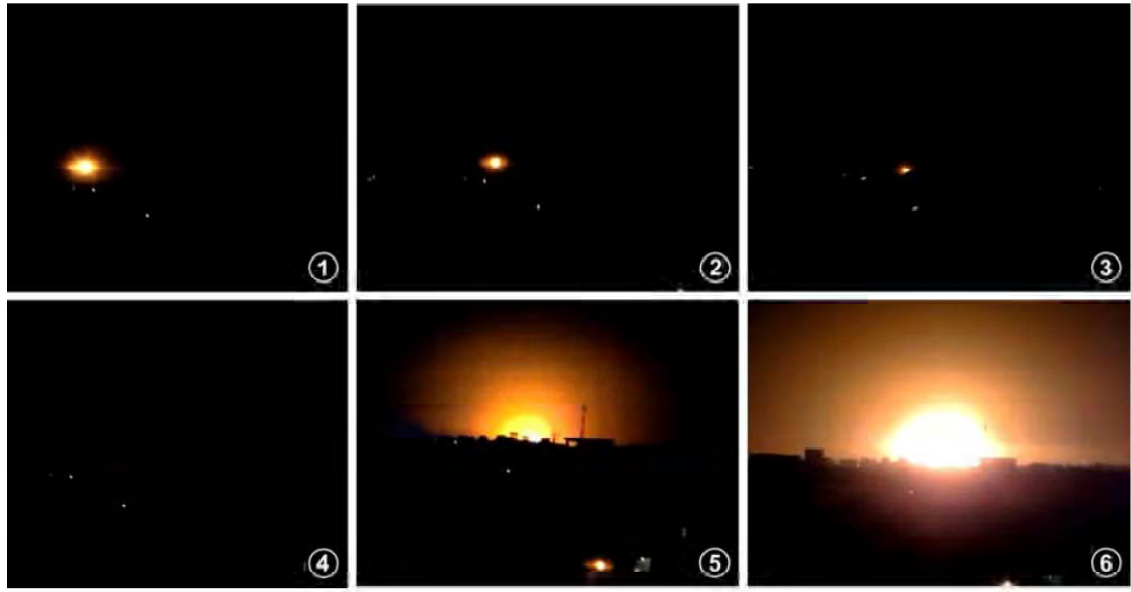
1.14.3. An amateur video also provided evidence that fire occurred onboard during climb after takeoff and continued till its impact with ground.

The amateur video record of mishap aircraft in-flight fire

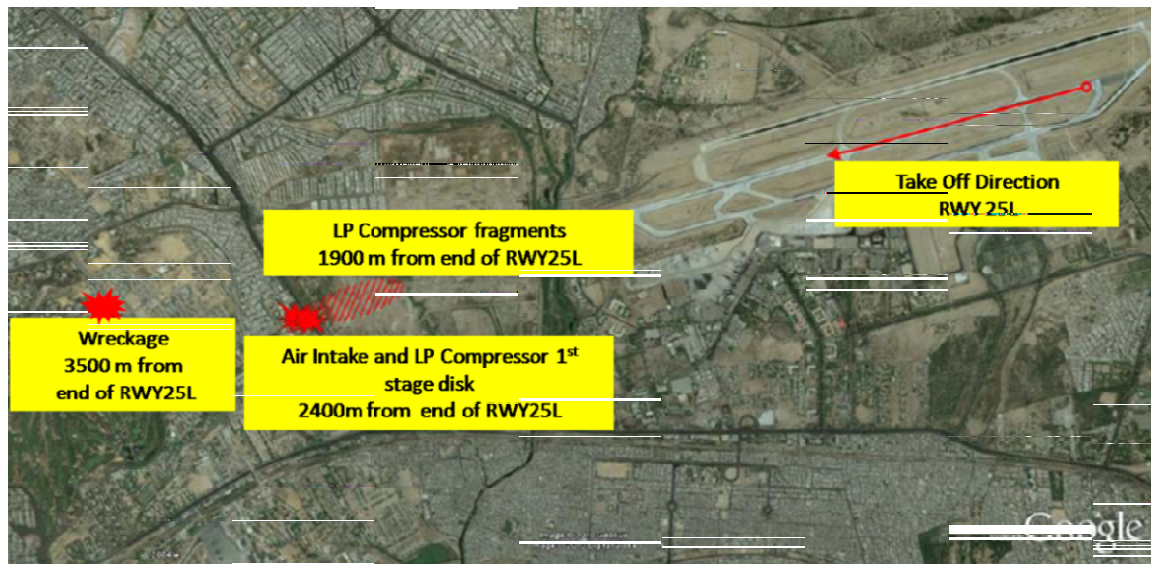
Engine # 4 fragments between the end of Runway 25L and crash site

- 2.22.6. All four engines were found in the main wreckage of the crashed aircraft. However, some parts of Engine # 4 were found on the flight path of the aircraft after takeoff. The engine parts found before the main aircraft wreckage included, fragments of engine front cowl, fragments of inlet guided vanes, fragments of LP compressor 1<sup>st</sup>, 2<sup>nd</sup> and 3<sup>rd</sup> stage casing, LP compressor 2<sup>nd</sup> and 3<sup>rd</sup> stage blades, LP compressor 1<sup>st</sup> stage disk with broken shaft and LP compressor 2<sup>nd</sup> and 3<sup>rd</sup> stage disks. These parts were located at a distance of approximately 1900-2400 meters from the runway end and about 1200-1400 meters before the main aircraft wreckage. These fragments had signs of mechanical damage only, and no signs of thermal / fire damage. This indicates that some part out of these experienced uncontained failure and caused extensive damage to Engine # 4.

- 2.22.7. Since the fragments of LP compressor 2<sup>nd</sup> stage disk were found approximately 1200-1400 meters before the main wreckage of the rest of the aircraft it was assumed that most probably it was the first component to fail. Most likely after failure of the LP compressor the LP turbine over speeded and its 6<sup>th</sup> stage disk disintegrated.

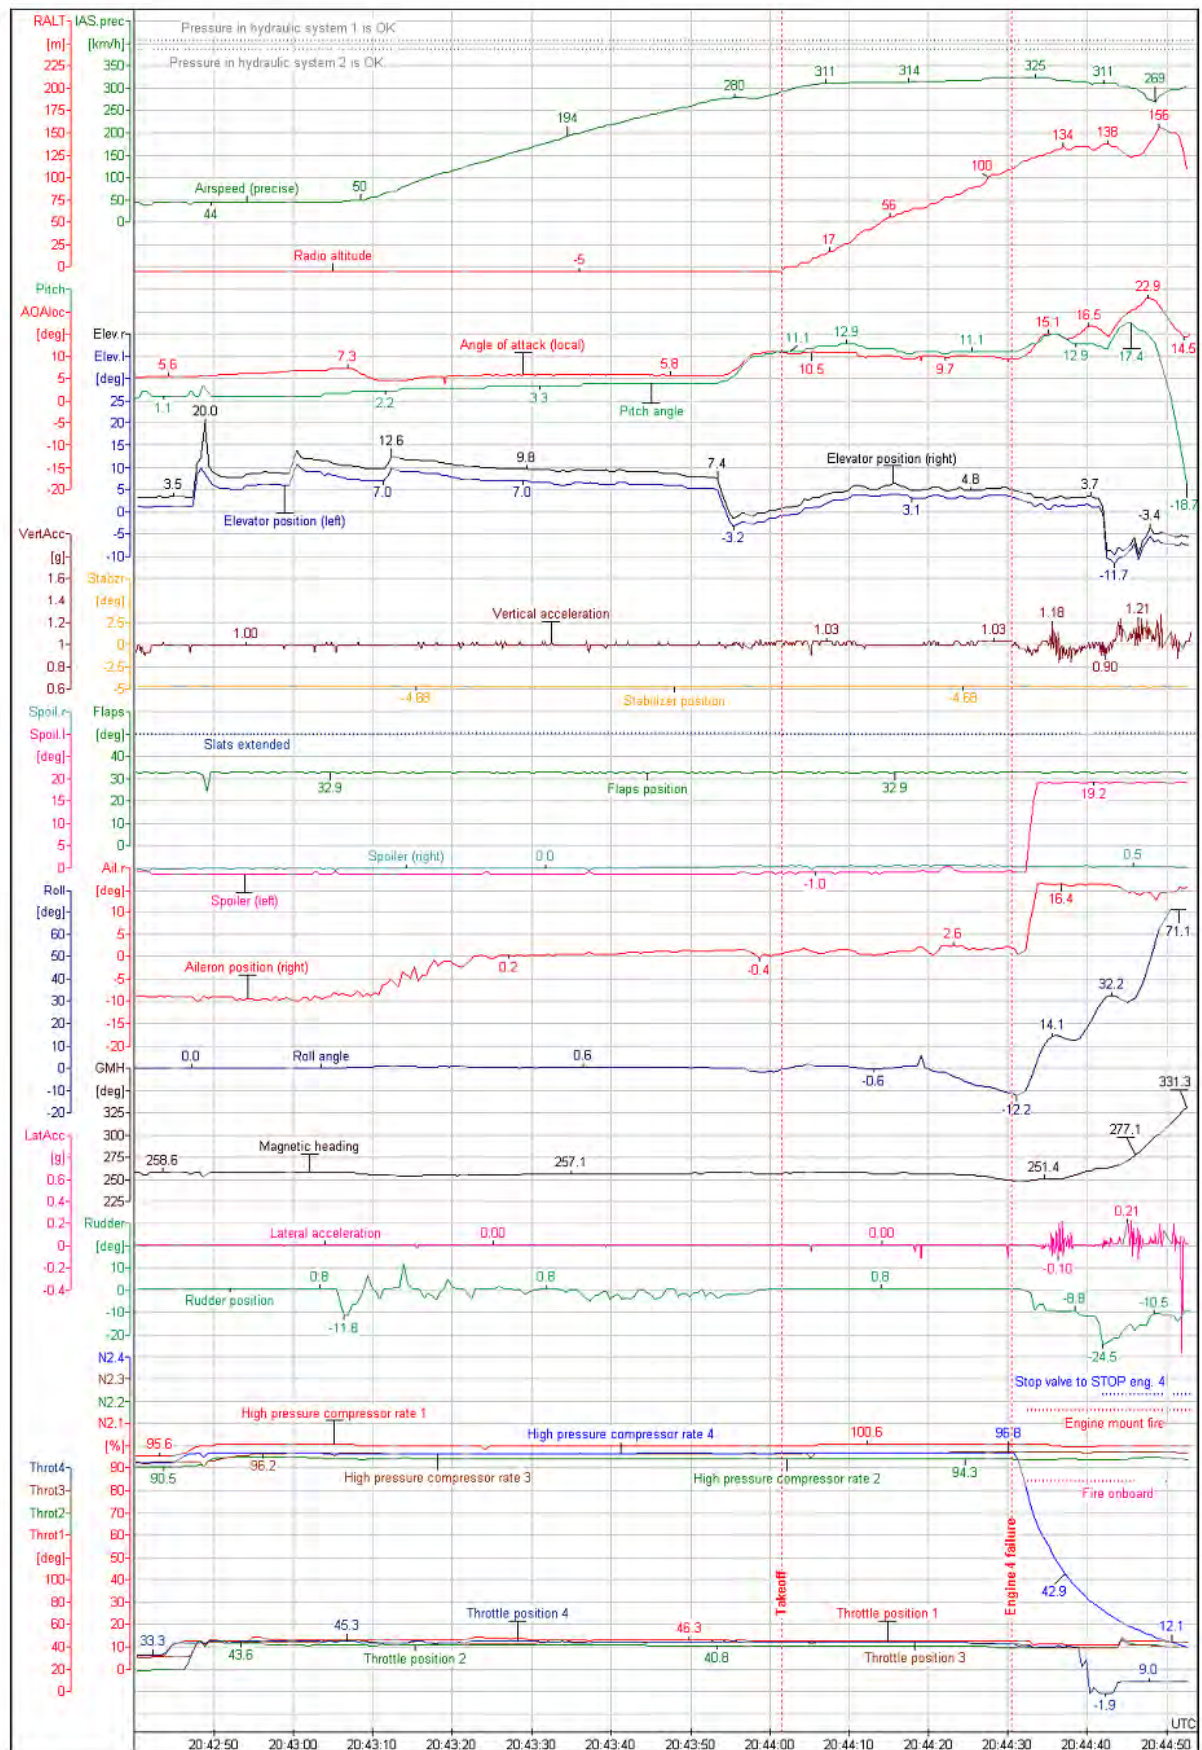
Pic 2.3 The FDR MSRP-64M of the aircraft IL-76TD 4L-GNI flight information. Takeoff in airport Karachi on 28.11.2010.

2.13. At 20:44:30.5 UTC the rotational speed of high-pressure compressor's rotor of Engine # 4 spontaneously went down along with the alarm "Fire of the engine nacelle" and "Fire onboard". At the moment of the Engine # 4 failure the aircraft was making a left turn with  $-12^{\circ}$  bank, altitude was about 100m, speed was 325 km/h, flaps were extended at  $30^{\circ}$ , slats were extended and undercarriage was retracted. Other three engines were working at take-off power. The aircraft at that moment was 2 km away from the runway 25L end. It may be noted that fragments of Engine # 4 were located at a distance of 1900-2400m from runway 25L end. All these fragments had only mechanical damages and no signs of fire. This information proves that Engine # 4 disintegration occurred during climb after take-off.

2.14. Approximately one to 2 seconds after Engine # 4 failure rapidly increasing right bank ( $8-9^{\circ}$ /second) was recorded, that consequently caused the right turn of the aircraft.

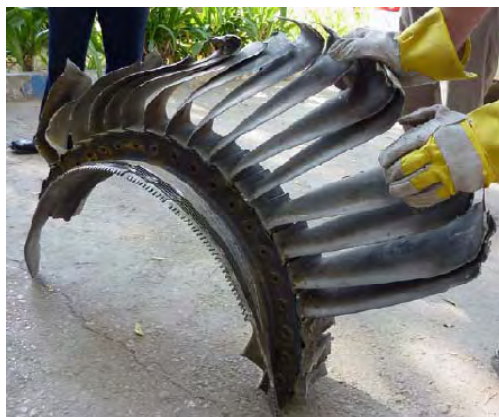
2.24.12. The fragment of the 2<sup>nd</sup> stage disk of the LP compressor was lost during the investigation. The fracture mode analysis was therefore, performed based on photographs of the damaged part.

The fragment of LP Compressor  
2<sup>nd</sup> stage disk

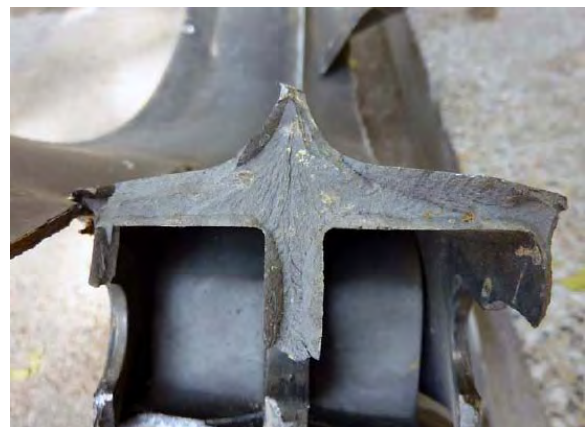
Fracture surface of LP Compressor  
2<sup>nd</sup> stage disk.

- 2.24.15. No angularity caused by plastic deformation in the initial fracture zone.
- 2.24.16. Smooth surface region in the fracture initiation zone.
- 2.24.17. The macro lines indicating stops of crack front.
- 2.24.18. The fatigue crack in the disk of LP compressor 2<sup>nd</sup> stage started from the extreme edges of the hole of the disk. The hole is meant for installing the bushing for pin of compressor blades (picture below).

The arrow shows the place of a fatigue crack initiation on LP compressor 2<sup>nd</sup> stage disk

- 3.2.1. The 2<sup>nd</sup> stage disk of LP compressor was the first component to fail because of fatigue fracture due to fretting corrosion in the holes designed to install the bushings for pin of the compressor blades.
