**CIVIL AVIATION AUTHORITY  
KARACHI PAKISTAN**

**INCIDENT INVESTIGATION IN RESPECT TO  
M/S PIAC BOEING 737 REG NO AP-BCB  
OCCURRED ON 31<sup>ST</sup> DECEMBER 2000**

## FINAL REPORT

### INCIDENT RELATING TO PIAC BOEING 737 PAKISTAN AP-BCB AT FAISALABAD AIRPORT ON 31<sup>ST</sup> DECEMBER 2000

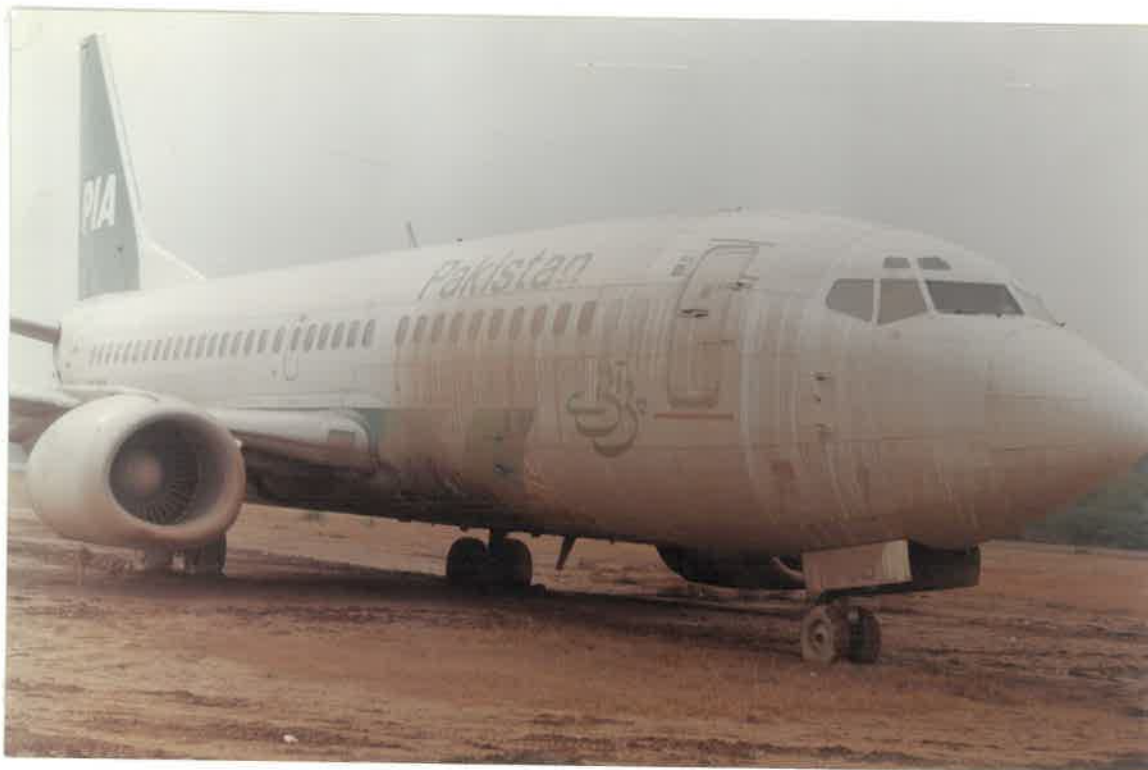
1.12.1 For Final Flight Path details refer Appendix 'G1 to G3'. For Ground Path refer Appendix 'H'. After landing, aircraft came to a stop in 'Kutchra' about 350 feet ahead of the stopway and about 22 feet left of the extended centre line.

VIEW OF AIRCRAFT ON KUTCHA

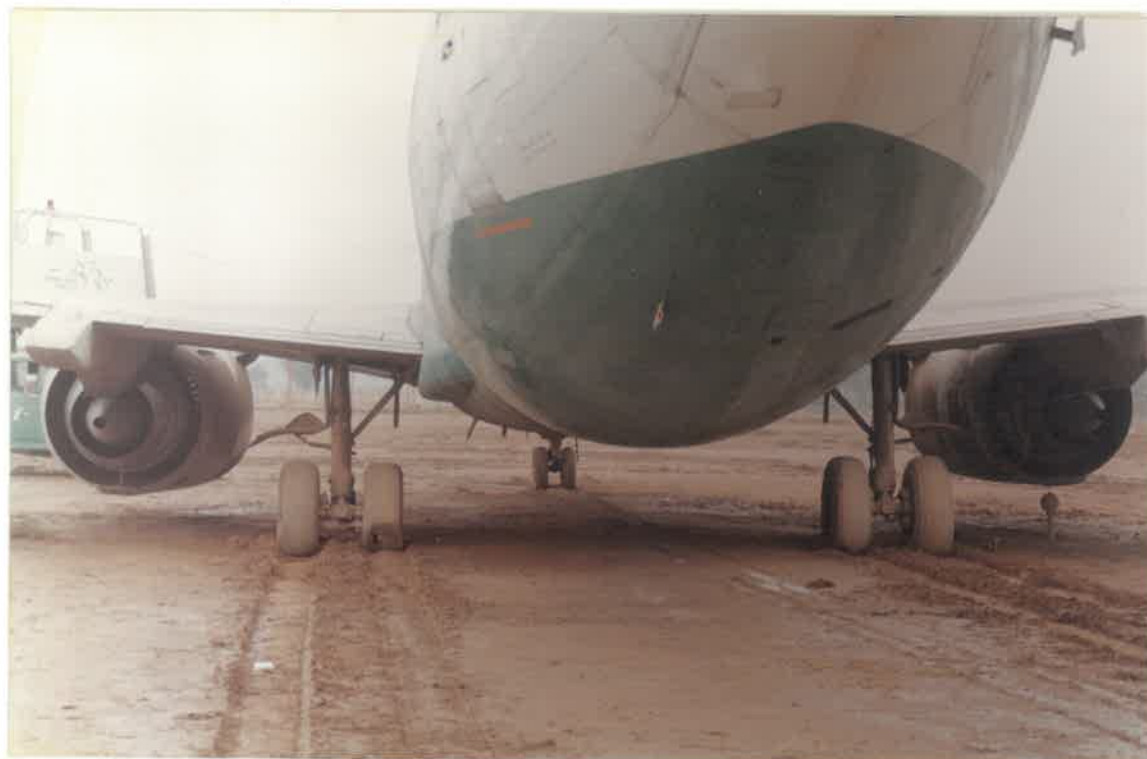
1.3 Damage to Aircraft No 2 and No 3 main wheel tyres burst. No 4 tyre had a deep cut. No 1 engine inlet cowl inner skin perforated (approximately ½") at three places. Twenty fan blades of No 1 engine and thirteen fan blades of No 2 engine damaged.

VIEW OF AIRCRAFT TYRES

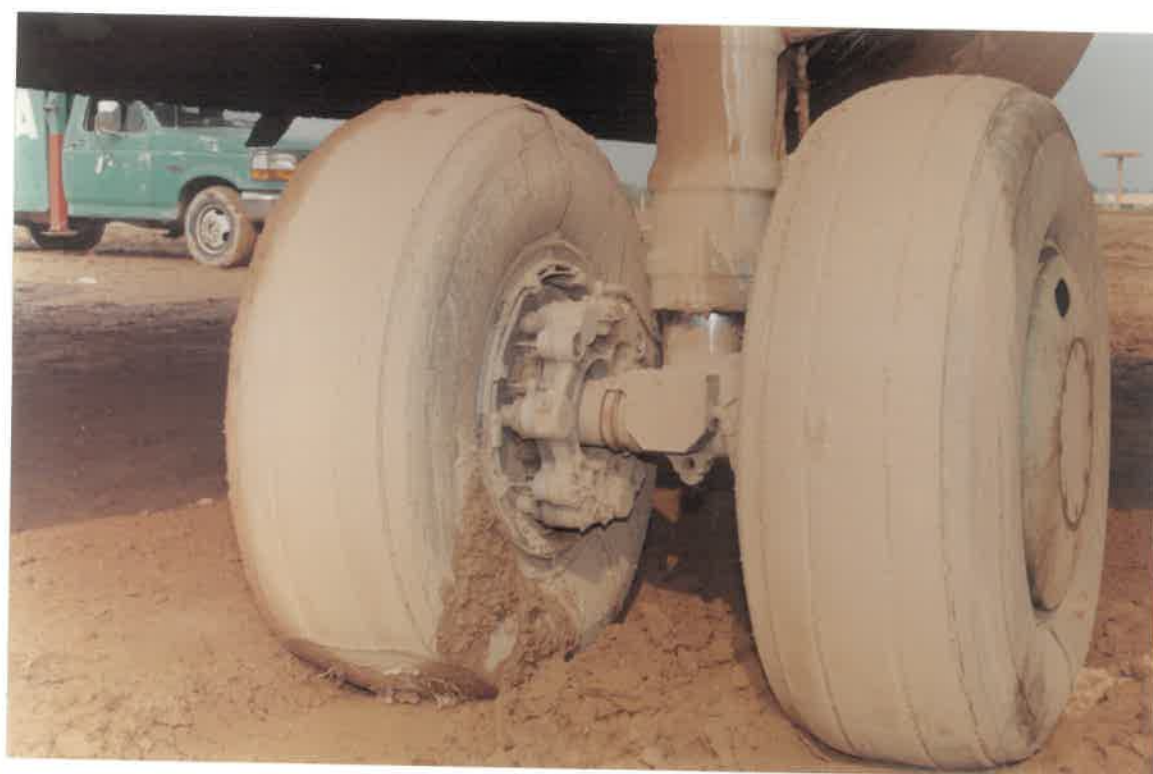
- 3.1.31 The runway remained closed for about 21 hours after the incident. Only one other PIA Flight to Faisalabad was affected during this period.
- 3.1.32 Both main inboard tyres (No 2 & 3) skidded on the runway surface, resulting in flat spots in tyres No 2 & 3 and deflation of left inboard (No 2) tyre. On shop inspection at Karachi the anti-skid system was found serviceable. The matter is being referred to Boeing Company for their opinion on the possible cause(s) of tyres failure.

RIGHT MAIN GEAR TYRES VIEWED FROM REAR OF AIRCRAFT  
(NO.3 TYRE HAS A FLAT SPOT)

- a) The possible cause(s) of tyre failure while the anti-skid system is serviceable.
- b) The pros and cons of switching off engines if the aircraft enters unprepared surface.

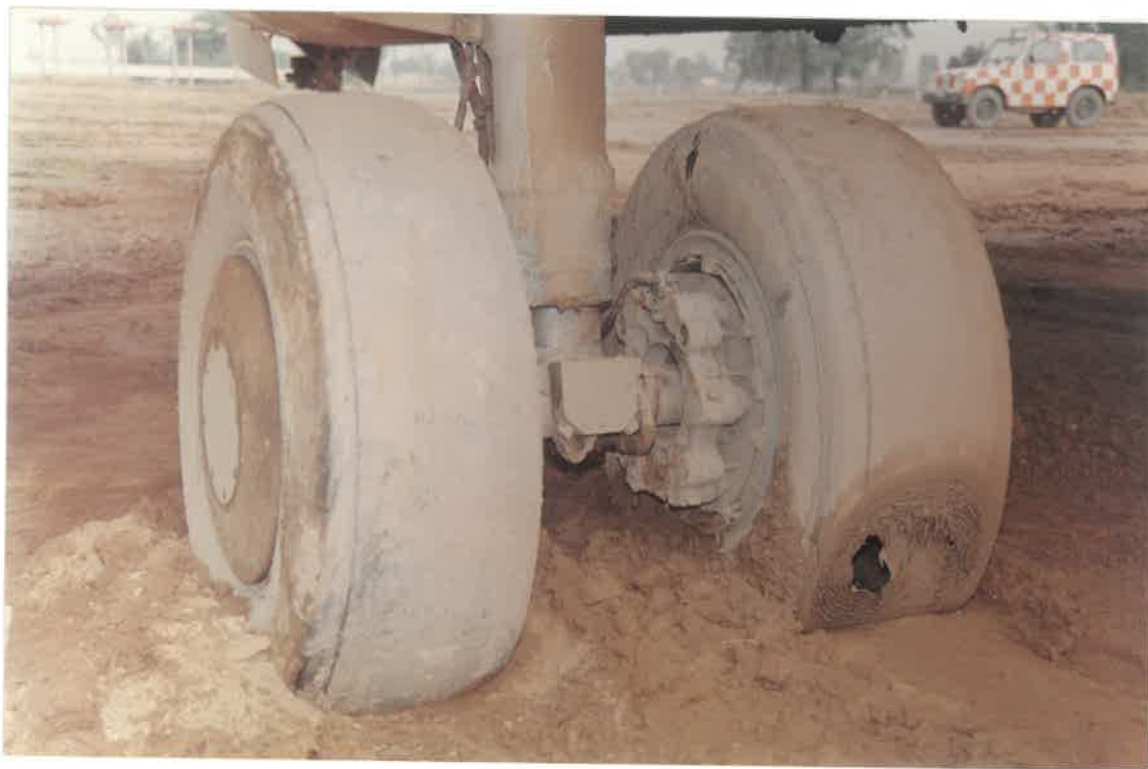
- 3.1.33 Tyre No 1 was found bald, though within satisfactory limits for flight. Bald tyres have reduced traction which can adversely affect landing distance especially on a wet runway.

LEFT MAIN GEAR TYRES VIEWED FROM REAR OF AIRCRAFT  
(NO.2 TYRE WITH A FLAT SPOT BURST & NO.1 TYRE BALD)

- a) Not using bald tyres during general inclement weather conditions.
- b) Positioning a universal tow bar at its airports.
- f) Carrying out annual route check flights for first officers.

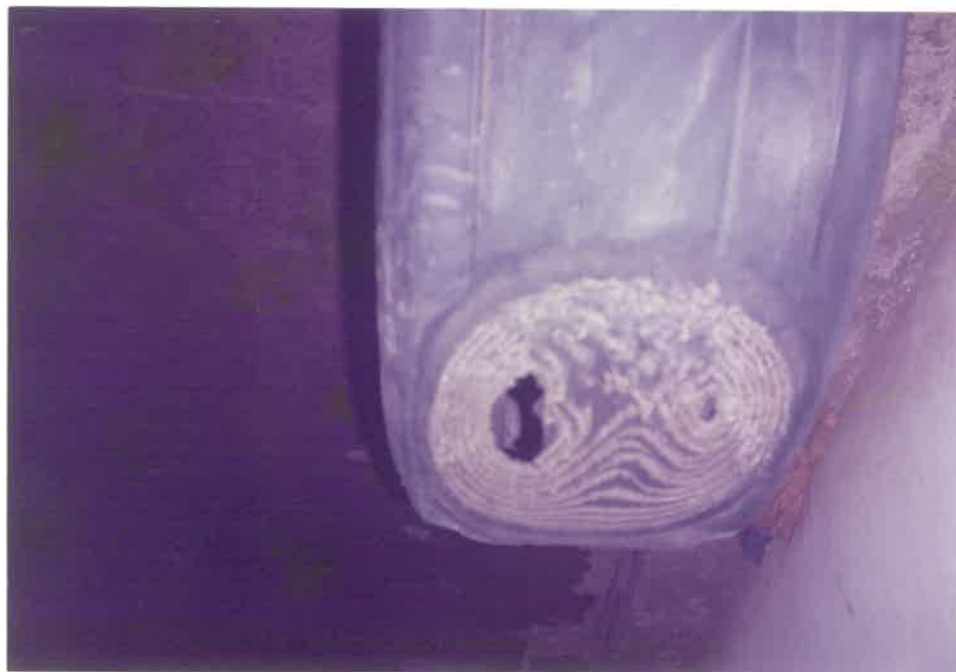
2.1.2.3 According to the aircrew this light did not illuminate. DFDR and other evidence show that the aircrew applied brakes after touchdown (all gears down). Yet anti skid system should have prevented wheel locking or skidding

even on a wet runway. Post incident inspection of the anti-skid system at Karachi revealed no defect with the anti skid system (Appendix 'N'). The case is being referred to Boeing for comments.

FLAT SPOT - NO. 2 TYRE

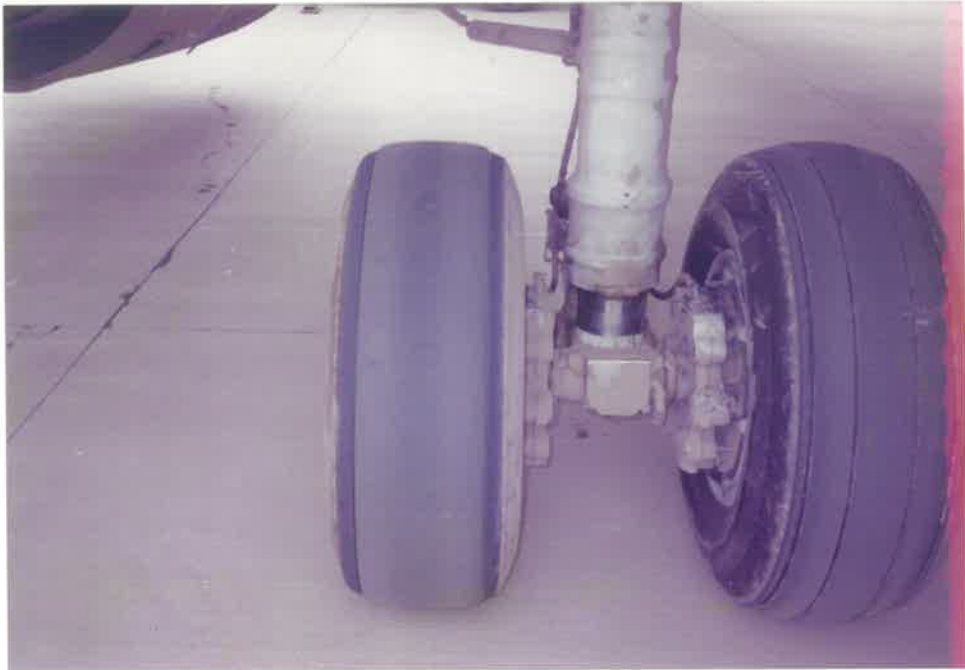
2.1.3.1 No 1 tyre was observed to be bald.

2.1.3.2 The tyres may remain in service if the tread reinforcement ply shows. As per Boeing maintenance manual chapter 32-45 (Appendix 'O') if the tread reinforcement ply does not show the tyre may be used without safety concerns. In this particular case, the tyre was not showing tread reinforcement ply. As such it was safe to use. It may, however, be noted that bald tyres may cause reduced wheel traction special due to aqua planing on wet runways which may contribute to jamming of the wheels.

BALD NO. 1 TYRE

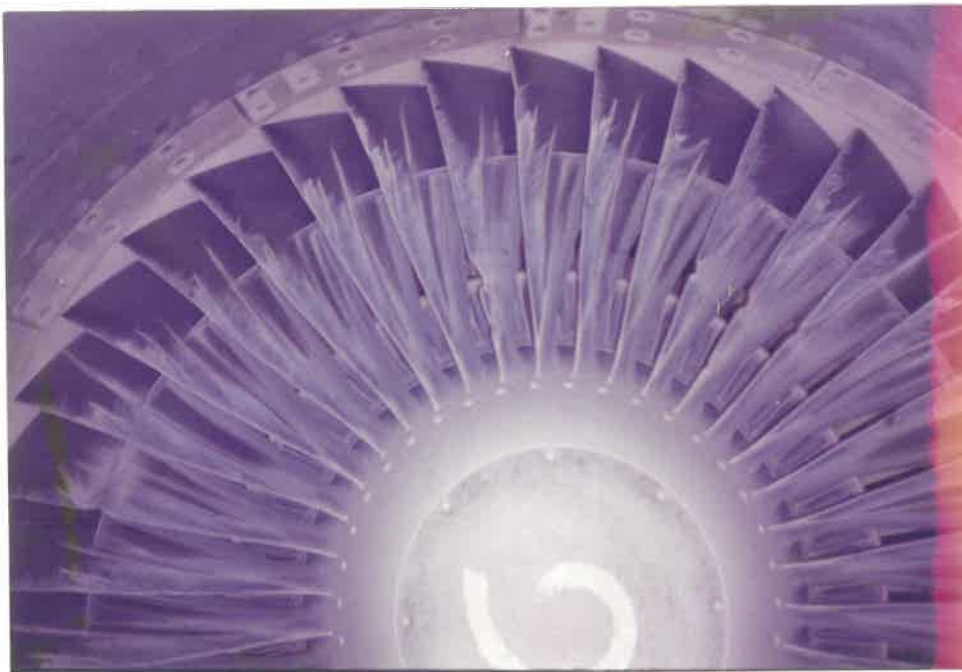
3.1.35 Fan blades of both engines were damaged. This can be best attributed to debris lifted up from the ground and ingested in the engines as a result of high power on engines plus reverse thrust when the aircraft went on to Kutcha.

ENGINE DAMAGE
