## FINAL INVESTIGATION REPORT

**SERIOUS INCIDENT (TCAS – RA) BETWEEN AERO NOMAD  
AIRLINE FLIGHT ANK4506, AIRBUS 320-233 AIRCRAFT, REG.  
NO. EX-32009 (OPIS – UCFM) & BRITISH AIRWAYS FLIGHT  
BAW2261, BOEING 777-236ER AIRCRAFT, REG. NO. GYMMD,  
(EGLL – OPIS) ON 05-06-2022**

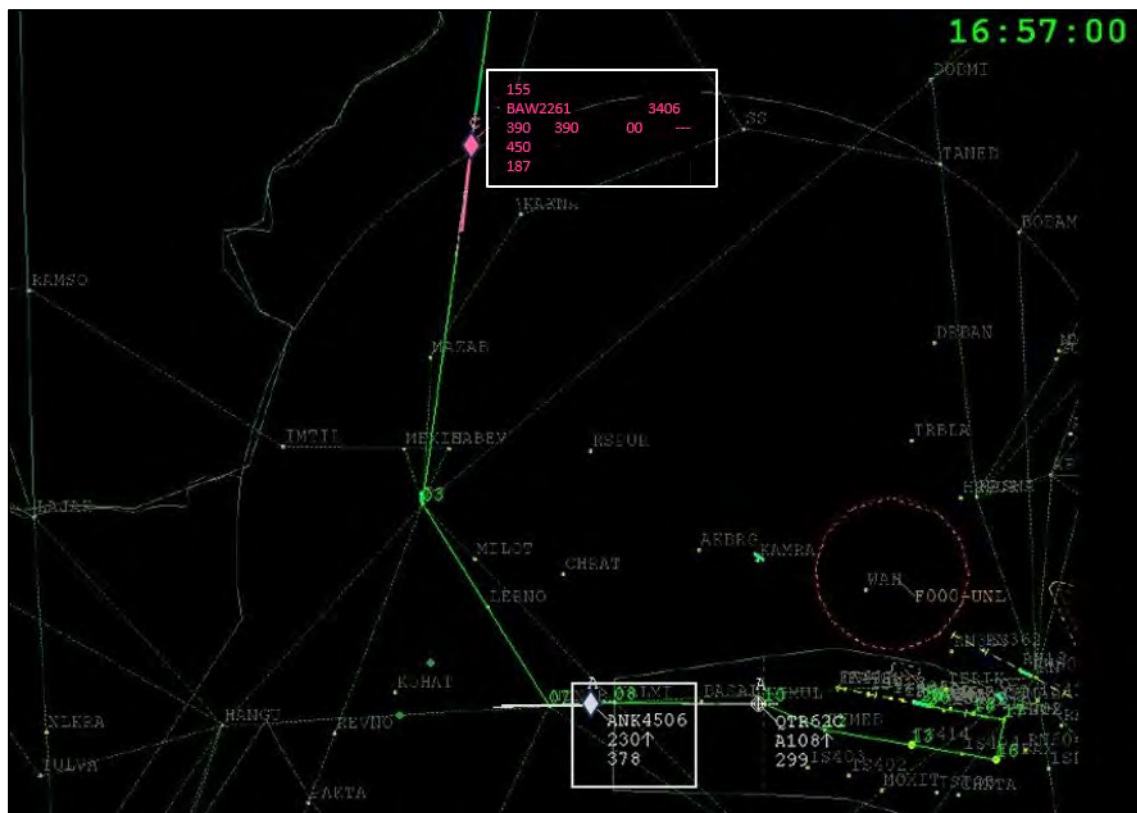
Figure 7 ANK came in contact with Islamabad ACC

2.1.4. At 16:57 h, ANK4506 came in contact with Islamabad ACC and was instructed to continue climb to FL320.

2.1.5. At the same time, BAW2261 was given descent to FL330.

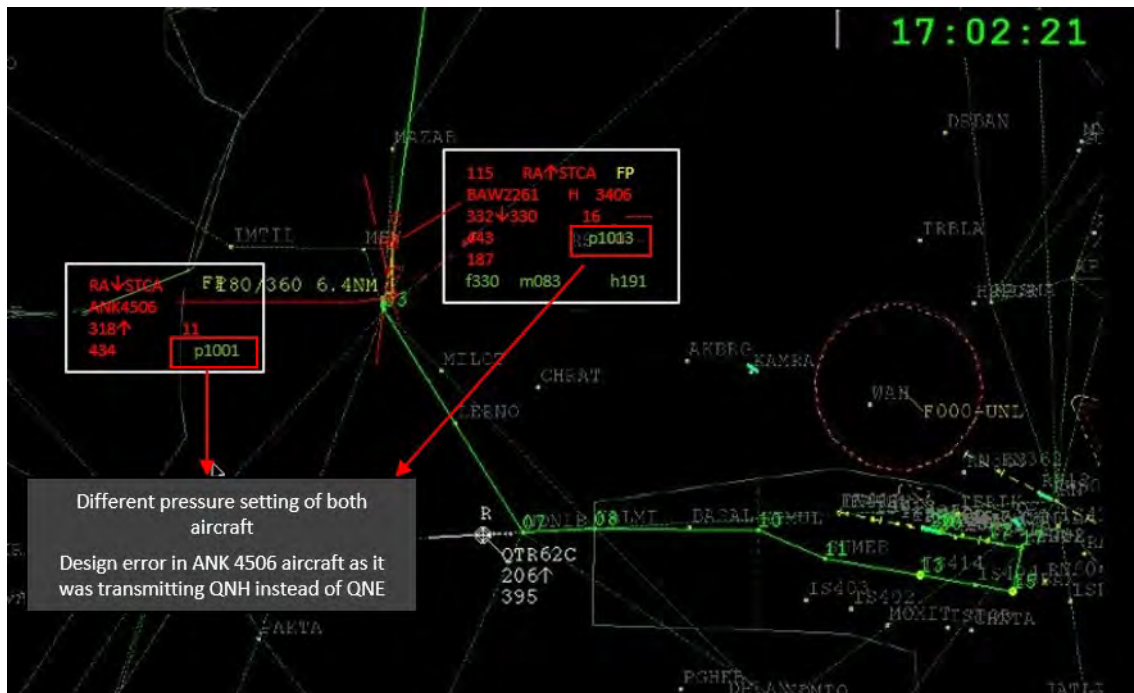
Figure 10 Activation of RA

2.1.9. When ANK4506 was 05 NM North of position PS VOR climbing out of FL318 for FL320 with ROC 1,100 ft/min, it encountered TCAS-RA with reciprocal traffic BAW2261 which was descending from FL390 to FL330 passing FL332 with ROD 1,600 ft/min at the time of incident.

2.1.10. ANK4506 descended from FL318 to FL315 on TCAS-RA. Meanwhile, BAW2261 did not report TCAS-RA however, it followed TCAS-RA command to level off at FL330<sup>9</sup>.

2.1.11. BAW2261 was maintaining high ROD Approx 2,200 ft / min just before RA which was contrary to ICAO Doc 8168 Vol-III<sup>10</sup>, which states: -

2.1.12. It was observed on Radar Display that the ROD of BAW2261 was fluctuating before the RA.
