**PAKISTAN CIVIL AVIATION AUTHORITY**  
**(SAFETY INVESTIGATION BOARD)**

**FINAL REPORT**

**SERIOUS INCIDENT OF M/S SCHON AIR CESSNA-172P**  
**AIRCRAFT, REG # AP-BJG FORCED LANDING NEAR**  
**SUPER HIGHWAY AT 064<sup>0</sup> / 56 NM FROM**  
**JIAP, KARACHI ON 19<sup>TH</sup> MARCH, 2012**

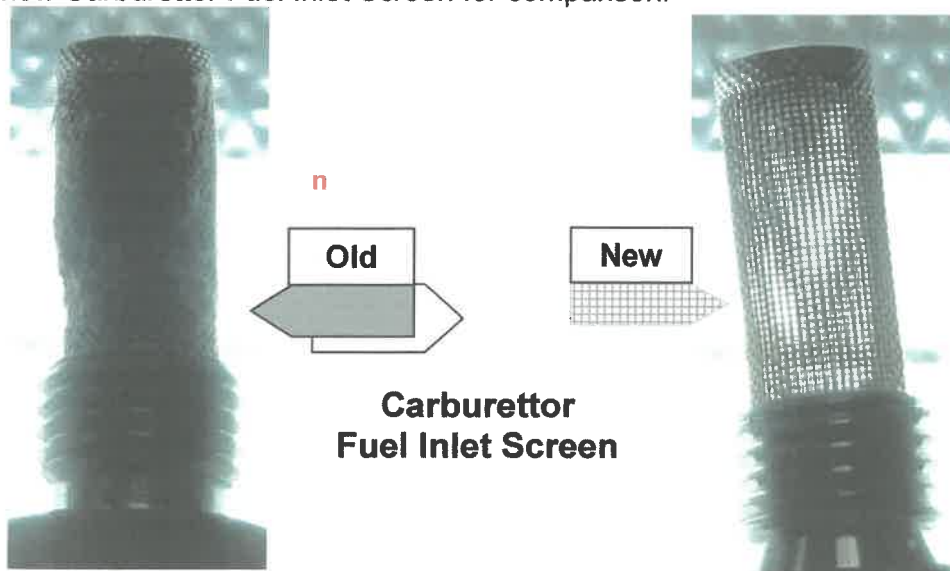
**2.2.4 Carburettor Fuel Inlet Screen.** Carburettor Fuel Inlet Screen was removed from the Carburettor. It was found in almost completely clogged condition. Further investigation revealed that the Carburettor Fuel Inlet Screen was not removed and inspected during the last overhaul by Schon Air Maintenance Organization considering it to be an integral part of the carburettor contrary to the Original Equipment Manufacturer (OEM) instructions which required its removal, inspection, cleaning and replacement (if found damaged or deteriorated). Reference maintenance procedures for Lycoming engines given in Lycoming Operator's Manual (refer Appendix "D") and carburettor overhaul instructions given in Marvel-Schebler Aircraft Carburetor Overhaul Instructions for models MA-4-5 and MA-4-5AA. The photographs below show the clogged Carburettor Fuel Inlet Screen removed from the carburettor and the new Carburettor Fuel Inlet Screen for comparison.

- 3.2.6 Carburettor Fuel Inlet Screen was found completely clogged.
- 3.2.7 Carburettor Fuel Inlet Screen was not removed and inspected during the last overhaul by Schon Air Maintenance Organization contrary to the OEM instructions.

- 5.1 **Cause of Occurrence.** Non conformance of the OEM instructions by Schon Air Maintenance Organization resulted in failure to carry out inspection of Carburettor Fuel Inlet Screen during the last overhaul which got clogged in subsequent operational service and caused the serious incident of partial power loss.

- 3.2.8 After replacement of the old Carburettor Fuel Inlet Screen with a new one, the engine ground run was performed in which all parameters were found within limits.

- 6.2 All general aviation maintenance organizations and operators are to ensure inspection of the Carburettor Fuel Inlet Screen as per the schedule inspections specified by the OEM.
