**CIVIL AVIATION AUTHORITY**

INVESTIGATION REPORT

FIRE INCIDENT TO RAJI AVIATION (PVT) LTD.

AIRCRAFT CESSNA-337 AP-BBX

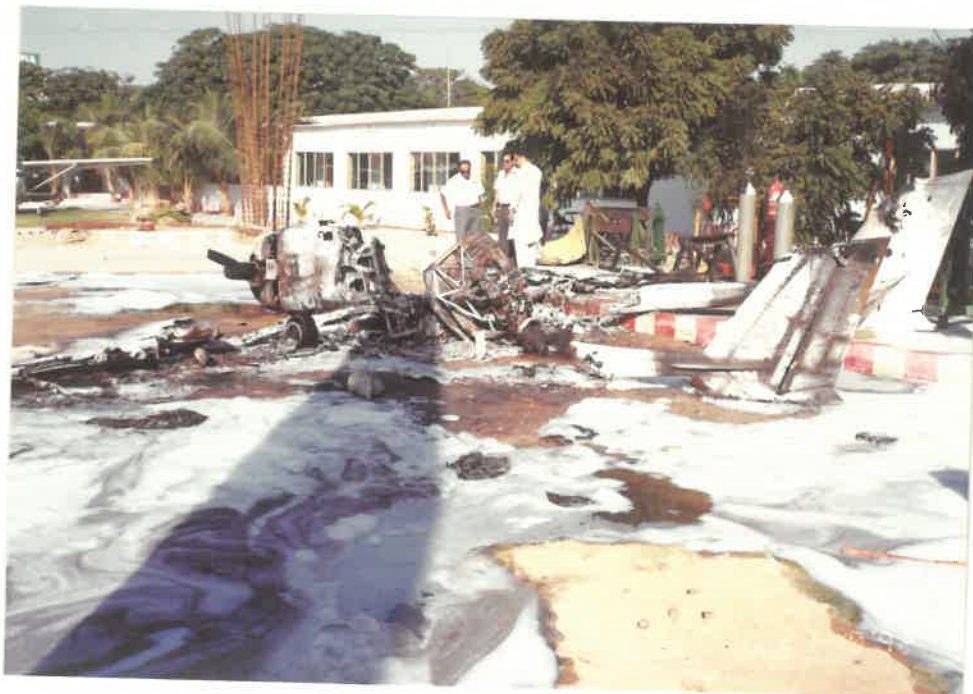
APP- "B<sub>1</sub>"

5.1. Upon arrival of investigation team at the scene on the day of fire incident at about 0645 P.M. the wreckage of aircraft was being removed at the spot. The brief look of wreckage indicates that aircraft was totally burnt. Both the wings had fallen apart and were found burnt. The engine position was similar as seen. The remains of aircraft was its totally burnt fuselage section.

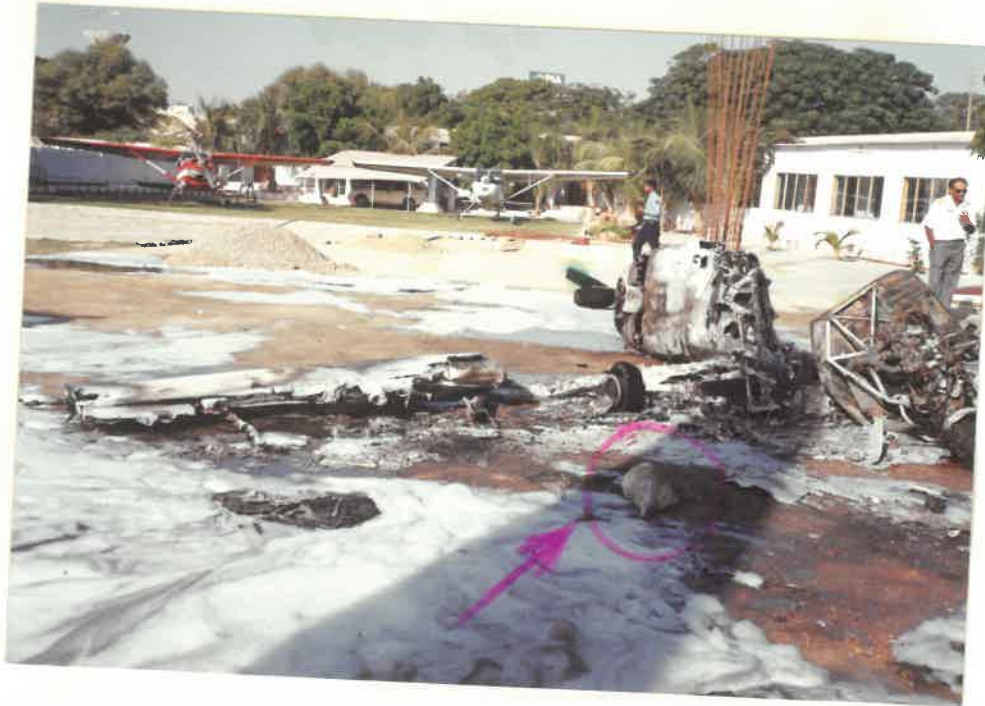
APP. "B4"

13.1. M/S. Raji Aviation had been involved in wrong practice of fuelling and defuelling aircraft without taking the required precaution. This is evident at (App."B4 - B11"). Although the aircraft was unairworthy, the aircraft was being refueled regularly. Fuel as much as 500 litres was being filled in this aircraft after a gap of 6 or 7 days indicates that this fuel was later on being transferred to other aircraft by means of small plastic buckets. This is a wrong practice as it may cause fuel contamination and cause flame out of the

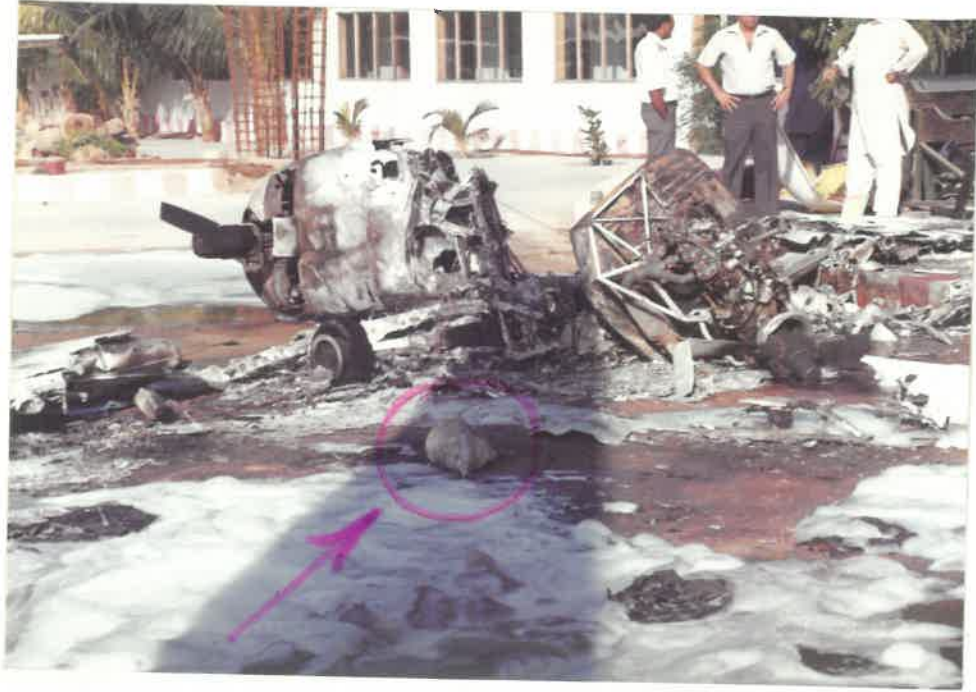
APP. "B11"

aircraft. On one of the inspections of Raji Aviation Company this point was mentioned by the officer in his inspection report (Appendix O&P ). The company were told to stop this practise immediately. The presence of the funnel in the photograph at (App-"B11") regular refuelling receipts (App."C1 - C2") is a clear indication that this aircraft was being used to store fuel and later on fuel was transferred to other aircraft as and when required. During one of the defuelling and transfer operations the aircraft caught fire. A spark from a cigarette could have resulted in fire.

16.5. A funnel used for fuel/oil was found lying near the burnt wreckage of aircraft at the time of fire incident which indicates that some fluid was either being removed or being put in the aircraft.

19.2. The still photography made at the scene of incident clearly shows that one "FUNNEL" is lying loose which was probably left near the aircraft at the scene when in use. It was heat of the fire which prevented from being picked up. It was being used in defuelling of aircraft when the incident took place.

- 22.1. Standard procedures for aircraft refuelling/defuelling should be followed strictly.
- 22.2. Concerned staff may be trained on aircraft fuel handling.
- 22.3. Standard burner should be used for aircraft paint scrapping with the approval of local Airworthiness Office.
- 22.4. M/S. PBS be advised to refuel the aircraft after checking aircraft Airworthiness document and noting thereof may be made on their slip.
- 22.5. M/s. Raji Aviation should be warned not to indulge in wrong practises of refuelling and defuelling. They should strictly abide by the existing maintenance procedures.
- 22.6. Airworthiness Branch CAA may be asked to design an Air Navigation Order for refuelling and defuelling aircraft procedures alongwith all necessary precautions required to be taken during the operation. This ANO should be issued to all operators alongwith strict instruction for compliance.
