INCIDENT INVESTIGATION REPORT ON THE  
INCIDENT TO PIAC F-27 REG. MK. AP-ALN  
WHICH OCCURRED ON 31ST AUGUST, 1982 AT  
GILGIT AIRPORT.

Authority : Director General of Civil Aviation.

Memorandum : NO:IB/7-11/82 dated 21st December, 1982. (App. "A").

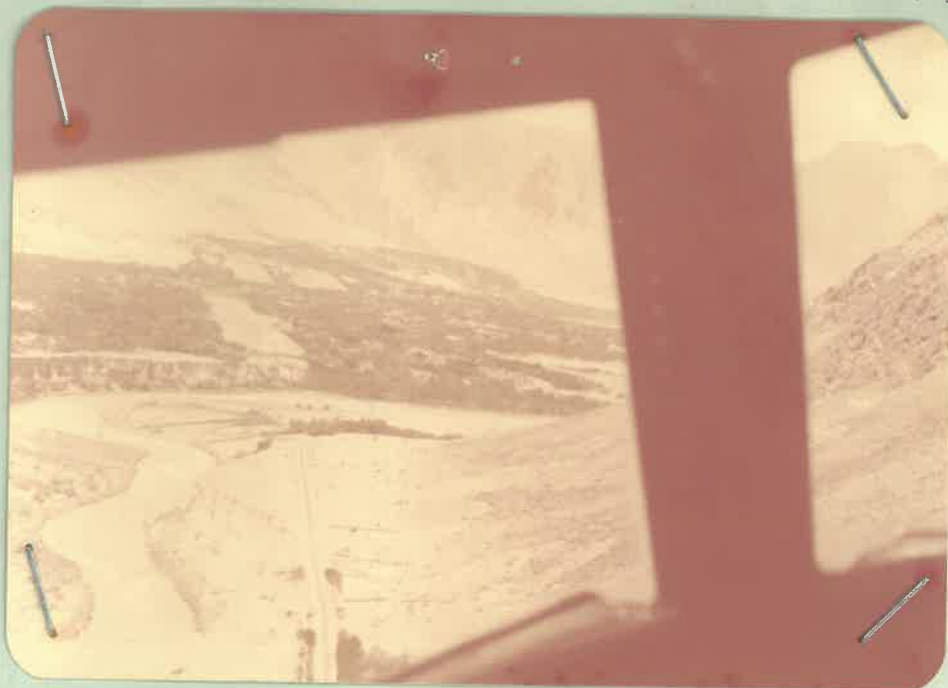
APP. 'F'<sub>1</sub>

10.1. There are hills on right hand side known as China hill. It appears close to approach path of aircraft when approaching runway 25. Proximity of the hill to the right wing tip is felt when turning on finals.

10.2. It is likely that certain pilots may feel alarmed and initiate the turn earlier than required due to incorrect rising terrain perception.

AIRCRAFT IN A LEFT TURN. NOTE HILL ON THE RIGHT HAND SIDE.

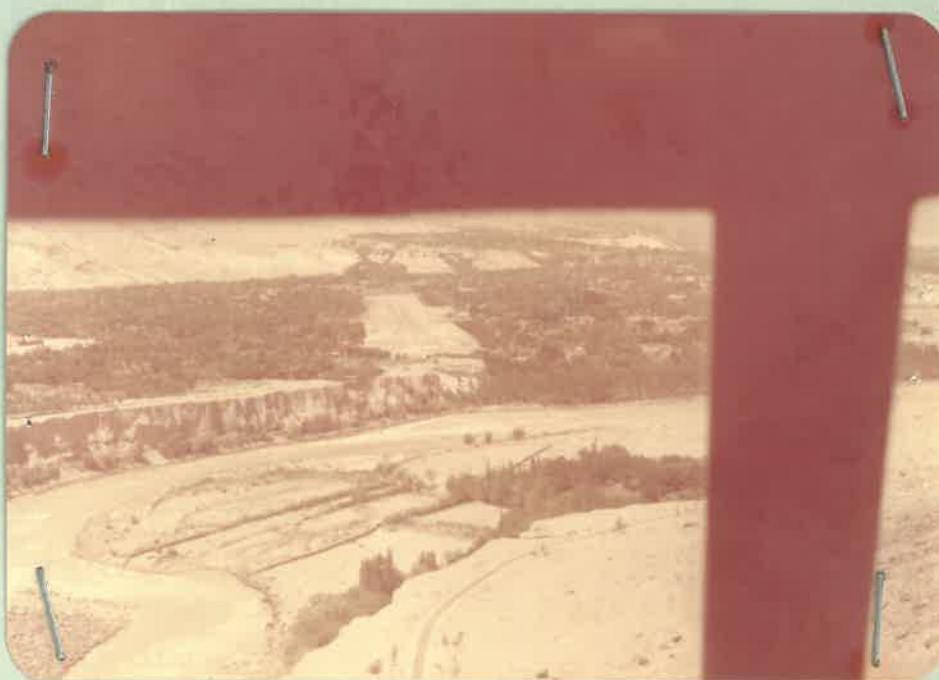
APP.  
F<sub>2</sub>

AIRCRAFT ON FINAL.

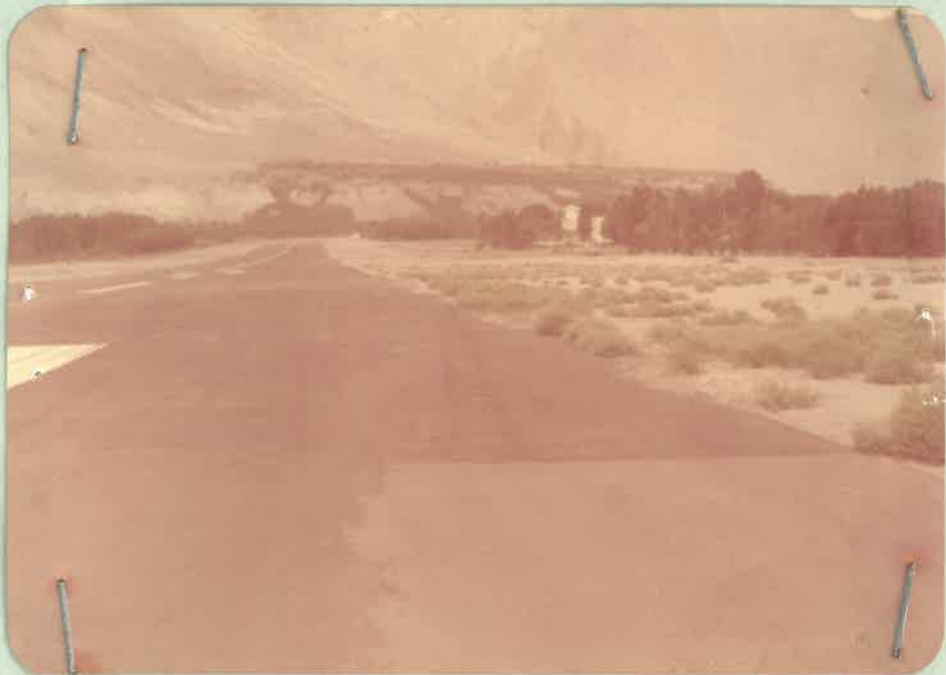
APP. "F4"

- ✓ 20.9. The aircraft was in the process of a left turn when it came in contact with runway surface. The aircraft was heading 270 degrees when the left gear touched the runway surface. The runway heading is 250 degrees.

4. TYRE MARKS SHOWING THE ANGLE AT WHICH THE LEFT HAND MAIN LANDING GEAR CONTACTED THE RUNWAY SURFACE. NOTE THAT THERE ARE NO MARKS OF RIGHT HAND LANDING GEAR.

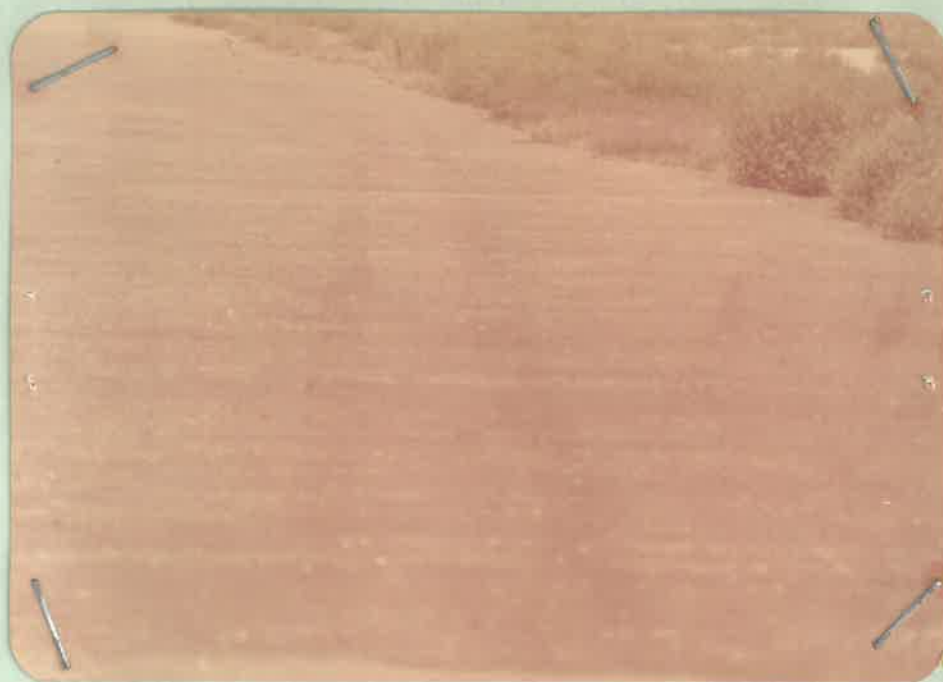
APP. F5

CLOSE UP OF THE LEFT HAND LANDING  
GEAR MARKS.

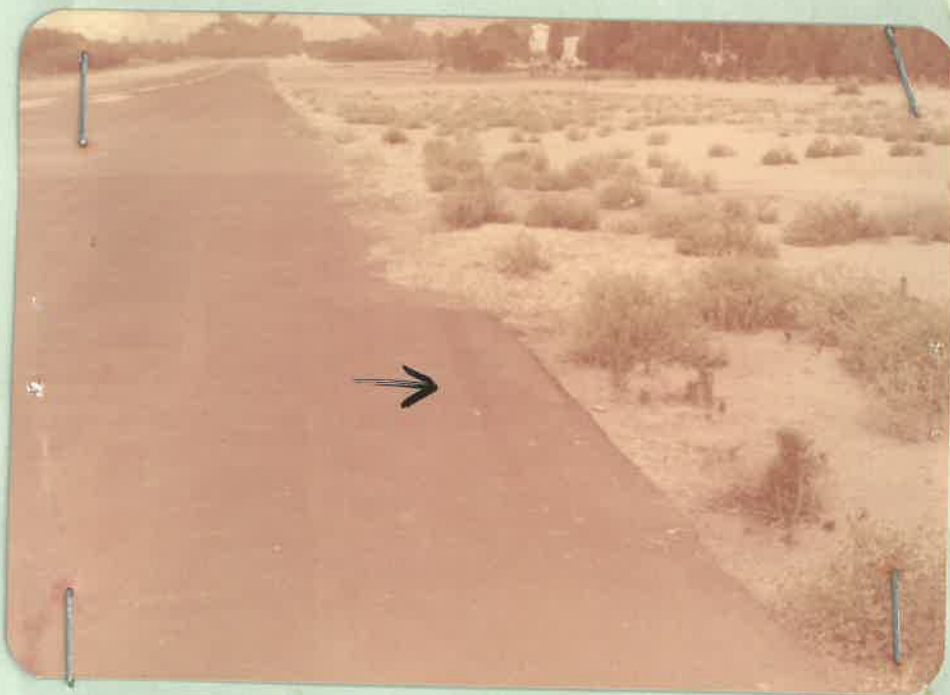
APP. F6

- ✓ 20.10. The aircraft departed the runway surface on a heading of 270 degrees.
- ✓ 20.11. The aircraft travelled on the fair weather strip for 900 feet before it re-entered the runway.

TYRE MARKS SHOWING LEFT HAND MAIN LANDING  
GEAR DEPARTING THE RUNWAY SURFACE. NOTE  
THE CONTROL TOWER AND THE FIRE STATION  
BUILDINGS ON RIGHT OF THE RUNWAY.

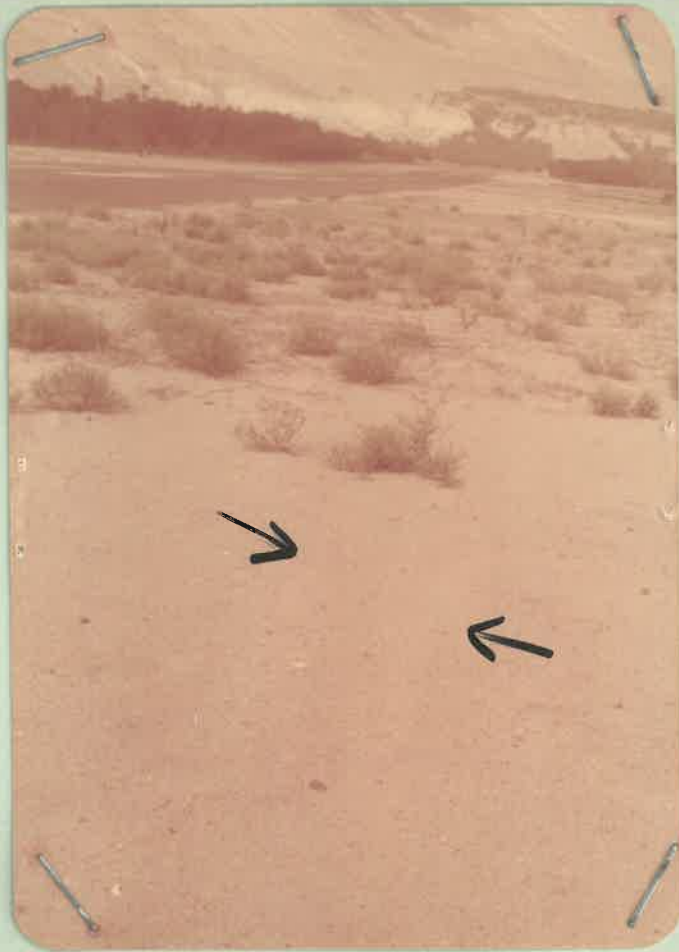
APP. F7<sup>4</sup>

19.11. After the aircraft left the runway surface, it has travelled on the fair weather strip, right of the runway for 900 feet. Tyre marks are visible on this strip. These marks were shown to Captain Akram Baig, during his visit to Gilgit by the Airport Manager, Gilgit. (APP. " E " ). This supports statement of the Airport Manager, who has stated that the aircraft travelled on this area for 900 feet. The tyre marks were still visible on the fair weather strip when the investigator visited Gilgit almost 9 months after the incident. (APP. " F " ).

RIGHT MAIN LANDING GEAR MARKS ON THE FAIR WEATHER STRIP, RIGHT OF THE RUNWAY. THE LEFT HAND LANDING GEAR MARKS CAN NOT BE SEEN IN THE PHOTOGRAPH DUE TO SHRUBS ALONG SIDE THE RUNWAY EDGE.

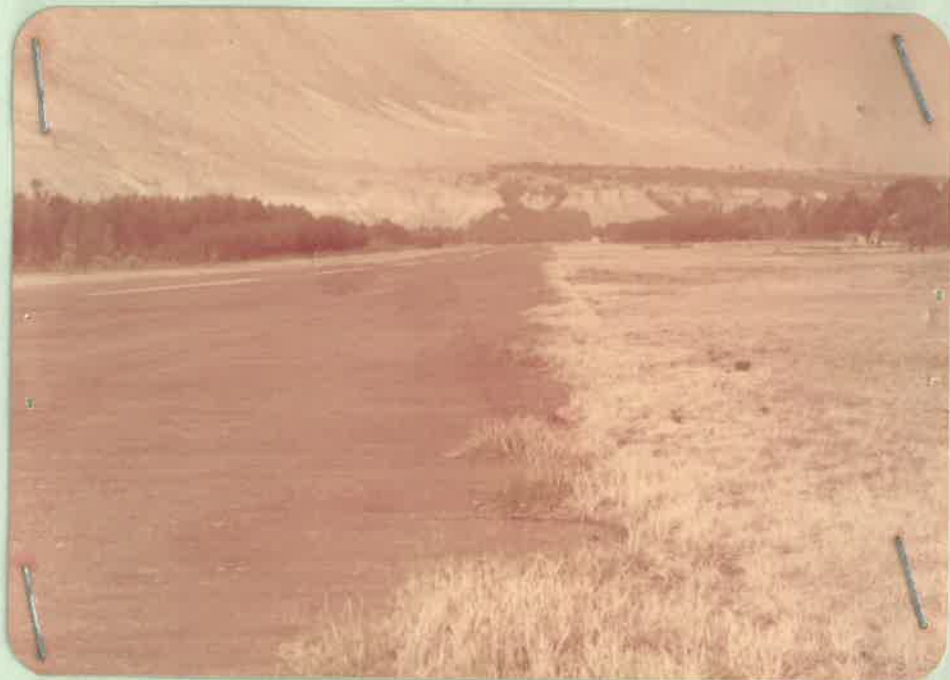
APP. F8<sup>4</sup>

19.12. After a travel of 900 feet on the fair weather strip, as stated in the preceding paragraph, the aircraft made a converging angle of approx 15 degrees to the runway heading. Once again this fact has been confirmed by the tyre marks. (APP. " F " ). Captain Akram Baig, after seeing the photographs which form part of this report, has confirmed that these are the same marks that he saw during his visit to Gilgit after the incident had occurred. The Airport Manager, Gilgit has also stated that after its travel on the fair weather strip, the aircraft came back on the runway. Read out of the Flight Data Recorder also confirms this fact. (APP. " B-1 " ).

19.13. Tyre marks on the runway at a point approximately 1500 hundred feet from the threshold of runway 25, continue for 300 feet on the runway. ( APP. " F " ). These marks are not visible after reaching 7 feet short of the centre line of runway. (APP. "F" ). Both the Pilots have stated that the aircraft was gradually brought to the centre. The tyre marks confirm that it was a gradual left turn ( 15 degrees ).

LEFT HAND MAIN LANDING GEAR TYRE MARKS SHOW RE-ENTRY OF THE AIRCRAFT ON TO THE RUNWAY. IT GRADUALLY DESIPATES WHEN APPROACH IN THE CENTRE LINE. PLEASE ALSO NOTE THE AIRCRAFT MAKING A GRADUAL LEFT TURN TO COME TO CENTRE OF RUNWAY.
