# **FINAL INVESTIGATION REPORT**

**SERIOUS INCIDENT OF M/S. KK AVIATION CESSNA – 172  
AIRCRAFT REG. NO. AP-BJG AT JINNAH INTERNATIONAL  
AIRPORT (JIAP) ON 06<sup>TH</sup> JUNE, 2017**

### SERIOUS INCIDENT OF M/S KK AVIATION CESSNA-172 AIRCRAFT REG. NO. AP-BJG AT JINNAH INTERNATIONAL AIRPORT (JIAP) KARACHI ON 06<sup>TH</sup> JUNE, 2017

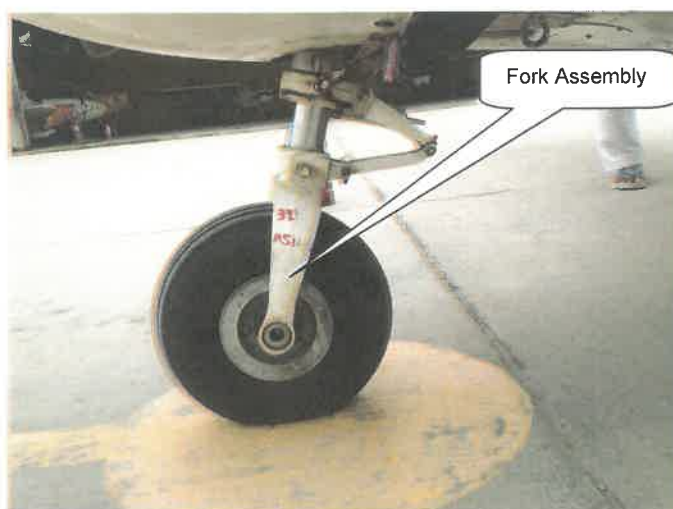
*Nose Wheel Assembly C-172*

- 2.1.1. The following picture shows the location of failed part and other related components of Nose wheel assembly.

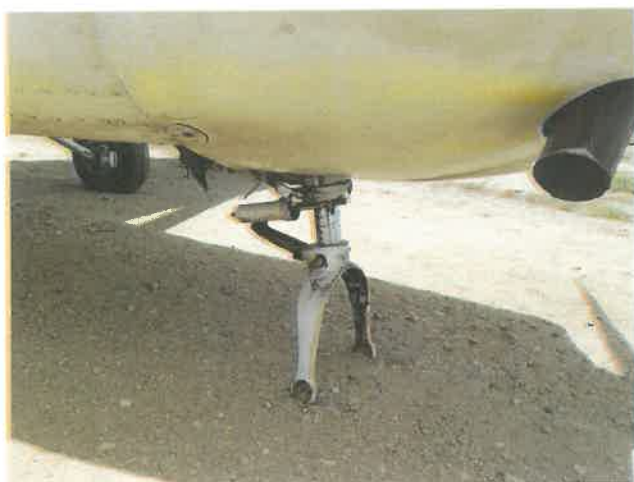
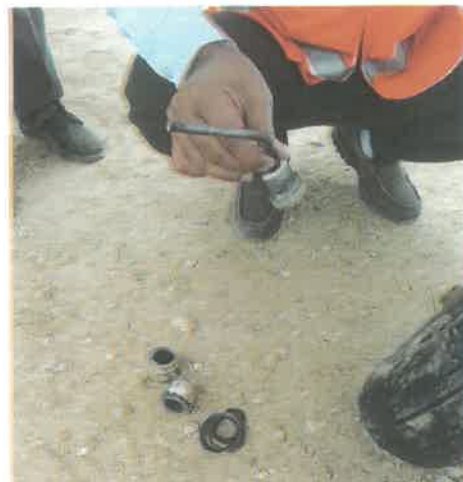
- 2.1.2. On post incident, nose wheel was found completely detached from the fork of nose landing gear and the aircraft was towed back to the premises of KK Aviation using a wheel disable dolly.

*Nose Wheel completely Detached Away from the Fork*

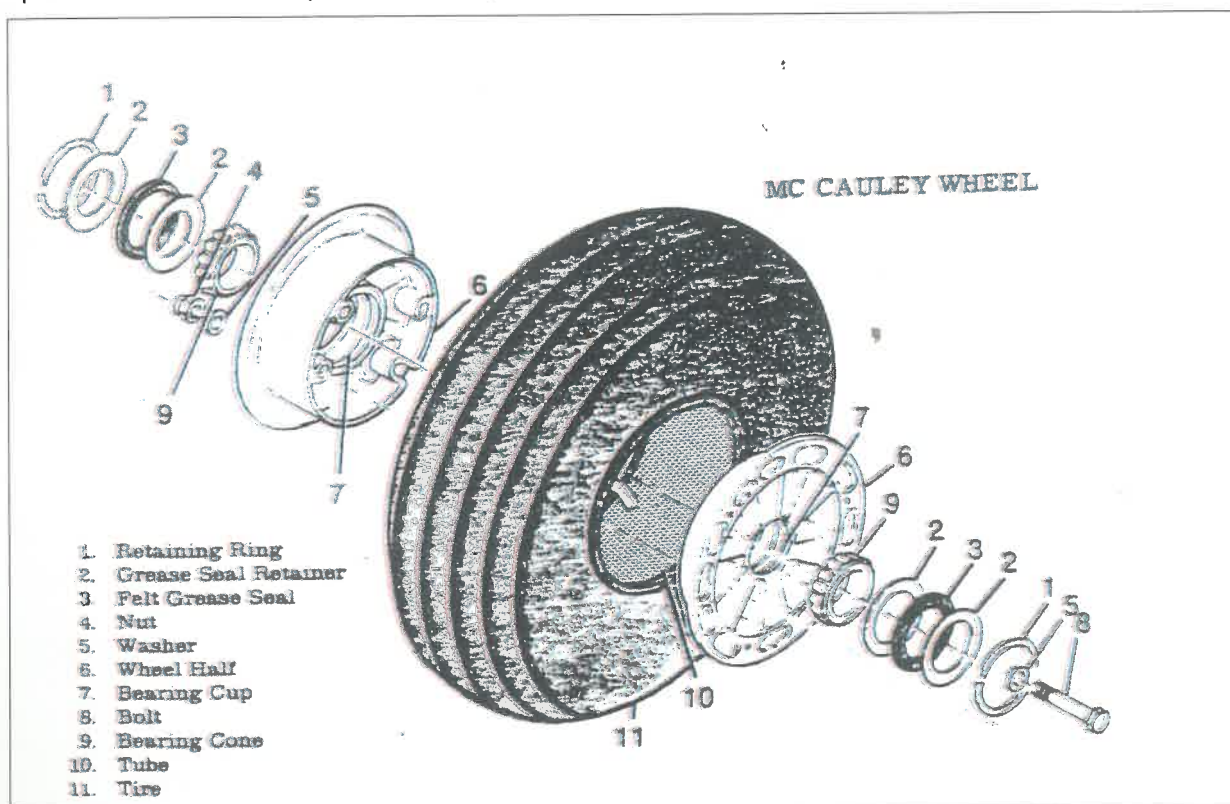
- 2.2. **Mechanism of Nose Wheel on Cessna-172.** The aircraft is equipped with 03 fixed legs including nose leg. The nose wheel is installed between a Fork with the help of different parts as shown in the picture below :

- 2.2.1. There are 02 identical sets of parts (One set contains S Nos 1-9 except S No 8 Thru Bolt which is used in Qty-01) to assemble the nose wheel onto the fork.
- 2.2.2. During post incident inspection, it was found that Thru Bolt (S No 8 as mentioned in the picture given above) was deficient of its one out of the two sets as shown in the picture below :

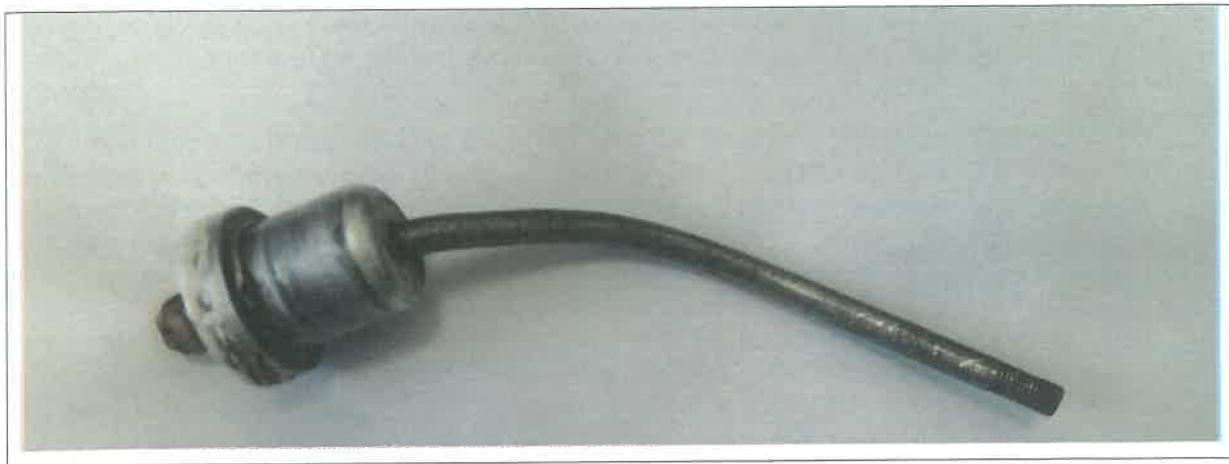
- 2.2.3. It was evident that the securing nut (S No 4) was missing along with its split pin besides other parts. Further visual and close examination of the threads show that 2-3 male threads on this thru bolt have been washed away at the point where the nut reaches once it is fully tightened whereas the remaining threads are in serviceable condition :

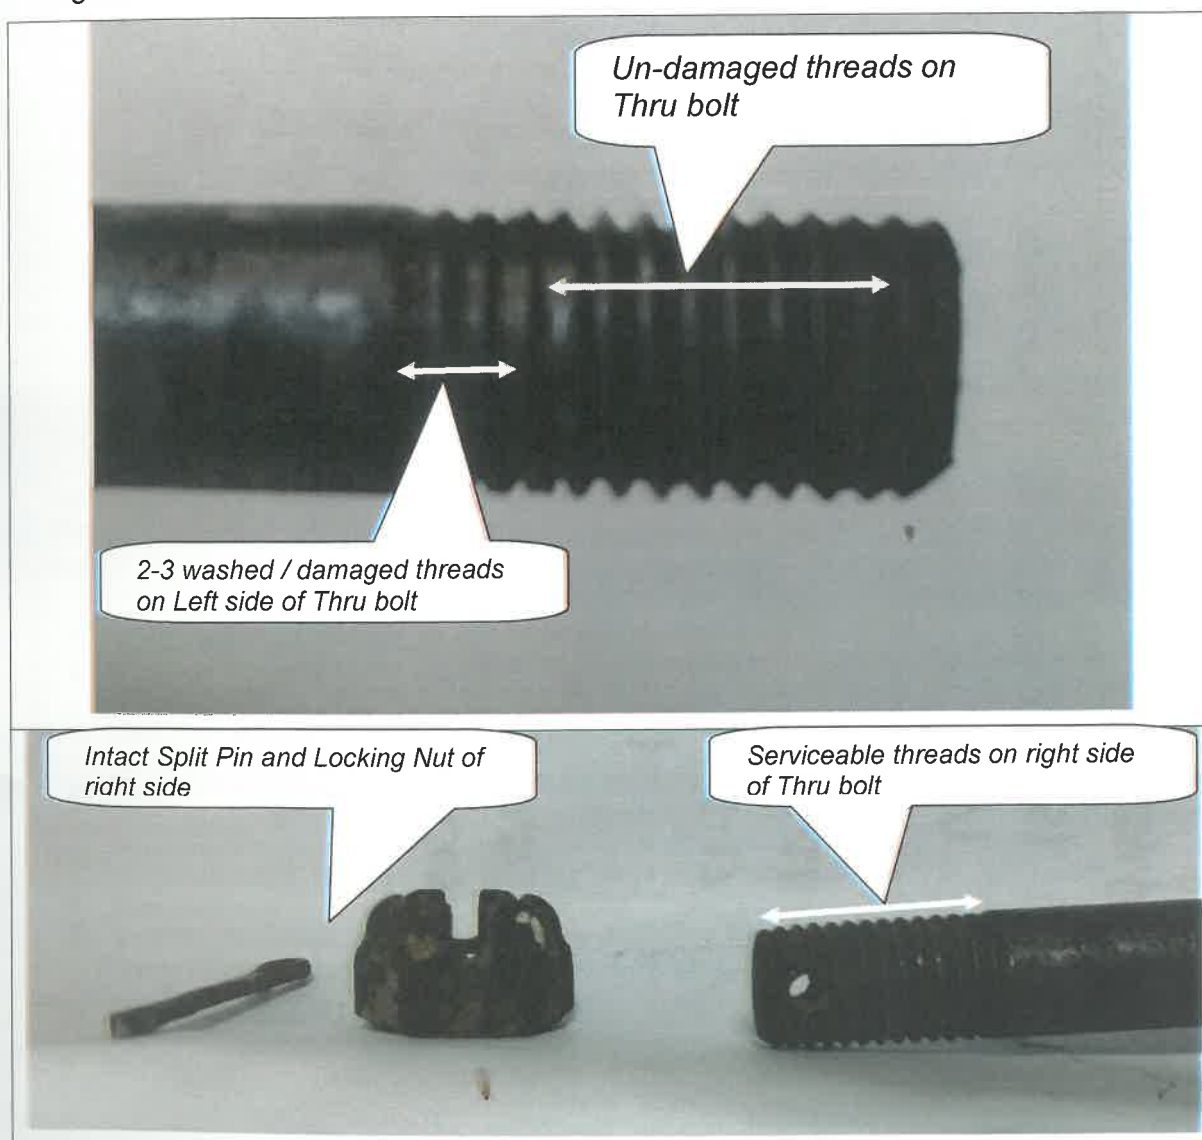
- 2.2.4. The damaged 2-3 male threads at the point where the nut reaches once it is fully tightened, indicate that the nut has initially slipped over these damaged male threads causing the split pin to slice away. The split pin is kept in place to avoid inadvertent rotation of the lock nut on thru bolt. Once the split goes away, the lock nut shall not retain its locked position and shall be rotated with the rotation of the nose wheel causing it to free the thru bolt.

- 2.2.5. The other intact end of the Thru Bolt was disassembled at the workshop as shown in the picture given above. The male threads on this end of the Thru Bolt are in serviceable condition.
- 2.2.6. The nose wheel is removed after every 500 hrs for servicing of the bearings. Last 500 hrs inspection was carried out on 20 August, 2016 and the aircraft had flown 331 hrs since then till day of the occurrence.

- 2.2.8. On the contrary, the worn out condition of male threads on Thru Bolt (as shown above) clearly suggest that Thru Bolt was to be replaced during previous inspection(s), however, same was not done at KK Aviation. Consequently, the Thru Bolt couldn't retain its Split Pin

and Lock not leading to inadvertent detachment of the nose wheel from its fork assembly just after landing.

- 3.2.1 The worn out condition of male threads on Thru Bolt lead to in-advertant slicing of the Split Pin leading to un-tightening of Lock Nut. Consequently, the Thru Bolt came out at its own from its Fork Assembly which resulted in detachment of the nose wheel during landing roll.

- 4.1. KK Aviation is required to ensure strict adherence to the steps mentioned in the maintenance manual provided by the OEM with a special emphasis on conditional change items.
- 4.2. KK Aviation is required to maintain an adequate stock level of all spares essentially required to carry out scheduled and un-scheduled maintenance of the aircraft.
- 4.3. KK Aviation is required to carry out one time inspection of Thru Bolts of all aircraft of same type held at their end to identify and replace any unserviceable one.
- 4.4. Directorate of Air Worthiness, PCAA is recommended to revisit their checklist for C of A to ensure that an operator has adequate stock of spares to accomplish schedule and un-schedule servicing of an aircraft at least for next one year.

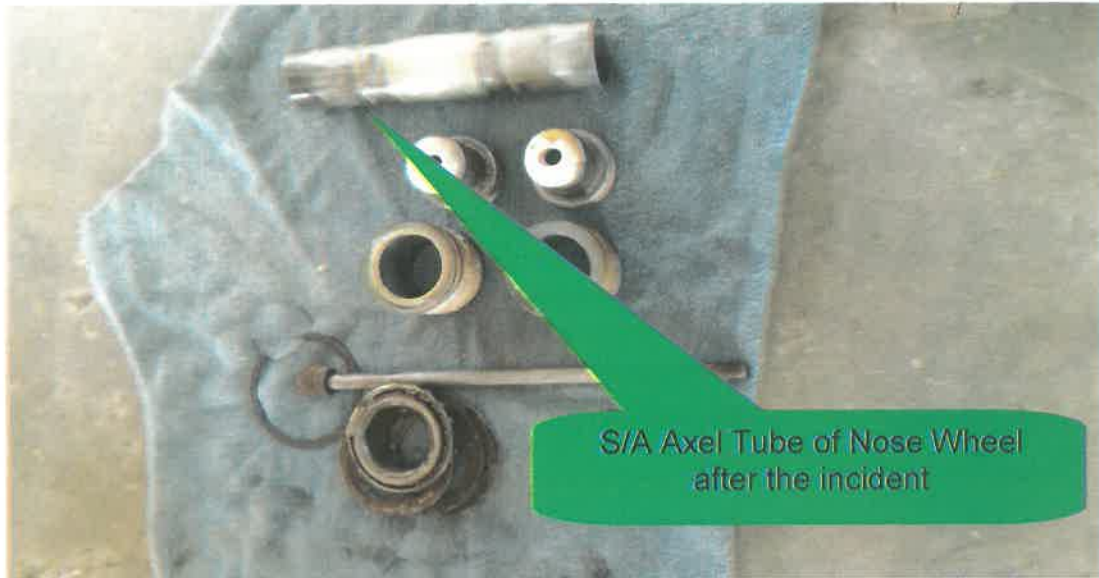
- 2.2.14. The mechanism of Nose wheel is such that the entire load of aircraft nose transfers to the tyre thru its Axel Tube without passing through the Thru Bolt (there is no load on Thru bolt from the nose of the aircraft). As a result of such a design, the stress of hard landing would damage the Axel Tube at first, however, the Axel Tube has been found free of any such

damage as shown in the picture below. Owing to this mechanism, the possibility of detachment of the nose wheel as a result of hard landing has been ruled out.
