## **FINAL INVESTIGATION REPORT**

**SERIOUS INCIDENT (SMOKE IN AFT CARGO) AIRBLUE  
FLIGHT ABQ-412 (SECTOR LHE – SHJ)  
AIRBUS A321 NEO, REG. NO. AP-BOE AT ALLAMA  
IQBAL INTERNATIONAL AIRPORT (AIIAP), LAHORE ON  
25<sup>TH</sup> JULY, 2022**

Dated: 14<sup>th</sup> February, 2024

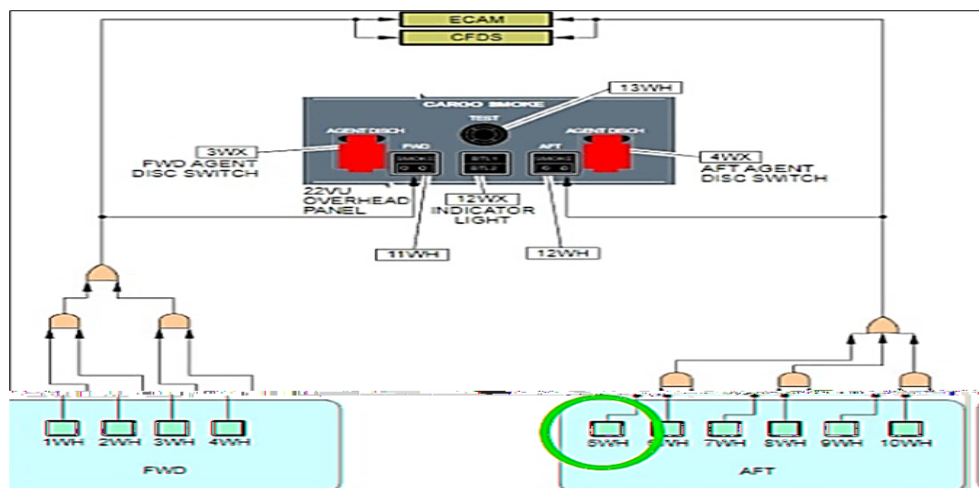
Figure 2 Fire / Smoke Warning System

2.2.1 On 24<sup>th</sup> July, 2022 aircraft maintenance Post Flight Report (PFR) indicated failure message associated with Smoke Detector at position 5WH, "SMK DET AFT LDCC (5WH)" a day prior to this serious incident occurred.

2.2.2 This failure message had no previous history. The defect was cleared by reset of the involved system as per Airbus Trouble Shooting Manual (TSM) Philosophy. The Smoke Detector at position 5WH cleared the functional test at shop. So, its contribution to this serious incident is unlikely.

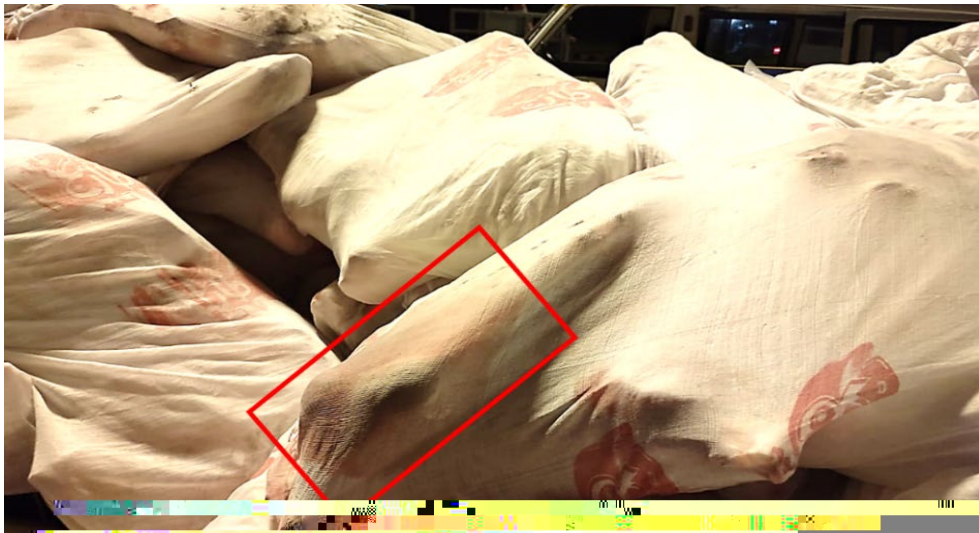
Figure 3 Traces of fluid / blood on bags

2.2.5 Animal meat was packed in fabric bags and traces of fluid / blood were found on these bags. It indicated inadequate packing / sealing of the bags containing the animal meat.

2.2.9 Animal meat contained in inadequate packing could have generated the humidity, thus increasing the humidity level in the sealed Cargo Compartment. This situation combined with the high relative humidity level at the Aerodrome could have led to

condensation, the droplets of which appeared to Smoke Detector as smoke particles, leading to spurious smoke warning after take-off.

3.2.1.1. Animal meat loaded on aircraft was not adequately packed. It generated humidity which augmented the prevailing high humidity level in the sealed AFT Cargo Compartment leading to in-flight spurious smoke warning.

4.1.1. PCAA may ensure that Airline Operators and Ground Handling Agencies have elaborated instructions for the packing and loading of perishable goods, animal meat etc on the aircraft.
