# AIRCRAFT INCIDENT INVESTIGATION

B-707 AP-AZW

WHICH OCCURRED ON  
7TH FEBRUARY 1992

LAHORE AIRPORT

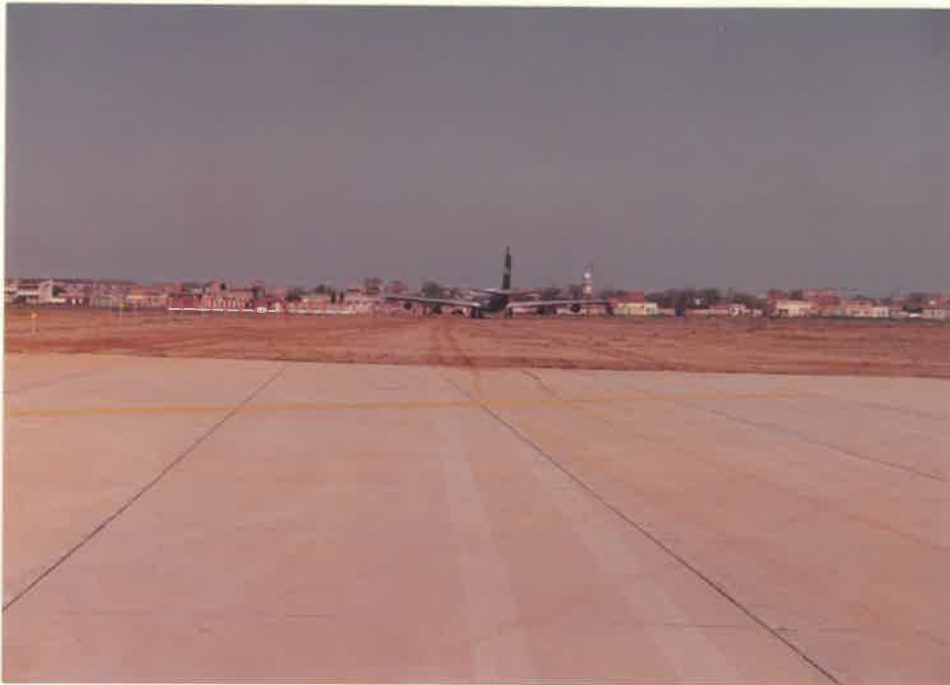
APP. "B<sub>1</sub>"

- 19.5. The main wheel tracks begin from about 4000 ft distance to go, (See App.B-1/B-2) and on the right half of the runway and then gradually further veering off to the right. This was done to stay clear of the approach lights etc by the Pilot intentionally (as stated by the Pilot).

WHEEL TRACK PRIOR TO GOING OFF THE RUNWAY

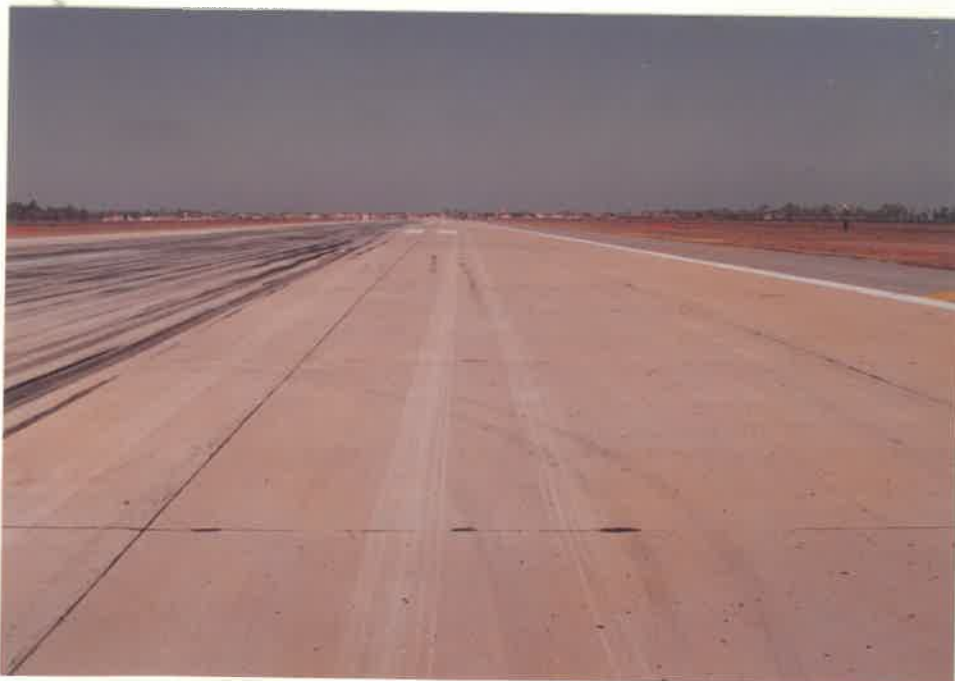
APP. "B<sub>2</sub>"

POINT FROM WHERE THE WHEEL TRACK COMMENCE

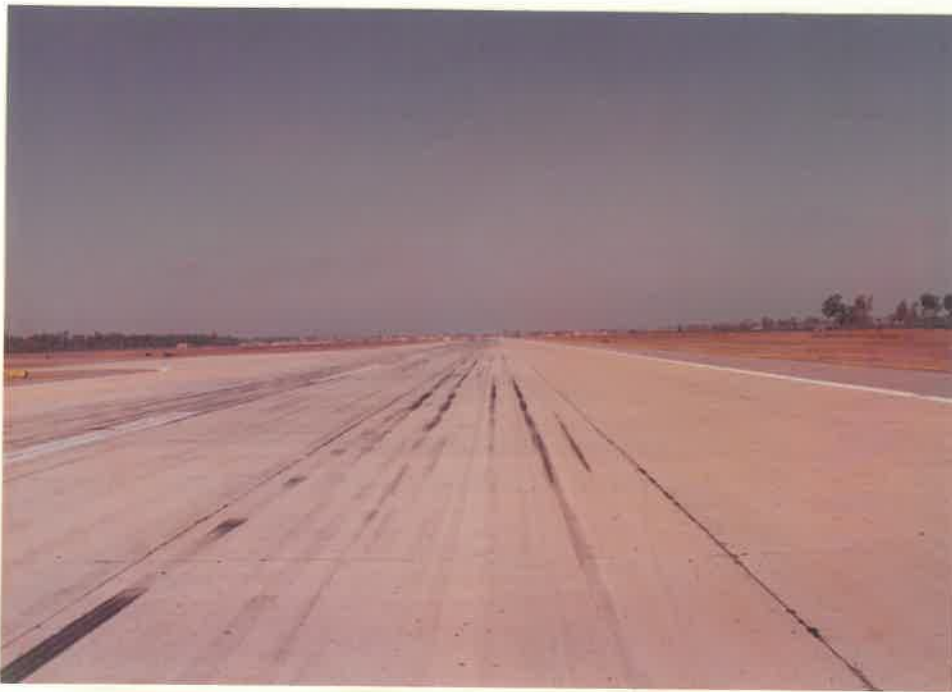
APP B<sub>3</sub>"

PROBABLE AREA OF TOUCH DOWN

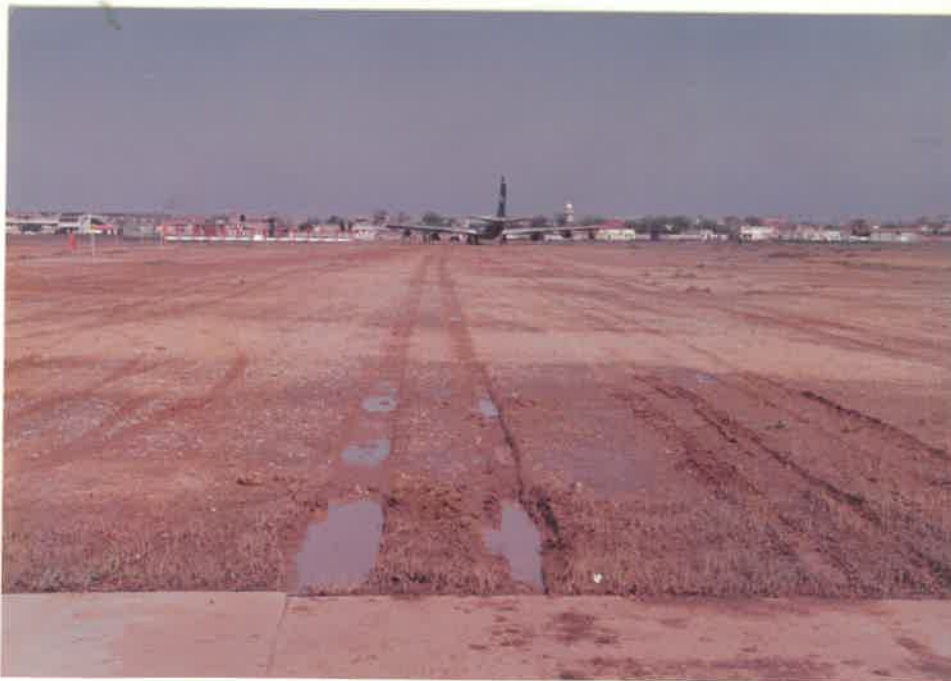
APP B<sub>4</sub>"

- 19.4. The wheel tracks left by the aircraft on Katcha were very prominent (See App.B-4) and can be traced back on to the main runway. These were very clear and identifiable.

LEFT WHEEL TRACK ON KATCHA

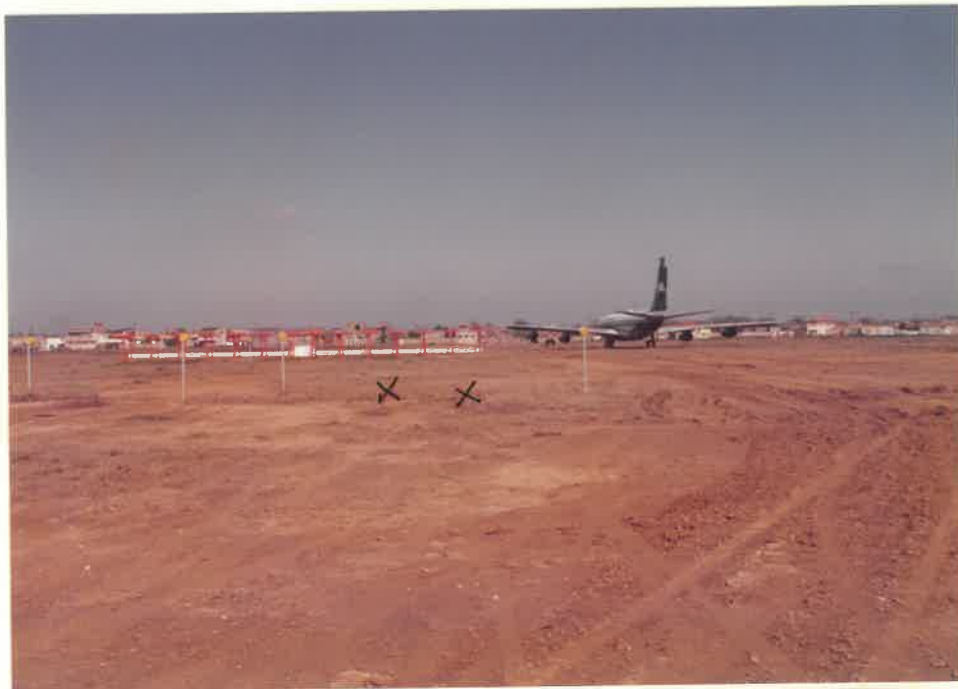
APP. "B5"

- 5.1. Two of the collapsable approach lights were broken down apparently due to thrust reversers blast from the No. 1 engine.

- 12.1. Though it culminated into a survivable incident, the conditions were all set for a disastrous situation; because aircraft came to a stop only about 500 to 600 ft short of the built up area ahead. Also had the Katcha area, where the aircraft over ran and stopped, not been a compacted one the aircraft could have sustained damaged and resulted in fire/injury to PXs etc. Also had the aircraft not been steered to the right it would have collided with approach lights and localizer antenna which may have resulted in a catastrophe.

TWO APPROACH LIGHTS MISSING AND DEPICTION OF CLOSENESS OF THE AIRCRAFT TO THE BUILTUP AREA AHEAD (ONLY 500' TO 600' AWAY ).

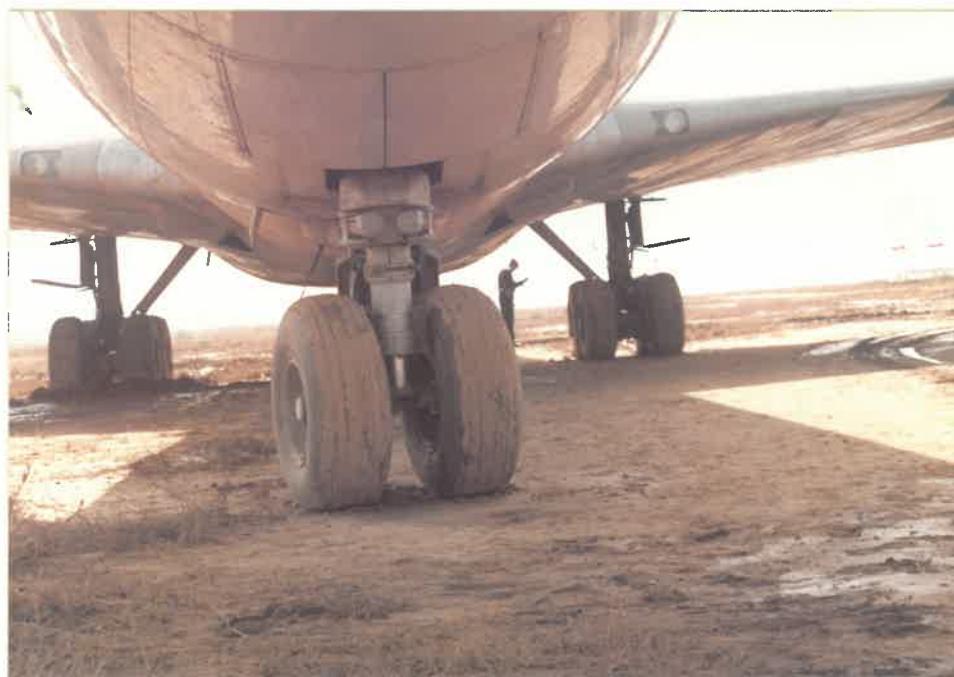
APP. "B6"

- 3.2. The pilot after observing the approach lights and the chequered hut at the end of the R/W approaching fast, on the left and ahead, steered the aircraft to further right with an intent to avoid collision with the approach lights and the localizer antenna. The aircraft crossed the stop way portion and traversed another 1035 feet beyond the over run and then came to a stop in the Katcha. (Appendix B4). This Katcha area happened to be in a fairly compacted state as such the aircraft did not sink. Only the right wheel had sunk down by about four inches. (See Appendix B6).

RIGHT WHEEL SUNK IN THE SOGGY/KATCHA AREA - LEFT MAIN WHEEL AND NOSE WHEEL ON A COMPACTED KATCHA GROUND

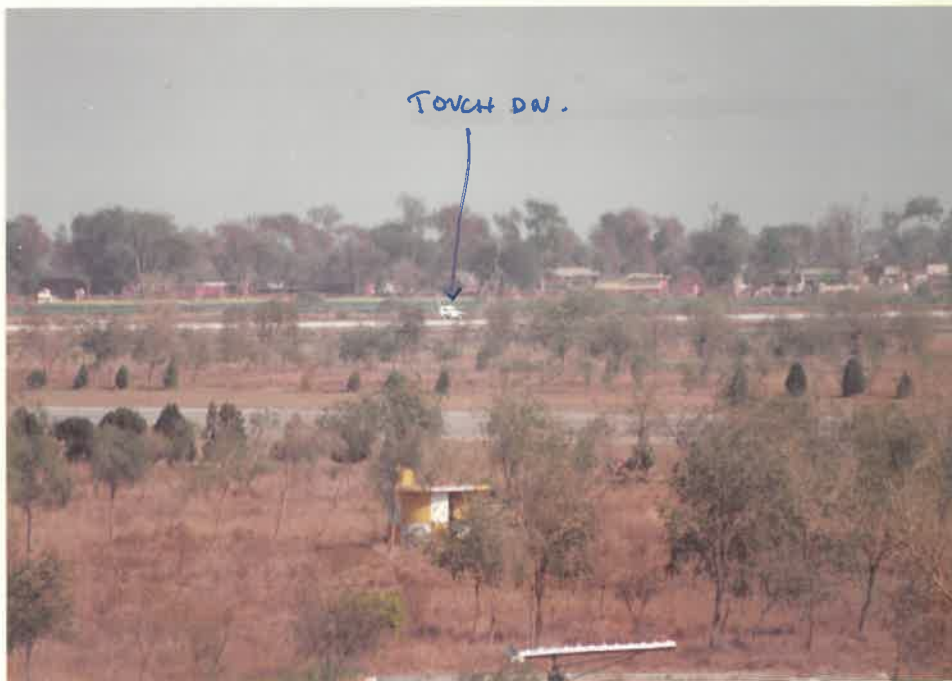
APP. B<sub>7</sub>"

- 19.7. The duty A.T.C.O was interviewed and asked to indicate exactly where the aircraft seemed to have touched down as observed by him while standing in the control tower. This was done with the help of a jeep fitted with R/T. The S.A.T.O. Lahore Airport was asked to slowly drive on the runway and was then guided by the eye witness to the exact place on the runway. The jeep was parked there and then photographed. (See. Appendix B-7).

TOUCH DOWN POINT - 5300 FEET FROM THE BEGINING  
OF RUNWAY -36 WAS OBSERVED BY THE DUTY ATCO FROM  
THE CONTROL TOWER ( NO.1 EYE WITNESS )

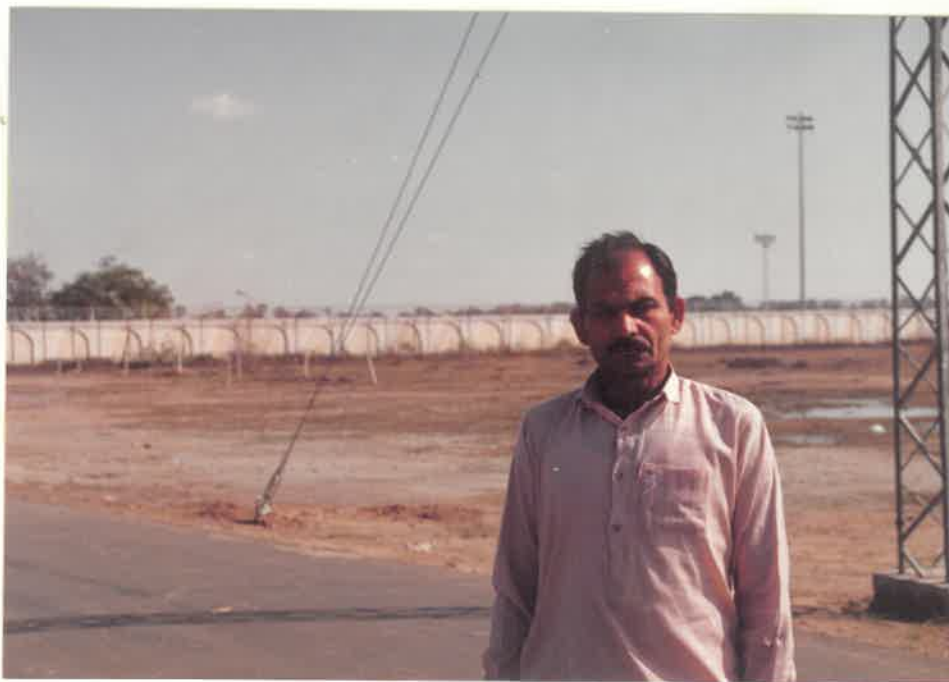
APP. B<sub>8</sub>"

- 19.8. The second eye witness. (See Appendix B-8) also observed the aircraft almost in the same area as stated by the No. 1 eye witness.

NO.2 EYE WITNESS - STANDING AT THE LOCATION FROM  
WHERE HE OBSERVED THE AIRCRAFT ABOUT TO TOUCHDOWN

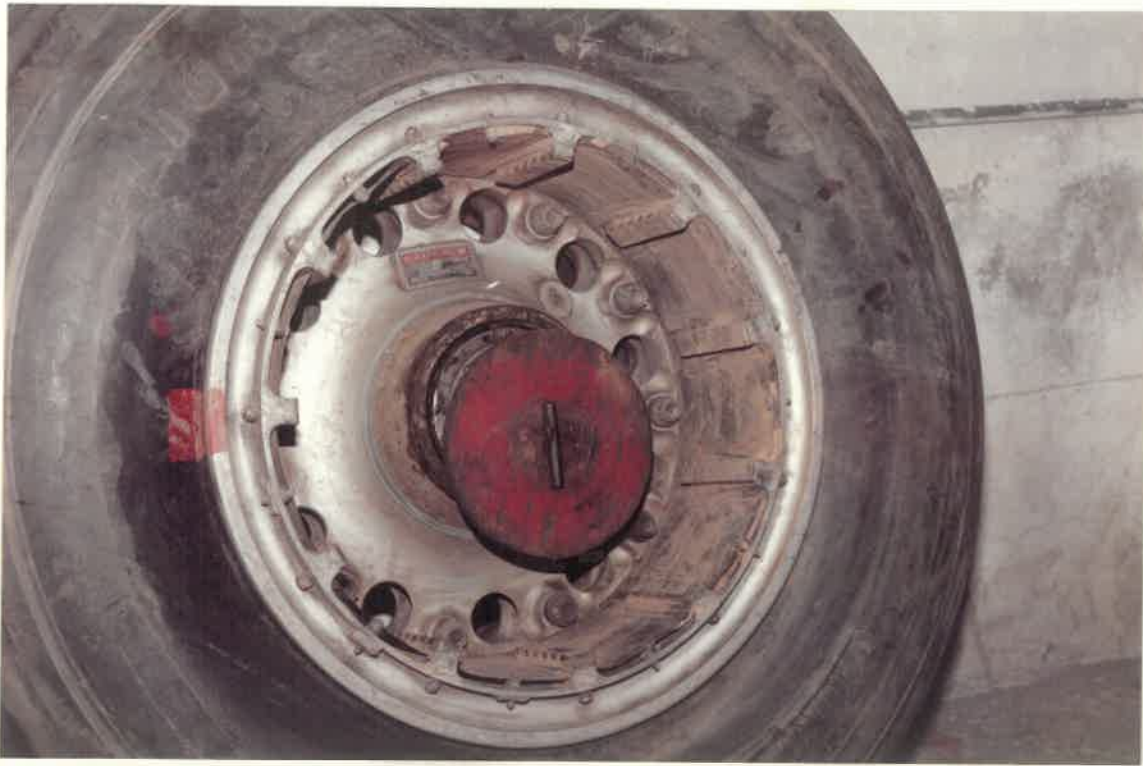
APP. "B9"

TYRE CREEP MARKS STILL IN PLACE

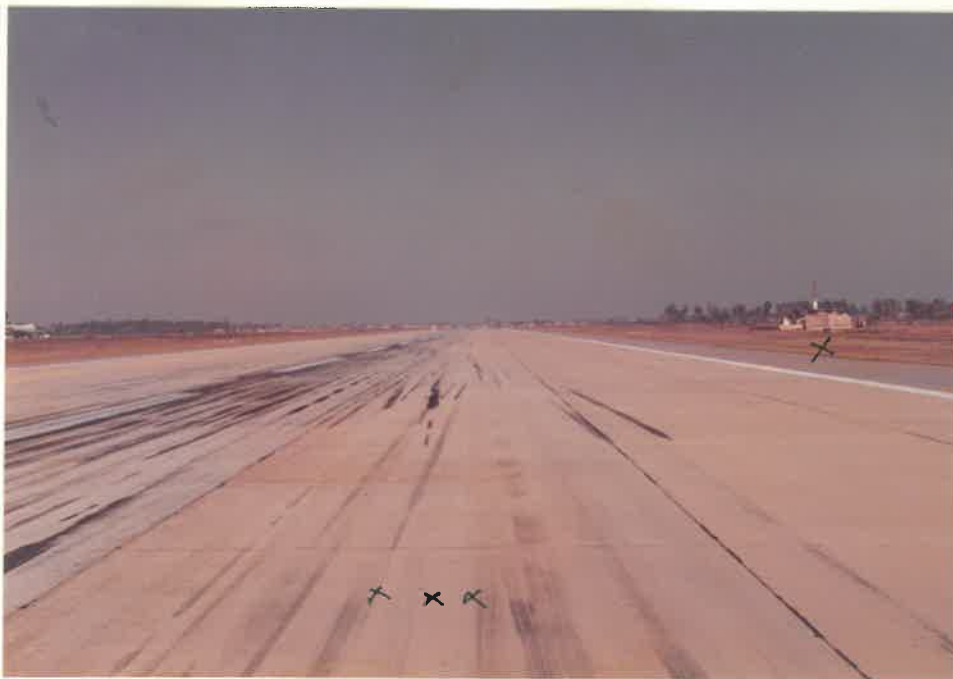
APP. "B10"

19.14. And the fact that the aircraft from then on stopped in about 5500 ft, further substantiates the probability that it touched down some where in the vicinity of the VOR hut which is exactly mid way point of the runway. Had the aircraft touched some where before this point the chances were that it would have stopped on the runway or at the most on stopway/over run area.

VOR HUT - MID WAY POINT OF TOUCH DOWN

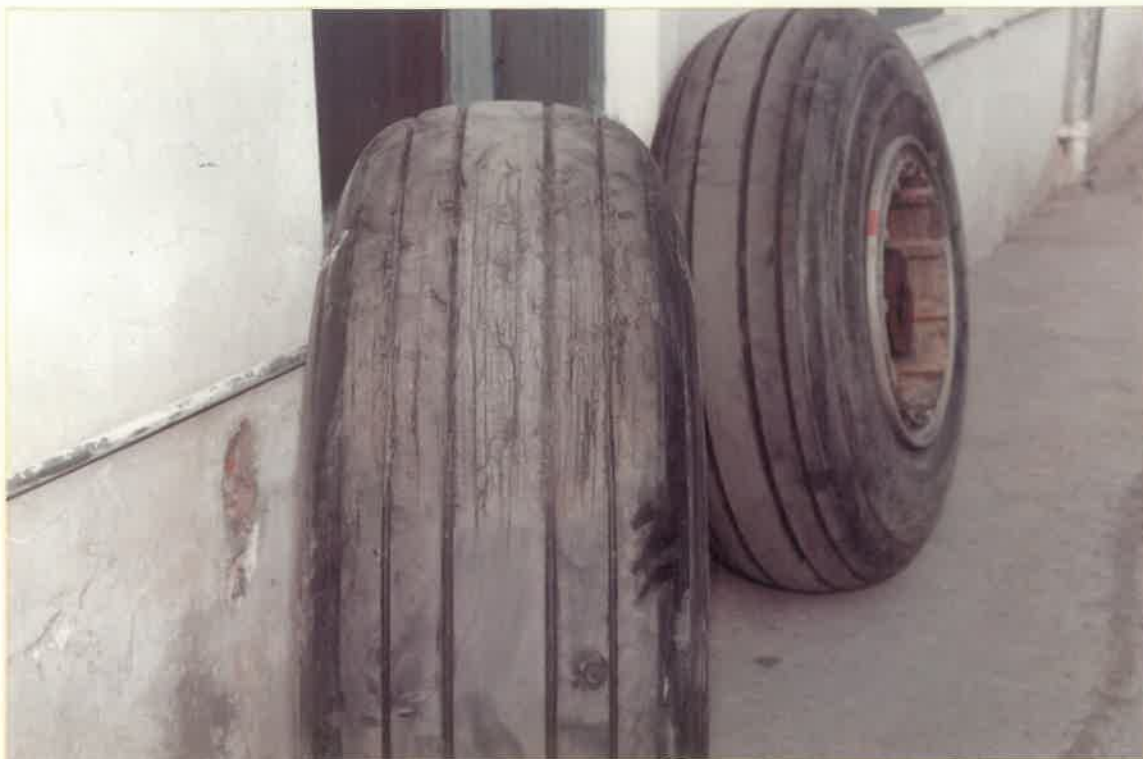
APP. B<sub>11</sub>

19.16. Referring to photographs (APP. B1-10) no damage to aircraft wheel is noticed. During post incident inspection no abnormality with aircraft tyres was observed, thereby indicating that no such phenomenon was experienced by the aircraft during landing on wet runway. Thus possibility of any aquaplaning is ruled out.

WHEEL TYRES

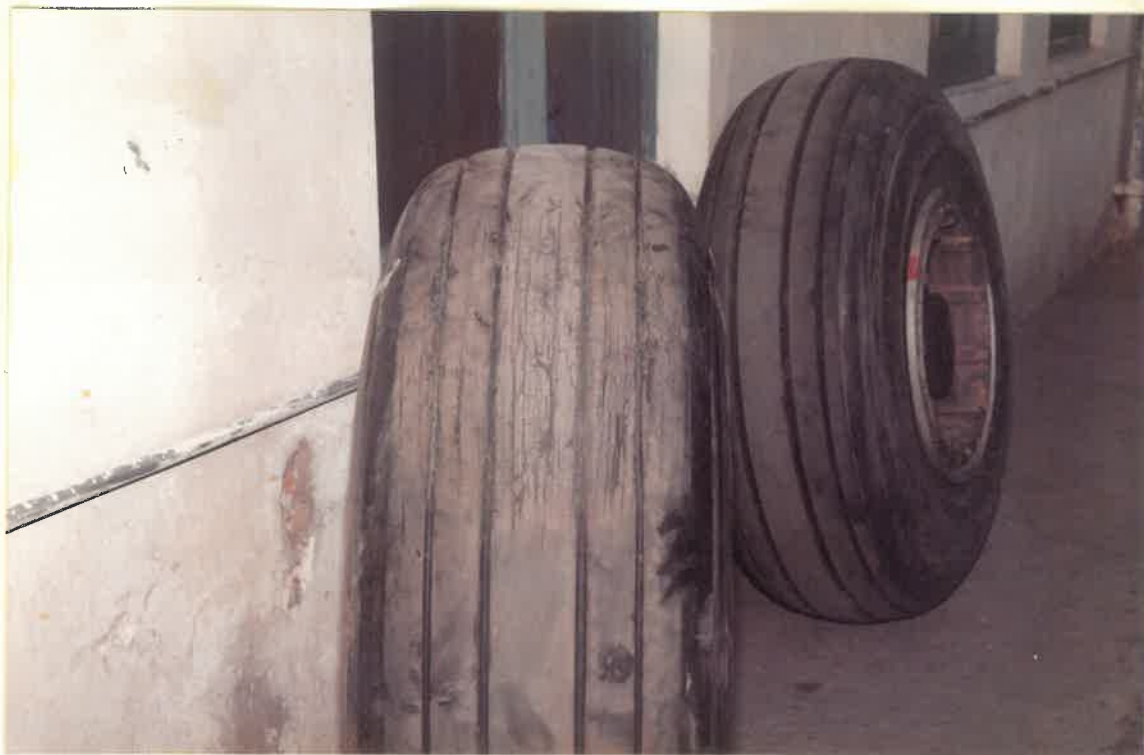
APP. B<sub>12</sub>

WHEEL TYRES
