**CIVIL AVIATION AUTHORITY**  
**KARACHI, PAKISTAN**

**AIRCRAFT INCIDENT INVESTIGATION**

**INVESTIGATION REPORT: M/S SCHON AIR (PVT) LTD.**  
**CESSNA -152 AIRCRAFT REG NO AP-BES WHICH HAD**  
**AN INCIDENT ON 3RD FEBRUARY, 1996**  
**AT KARACHI AIRPORT.**

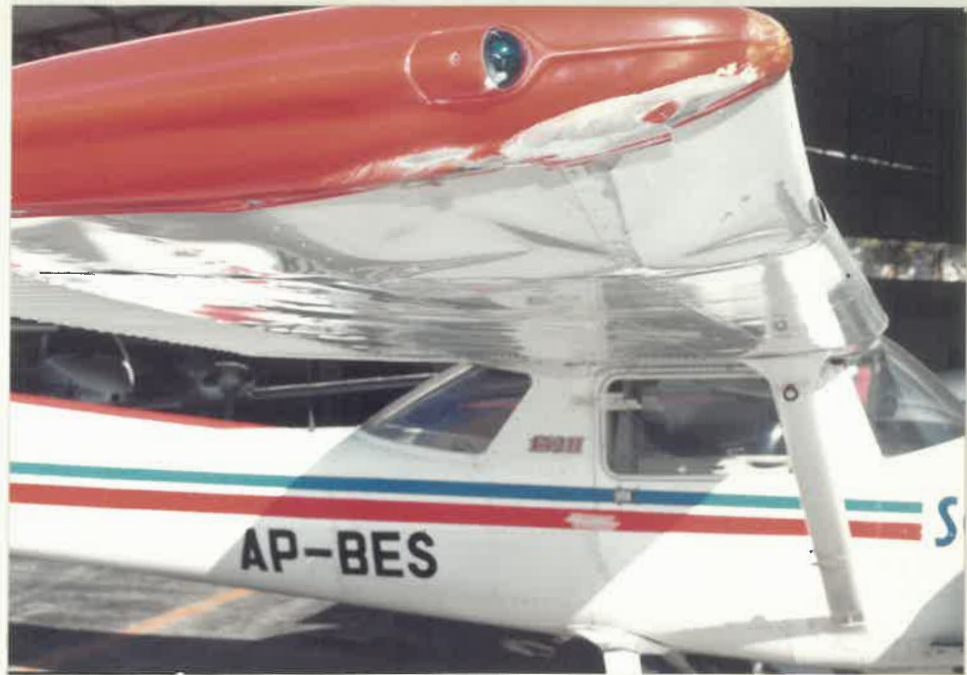
APP E1

RIGHT WING DAMAGE

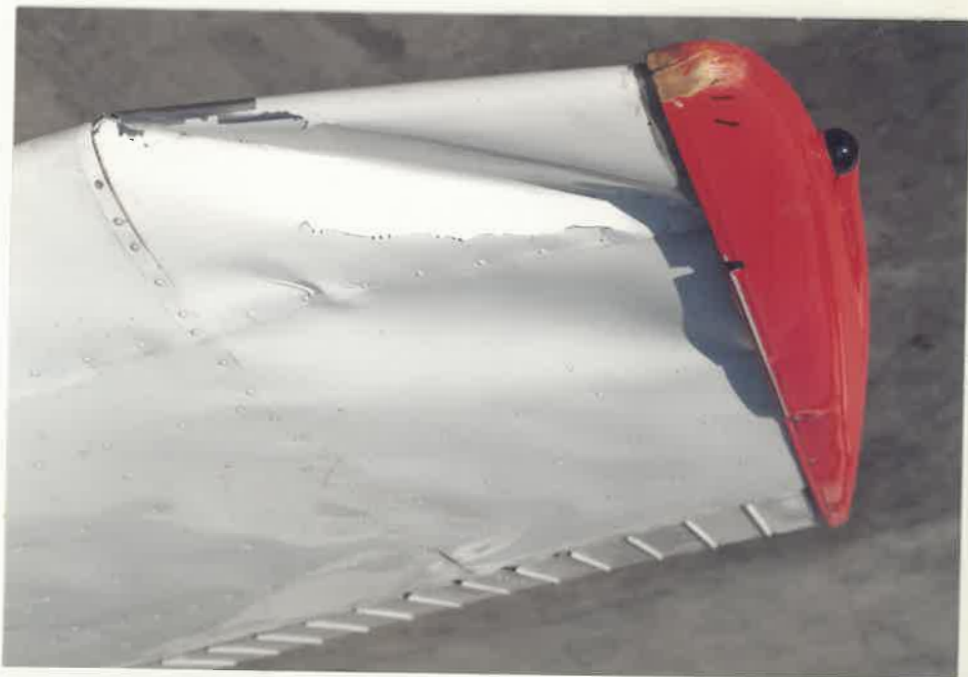
APP E2

RIGHT WING TIP DAMAGE

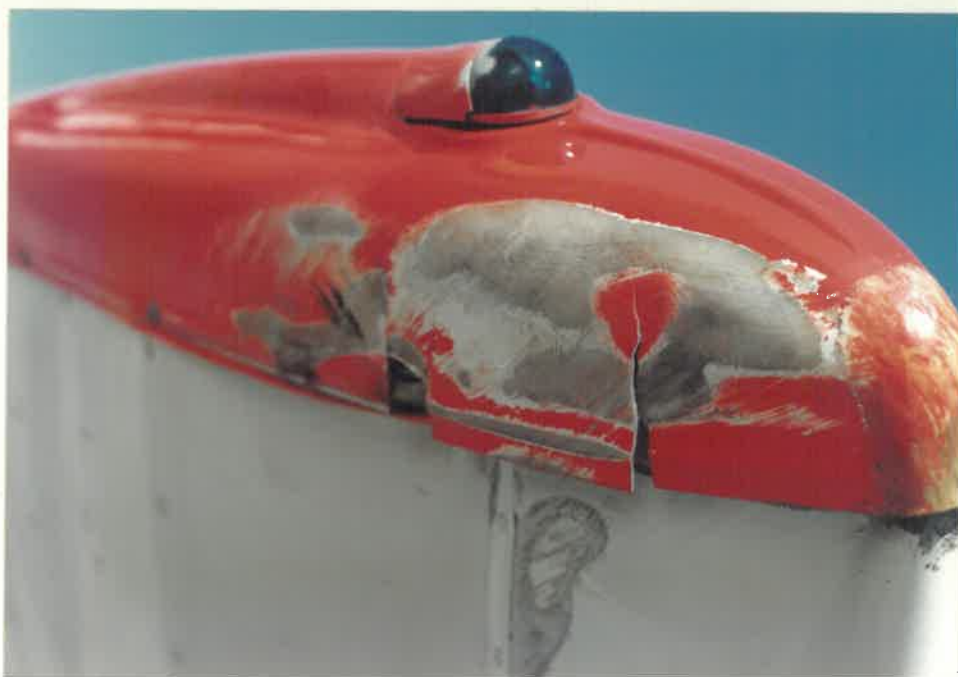
APP. "E3"

RIGHT WING TIP DAMAGE ANOTHER VIEW

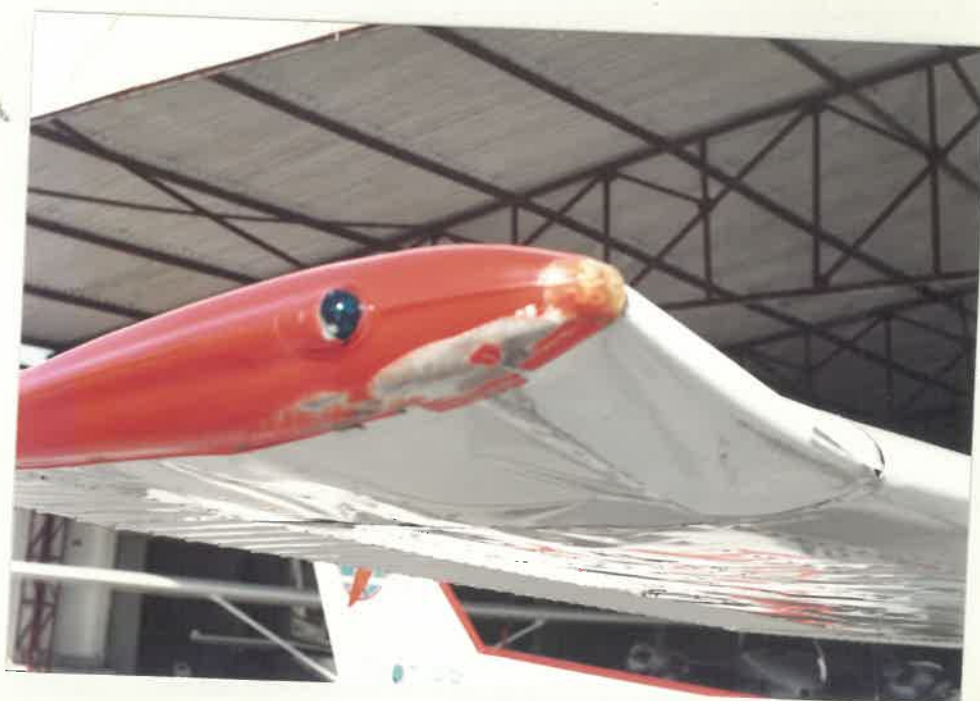
APP. "E4"

RIGHT WING TIP TWISTED

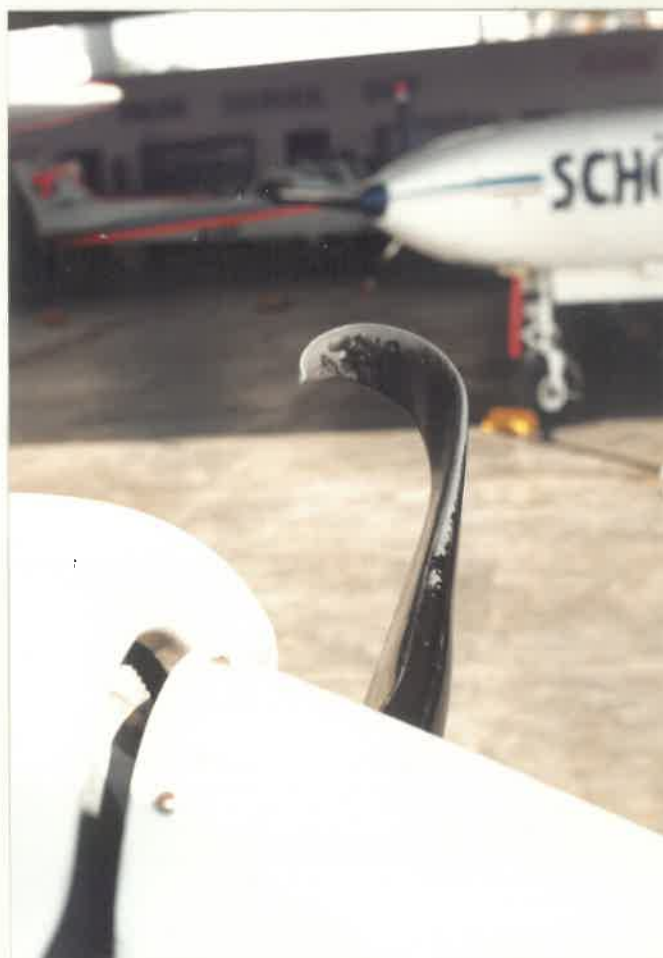
APP. E8"

DAMAGED PROPELLER

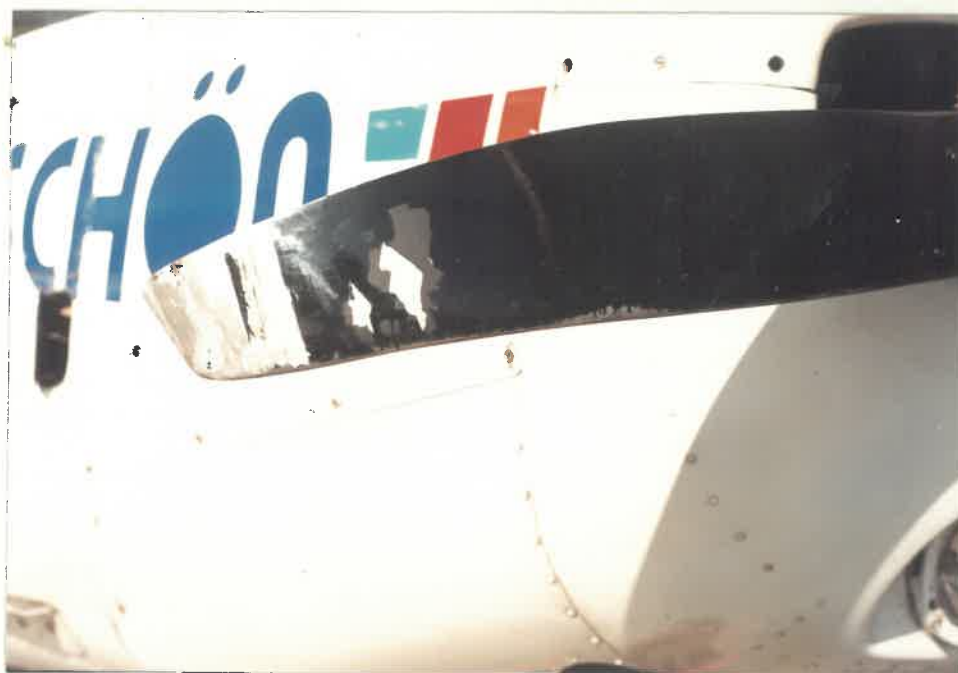
APP. "E10"

DAMAGED PROPELLER BLADE ANOTHER VIEW

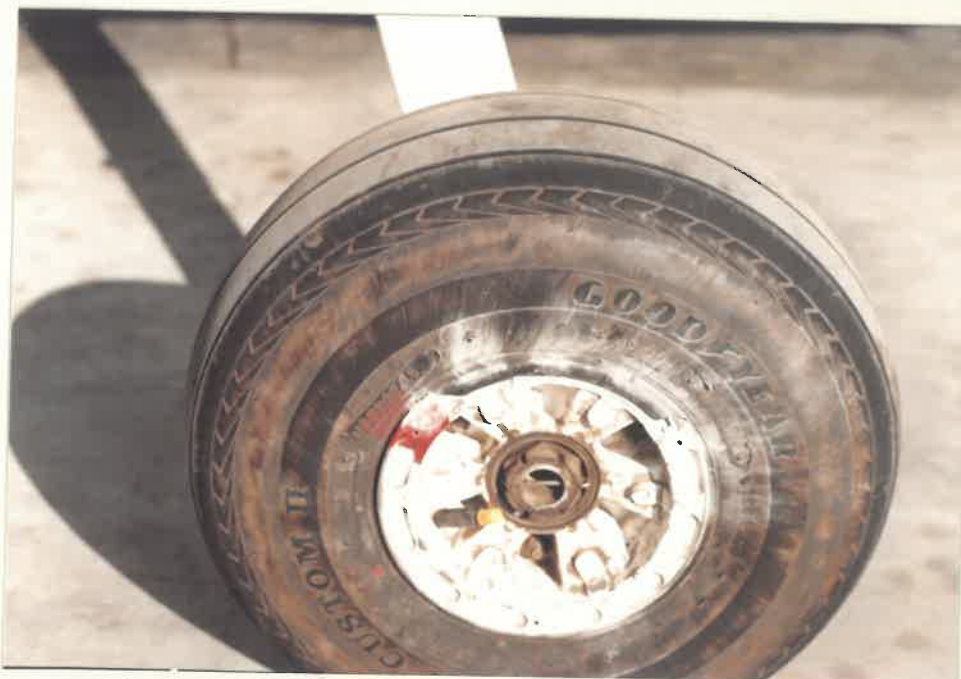
APP. E12

RIGHT MAIN WHEEL HUB CRACKED
