CIVIL AVIATION AUTHORITY  
ISLAMABAD AIRPORT

INVESTIGATION REPORT INTO THE INCIDENT  
INVOLVING PK-407/090784 AIRCRAFT, REG.  
NO. AP-ALN, WHEN THE AIRCRAFT WENT INTO  
THE OVERSHOOT AREA, AFTER LANDING

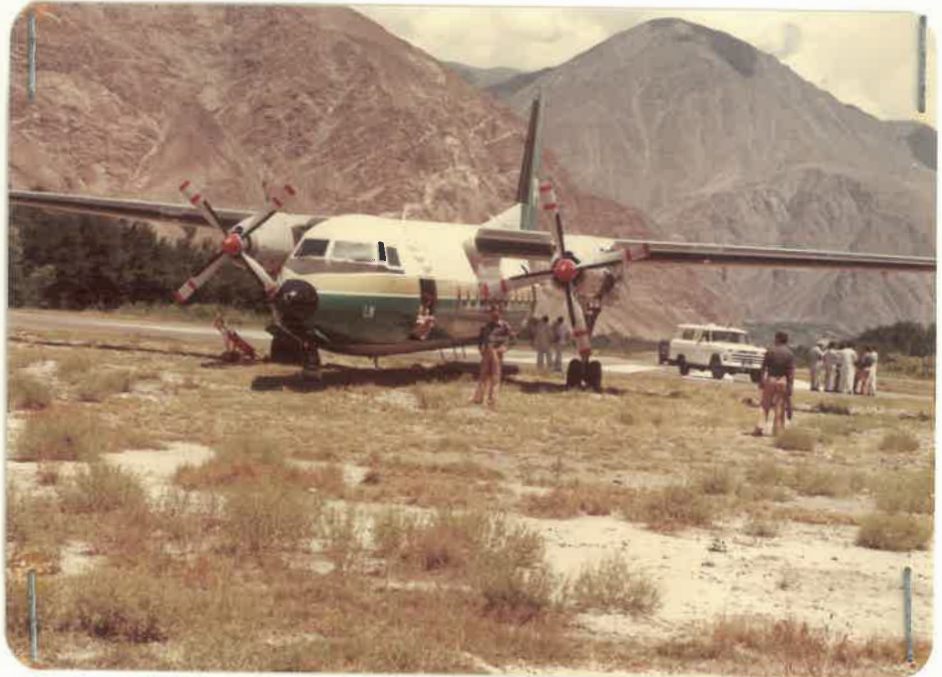
①

- 2-3 After normal selection of ground pitch the brakes were applied but it soon became apparent that the aircraft would not stop in the remaining portion of the Runway. Therefore, "Emergency" brakes were used and the aircraft came to a stand still. During this time the aircraft had gone 25 feet in the pucca over Run area and further 5 feet in kucha portion (Appendix 'H').

- 3-3 As the normal braking could not stop the aircraft, Emergency brakes were used, and ultimately the aircraft was stopped 30 feet in the over run area out of which 25 feet was pucca overshoot area and 5 feet was the Kucha portion (Appendix 'H').
- 3-4 No one including the crew was hurt/injured.
- 3-5 There was no damage to the aircraft at that time due to this incident.
- 3-6 The weather was normal and the tail wind as reported was 4 to 5 Kts. (Appendix 'F').

PHOTOGRAPHS *Showing where aircraft stopped*  
IN OVER-RUN AREA

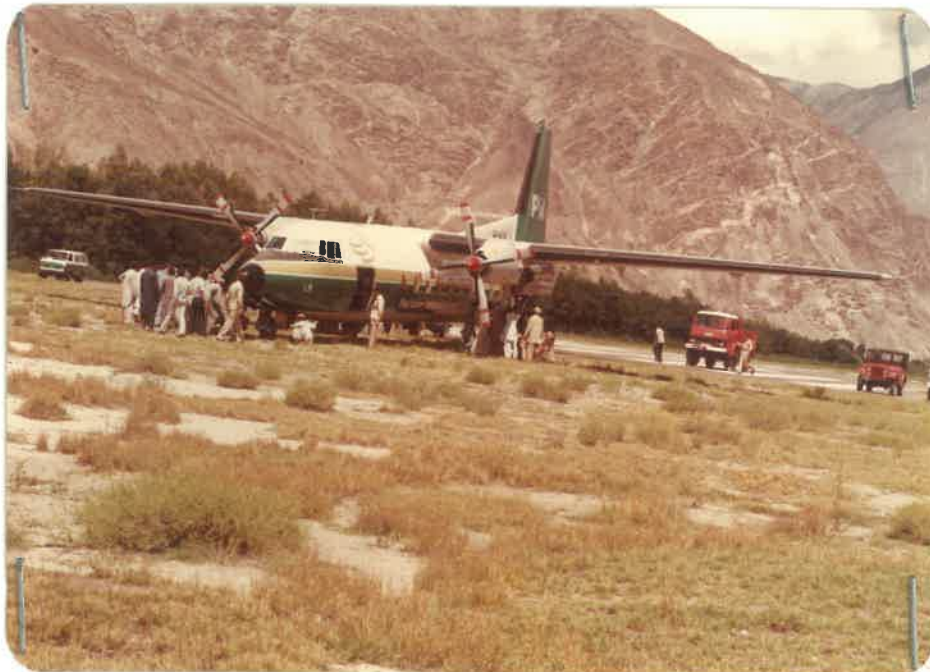
①

- 2-5 The aircraft was pushed back with the help of man power and two trucks/jeep were used. (Appendix 'H').
- 2-6 The Met report was normal (Appendix 'E').

# AIRCRAFT BEING PUSHED BACK
