**TYRE BURST INCIDENT TO M/S PIAC  
A-310 REG NO AP-BEQ**

**ON 5<sup>TH</sup> APRIL 1999**

**QUAID-E-AZAM INTERNATIONAL AIRPORT  
KARACHI.**

## **FINAL REPORT**

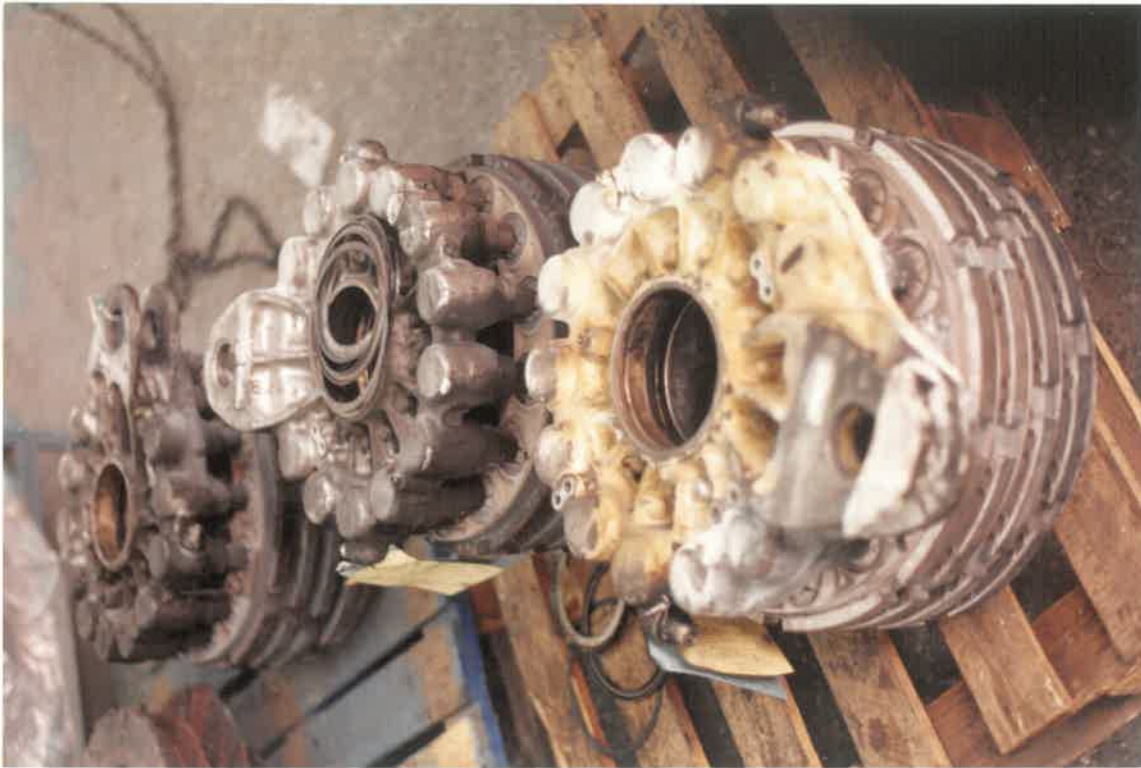
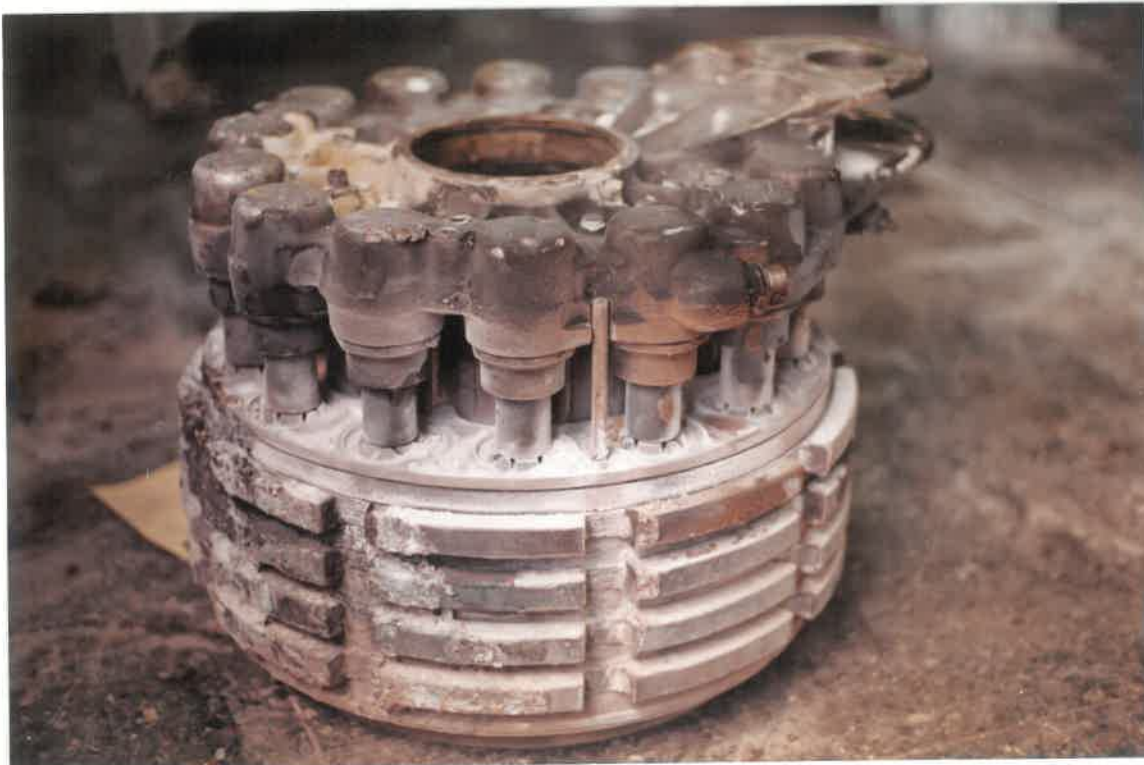
2.5.3.1. The main wheel and brake assemblies were checked for their proper functioning. Although the main wheels were deflated and rubbed, no abnormality was observed in them. The brake assemblies were affected by the high temperatures but did not show any signs of abnormality in brake assemblies. The cause of overheating has been determined as high speed abort (above V1), necessitating maximum application of brakes at high speed. PIAC's Shop Report on Brakes, Main Wheel Assembly and Boggie Beam Assembly is placed as Appendix 'R'.

BRAKE ASSEMBLIES SHOWING HEAT EFFECT

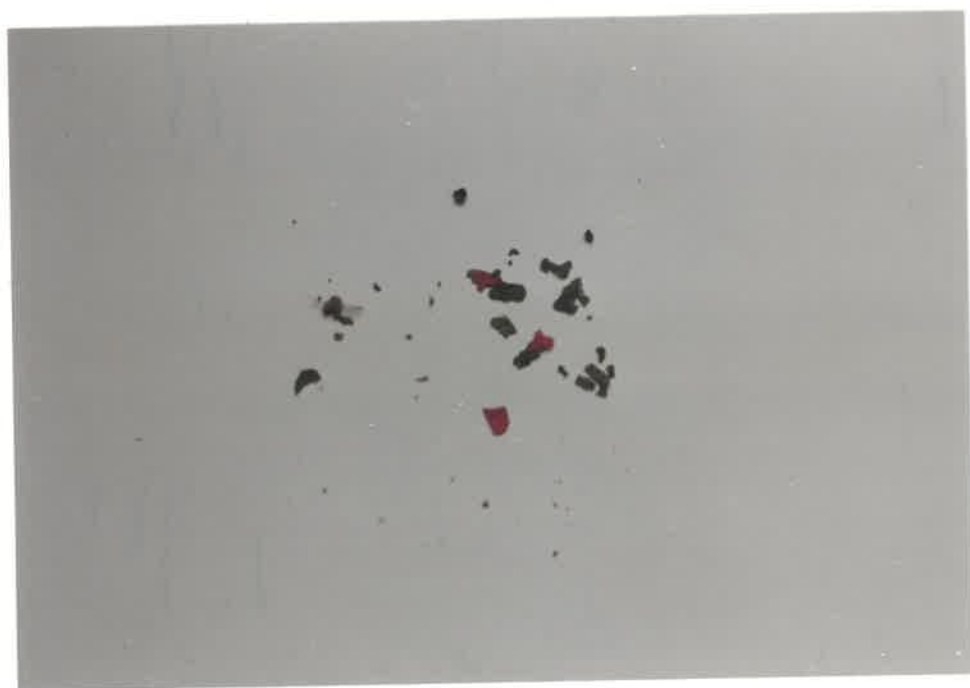
2.5.2.2. A test for the pitot static system was carried out by flushing the system. It was found that the First Officer's (F/O) pitot tube contained FOD. This FOD consisted of dry leaves stuck in the pitot tube, allowing only partial dynamic pressure to reach the system. Thus the F/O indicator was under-reading the speed of the aircraft.

- 2.5.2.6. The build up of FOD appears to be cumulative in nature. Most probably, it takes place when the aircraft is parked on the ground for a comparatively long duration without pitot covers. Even though it may be a difficult exercise to install pitot covers when the aircraft is parked for a relatively smaller duration e.g. two to three hours, yet it is important to formulate a procedure such that the chances of FOD are minimised.

- 3.1.26. The FOD was found to comprise Bougainvillea leaves and an insect.
- 3.1.27. PIA had suggested to the Airbus Industrie to modify the design of the pitot tube to minimise the chances of FOD. The Airbus Industrie have declined to make any change in the existing design and suggested that pitot covers be used as a preventive measure.

FOD EXTRACTED FROM PITOT TUBE

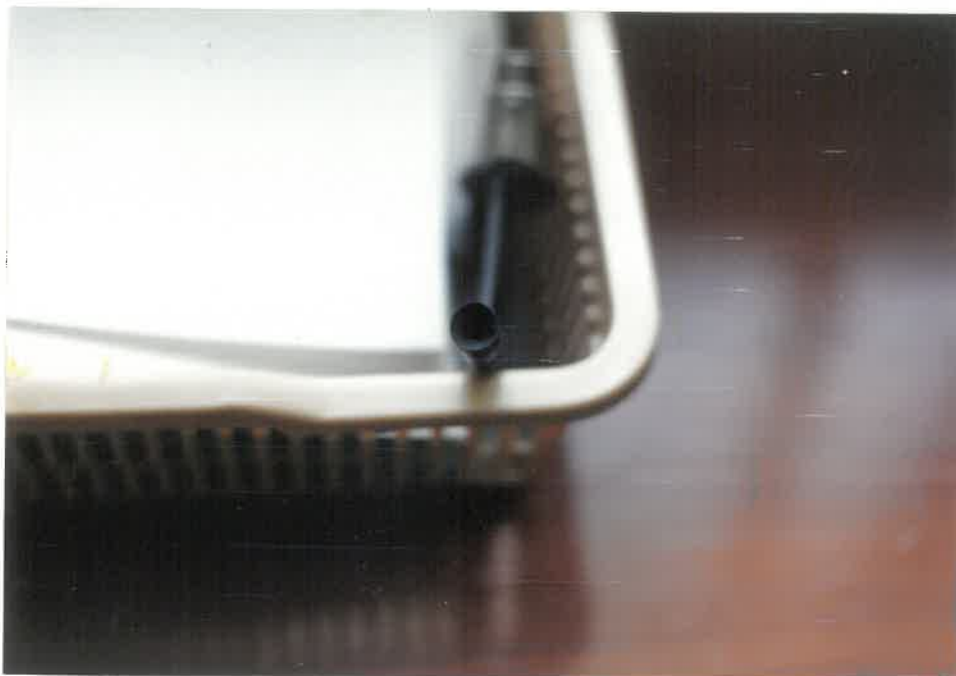
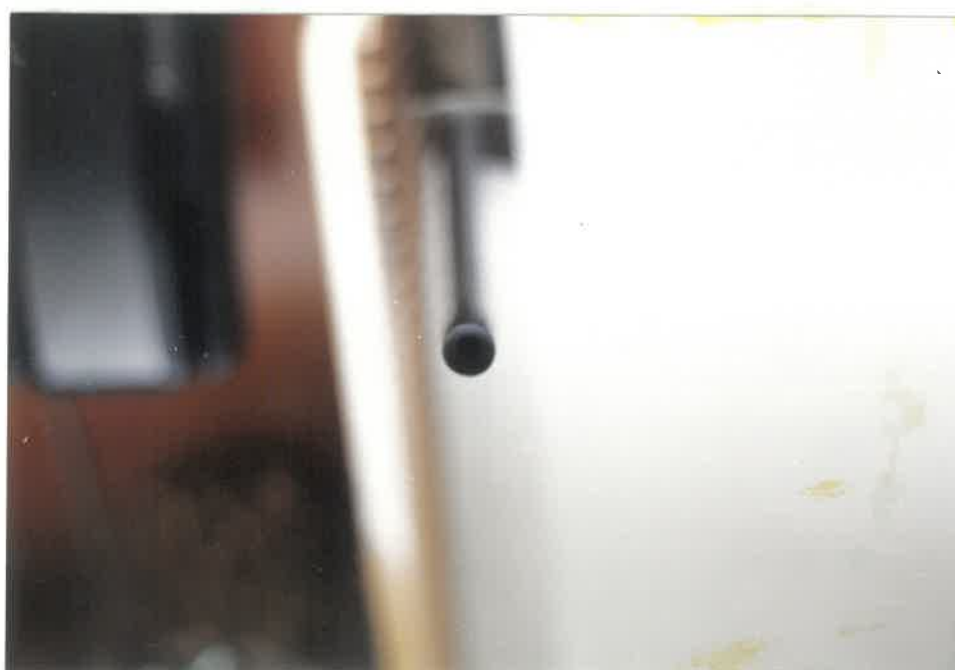
PITOT TUBE

- 2.5.2.5. This is not an isolated case of FOD. In fact FOD is a known problem in A-310s. The cause of FOD in A-310s pitot tube has been identified by PIA as a possible weakness in its design. Most of the time tiny flowers, leaves etc, constitute the FOD. It seems that when the aircraft is parked, small insects pluck up these leaves from the plants nearby and take small pieces of these leaves into the pitot tubes. In regard to this FOD problem, correspondence between Airbus Industrie and PIA is referred, which is placed as Appendix 'Q'. The Airbus Industrie have declined to make any changes in the pitot tube design but have suggested the use of pitot covers. Even though PIA claim to be using the pitot covers as suggested, yet the incident highlights that the present system being used by PIA does not ensure adequate protection against FOD.

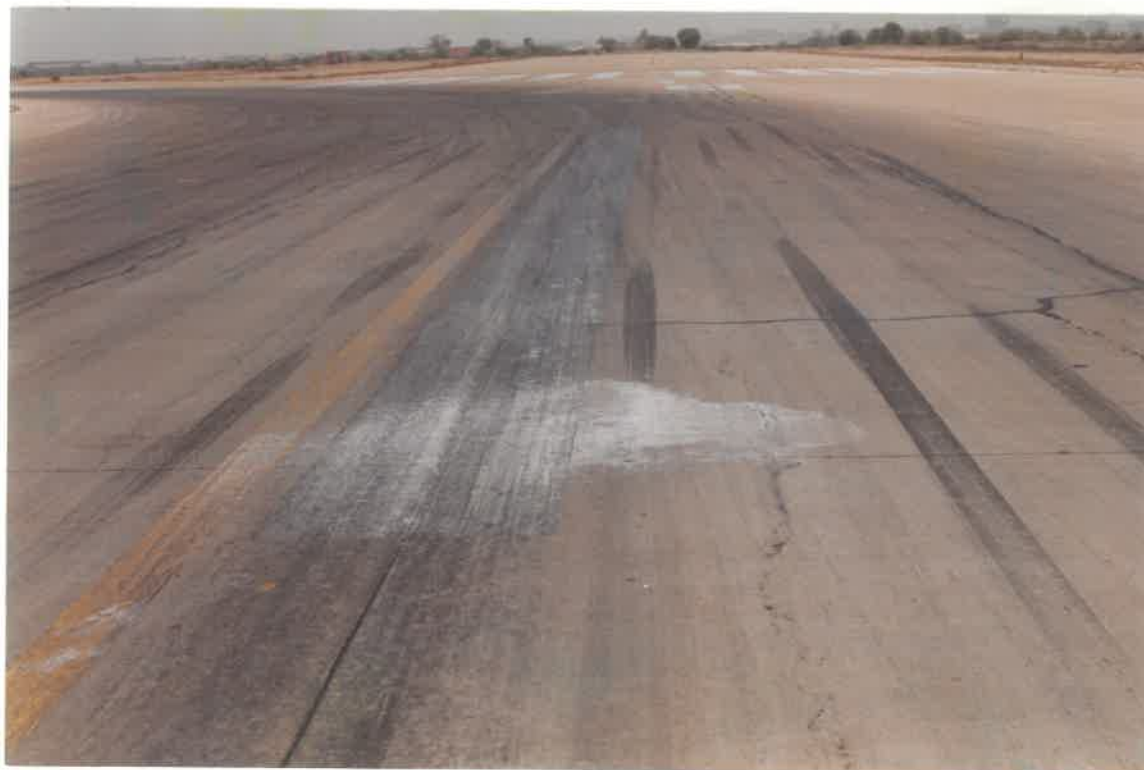
**RUNWAY TYRE MARKINGS**

- 3.1.20. The aircraft stopped about 276 feet short of the end of runway.
- 3.1.21. High-speed abort (about 10 KT above V1) caused seven of the eight main wheels to deflate and the brake temperature soared to over 700 degrees Celsius.

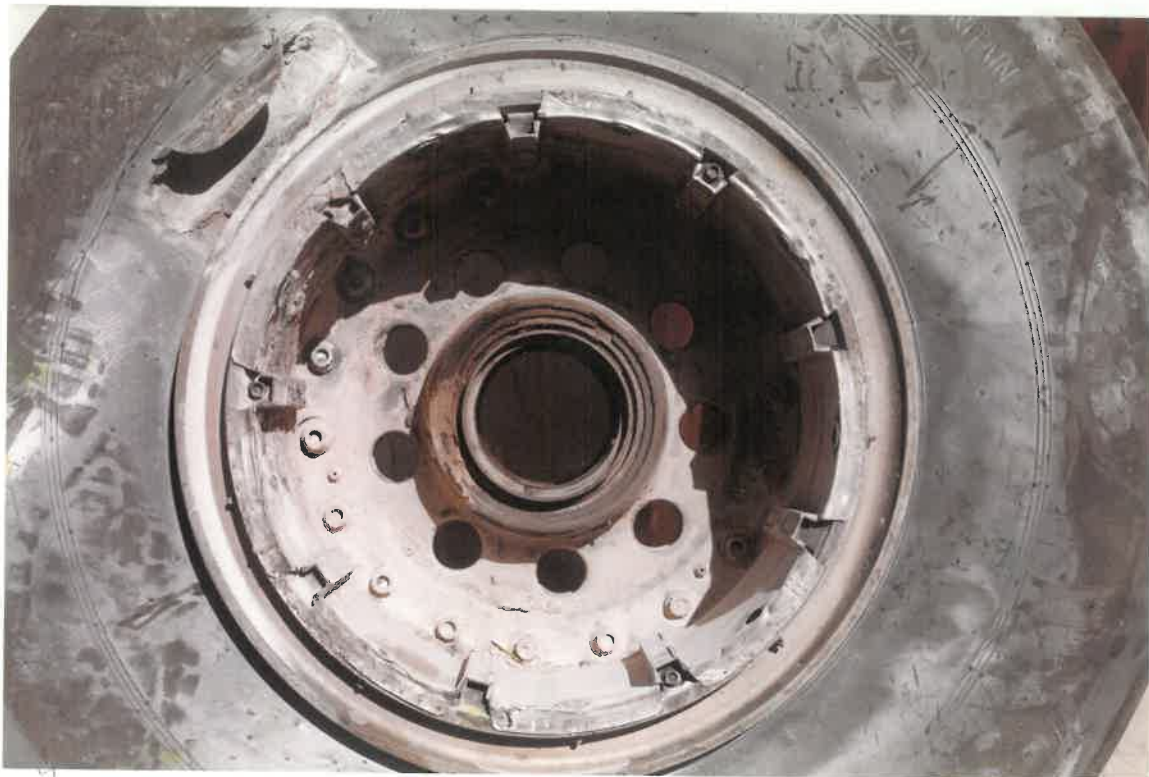
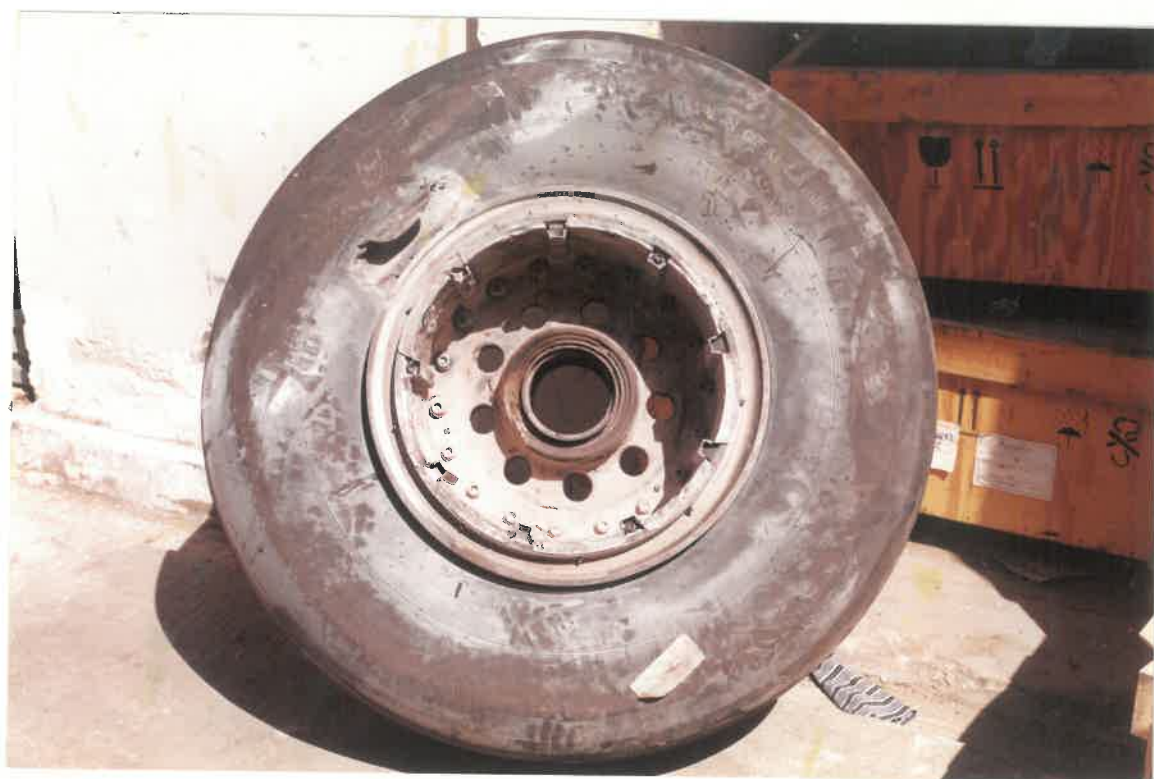
WHEEL ASSEMBLY

- 1.2. Injuries to Persons: Nil.
- 1.3. Damage to Aircraft: There was no damage to the aircraft; however, eight main wheels and brake assemblies were scrapped. The forward axle of bogie beam assembly was also replaced due to diffusion/melting of cadmium plating.
