REPORT ON THE INQUIRY CONDUCTED TO  
INVESTIGATE INTO THE CIRCUMSTANCES  
WHICH LED TO THE OCCURRENCE OF FIRE  
IN THE FLYING CLUB HANGAR SITUATED  
AT ARMY AVIATION'S KHALID AIRBASE  
QUETTA CANTONMENT ON 13TH NOV. 1990:

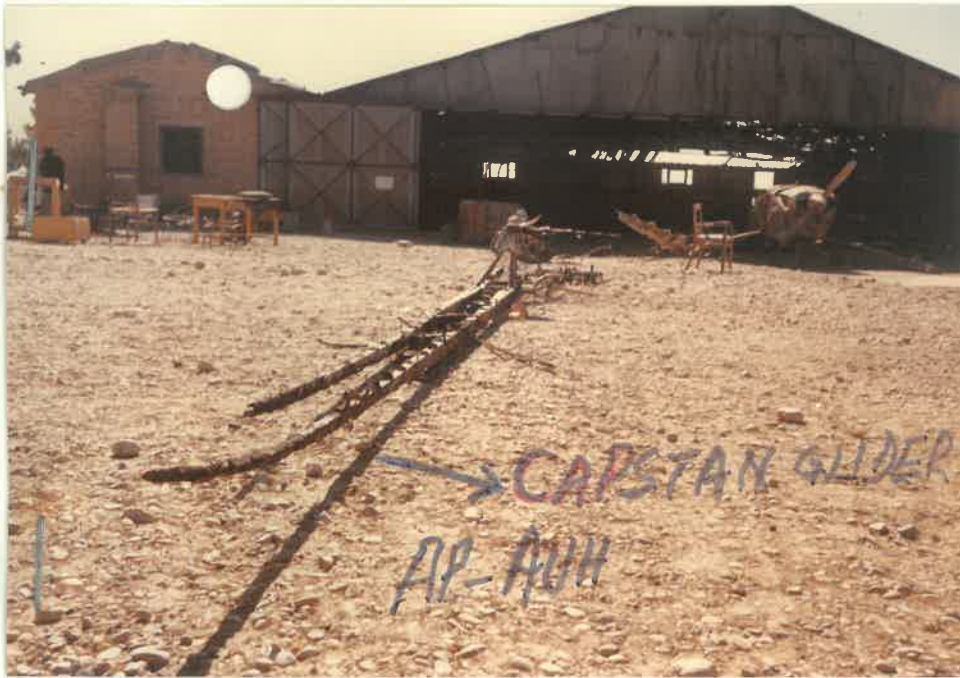
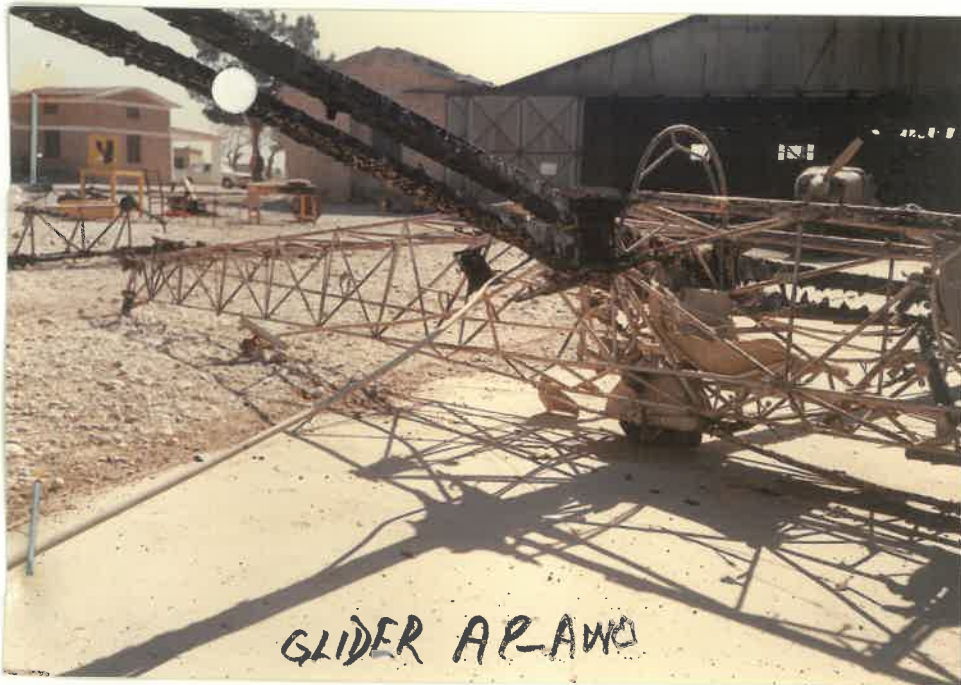
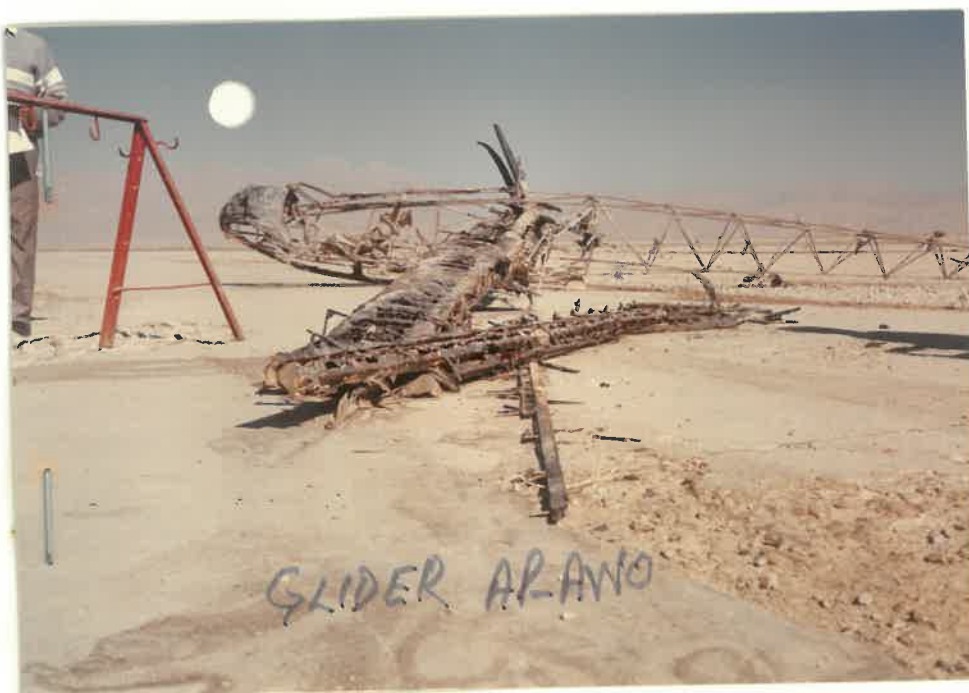
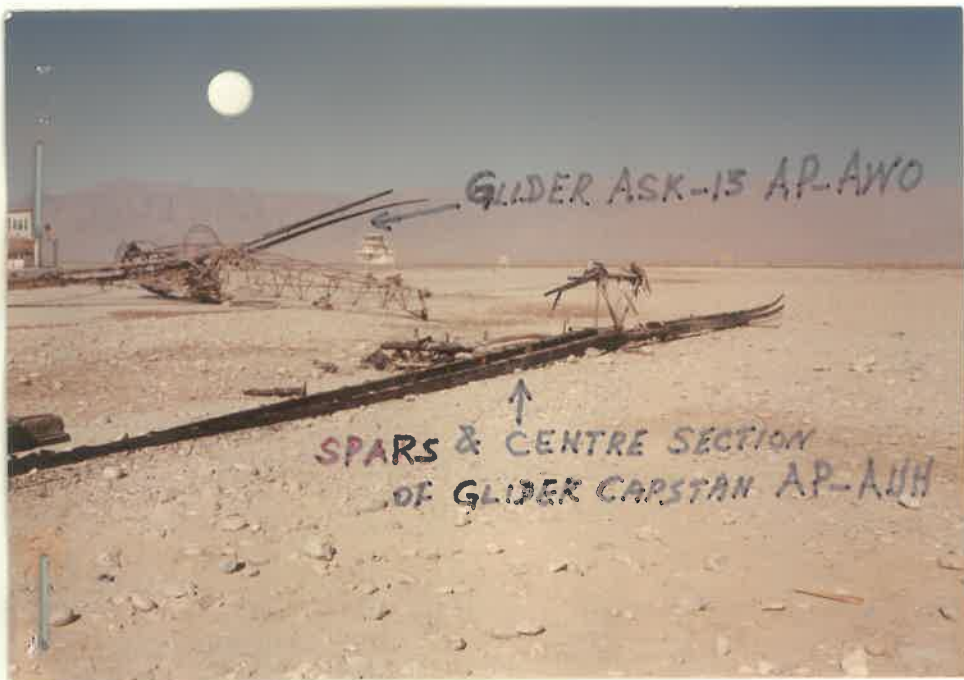
On arriving in front of the Hangar the first thing that one stumbled across were the remains of Glider Capstan AP-AUH. All that was sprawled across on the ground at about 90 degrees to the Hangar and 40 feet away from it, were the half burnt spars and the Centre Section made up of metal pipes and plates. On detailed inspection of the site it was revealed that this was all which was left of the Capstan Glider. While facing the doors of the Hangar, there to the right and slightly closer to the Hangar, was the burnt out structure of the Glider ASK-13, AP-AWO. The tubular structure of the fuselage was burnt naked ~~front~~ to rear. The left wing tip was on ground, Ribs and spars half burnt but the skin completely gone. The right wing completely burnt out with remaining portions of Spars turned into charcoal but were still attached to the anchorage points at the Centre Section of the Fuselage. This Glider <sup>therefore</sup> was also found totally destroyed. Both these Gliders are shown in the photographs enclosed as "Exhibit F".

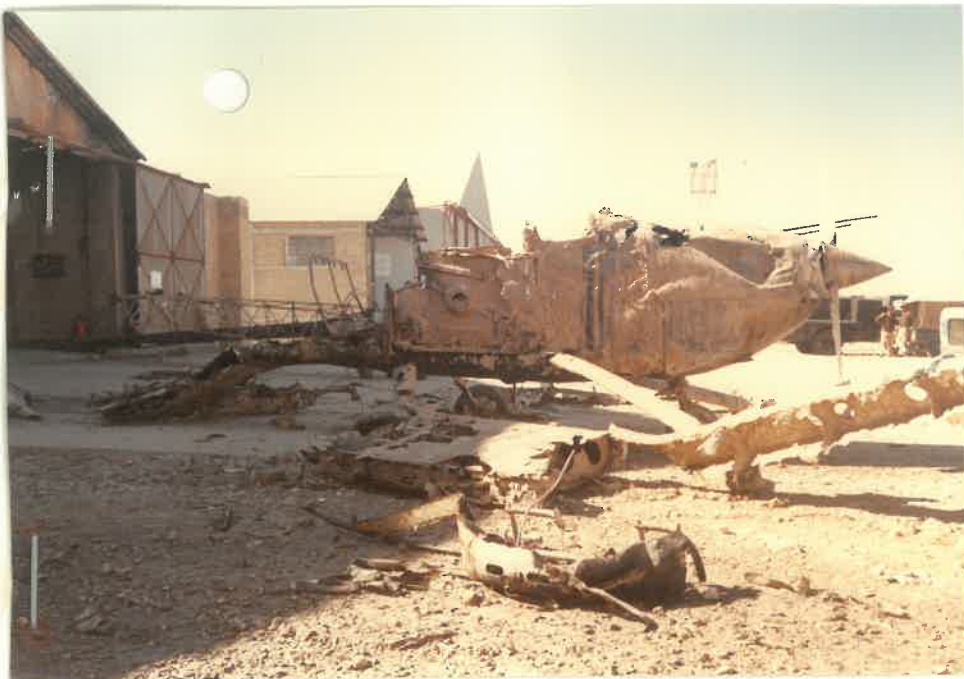
EXHIBIT-G-1

The Aircraft was parked in the south western corner of the Hangar i.e. in the last portion of the Hangar the previous evening. Its serviceability status since 26th April, 1989, was "Placed in storage for Engine Change". The extent of damage sustained by the Aircraft through fire is indicated by photographs enclosed as "Exhibits G, G-1 & G-2", stappled together.

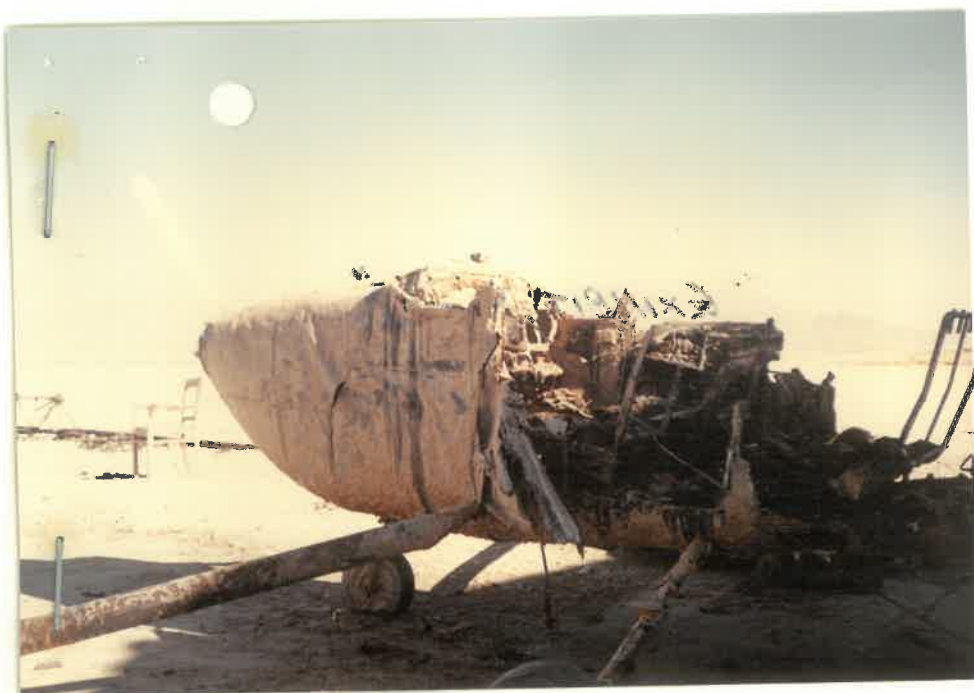
EXHIBIT-G

Further up in the middle and closer to the Hangar ( to be exact. 22 feet from the railings of the Hangar Doors) was lying the major portion of the front fuselage <sup>of Cessna 172,</sup> comprising the engine bay and the cabin, with wings blown off but the wing struts and the under-carriage legs buckled and still

attached to it. One blown up wing was found in shreds and the other one lying 6 feet, to the starboard side of the main remains of the Fuselage. The Empenage was also found detached from the Fuselage, with the pieces of tail unit lying scattered around. The main tyres were found burst. The control wheels/columns, Instruments' Panel, the seats, the Wind Screen, everything had been burnt and the entire remain was covered with Foam Soray left on it during Fire fighting operations. The entire structure of the Aircraft seemed to have been exposed to fire and intense heat barring the Engine Bay and the belly of the front Fuselage.

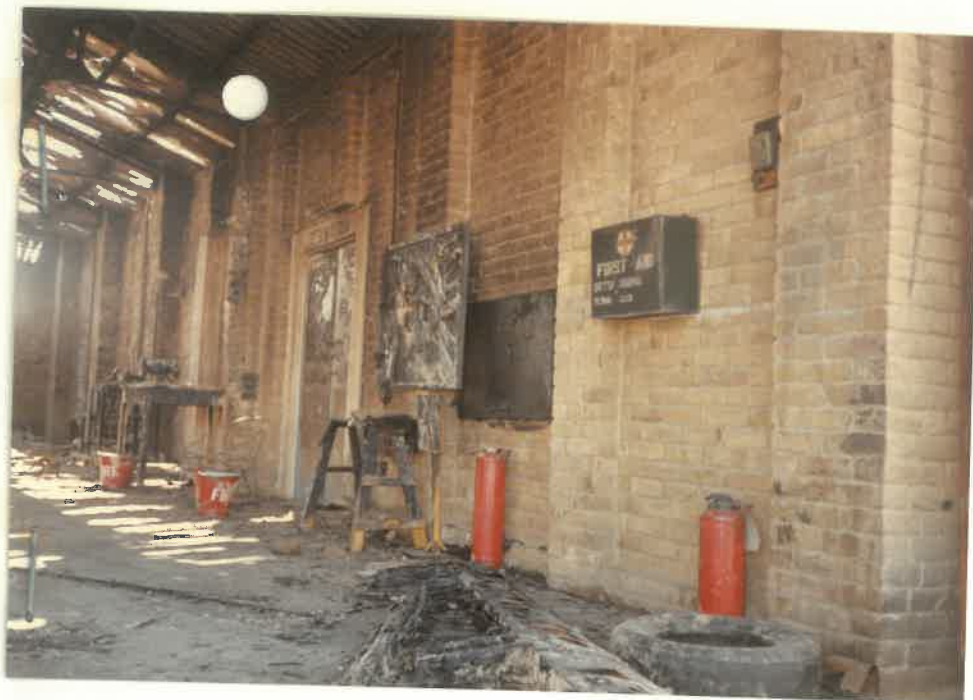
EXHIBIT-J-2

Asbestos sheets of the Hangar Roof, burnt out pieces of wood from the structure of Gliders, control cables, wires, metal fittings etc. Almost the entire floor was covered with ash of the burnt out stuff and pieces of Asbestos sheets. Along the western wall the two unused fire cylinders and two buckets were found lying on the floor. The First Aid Box was in its place and intact. A wooden Trestle, Tools Board, Performance Board, the Grinder Wheel and the Bench Vice's wooden table were found half burnt. A wooden Padestal ladder was also found burnt. The steel door of the stores was found blackened out but no traces of fire or damage inside the stores were found. This western wall of the Hangar and ~~entire~~ <sup>entire</sup> portion of floor ~~near it~~ is illustrated by ~~the~~ photographs enclosed as "Exhibit J".

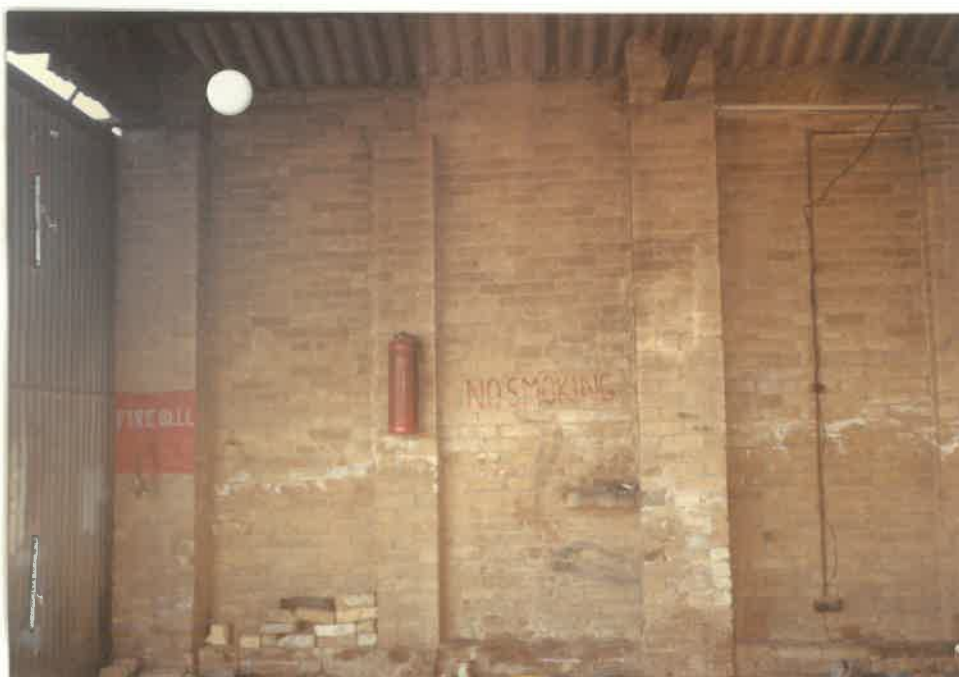
EXHIBIT-L-1

The Eastern wall was found to be carrying the "Main Switch" of the inside of the Hangar near the corner where it meets with the rear wall. Location of the Main Switch is marked with a circle on the photograph enclosed as "Exhibit -L". In addition this wall carried two points for a tube-light and a bulb and an external point for Air Compressor or a drill machine. On the other side of this wall are the rooms of the Army Aviation Squadron who have not raised another wall in between and therefore, this wall has become a common wall. The main supply electric wire also passes through this wall, coming from the Battery Room of the Army Aviation and entering the Hangar near the point where this wall meets with the rear or southern wall. This wall is shown in two portions alongwith its joint with the rear wall, the internal main switch and the point where the supply wire enters the Hangar. Please refer to the Photographs which are enclosed as "Exhibits L & L-1". It also shows the Area on the floor where Capstan Glider was parked.

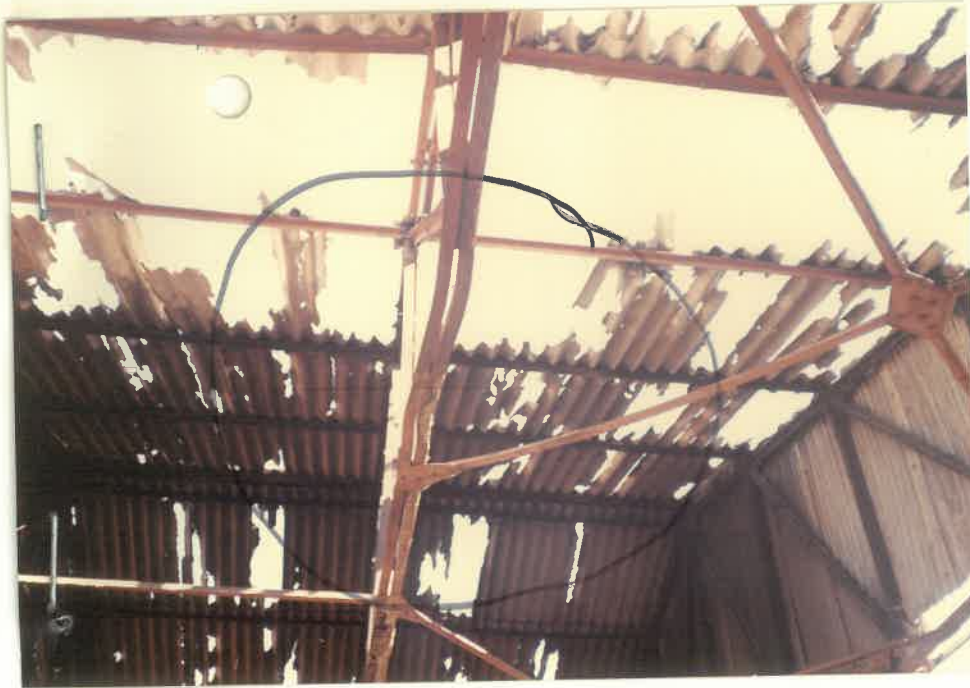
EXHIBIT-M

All the doors of the Hangar were found undamaged. The upper half of the walls was found completely smeared with the Foam Spray used by the Fire Fighting Parties. All the electrical boards, switches and sockets were found half burnt out. A few brick pillars were found damaged which were located near the Cessna Aircraft; and apparently this damage occurred after the petrol tanks of the Cessna Aircraft blew up. The roof sheeting of Asbestos was completely shattered over an area of about 2/3rd of the roof and sheets of the remaining area were found cracked. The steel structure was found undamaged except for one Truss which was found

a little bent and deformed, It seems to have received direct hit at the time of explosion of the fuel tanks of the Aircraft. This damage is shown encircled on the photograph enclosed as "Exhibit M" + Damage to pillars in "Exhibit N" The general condition of the Hangar, its walls and the roofing is amply shown by the photographs enclosed as "Exhibit O, O-1 & O-2". The general view of the area in front of the Hangar on the first inspection of the site, after fire incident, looked like as shown by the photograph enclosed as "Exhibit P" . Hand sketch "Exhibit Q" should also help. Three sessions of photography were held to cover as many aspects of this incident as possible. This ofcourse was confined only to the areas falling under the jurisdiction of the Flying Club or allowed by the Army. The debris was finally removed after the permission from Mr.Mohammad Ali Siddiqui, Ops.Investigator. The following witnesses were examined and their statements recorded:-
