**AIRCRAFT ACCIDENT INVESTIGATION REPORT**

**CRASH OF CESSNA 402B REG # AP-BFG  
IN ARABIAN SEA NEAR KARACHI  
ON 24<sup>TH</sup> FEBRUARY 2003**

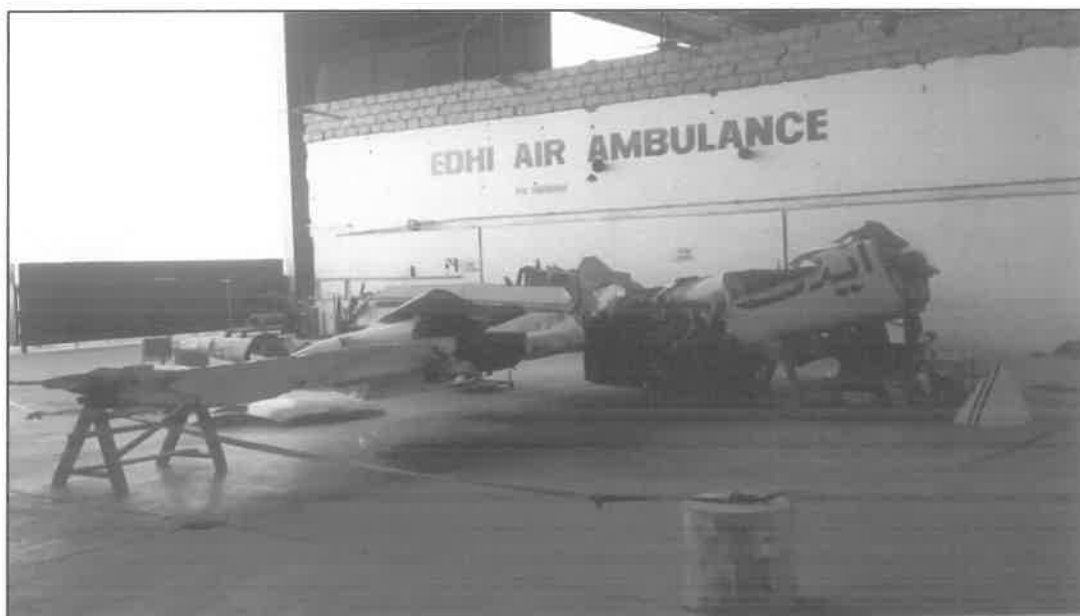
**3.5.1** A general view of the aircraft wreckage reconstruction showed that main wreckage consisted of three major parts i.e fuselage with right wing, the left wing and tail area in many pieces. The right wing was still attached to the fuselage. There was no evidence of any fire or damage due to external hit by any physical object or spherical disintegration. The carpet in the passenger cabin was undamaged. There were no fire marks, carbon deposits, or any kind of sharp cuts or holes or wrapping effects. It indicated the absence of any explosion or collapse of aircraft cabin floor prior to impact with water. The carpet, passenger cabin furnishing, seat cushions, entire structure of right side fuselage wall and seat installation railing on the floor were examined and there was no evidence of explosion or fire.

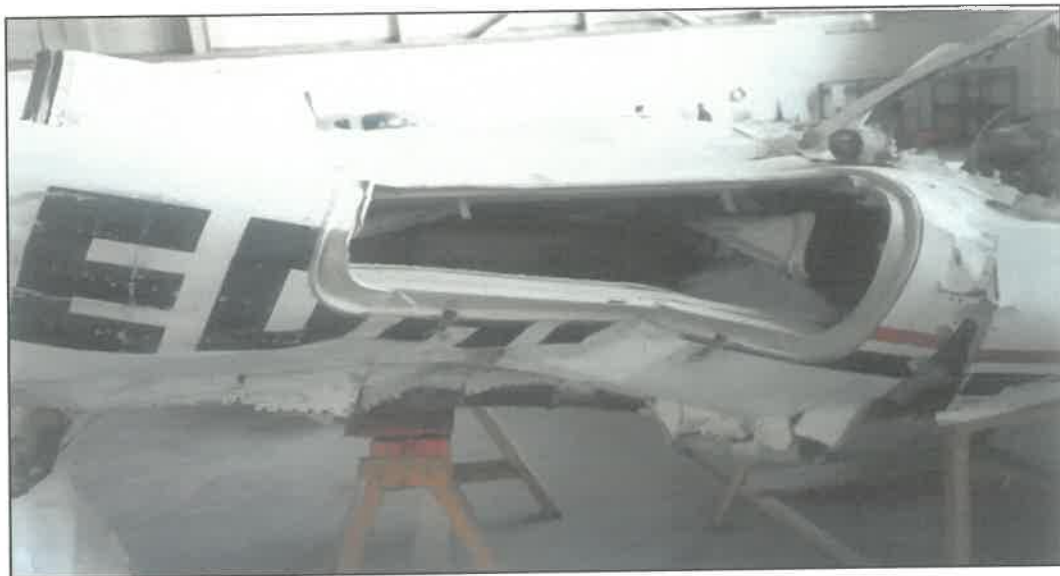
**3.5.2** Luggage compartment was found absolutely in clean condition and no in-flight cargo compartment fire signs were observed. There were no signatures of any explosive device being operated; the compartment was intact and it collapsed due to impact. There were no signs of any dragging of luggage or hit marks.

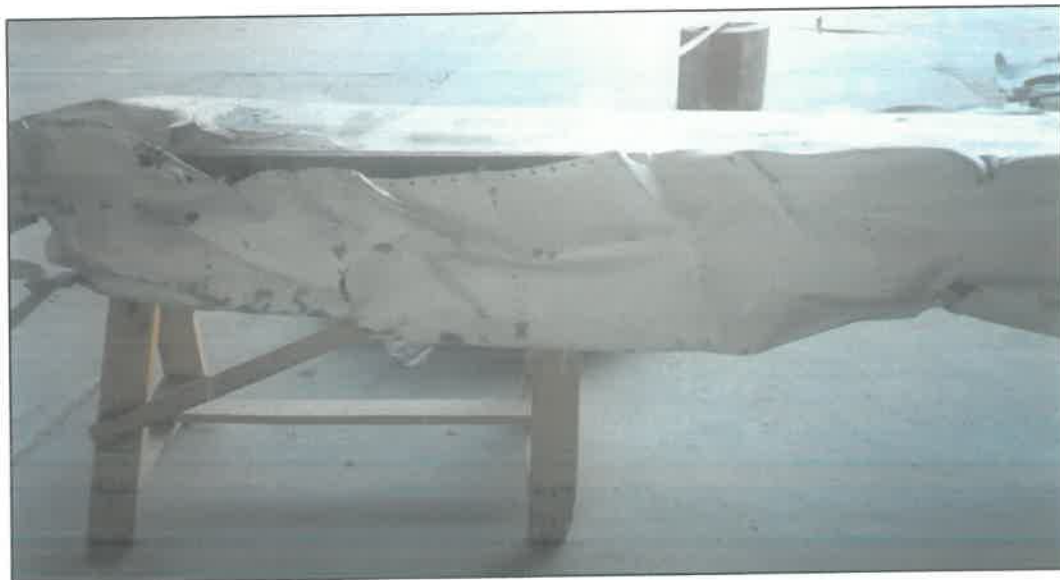
3.5.3 The damages to right wing leading edge; were caused due to impact with water. There were no cuts, smears, colour marks or dents. The wreckage parts also did not show any evidence of fire or explosion.

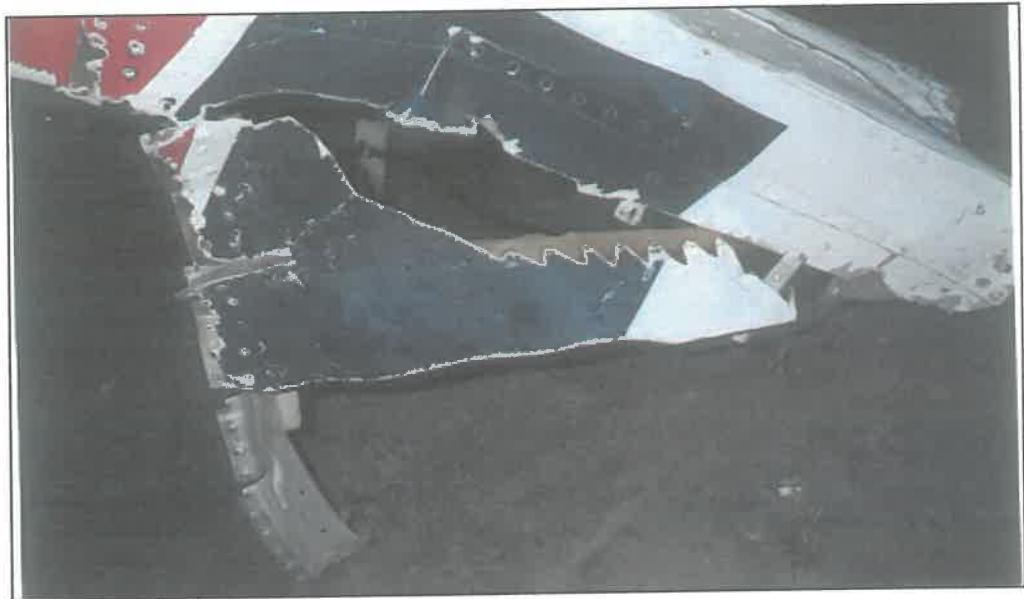
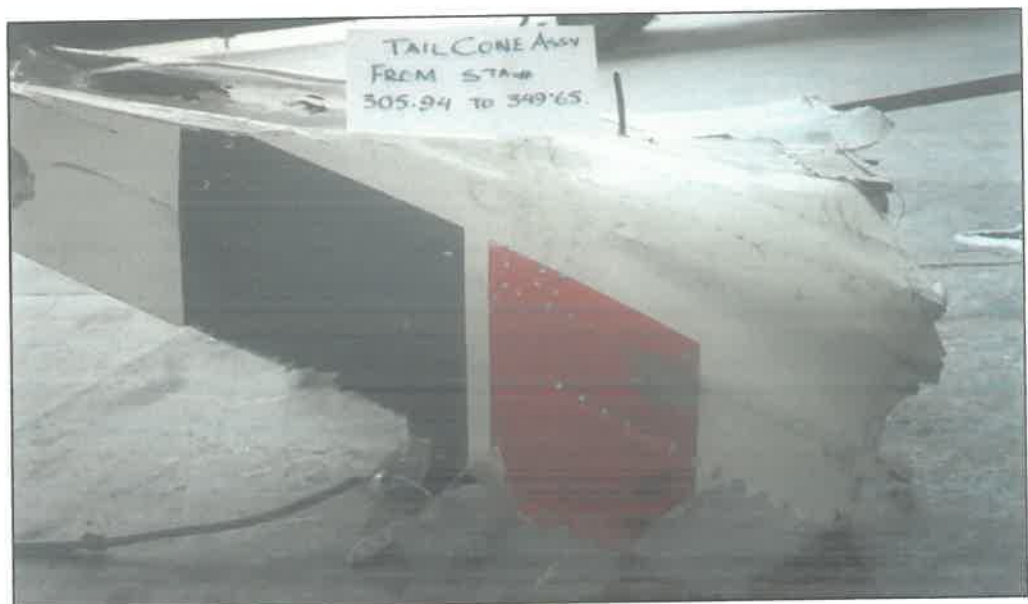
**Tail/Aft Fuselage Breakage Pattern**

- b. Structure close to tail section was found in many panels, which appeared to have separated into haphazard and sheared off pieces. A very important fact was that there was little impact damage on the vertical fin.

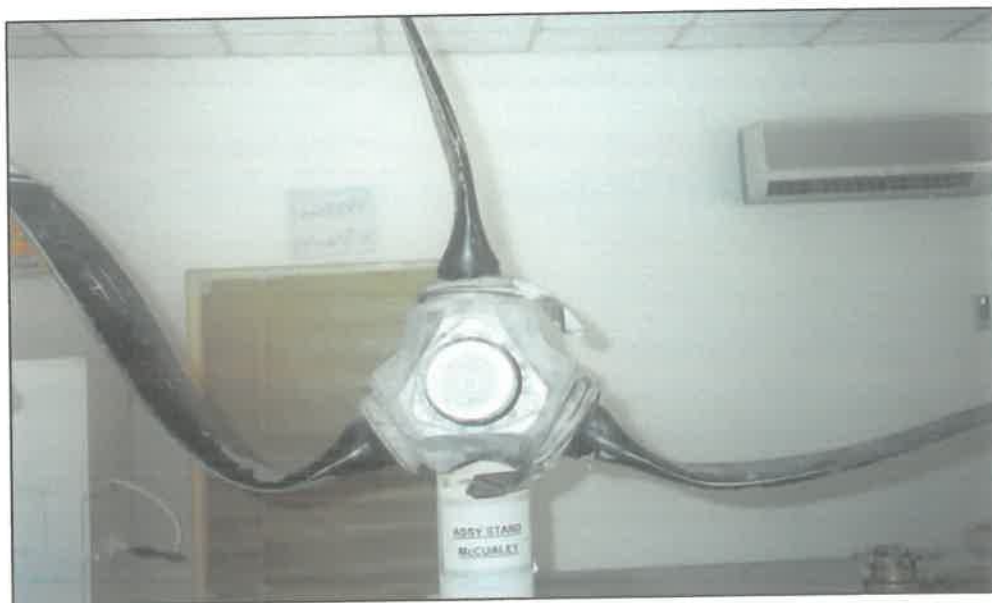
- 3.11 **Propeller Blades and Hub Assembly Examination:** MaCauley Propeller serial numbers 940538 and 931435 were mounted on engines NO 275485 and 8122680 respectively. All the blades of propeller 940538 were found in feathered condition. Blade serial number one and two were found bent in the direction of rotation, whereas blade three was found bent in the direction opposite to the rotation. The links were found intact at piston rod position and there was no evidence of any mechanical failure or maladjustment or abnormality in the hub assembly. The results were similar on the blades of the other propeller with the exception that blade two was found slightly bent.
