**PAKISTAN CIVIL AVIATION AUTHORITY**  
**(SAFETY & INVESTIGATION BOARD)**

**SERIOUS INCIDENT TO M/S. ASSL**  
**PIPER SENECA – III, AIRCRAFT, REG. # AP-BCK**  
**ON 22 MAY 2010 AT PARACHINAR AIRPORT**

## FINAL REPORT

### SERIOUS INCIDENT TO M/S AIRCRAFT SALES & SERVICES AIRCRAFT PIPER SENECA – III, REG. NO. AP-BCK AT PARACHINAR AIRPORT ON 22 MAY 2010

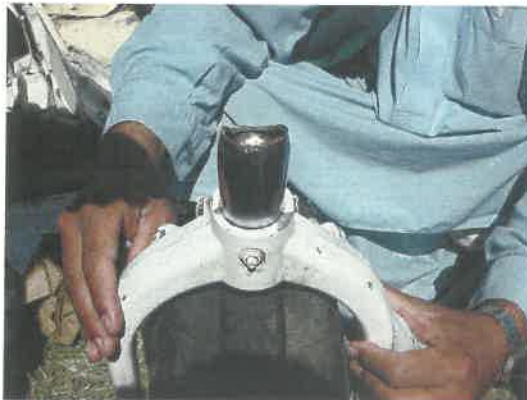
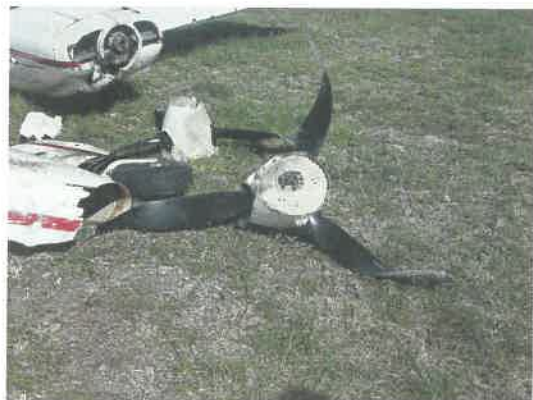
- 1.1 **History of the Flight:** Chartered Flight from Peshawar to Parachinar Airport.
- 1.2 **Injuries to Persons:** No injury to passengers was reported. However, pilot had two minor cuts on forehead and nose.
- 1.3 **Damage to Aircraft:** Aircraft sustained major structural damage including broken Nose Landing gear strut, collapsed / broken Main landing gears and badly damaged / bent Propellers which were found completely separated from the respective engines. Fuselage twisted / buckled from various positions and fire wall and cowling damaged. Detail of damages is as below:

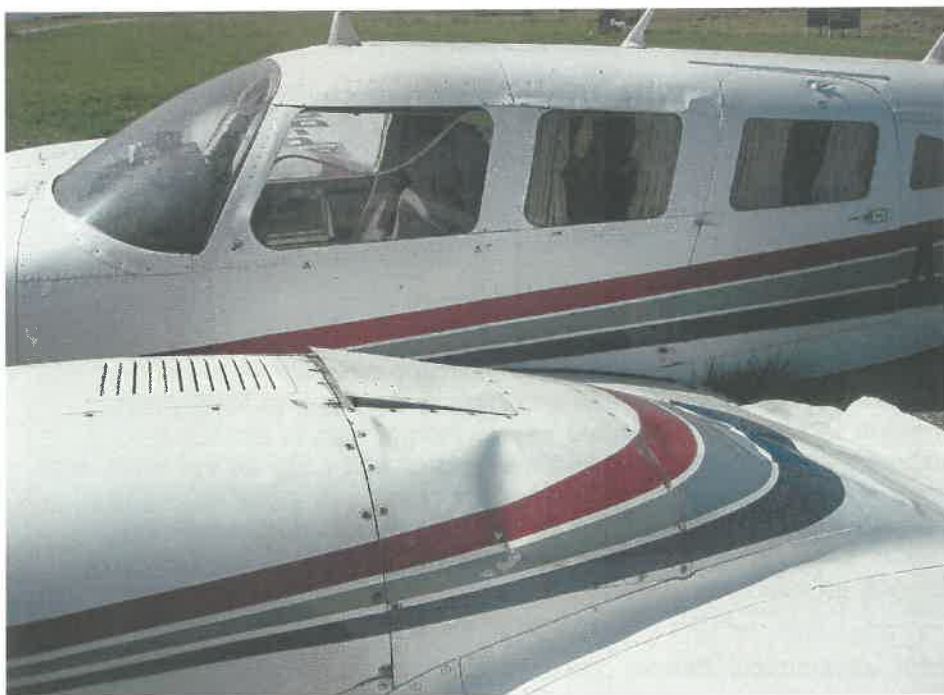
- 1.10 **Wreckage and Impact Information:** Aircraft impacted with ground at Parachinar runway at 600feet down the runway during landing, after rebound, at about 1100 feet dug marks of both Propellers were observed, nose gear strut of aircraft broke at about 1700 feet and propellers of both engines and the nose of the aircraft touched the runway again. Aircraft came to stop at approx 2000 feet of distance from beginning of the runway after sharp 90 degree right twisting turn, resulting into collapsed / breakage of both the main landing gears and hence aircraft rested on its belly as shown below:

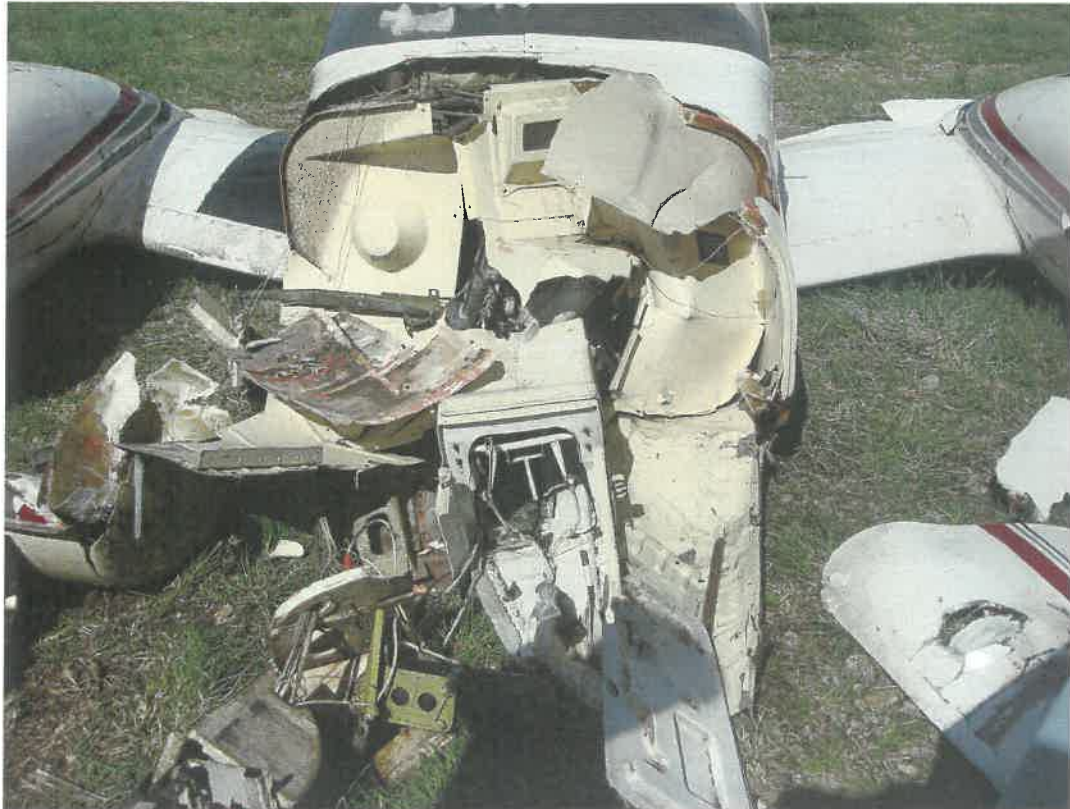
- 1.11 **Flight Recorder / CVR:** Aircraft was not equipped with FDR / CVR.
- 1.12 **Weather Information:** Weather reported was partly cloudy; wind at Parachinar Airport was light and variable, and visibility more than 10 KM.
- 1.13 **Fire / Smoke:** Fuel / oil leakages of moderate nature were observed, however, no fire / smoke was reported.
- 1.14 **Aircraft Wreckage Analysis:** After the occurrence the survey of accident site was conducted, the important signs / marks on the runway and evidences were preserved through digital photography. Damaged aircraft and scattered parts were examined with a view to establish cause/s of accident. The wreckage detail as seen below:

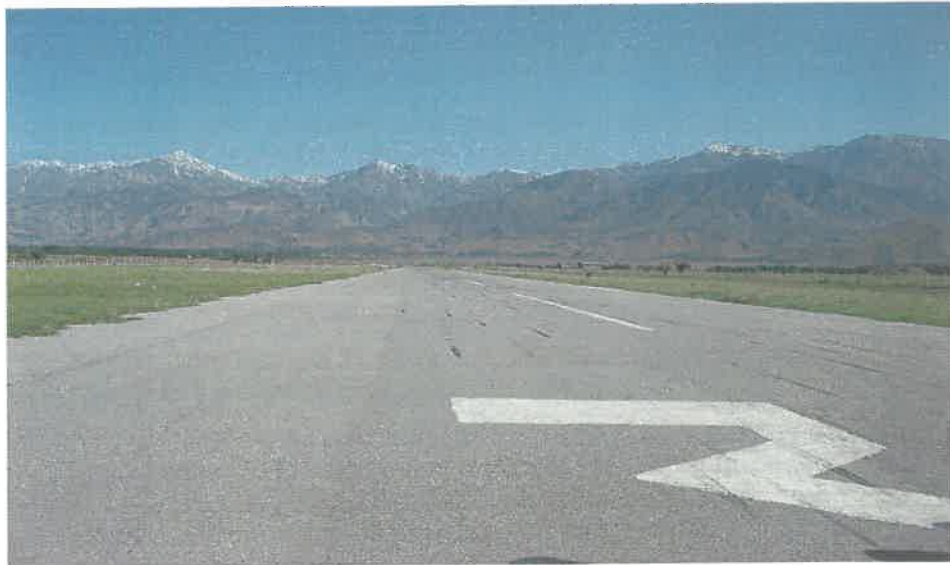
- 2.1.3 Post impact examination revealed that; there were three impacts starting from the first impact at 600 feet down the runway and after a bounce, the second impact was at 1100 feet down the runway where propeller deep dug marks were found on ground and propeller were observed to be bent. The third impact was indicated at 1700 feet where the breakage of nose landing gear strut and touching of front section belly were reported.
- 2.1.4 Aircraft impact pattern, position of scattered debris, type of parts damaged and stress / marks indicated that the aircraft had made touch down at higher than recommended speeds.
