# FINAL INVESTIGATION REPORT

SERIOUS INCIDENT OF M/S. PIAC FLIGHT PK-4522 (SECTOR SKD – ISB)  
ATR 42-500, AP-BHO ENGINE NO. 1 UNCOMMANDED SHUTDOWN  
ON 15<sup>TH</sup> SEPTEMBER, 2014 AT SKARDU

## FINAL REPORT

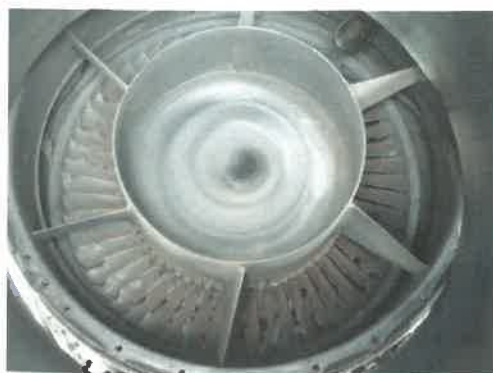
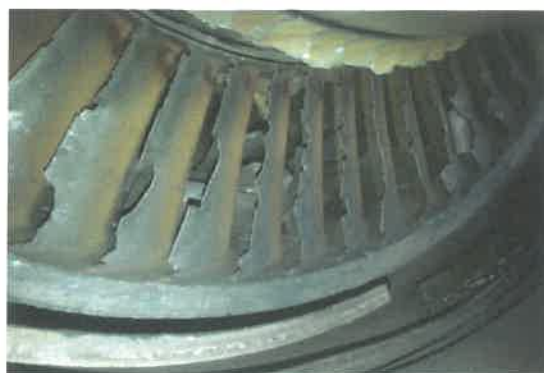
- 2.1 On wing inspection of the engine revealed damage to power turbine and free turbine. Post occurrence oil quantity was found within normal limits. The metal particles were found in metal chip detectors (MCD). Borescope inspection revealed severe internal damage to engine.

Power and free turbine damage, pictured on post flight

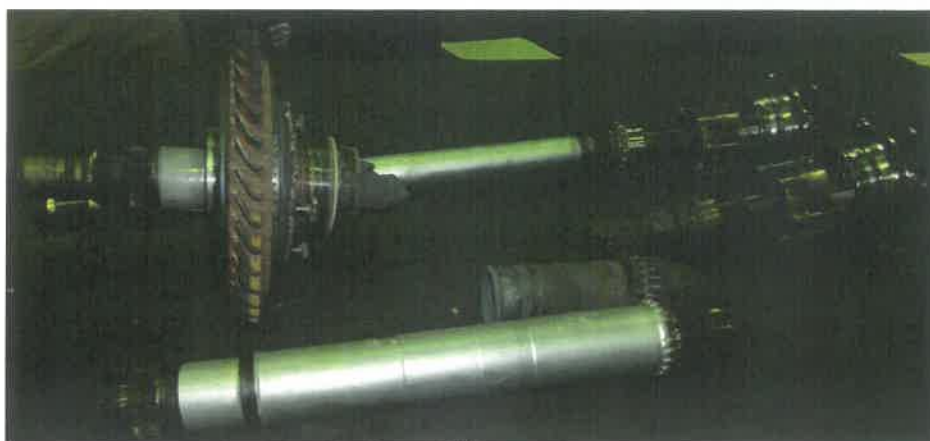
- 2.4 No. 2 roller bearing was found dry and in extensively damaged condition. Due to No. 2 bearing failure engine shafts got misaligned and apparently showed signs of exposure to extensive frictional / thermal stress (melting). The part of the Power Turbine (PT) shaft got melted away (approximately 20 cm) due to frictional/combustion heat and the molten material was observed spread over internal cavities. As depicted in the schematic diagram the No.2 bearing is not located in hot zone of the engine. The most probable reason of observed thermal damage and melting of the Power Turbine (PT) shaft and Low Pressure (LP) Compressor shaft was friction due to rubbing of the shafts as they got misaligned after the bearing failure.

Comparison of PT shaft and LP shaft damage with new parts

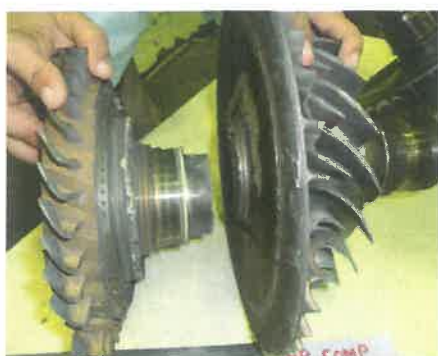
HP compressor and HP turbine and HP shaft damage

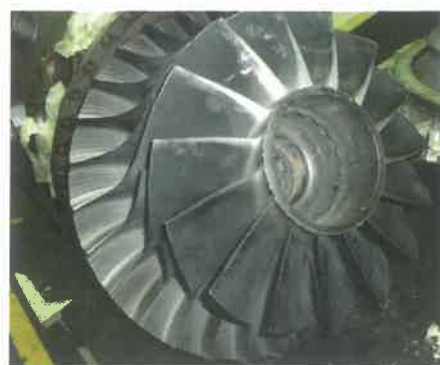
- 2.3 Strip examination of the engine did not show evidence of foreign object damage in intake area and low pressure and high pressure compressors. Rubbing on the tips of the impeller supported the possibility of misalignment of shafts due to No. 2 bearing failure.

LP compressor

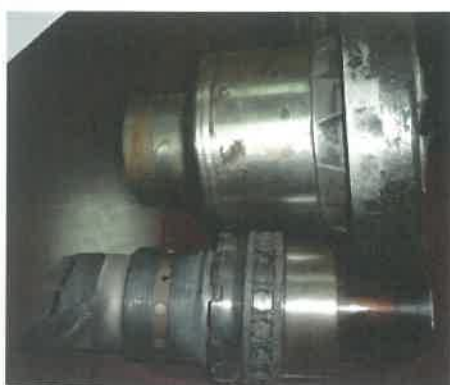
No. 2 Bearing and its housing

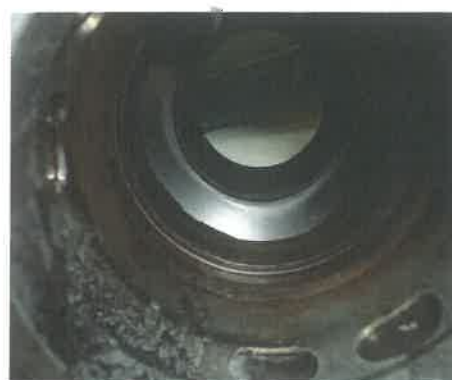
Internal view of No.2 bearing housing

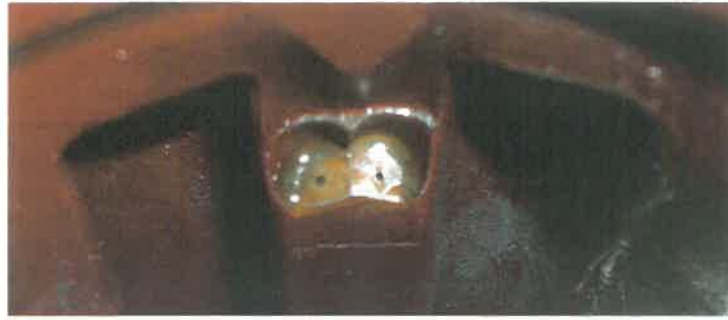
- 2.5 All other bearings were found intact with evidence of availability of lubrication.
- 2.6 The two oil jets designed to provide lubrication of No. 2 bearing were found totally (100%) blocked. The oil pressure was applied in accordance with the procedure for checking oil jet flow pattern. During this procedure no oil flow was observed from the oil jets. The external surface of the oil jets was clear of any dust or dirt accumulation. Fine metal wire was passed through the oil jets in attempt to collect the debris blocking the jets. The debris could not be collected due to very small size. However, passing of wire cleared the jets and subsequent application of pressure gave solid jet of oil.

No. 2 Bearing oil jets

- 2.14 Based on the available evidence and manufacturer's literature the exact reason of No.2 bearing oil jet blockage could not be established. One of the probable reasons could be introduction of small environmental contaminants which passed the system filters and accumulated over time in the oil jets. The second probable reason could be formation of coke or oil burn products in the oil jets similar to fuel nozzle coking due to inadequate cooling before engine shut down.

- 4.1 Keeping in view the harsh weather environment, the operator (PIAC) to implement following recommendations to avoid similar occurrences in future:
  - 4.1.1 ✓ To educate technical crew on best practices to ensure engine oil servicing free of environmental contamination.
  - 4.1.2 Consider implementation of monitoring of FDR data for adherence to approved engine shut down and ground operation.
  - 4.1.3 ✓ Consider use of suitable engine oil dispenser instead of funnel after getting due approval from the aircraft/engine manufacture.

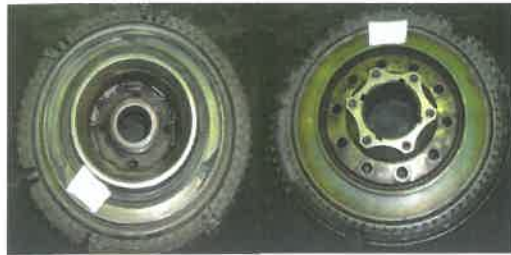
- 2.7 The turbine blades and stators were also observed extensively damaged.
- 2.8 Following pictures depict the extent of damage observed during strip examination.

Power turbine 1 and 2  
(Blades removed for inspection)

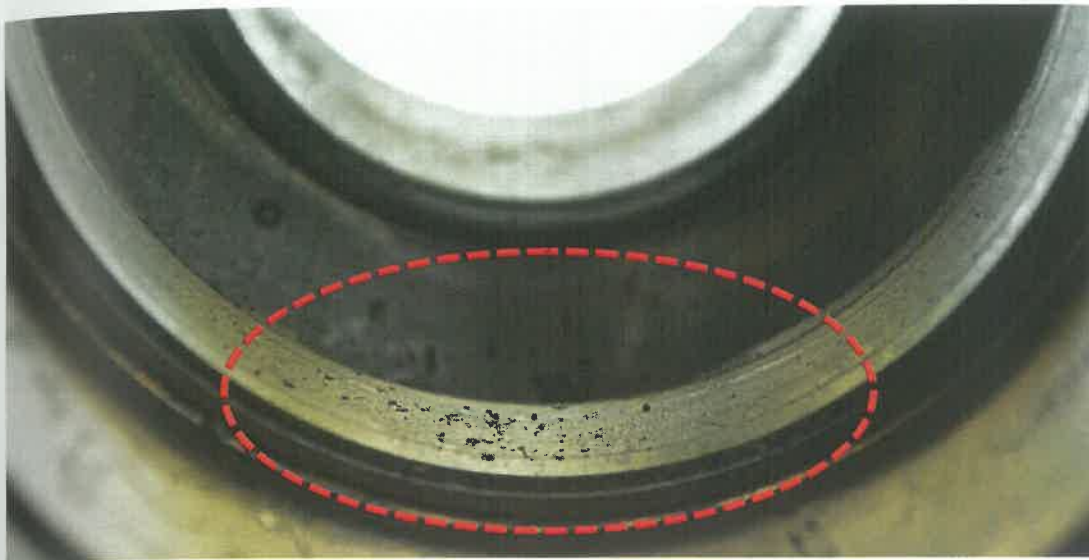
Fig. 5. Outer race of roller bearing exhibiting wear marks.

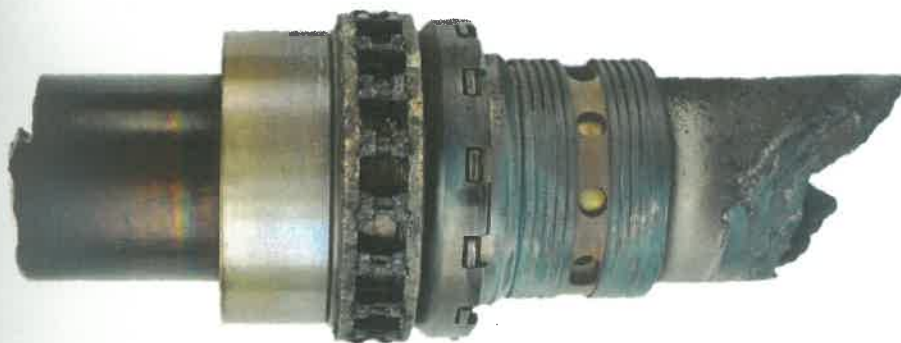
Fig. 6. Inner race of roller bearing attached with left over portion of PT shaft.

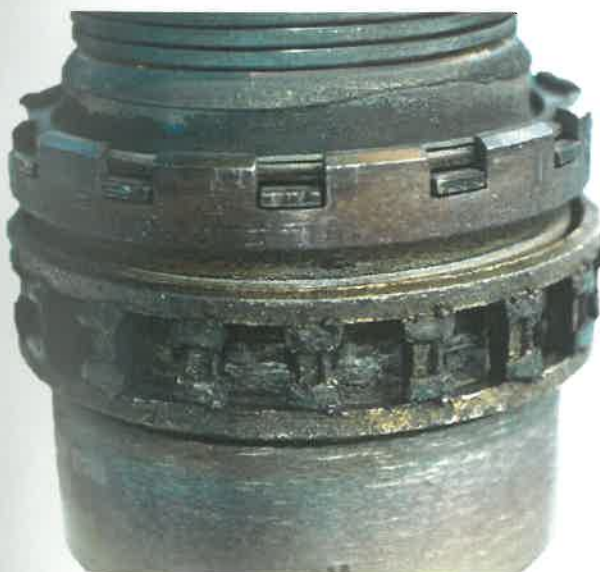
- 2.9.1 Oxide/metal deposits were found on half of the inner race, indicating that bearing had already been ceased when it got exposed to fire.
- 2.9.2 Cups of the bearing cage were deformed due to friction between the rollers and the inner race during dry run.

Fig.7. Oxide deposits on the inner race of roller bearing.

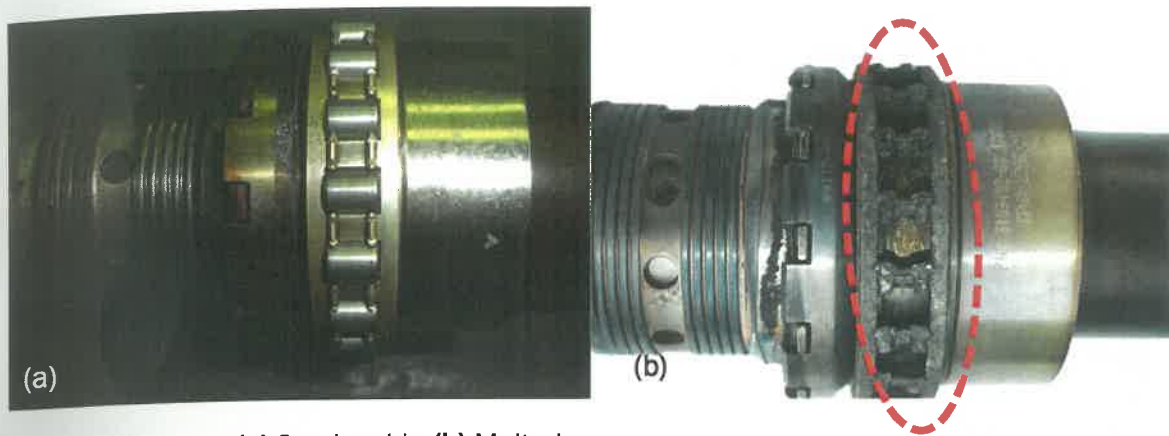
**Fig. 8.** Roller cage (a) Serviceable (b) Melted.

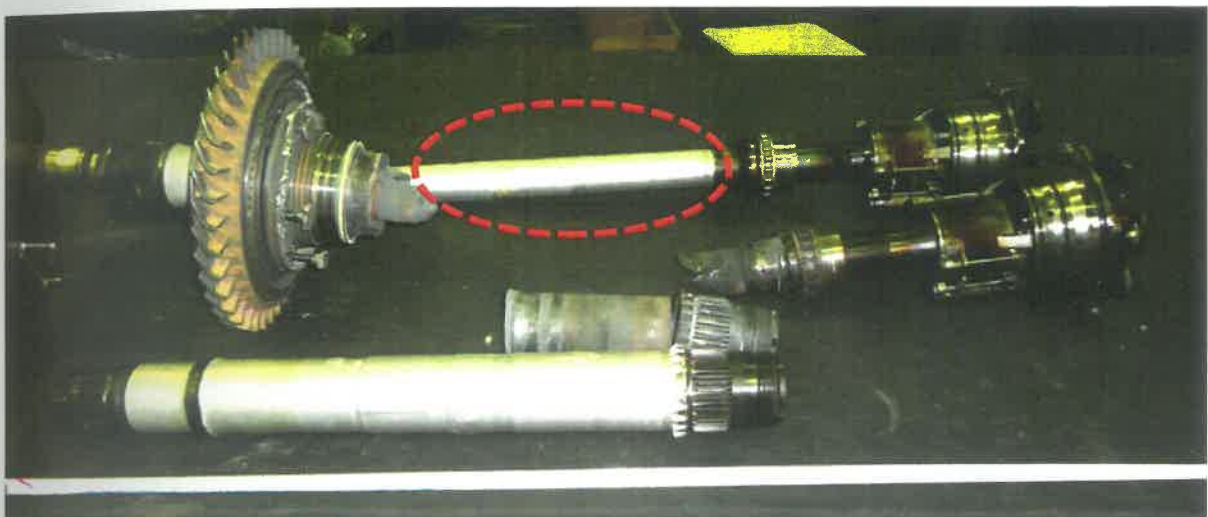
**Fig. 9.** Serviceable PT shaft and damaged PT shaft.

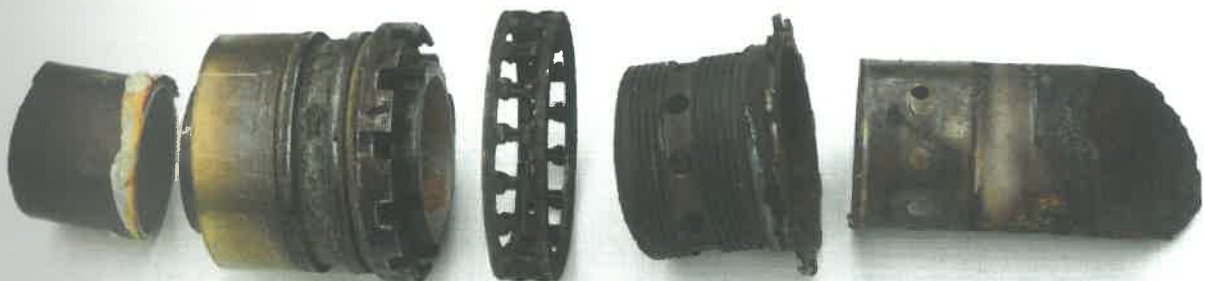
**Fig. 10.** Disassembled inner race of roller bearing.
