**PAKISTAN CIVIL AVIATION AUTHORITY**  
**(SAFETY & INVESTIGATION BOARD)**

**SERIOUS INCIDENT TO M/S SHAHEEN AIR**  
**B-737-200, AP-BHA, FLIGHT NO. NL-785**  
**ON 7 JANUARY 2008**  
**AT**  
**DUBAI – UAE**

## FINAL REPORT

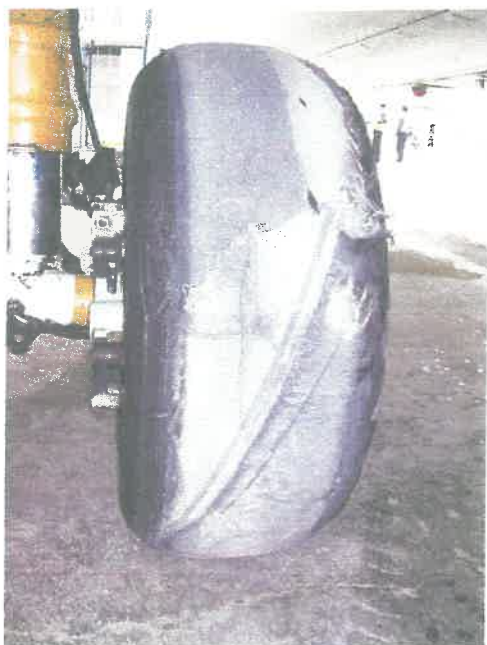
- (a) Tread of No. 2 tire of left MLG was found separated (Photographs 1 & 2).
- (b) A 4 feet long and 8 to 16 inches wide tire -tread piece was found entangled in landing gear. (See Photographs No 3)
- (c) The left hand actuator support link was found fractured in two parts. (See Photograph NO 4, 5 and 8)
- (d) Left Wing upper surface triangular panel found torn and pieces missing (See Photographs 5 & 6).
- (e) Hydraulic lines broken and protruding above wing surface. (See Photograph 9 & 10)
- (f) The main gear actuator assembly along with walking beam and hanger was protruding above wing surface with hanger link broken (See Photographs 9 & 10).

Photograph - 1 TYRE TREAD  
PEELED-OFF

- 4.1. Aircrew and ground crew should be vigilant during go-around inspection of aircraft especially the landing gear bays where chances for presence of foreign objects and small animals are high.
- 4.2. Aircraft tyres be maintained as per applicable Maintenance Manual to avoid such sudden tyre failure.
- 4.3. SAI to monitor the Quality of "Re-treaded" tires from Goodyear, Thailand.
- 4.4. DFDR must be preserved after occurrence.
- 4.5. Aircrew decision to proceed to Karachi may be reviewed by Flight Standards (PCAA) and SAI (Flight Operations).

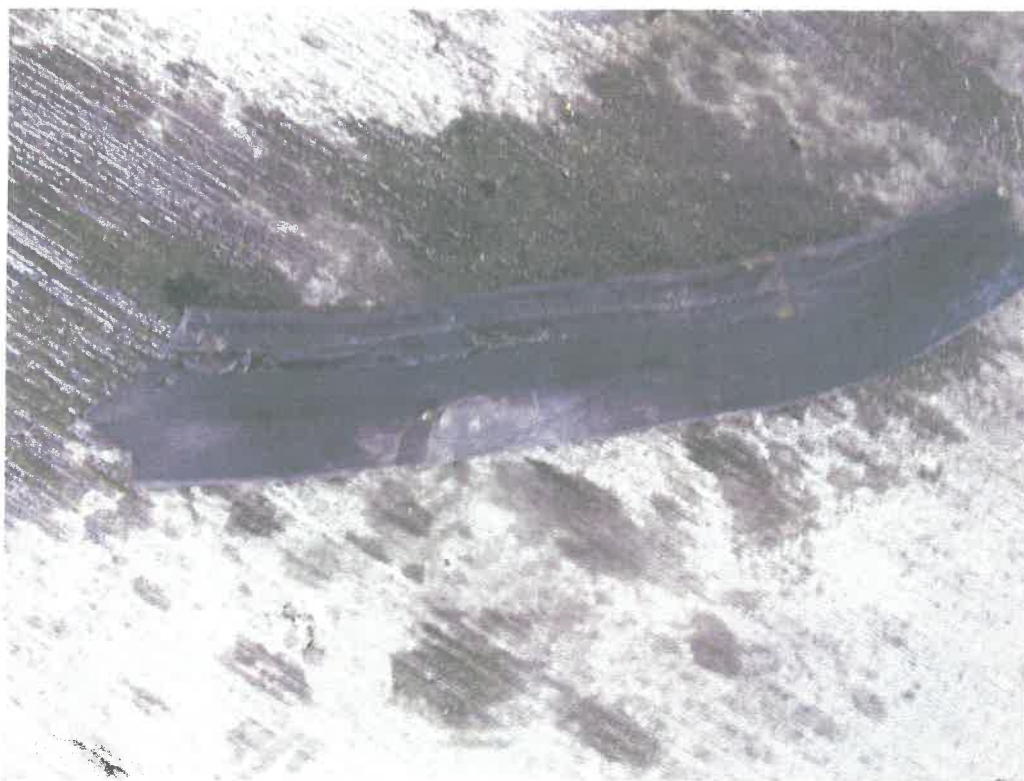
Photo 3 A 4 feet long tyre piece was held up in M24.

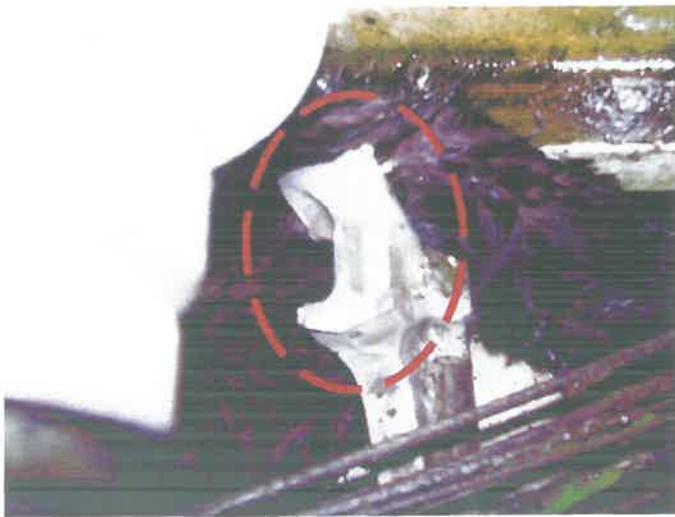
4

- (g) A full size black cat was found sandwiched between landing gear hold up beam and lower broken portion of hanger link (LMG actuator link). (See Photographs 4, 7, 8, 12 & 13).

- 2.6 The actuator link was dispatched to Boeing Air Safety Investigation, USA along with all necessary information and photograph. The Boeing carried out the fracture analysis with the help of Material and Process Technology, the report is attached as **Appendix 'C'**. The report has made the following conclusions:
- (a) Rework to support link exhibited a poor overall finish to the part. Primer adhesion was poor. The aluminum surface was abraded, partially anodized and not thoroughly shot peened.
  - (b) In cross-section, several shot preening folds to the outer corner radius of the center I-web section was observed.
  - (c) The support link fracture initiated by a fatigue crack. A shot preening fold likely contributed to the crack initiation.
  - (d) Scanning Electron Microscopy and striation analysis estimated that the fatigue crack Initiated shortly after the November 2002 overhaul.

- 2.7 In brief the Boeing metallurgical analysis has attributed presence of a “**Fatigue Crack**” as cause of actuator failure; and it confirms that the fatigue originally initiated in 2002 during its last overhaul. It further identifies “poor finish” and improper shot peening as the cause of fatigue initiation.

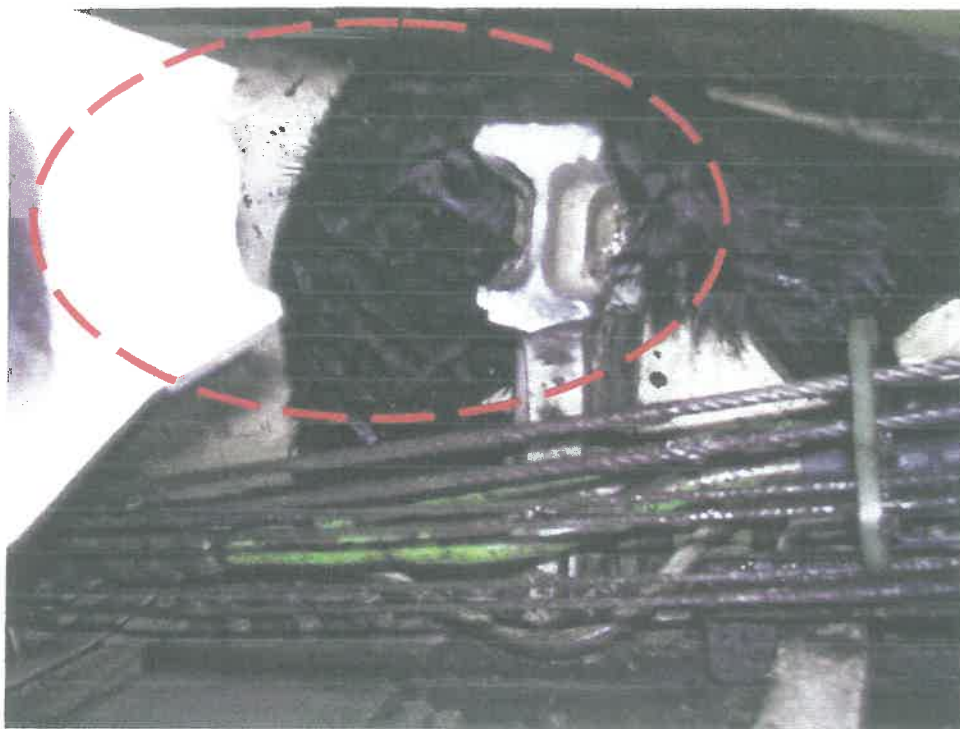
Photograph 7

- 2.4 The cat was found frozen and was lying exactly over the broken actuator link. It initially appeared that it might had caused an obstruction to the movement of the actuator link; however considering that facts that the cat was still intact i.e. not even ruptured or pressed between broken portions of the actuator link; it was quiet obvious that this animal consisting of soft tissues can not cause the failure of a metal component made of cast aluminum alloy. Hence presence of the cat to contribute to Landing Gear failure was ruled out.

B737-200 - AP-BHA (SHAHEEN AIR INT'L)  
VIEW OF LH LDG GEAR ACTUATOR ATTACH FITTING -- BROKEN
