**CIVIL AVIATION AUTHORITY – PAKISTAN**

**SERIOUS INCIDENT TO PIA FLIGHT 786**

**B-747 REG # AP-BFV, AT ISLAMABAD**

## FINAL REPORT

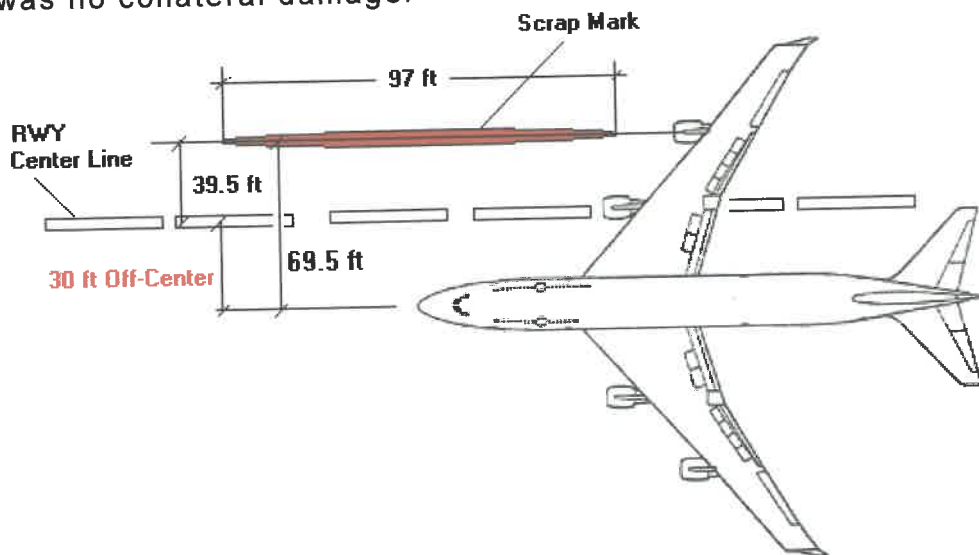
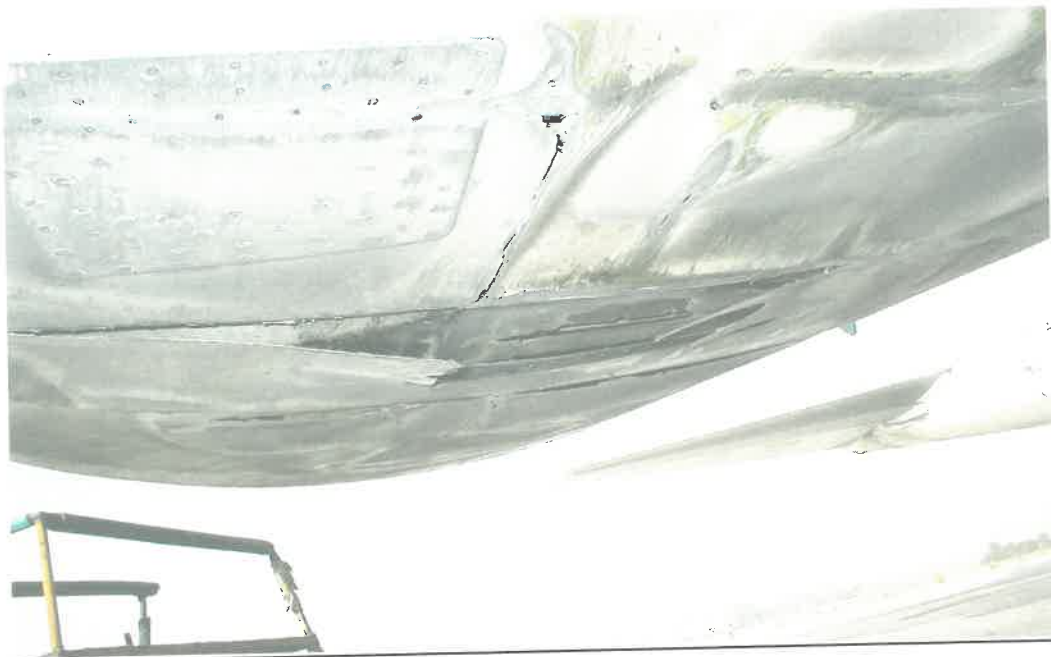
**Brief Resume:** On 03 January 2005, AP-BFV, a B-747 was en-route to Islamabad from London (Heathrow). On landing at Islamabad, the aircraft's right outer engine pod (# 4 engine pod) grazed the runway and the engine cowling was damaged. There was no collateral damage.

1.3.1 No. 4 Engine Cowling (under-side, 6'O clock position) grazed the ground while landing and sustained the following damages:

- (i) Both fan cowls portion found damaged.
- (ii) Translating sleeve lower portion found damaged.
- (iii) No. 4 engine fluid drain mast found damaged.
- (iv) No. 4 engine I.D.G. found damaged.

(v) No. 4 engine fire wall found buckled at the lower portion.

(vi) Plumbings found damaged in lower portion of No. 4 engine.

(vii) No. 4 engine oil quantity indicating 13.5 Qtrs (22 Qtrs when full).
