**CIVIL AVIATION AUTHORITY**

**AIRCRAFT INCIDENT INVESTIGATION M/S PIAC  
BOEING - 747 REG.NO.AP-BCO WHICH OCCURRED  
ON 17TH MAY, 1996**

**QUAID-E-AZAM INTERNATIONAL AIRPORT  
KARACHI.**

**INVESTIGATION REPORT**

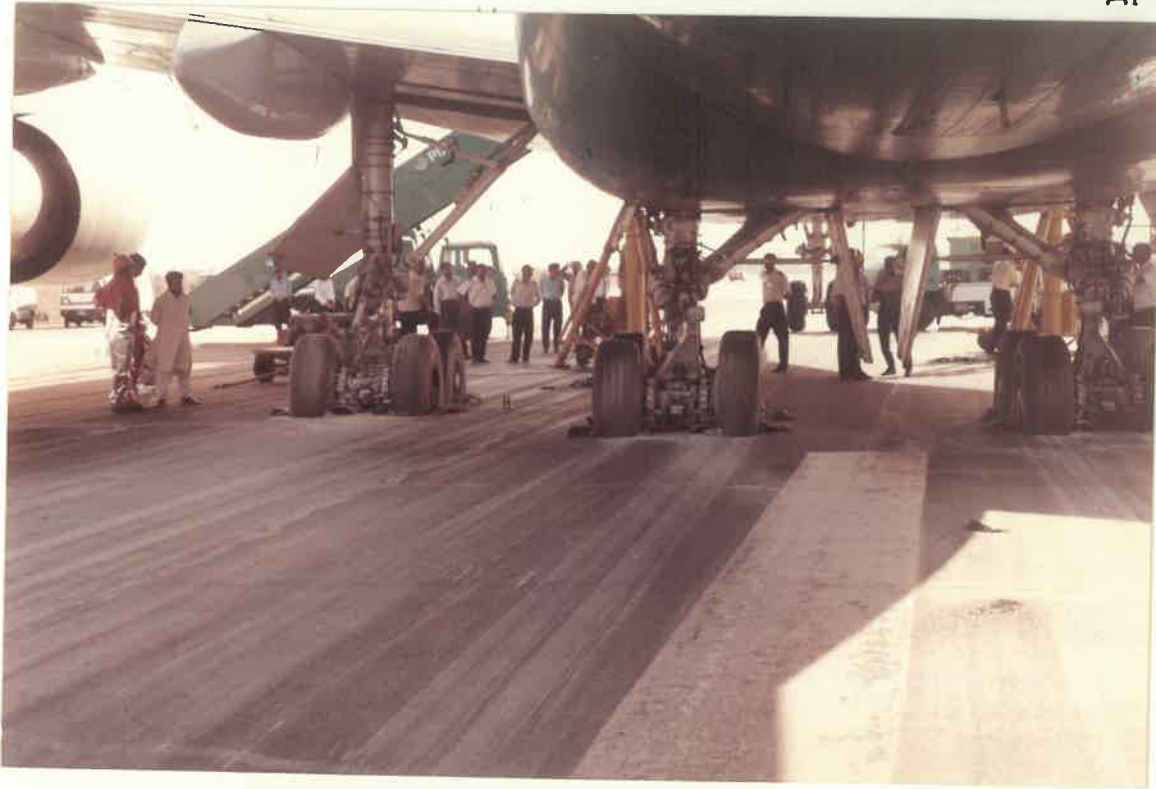
APP. 'B1'

PHOTO TAKEN AFTER LANDING LEFT BODY GEAR & WING  
GEARS TYRES BURST

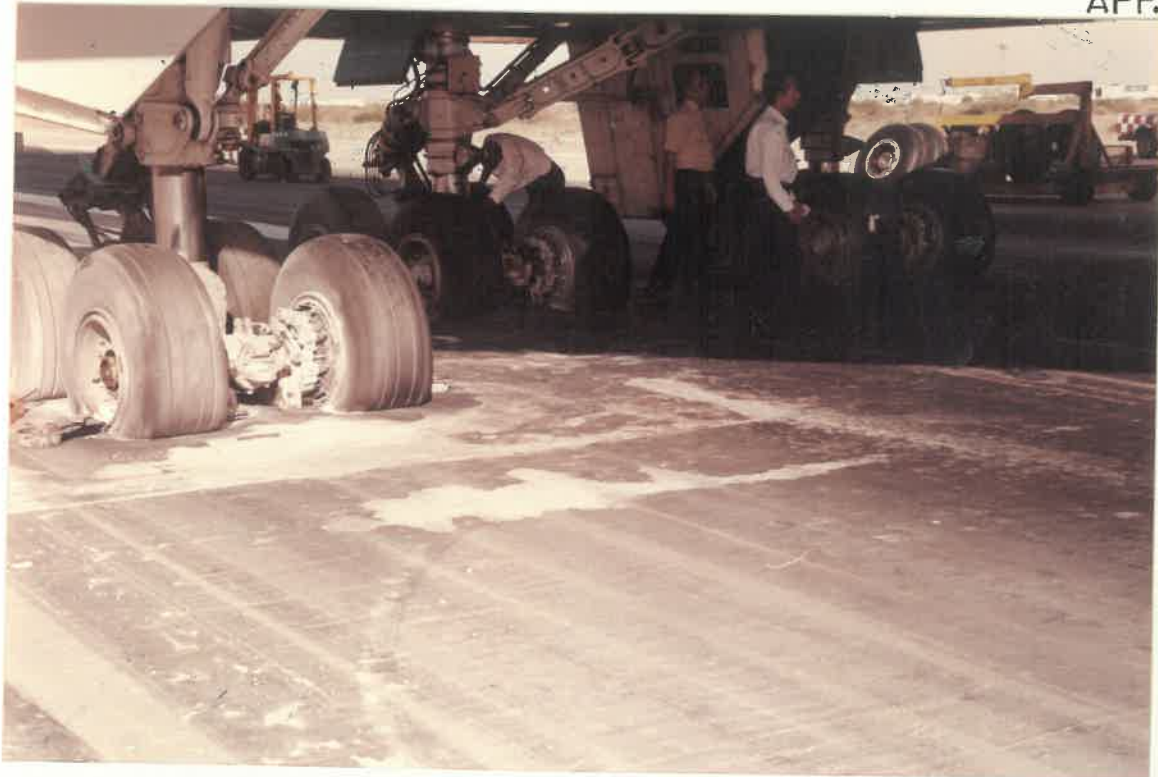
APP. 'B2'

BODY GEARS & WING GEAR ALL TYRES BURST

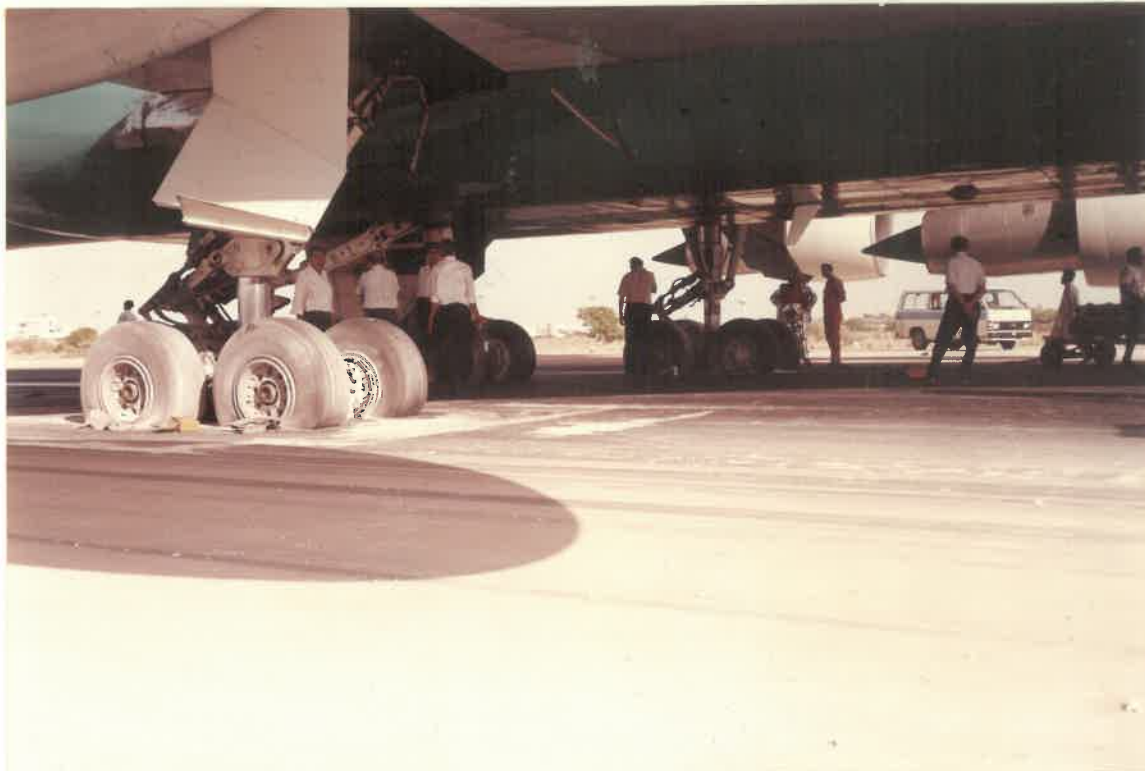
ANOTHER VIEW OF LEFT WING GEAR TYRES BURST

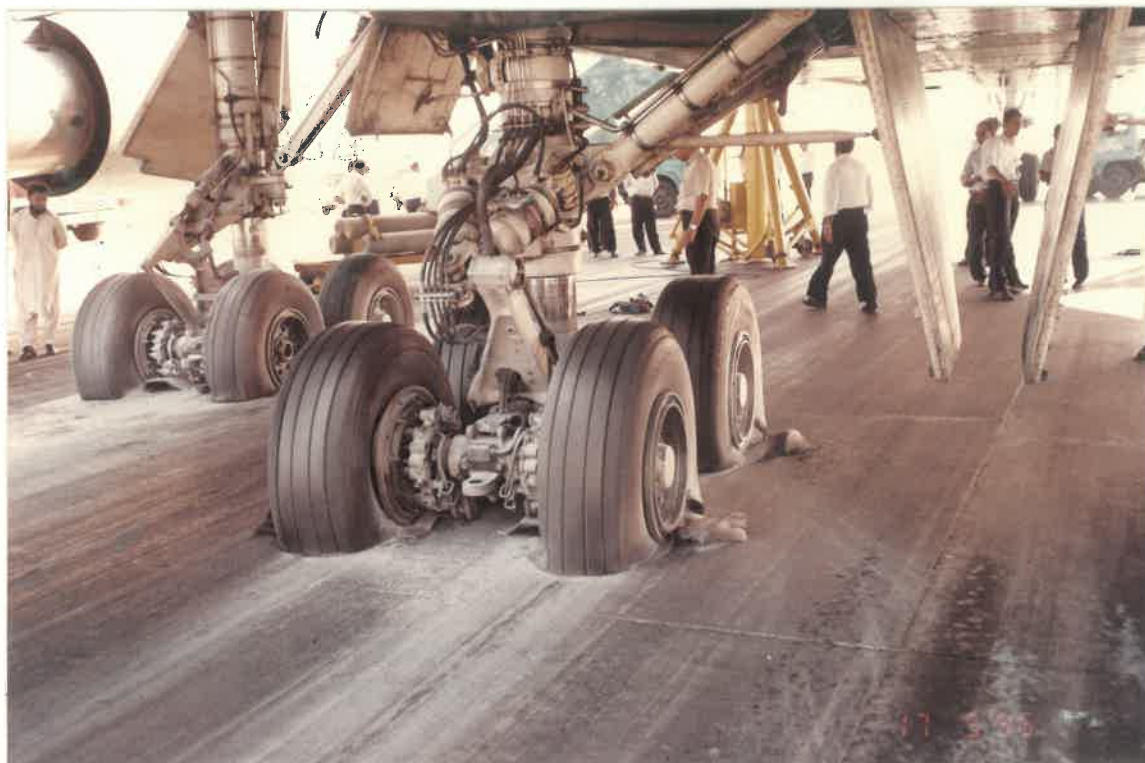
CLOSE UP VIEW OF LEFT WING & BODY GEARS TYRES

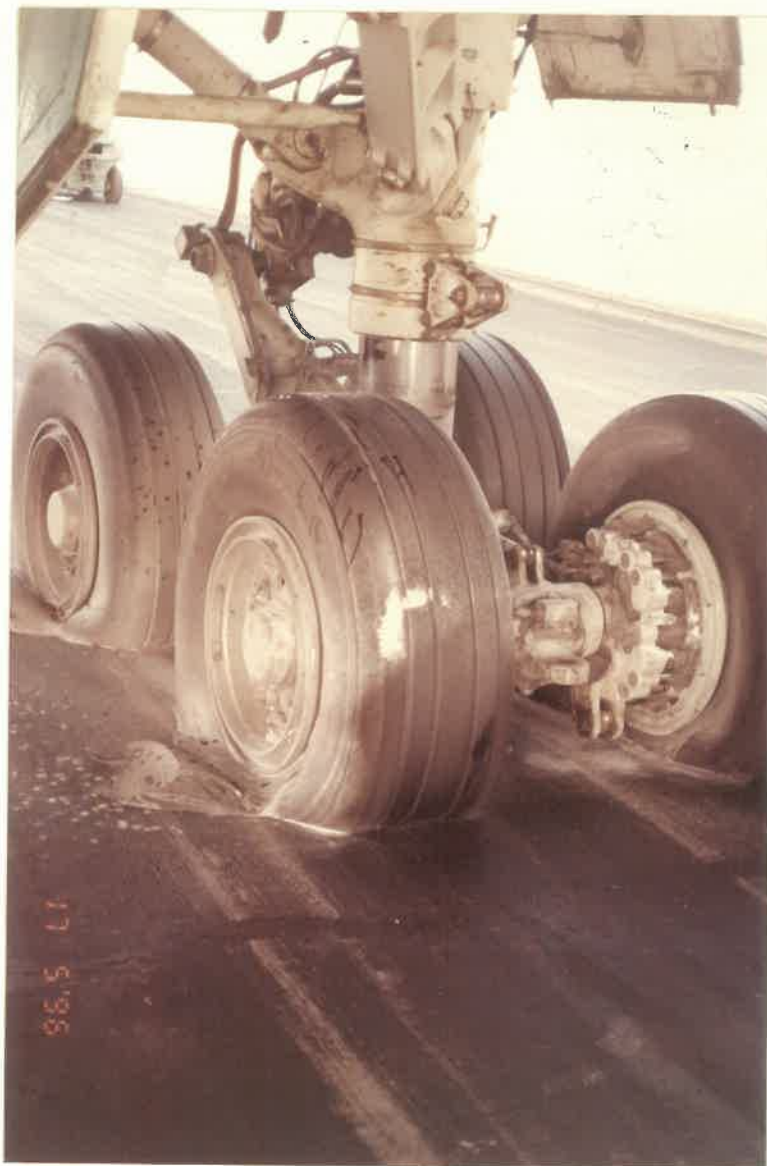
APP. 'B5'

LT. WING GEAR WING GEAR TYRES BURST

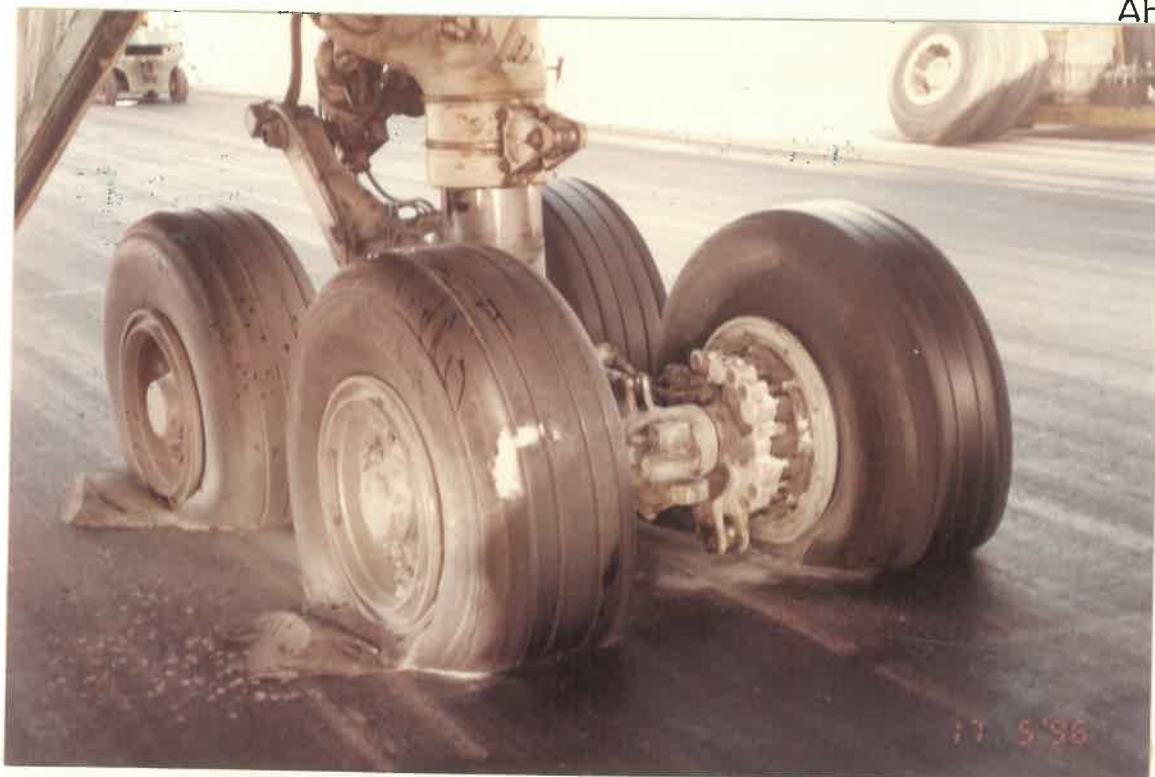
APP. 'B6'

LEFT BODY GEARS TYRES BURST

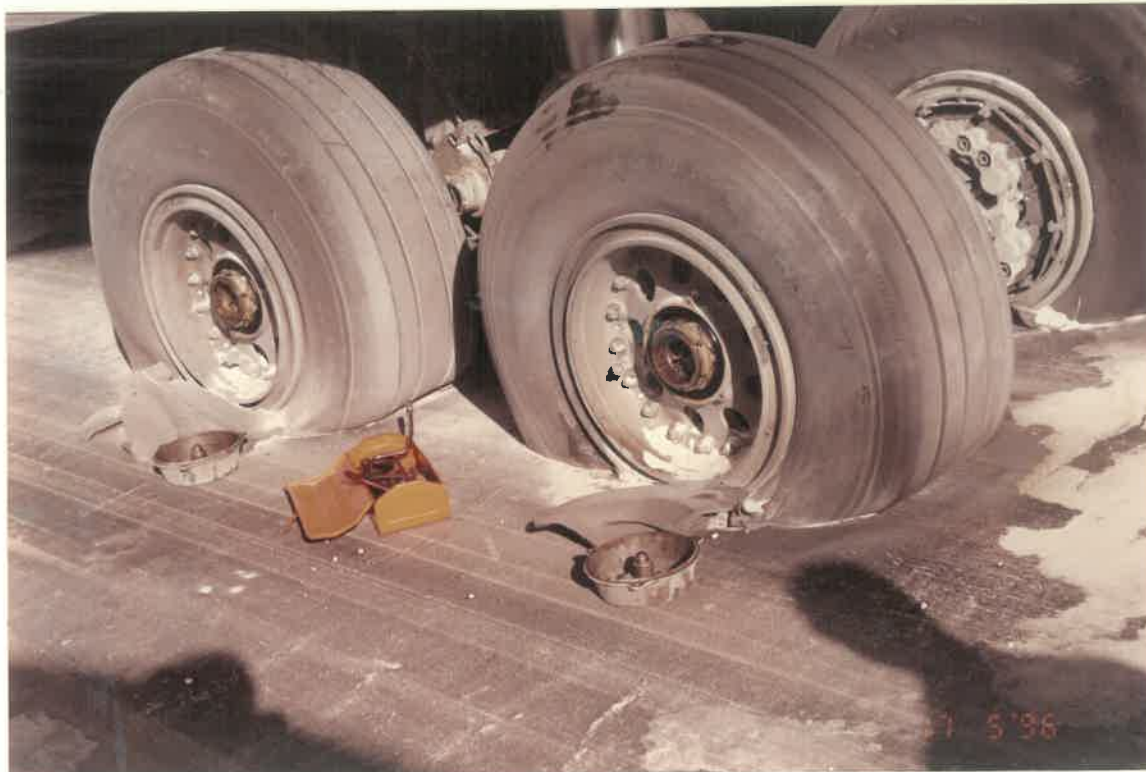
APP. 'B7'

RT. BODY GEAR ALL TYRES BURST

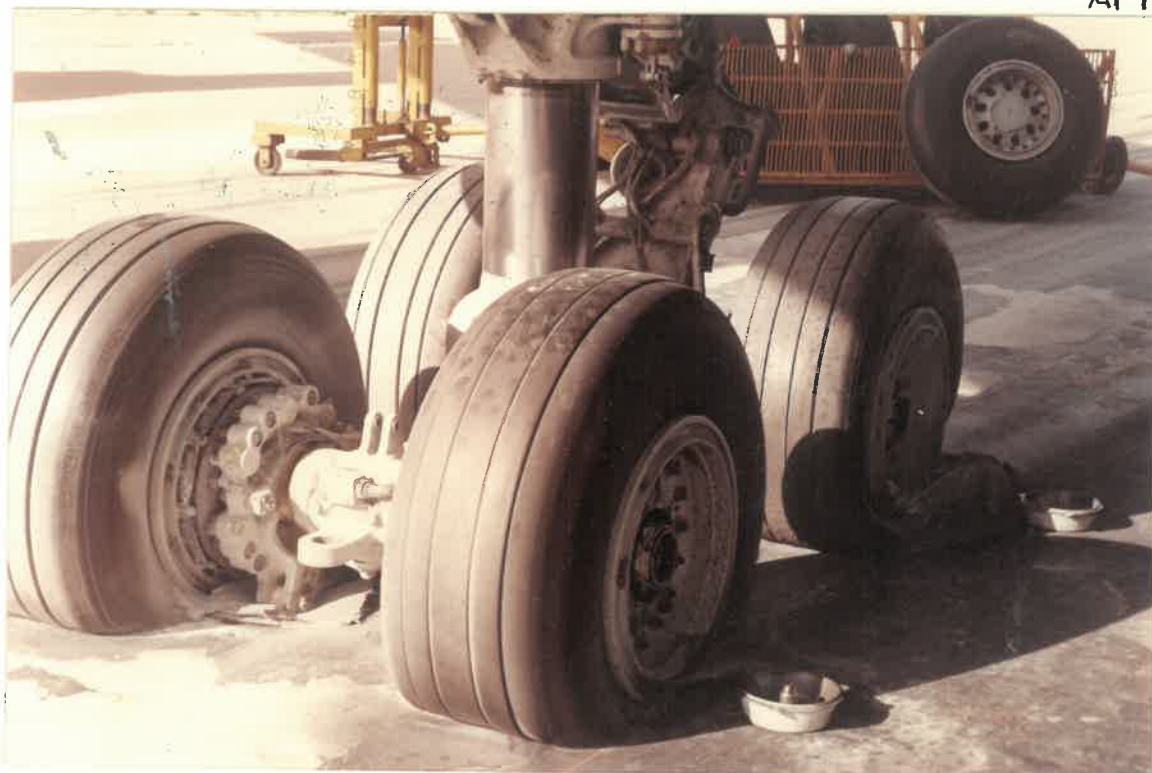
APP. 'B8'

ALL TYRES BURST WING GEAR

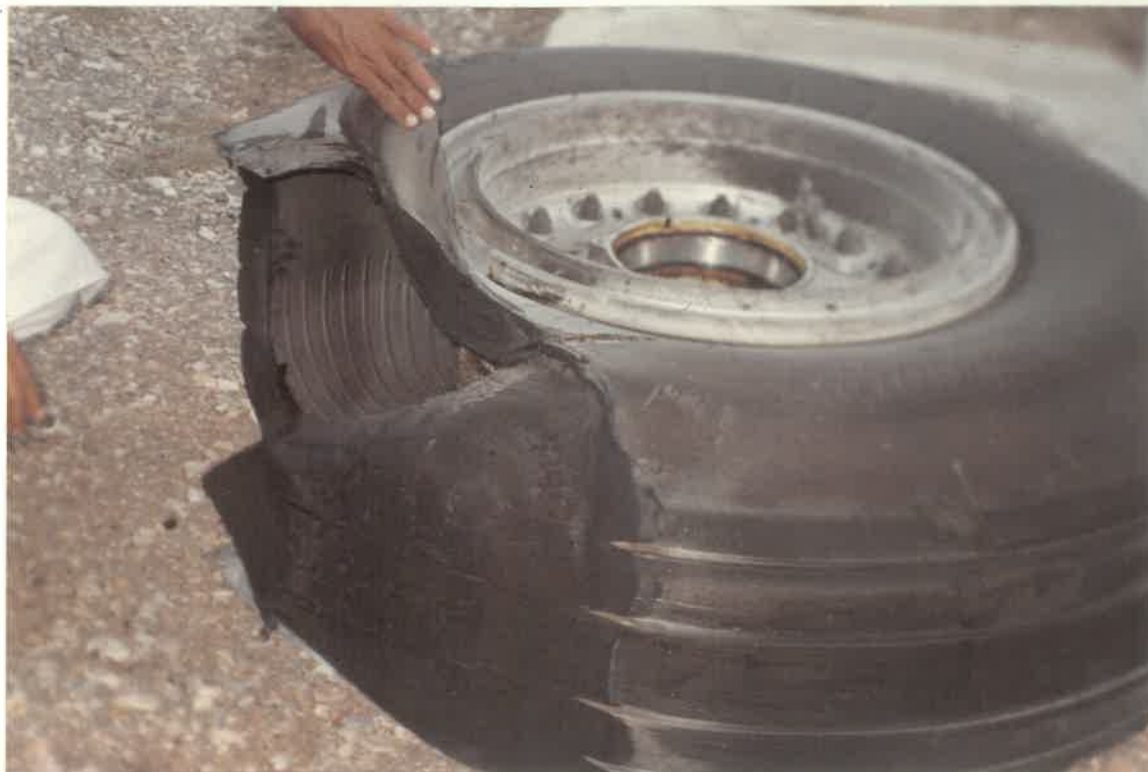
APP. 'B9'

- 19.12 The aircraft stopped about 1000 ft short of the runway end.
- 19.13 All the sixteen main tyres were burst and portion of all tyres rim surface were rubbed off about 2 to 3 inches.

TYPICAL TYRE & RIM AFTER THE INCIDENT.  
NOTE: THE DRAG MARK ON THE RIM OUTER SURFACE

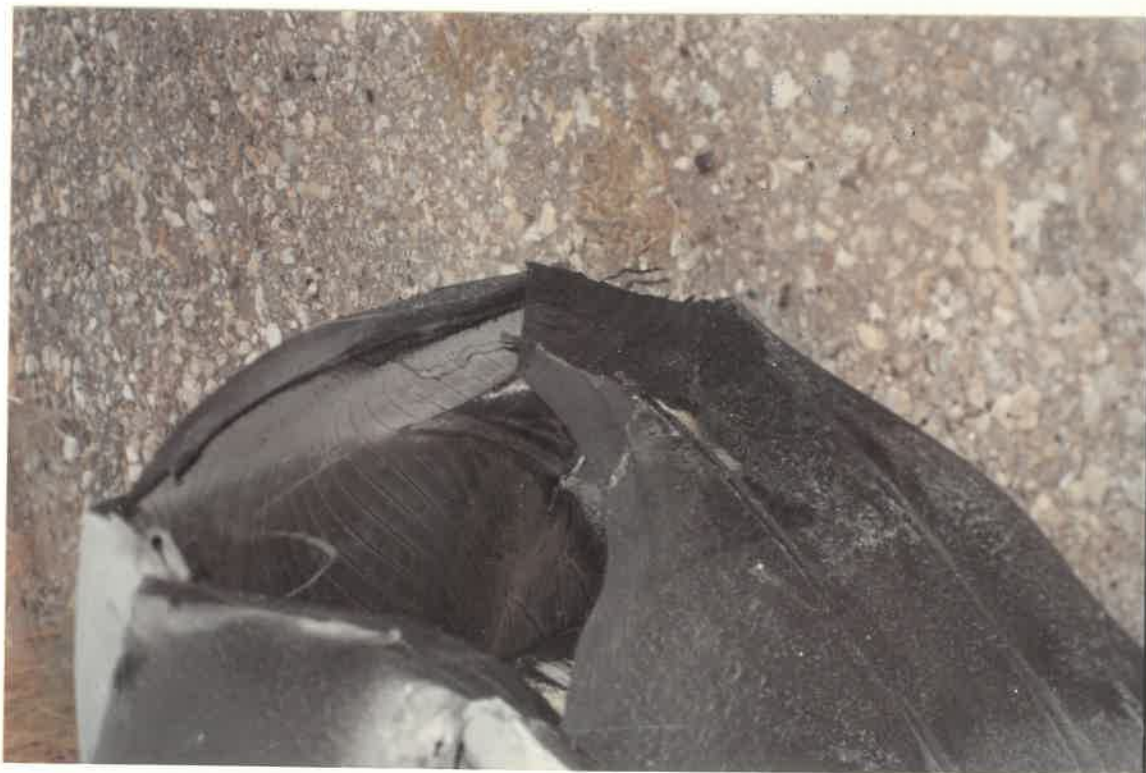
APP. 'B10'

TYPICAL TYRE BURST SURFACE

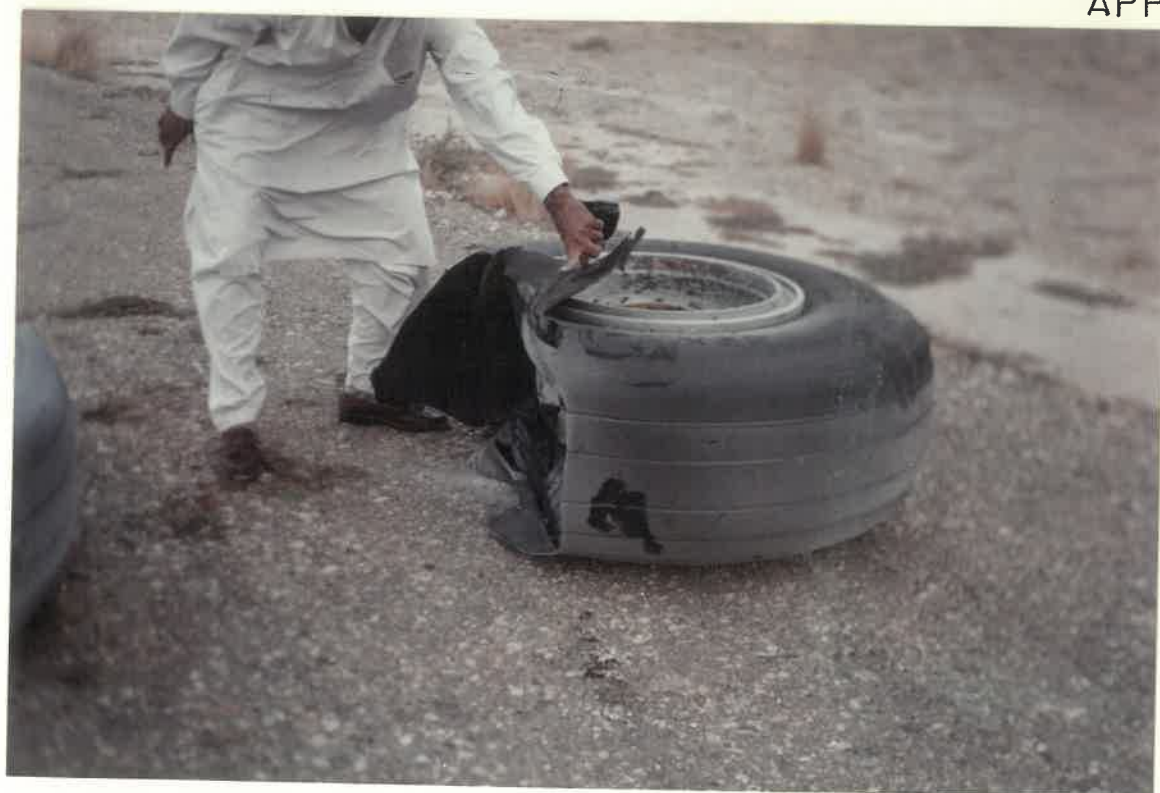
TYPICAL TYRE BURST SURFACE

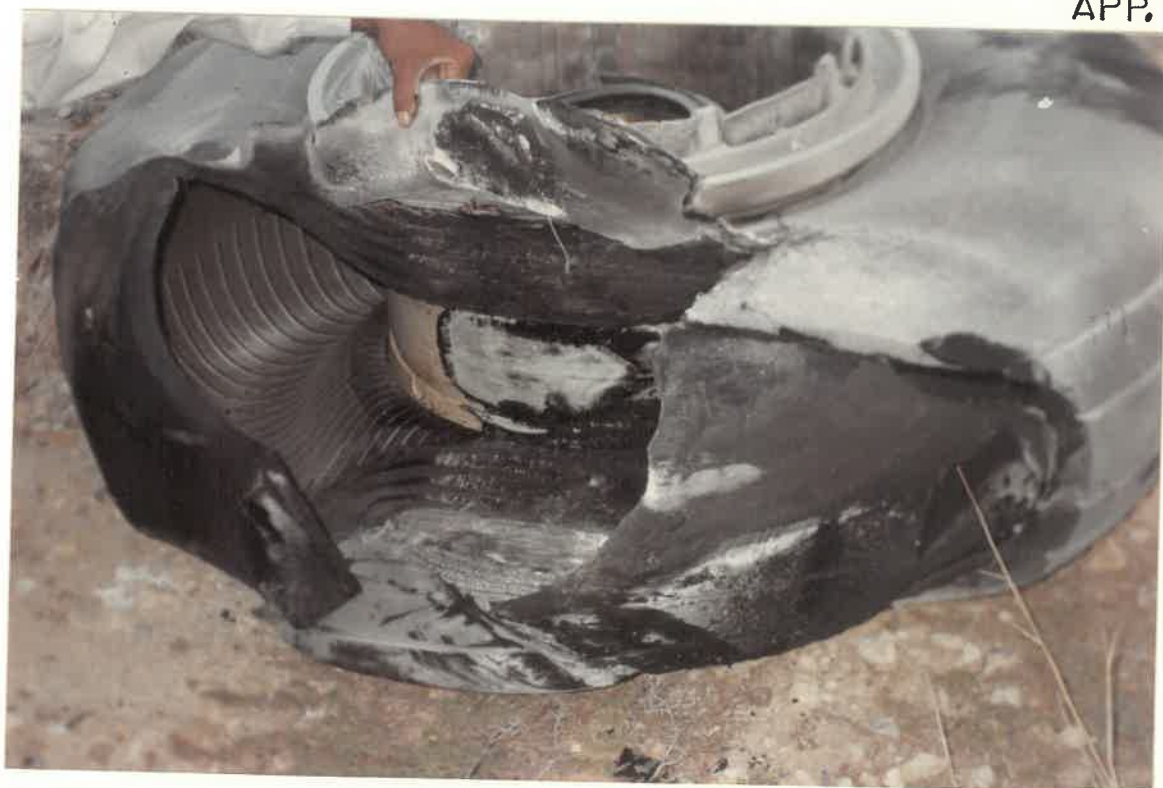
TYPICAL TYRE BURST SURFACE
