**INCIDENT TO PACTEC AVIATION**

**CESSNA T-210**

**ON 23<sup>RD</sup> MAY, 2000**

## FINAL REPORT

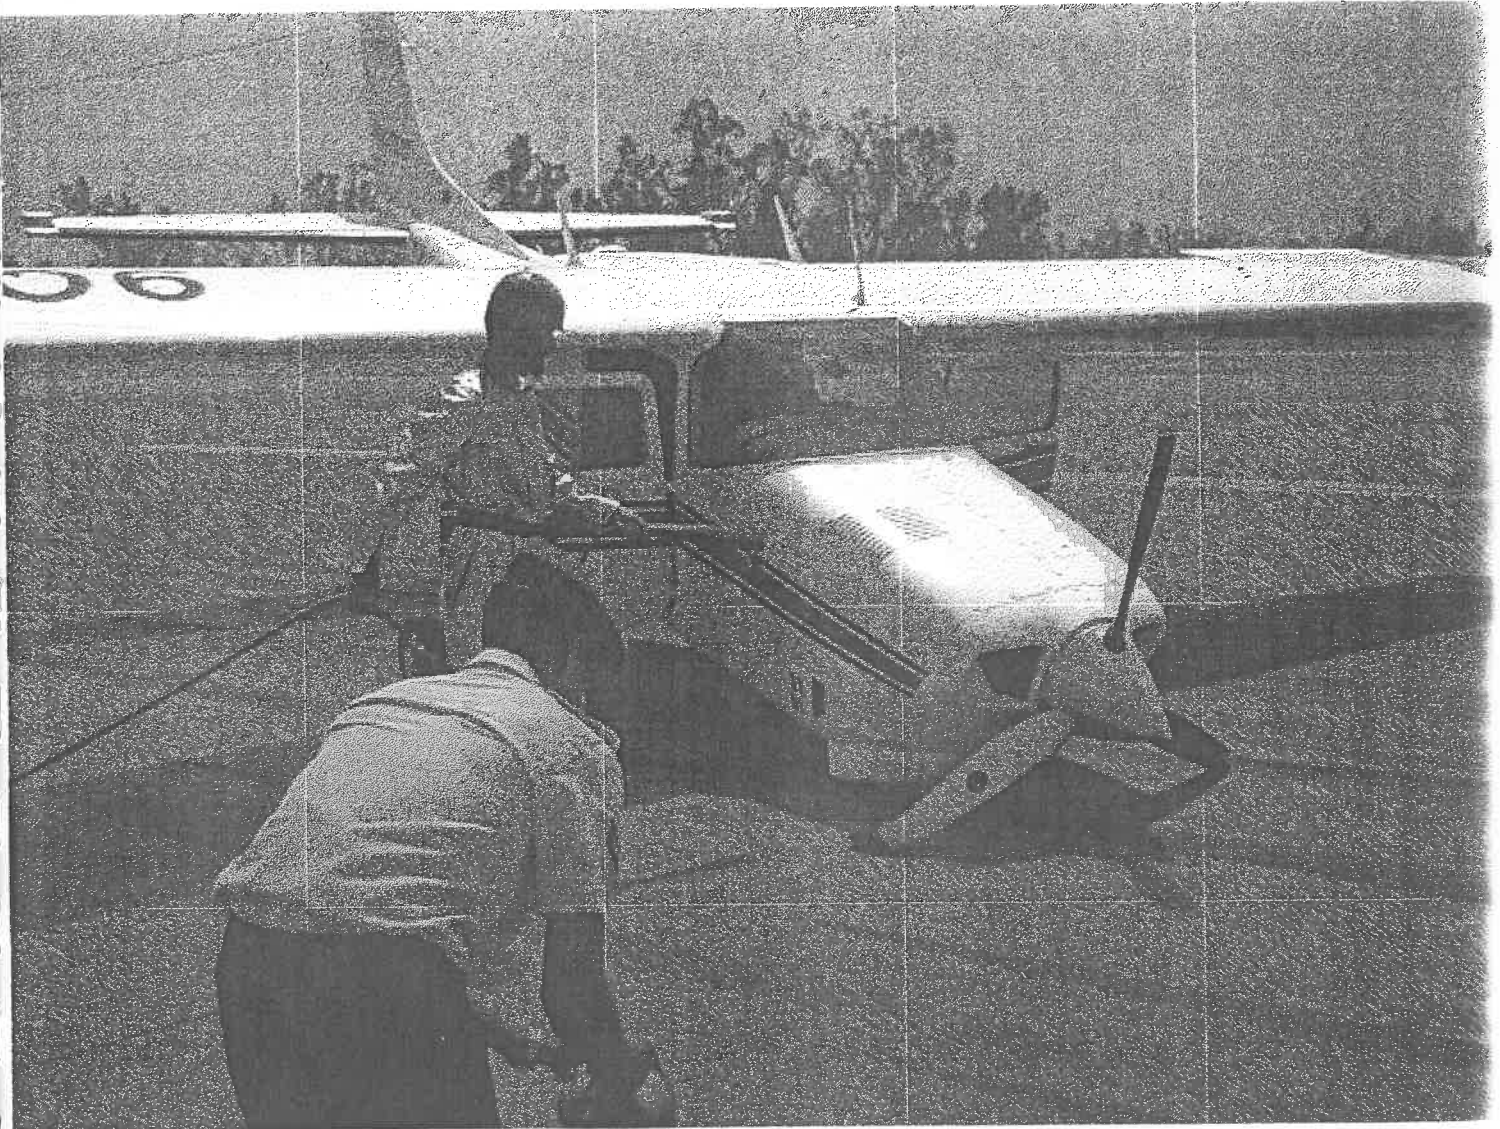
1.12.1 The aircraft came to rest slightly off the centerline of runway 35 (see Appendix 'K1' & 'K2'). The propeller blades, nose wheel doors and lower engine cowling came in contact with the pavement. Time elapsed from main wheels touchdown to nose touchdown was 11 seconds, from nose touchdown to aircraft stop 09 seconds, and from aircraft stop to occupants' evacuation 03 seconds. The aircraft was cleared off the runway within 07 minutes of main wheels touchdown.

AIRCRAFT AFTER TOUCHDOWN

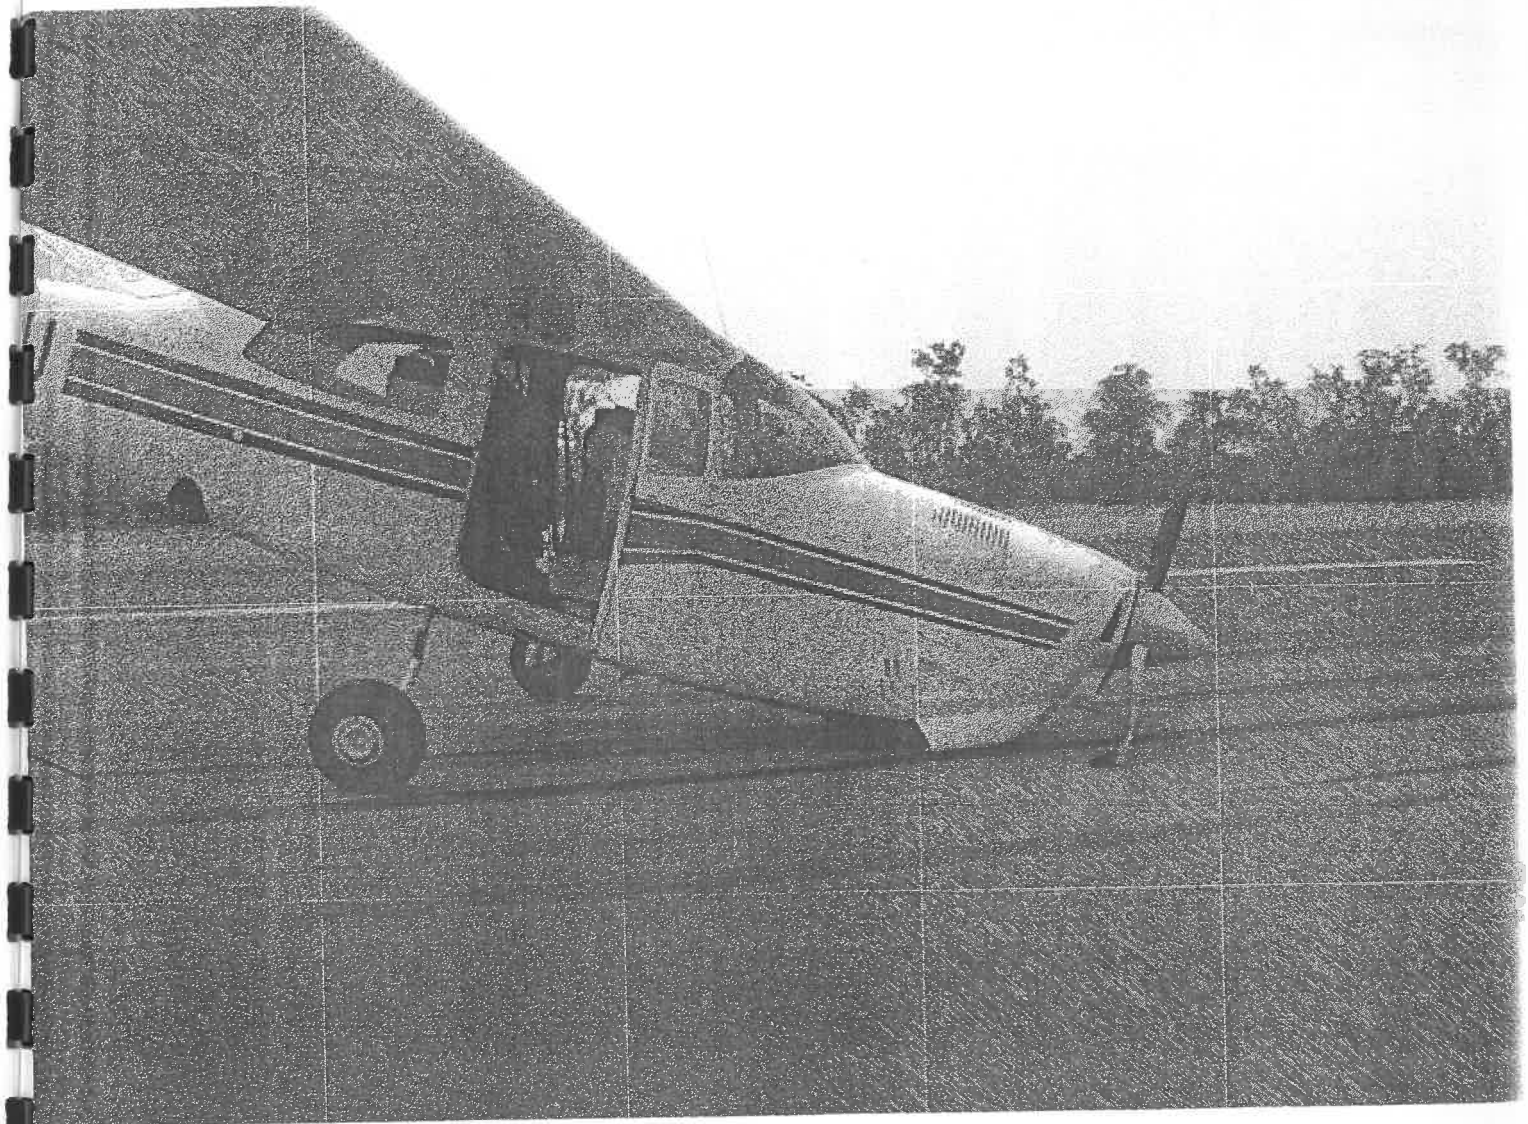
AIRCRAFT AFTER TOUCHDOWN

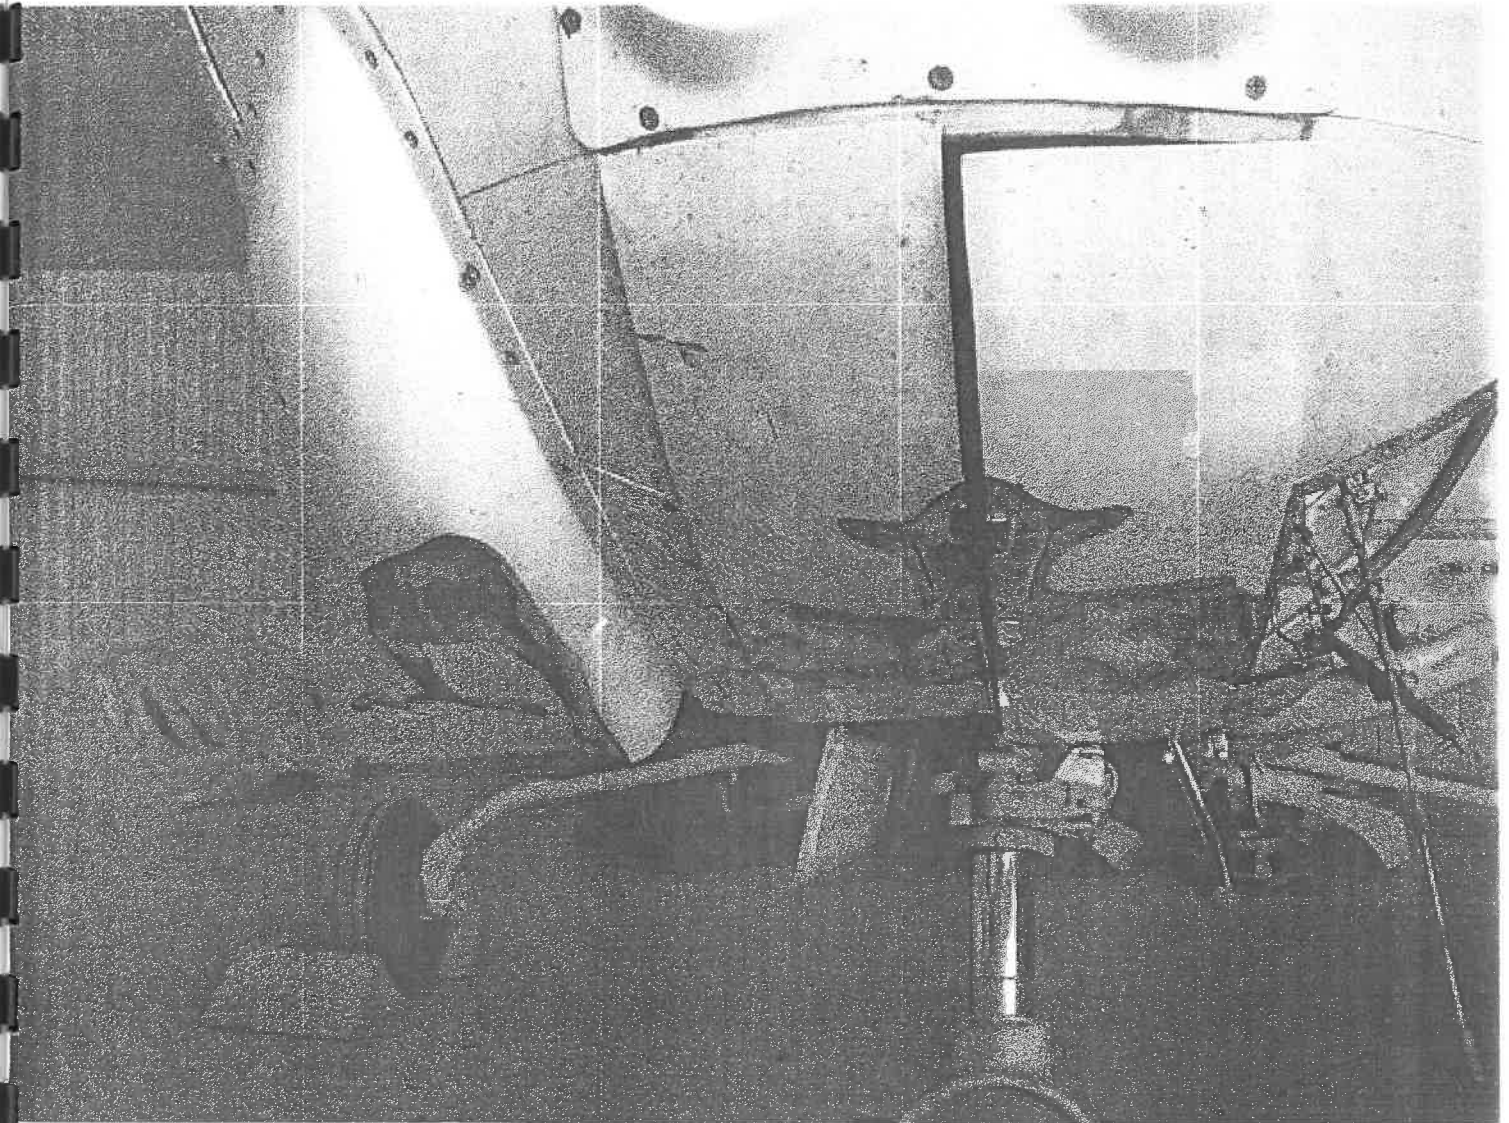
1.3.1 All the three blades of the propeller were damaged due to contact with ground. Two nose wheel doors and augmentor tube on the lower right hand cowling were also damaged (see Appendix 'K3').

DAMAGE TO THE AIRCRAFT

CRACKED & DEFORMED  
COWLING SKIN.

CENTRE HINGE  
ATTACHMENT  
POINT.

DOOR IN CLOSED  
POSITION.

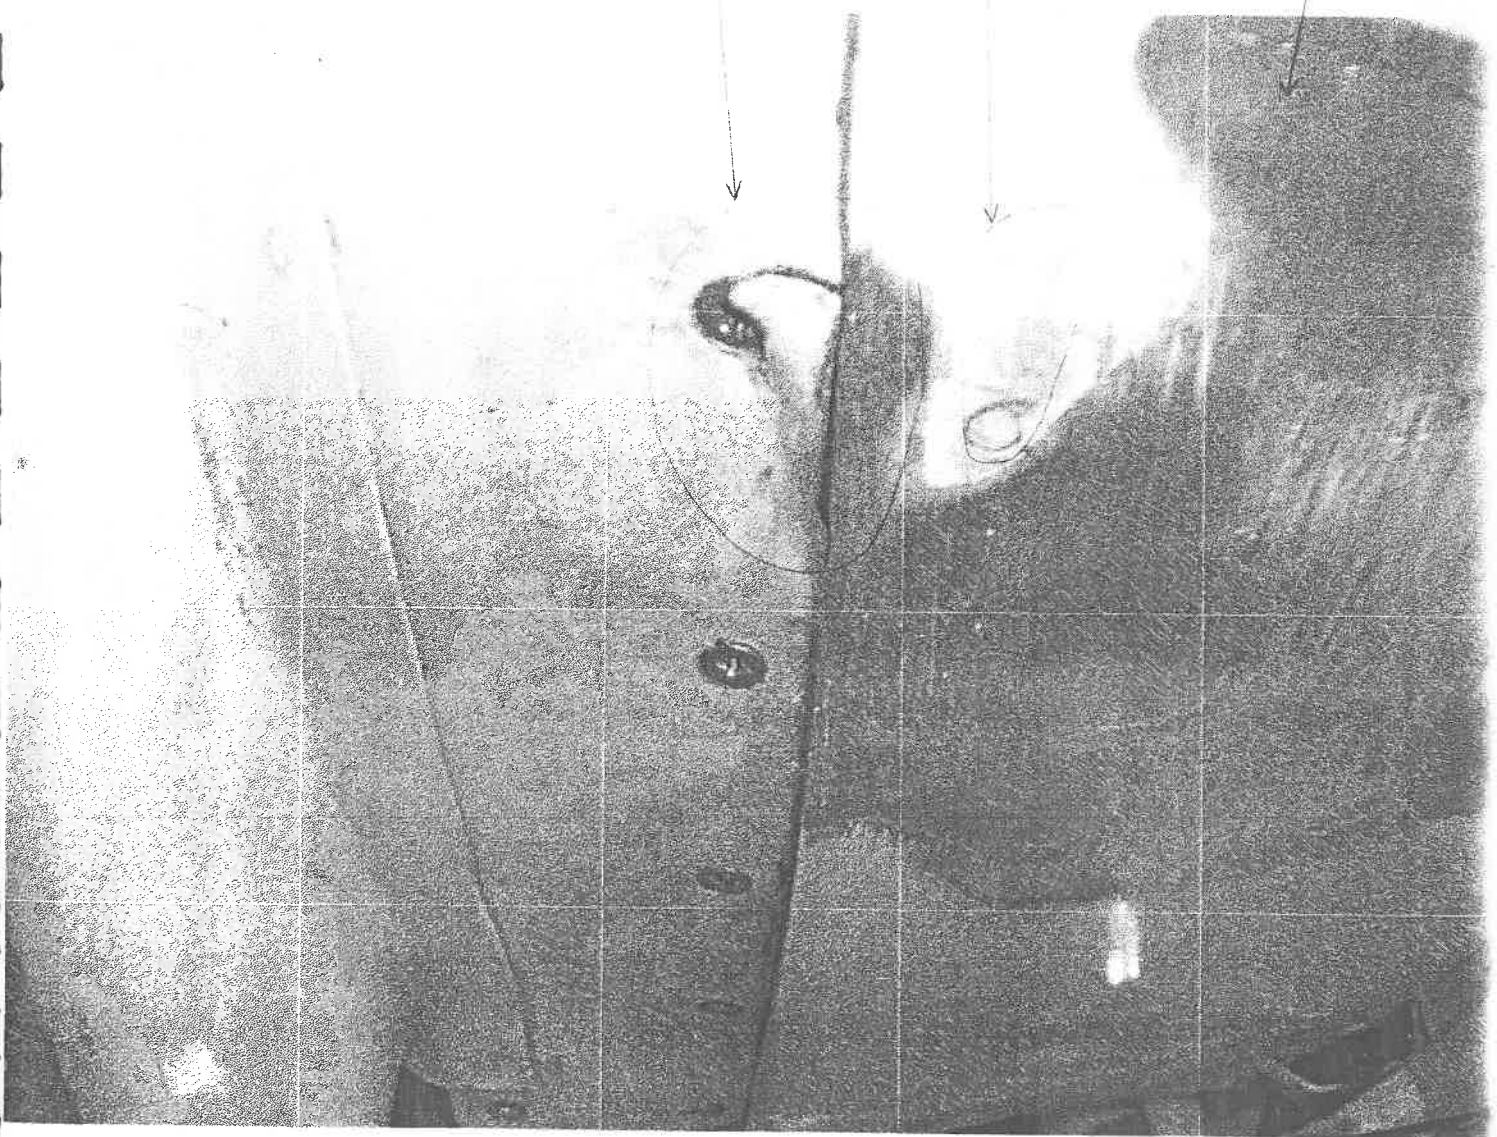
2.2.2. On post flight inspection, a portion of the lower engine cowling sheet metal was found to be cracked and deformed at one of the screw holes. This deformation had jammed the door in partially closed position and prevented the nose gear strut from moving down.

2.2.3. The crack in the cowling sheet metal was formed at a point that is adjacent to the center hinge of the right front nose wheel door in its open position. The clearance between the hinge and the cowling skin at this point is very small. There is a possibility that if the rigging of the door is disturbed, the hinge can strike the cowling while opening under the force of the spring and can cause the cowling skin to crack. This crack would not be normally visible on ground as the door remains open and overlaps this area.

3.2.1. The nose landing gear failed to extend as it's front right door was jammed by a piece of cracked and deformed cowling sheet metal which was obstructing it's movement. The deformation of the cowling sheet metal was most probably caused by the door hinge striking it under the spring force, during the extension cycle, as a result of disturbed rigging of the nose gear doors.

ENGINE COWLING SHEET METAL DEFORMATION

4.1 M/s PACTEC Aviation may consider formulating a system whereby, during phase inspections, the initial inspection and subsequent cross check are done by two different persons.
