TO INVESTIGATE INTO THE GROUND ACCIDENT IN WHICH  
TWO, TWIN OTTER AIRCRAFT REG. AP-BCG AND AP-BCH  
RESPECTIVELY WERE BADLY DAMAGED ON 5TH SEPT, 1985  
AT 0230 L.T. PARKED ON BRAVO TAXIWAY  
AT ISLAMABAD AIRPORT

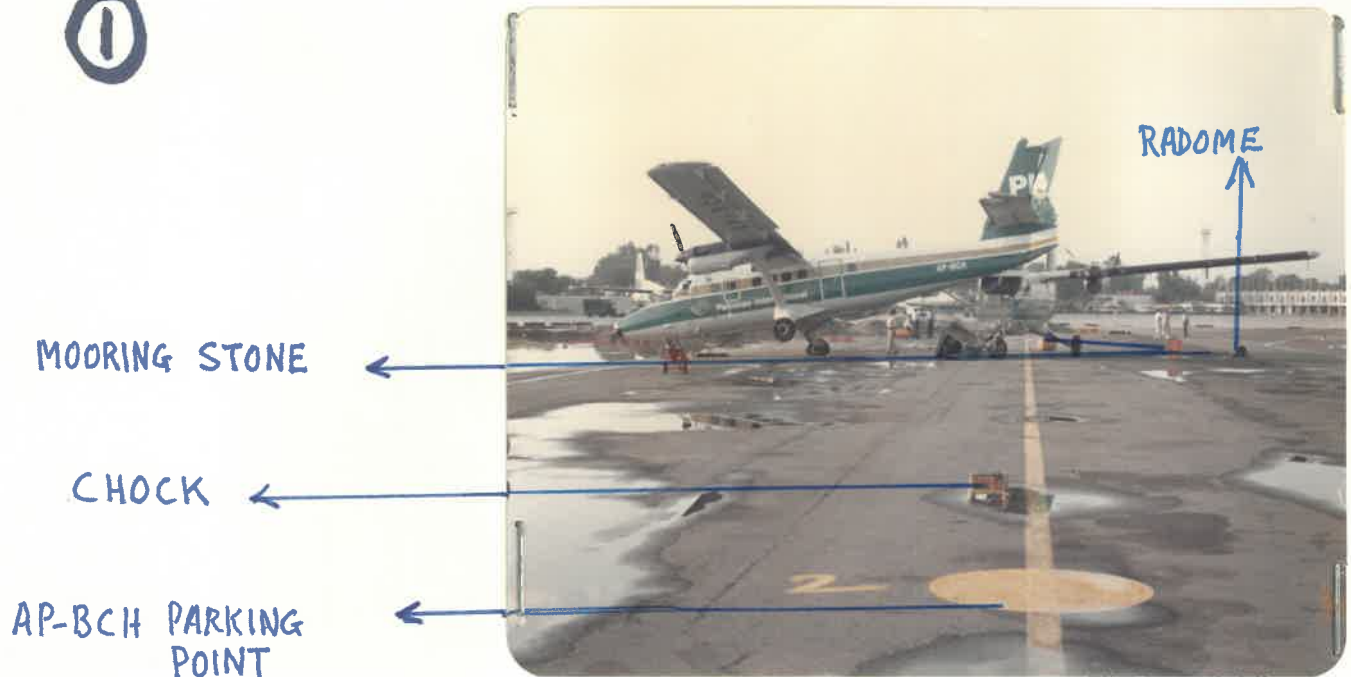
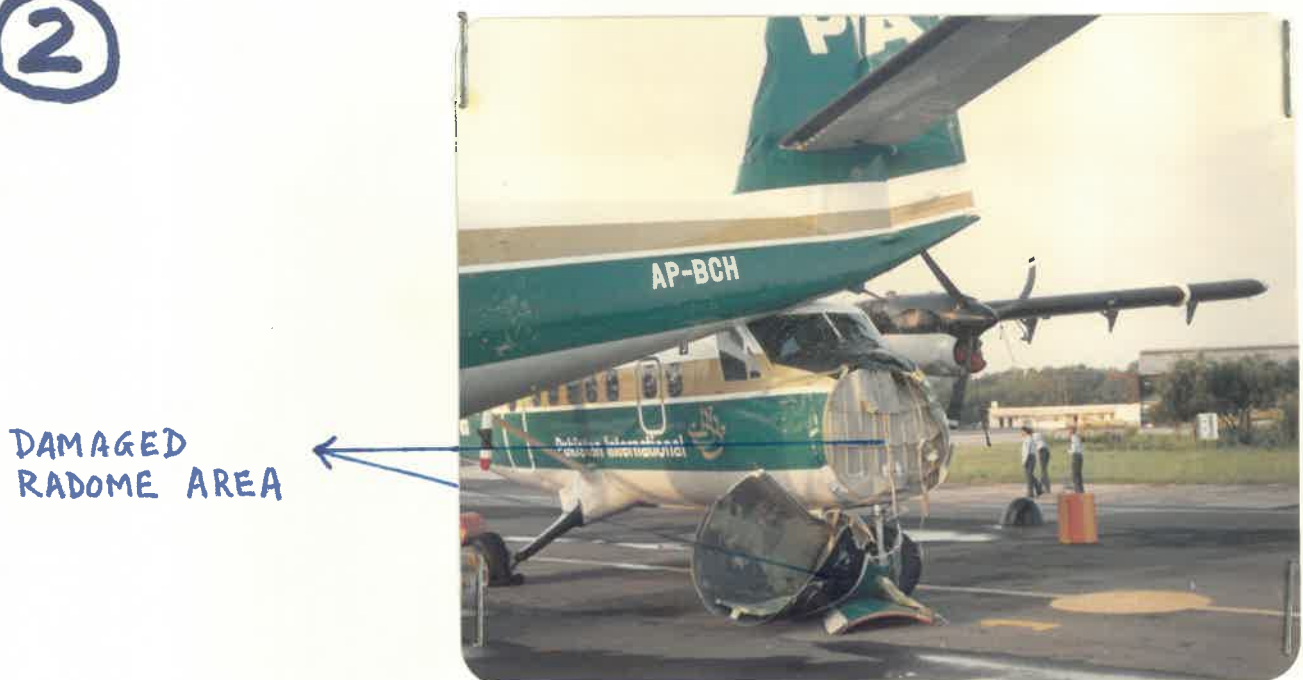
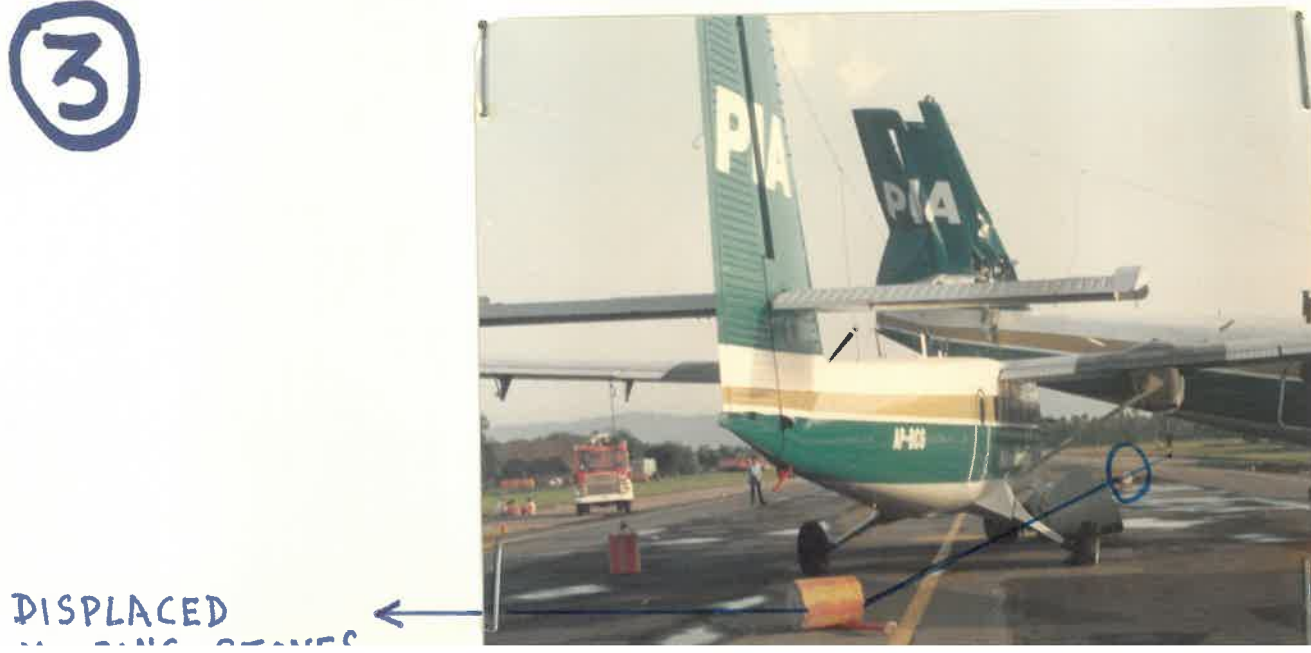
## VARIOUS VIEWS OF THE SCENE (EIGHTH PAGE)

### OF ACCIDENT AND SCATTERED PARTS

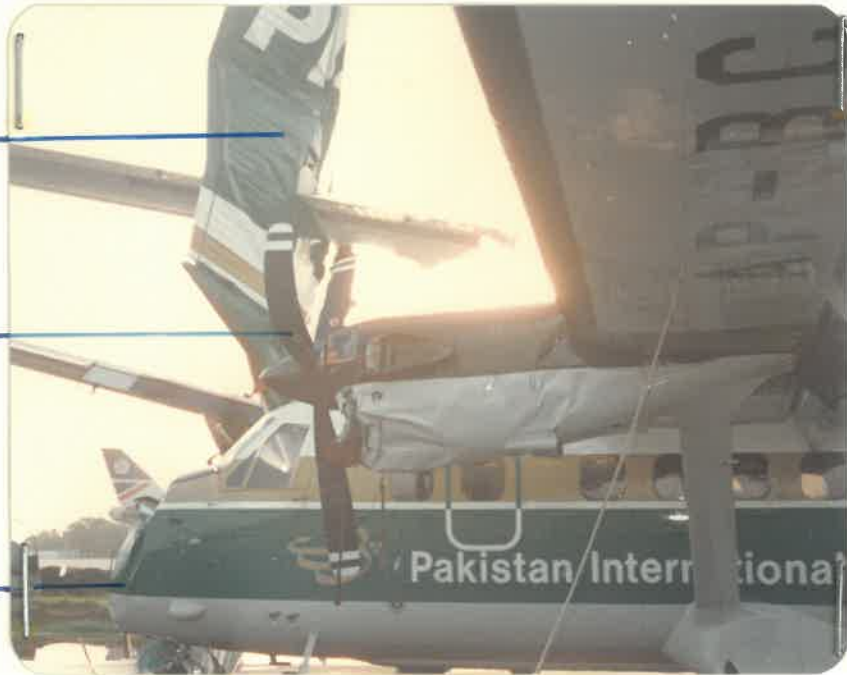
①

TAIL PLANE  
AP-BCH

PROPELLER  
AP-BCH

RADOME  
SECTION  
AP-BCG

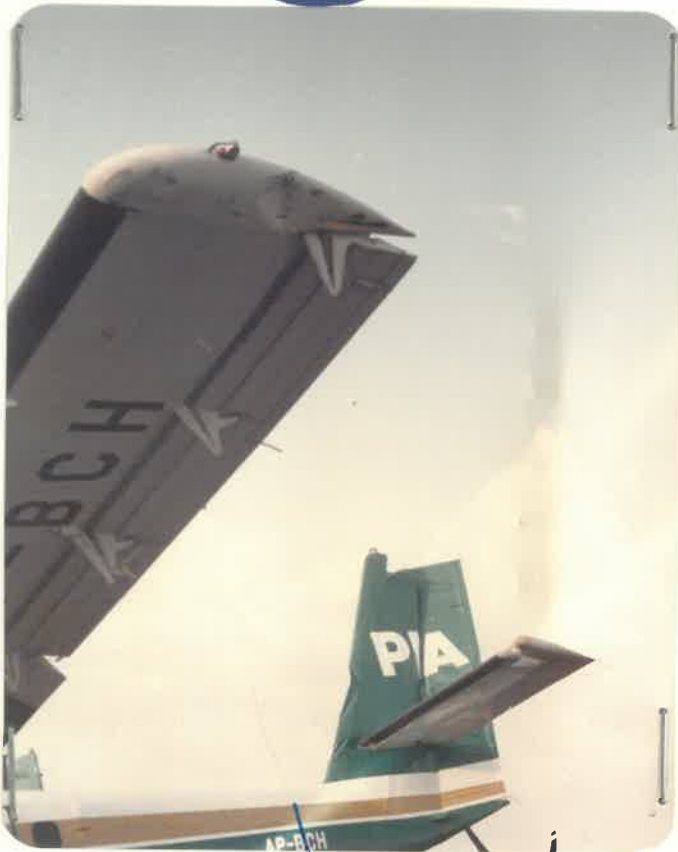
②

FUSELAGE  
AP-BCH

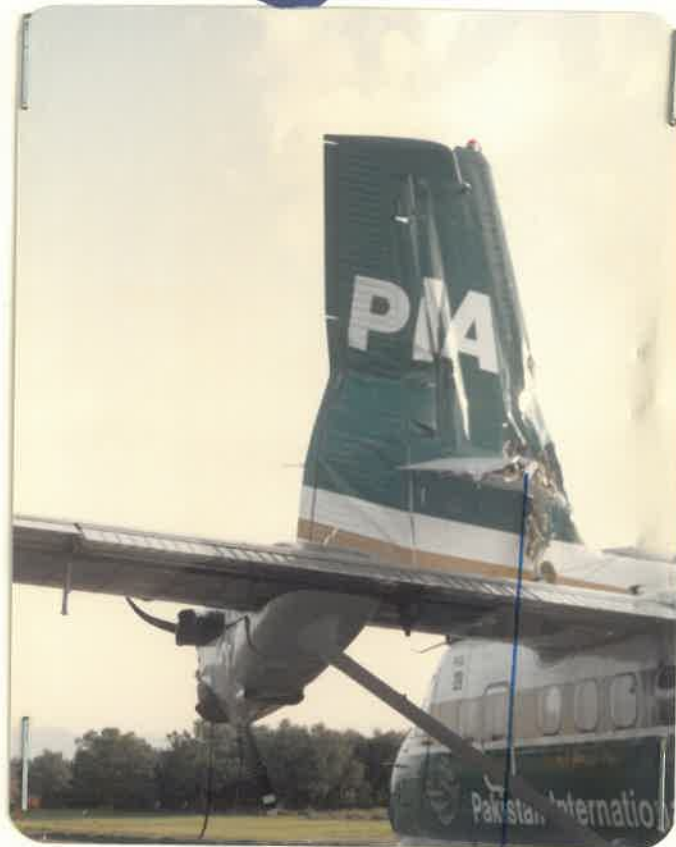
③

TAIL PLANE  
AP-BCH

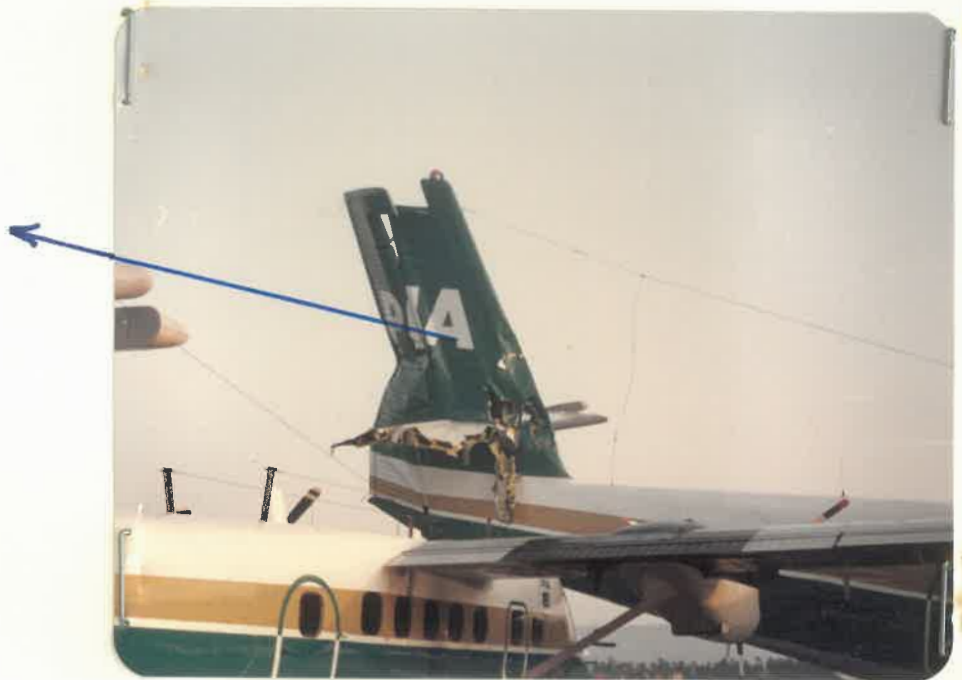
①

DAMAGED TAIL  
AP-BCH

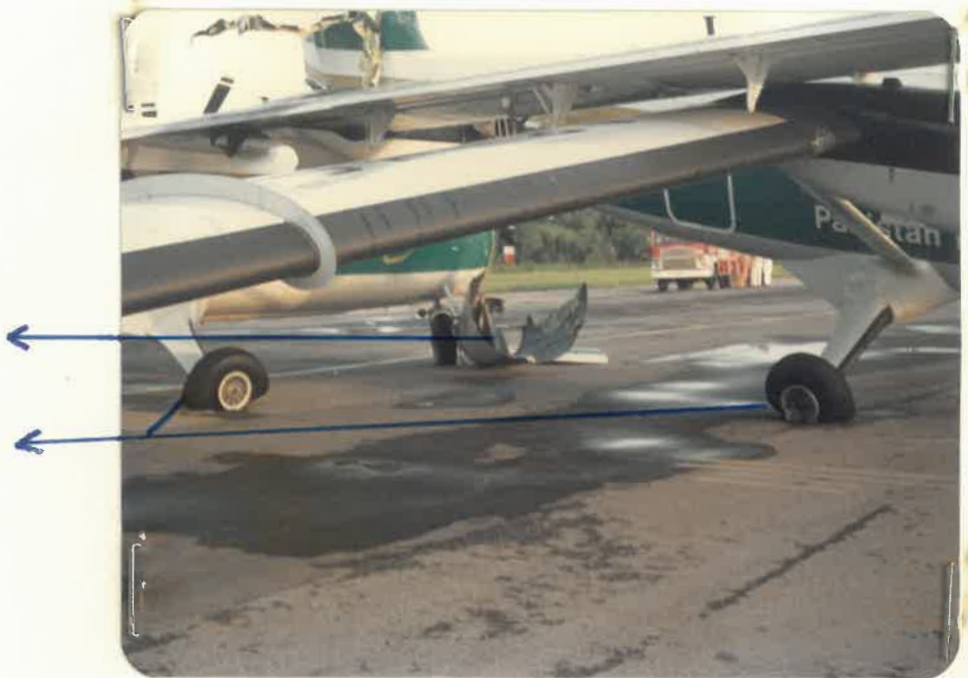
②

DAMAGED RADOME  
AP-BCG

DAMAGED TYRES

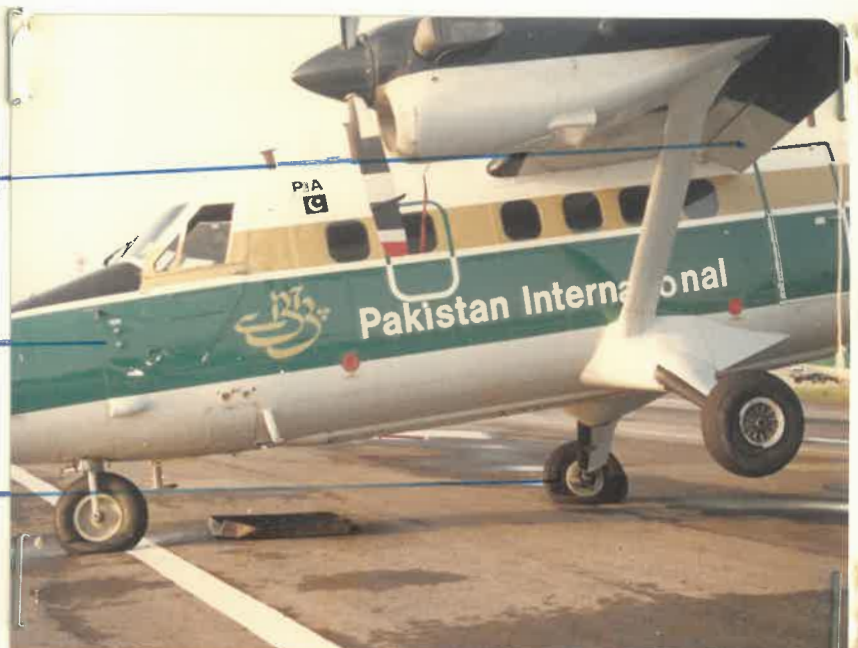
③

- 16-4 The flaps of Twin Otter aircraft Reg No. AP-BCH were found down ( $20^{\circ}$ ) by the investigator incharge, thus providing maximum lift. This defect in flaps had been reported earlier and is caused due to internal leakage.

21-1-7 The flap of Twin Otter aircraft AP-BCH which was found 20° down at the time of accident had crept to that position. This was not due to result of thunder storm and its after effects as stated by Deputy Chief Engineer PIAC (Appendix "C").

FLAPS 20° DOWN  
AP-BCH

DAMAGED FUSELAGE  
AP-BCH

DAMAGED TYRES  
AP-BCH

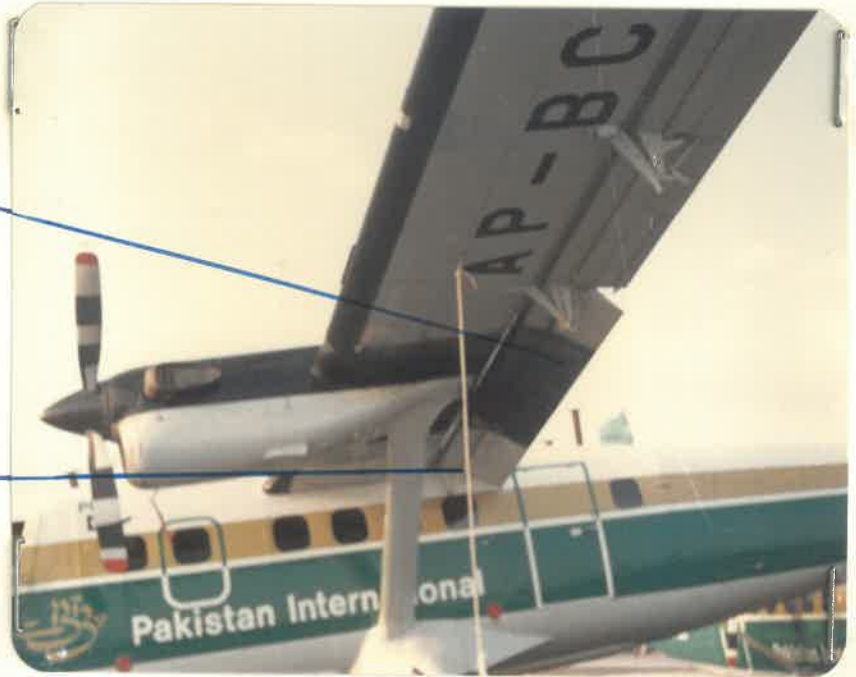
FLAPS 20° DOWN  
AP-BCH

MOORING ROPE

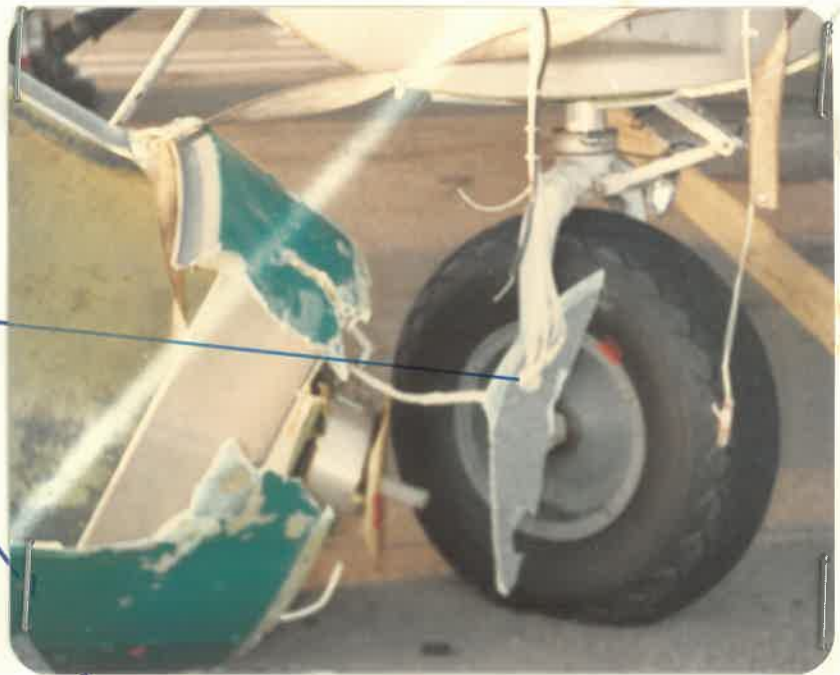
CLOSE UP VIEW OF THE  
DAMAGE - AP-BCG

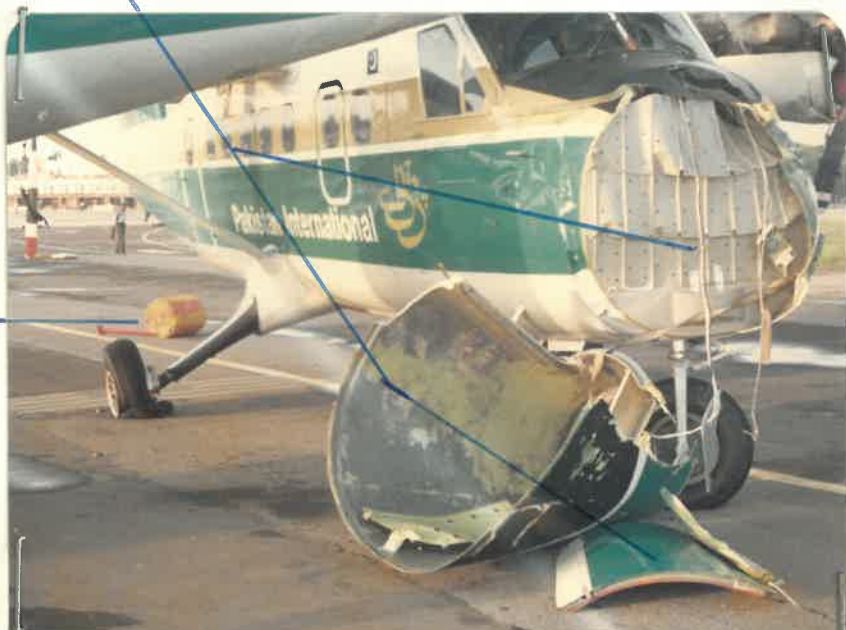
DISPLACED  
MOORING STONE

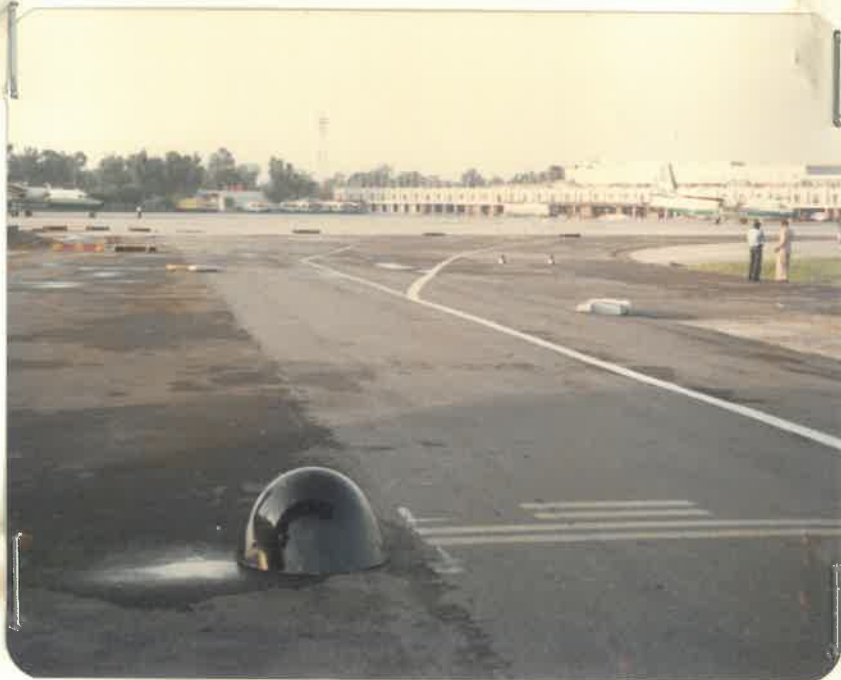
SCATTERED A/C  
PARTS.

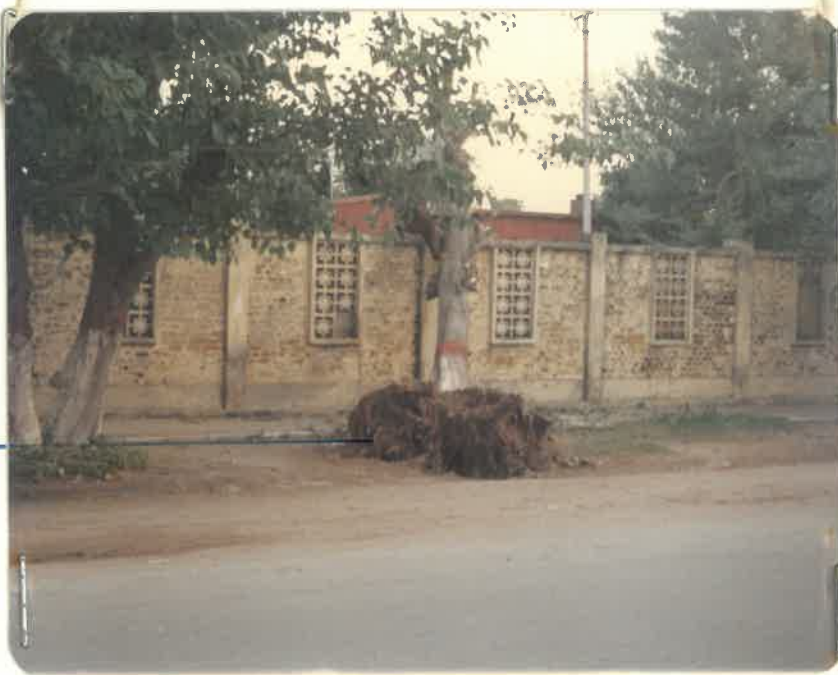
①

16-10 Three huge trees were uprooted (Appendix "CC", page, 5 & 6).

PATH OF  
CYCLONIC THUNDER  
STORM-UP ROOTED  
TREE ←

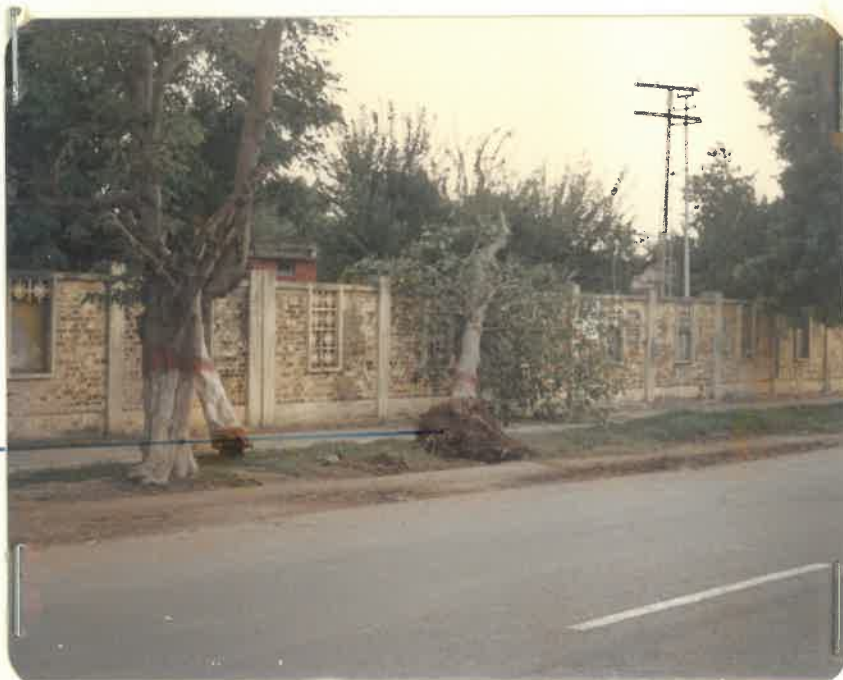
②

NO. 2 UPROOTED  
TREE ←

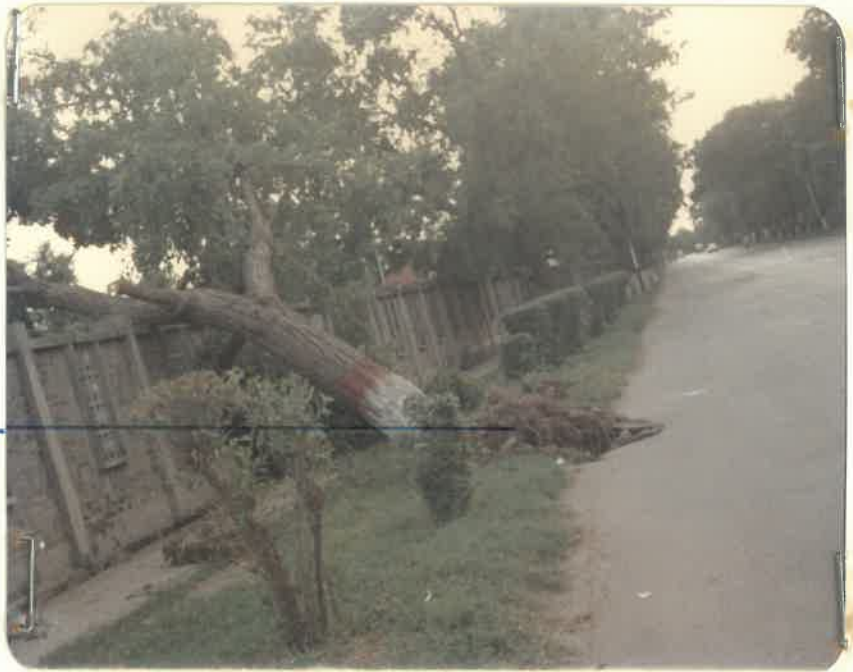
③

No. 3 UPROOTED  
TREE.

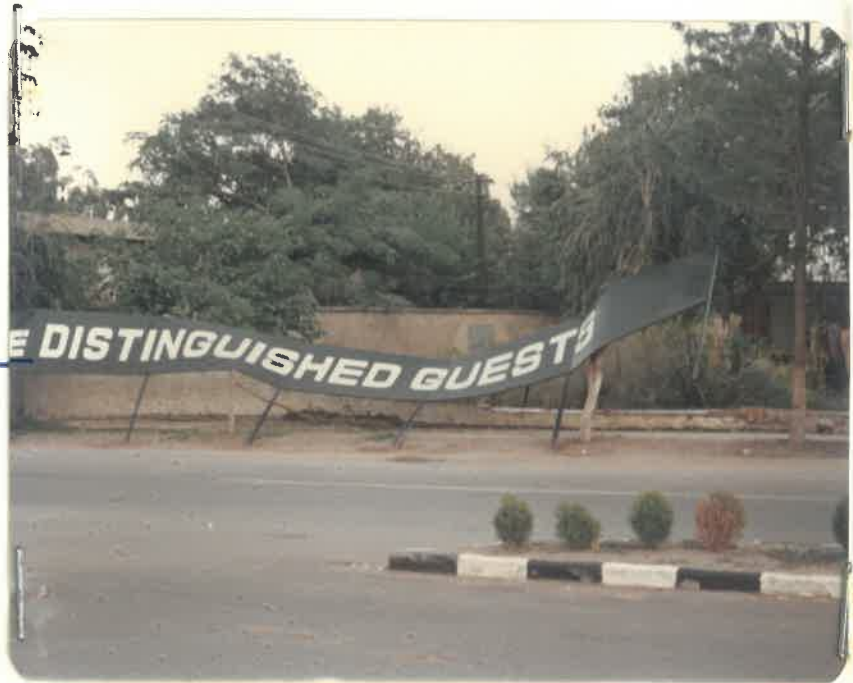
④

- 16-7 Pakistan Burma Shell gate was lifted from the ground and fell on main road.
- 16-8 A metal placard "Welcome distinguished guests" fixed in front of Airport exist was badly wrinkled (Appendix "CC" page, 6).

DAMAGED  
METAL DISPLAY  
BOARD

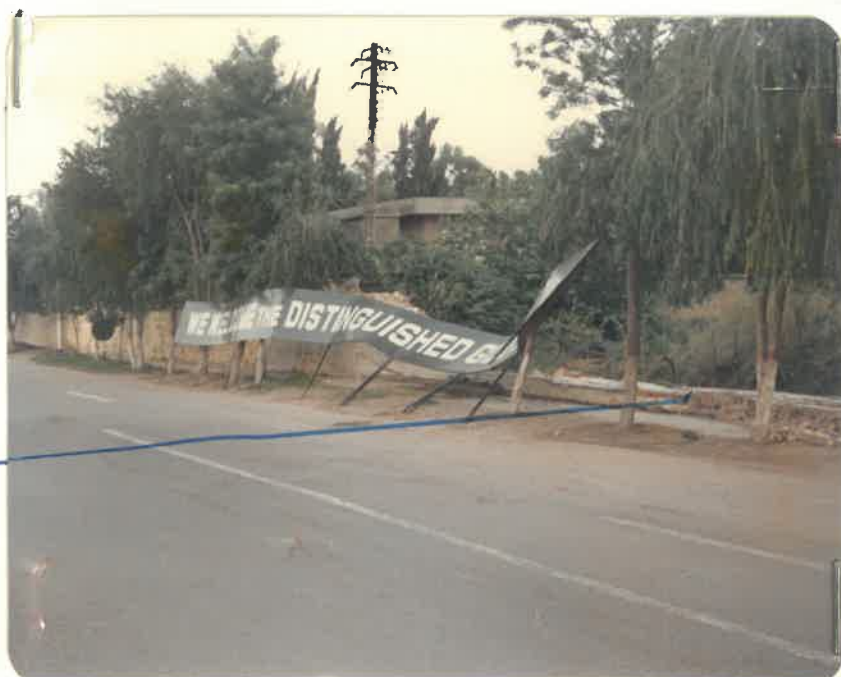
⑤

16-9 The PAF Machinery Pool boundary wall 50 feet in length had fallen (Appendix "CC" page, 6).

50' OF FALLEN  
WALL DUE TO  
STORM.

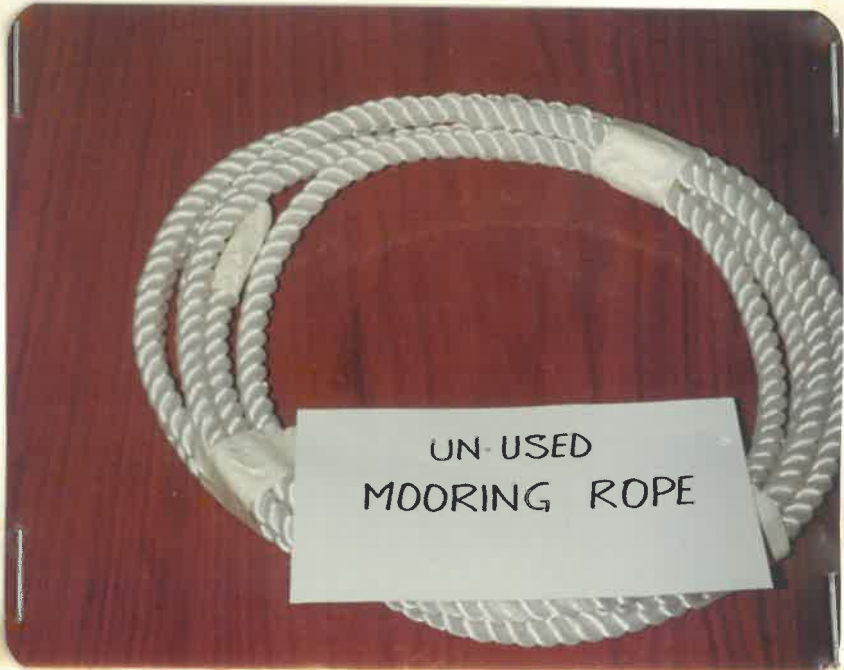
1

NEW MOORING ROPE AND USED ROPE  
BROKEN DURING STORM ON 05 SEP. 85

UNAPPROVED

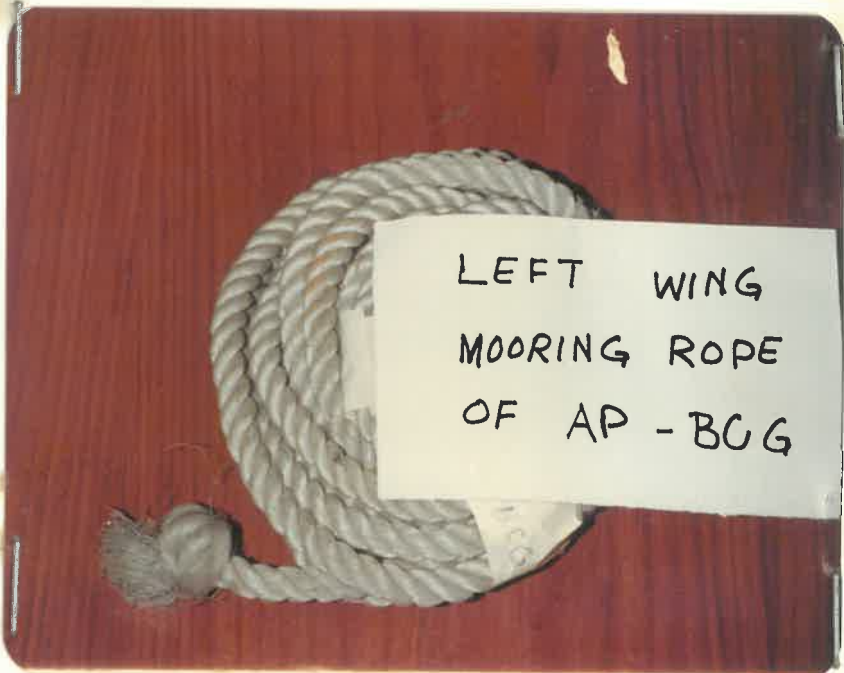
- 23-4-3 Un-approved Polyester rope used by PIAC on these aircraft was tested in Naval Dockyard Karachi and is found to have breaking strength of 1653 pounds comparing with the laid down breaking strength. <sup>/6288 Lbs</sup> the Polyester rope used has 1/4 strength. This is a violation of Rule 40 (1 & 2) of Civil Aviation Authority Rules 1978.

AP-BCG

2  
BREAKING  
STRENGTH  
1653 lbs.  
APPROX. 1/4  
OF ORIGINAL  
APPROVED ROPE.

24-2 Mooring rope as given in the Maintenance Manual must be used. Breaking strength of the rope should not be less than 6288 pounds as recommended by the manufacturer's.

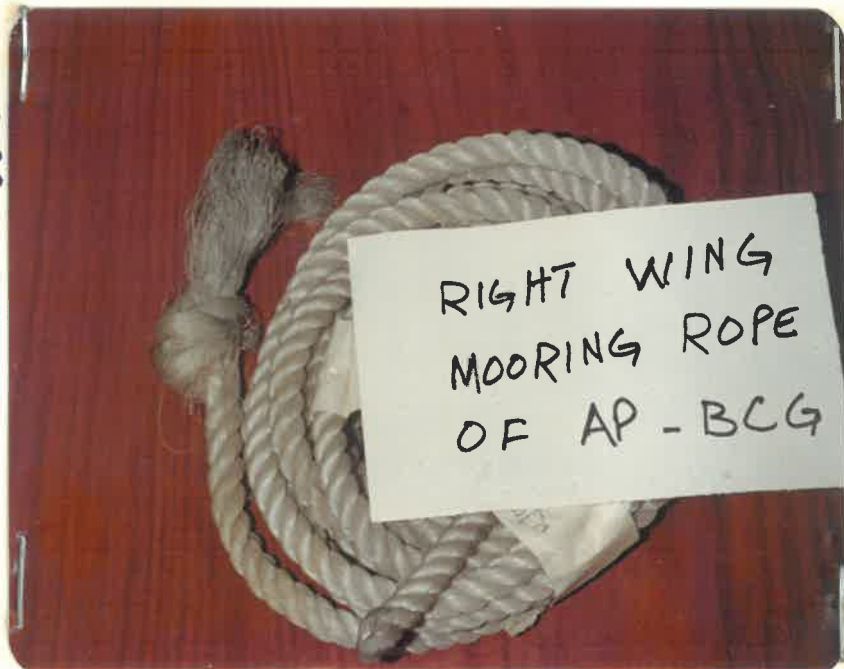
3

AP- BCH, MOORING ROPE
