**CIVIL AVIATION AUTHORITY**

**AIRCRAFT INCIDENT INVESTIGATION M/S PIAC**

**BOEING 747 REG.NO.AP-BCN WHICH OCCURRED**

**INVESTIGATION REPORT**

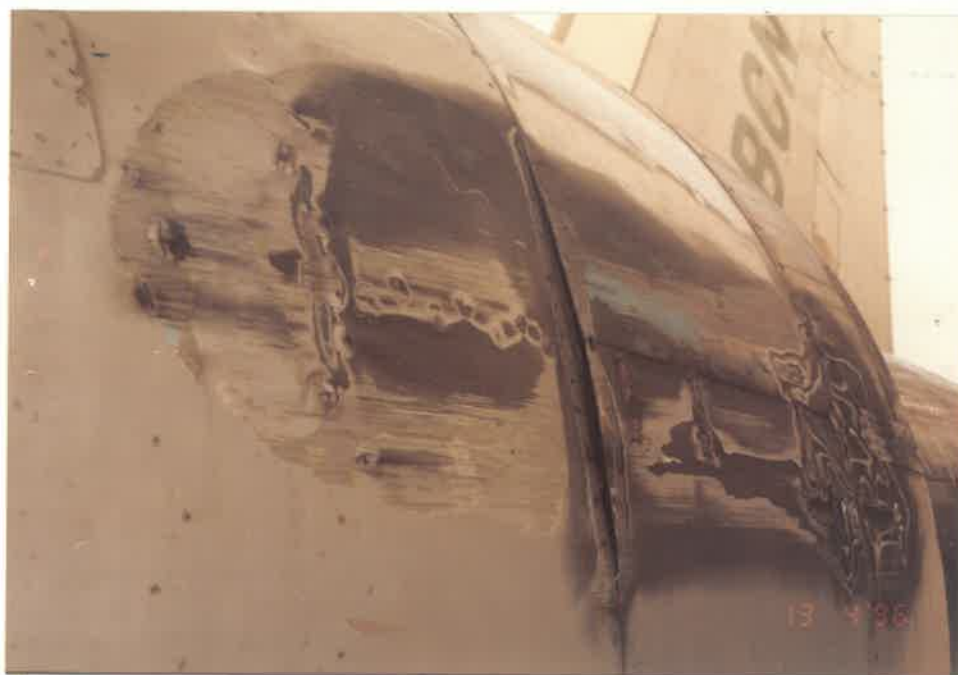
B.1

ANOTHER VIEW

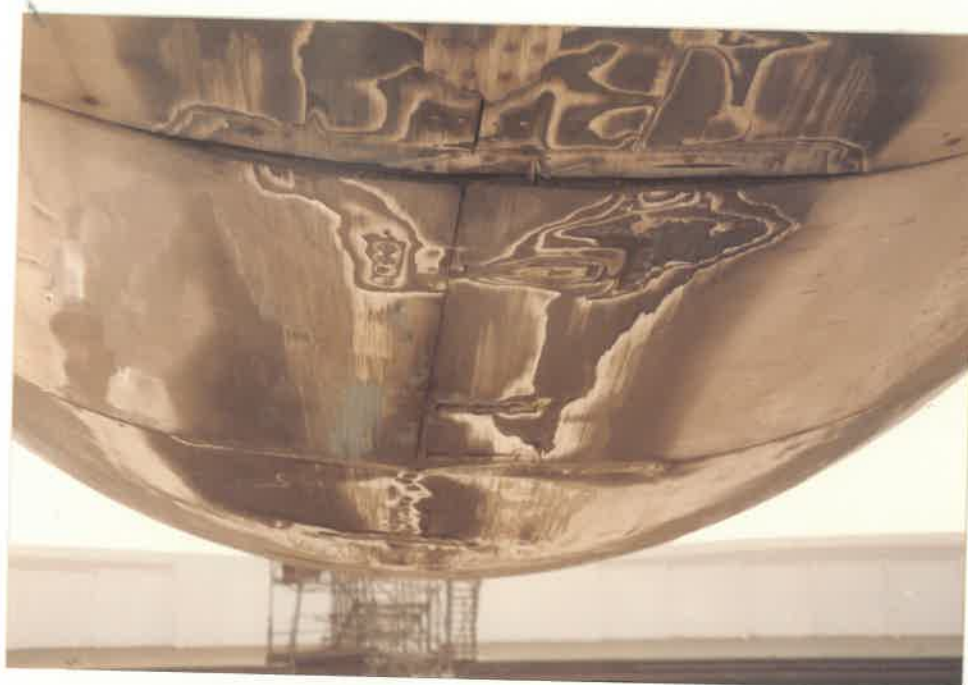
B.2

ANOTHER VIEW

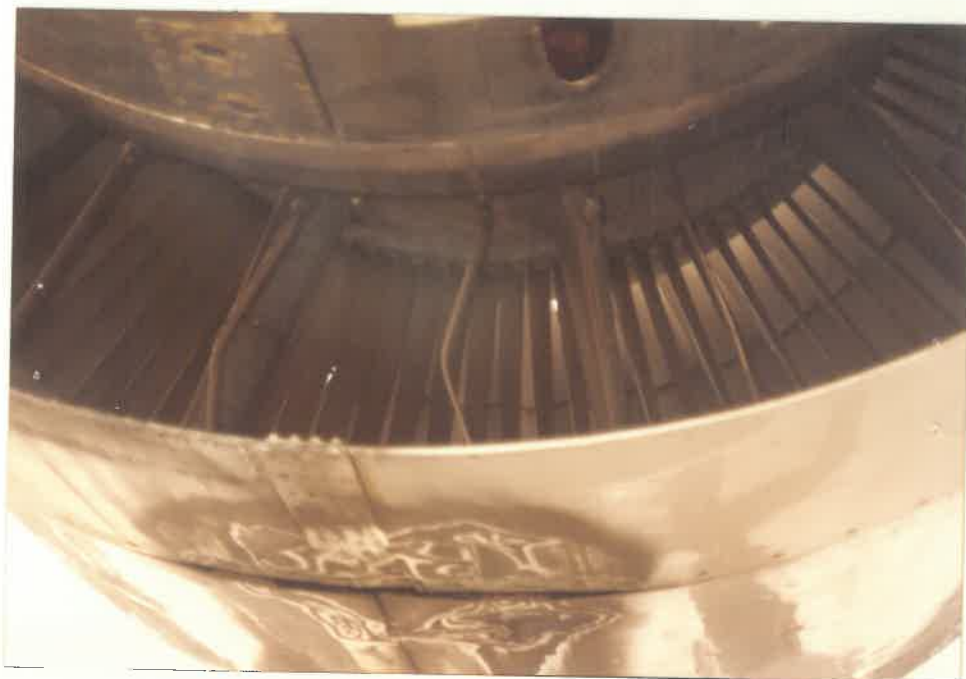
B.3

18.8 **Pattern of Damage to No.1 Engine.** The pattern of damage to No.1 engine was examined very carefully by the Investigation Team, PIAC Engineering Staff and Mr. David Asst. Manager /Boeing Coordinator. The D-Shaped rubbing of the Nacelle at the 6'O clock position indicates that the under surface of No.1 engine had been dragged against a large, solid and level surface. The possibility of a having this type of damage being caused due to any vehicle was examined but the pattern of damage could not be co-related. The pattern of damage gave very strong indications that No.1 engine may have contacted the runway during landing at Jeddah, Lahore or Karachi.

21  
UNDER SURFACE DAMAGE OF NO.1 ENGINE

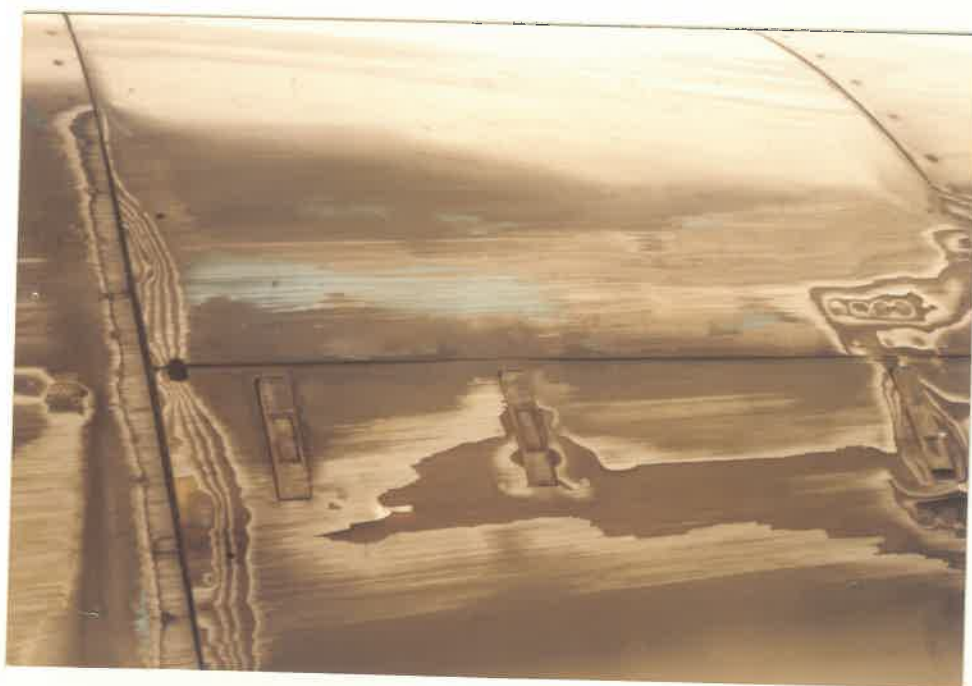
B.4

UNDER SURFACE SCRUB MARKS ON NO.1 ENGINE

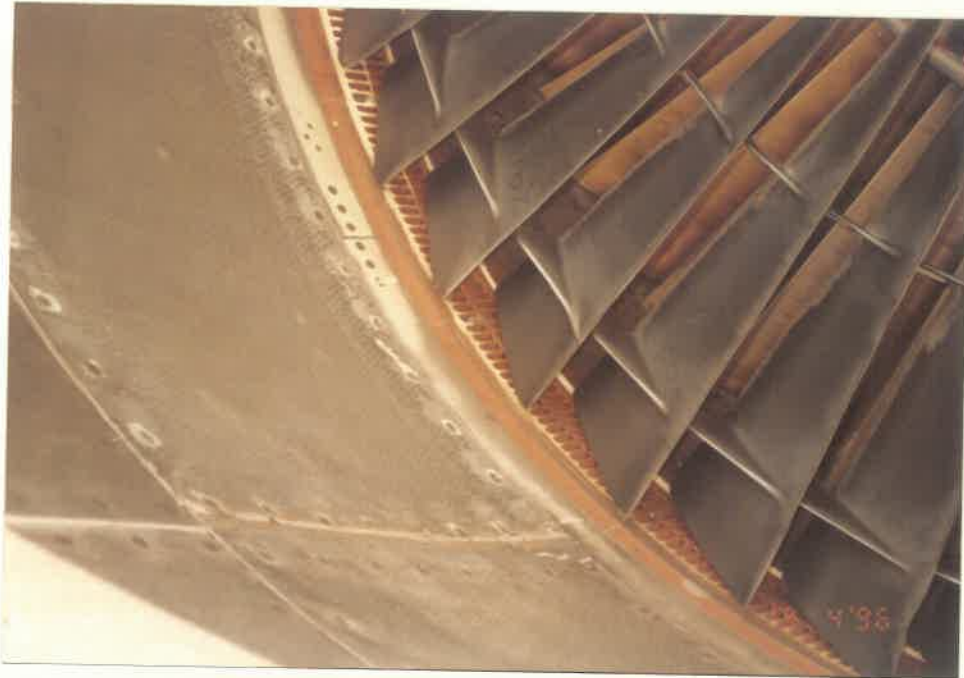
B.5

DAMAGED FAN BLADES

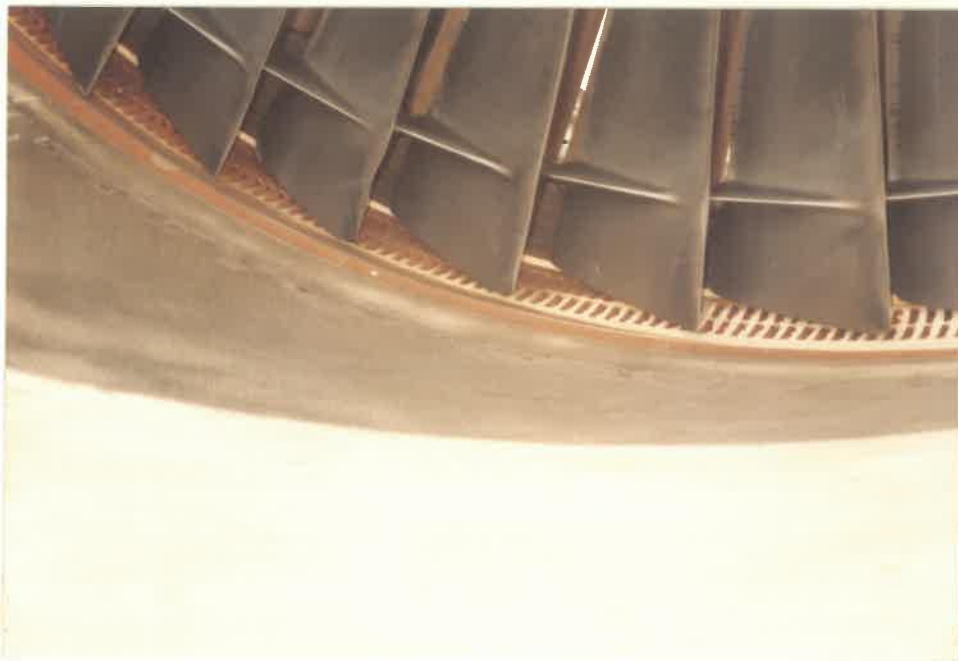
B.6

DAMAGED FAN BLADES

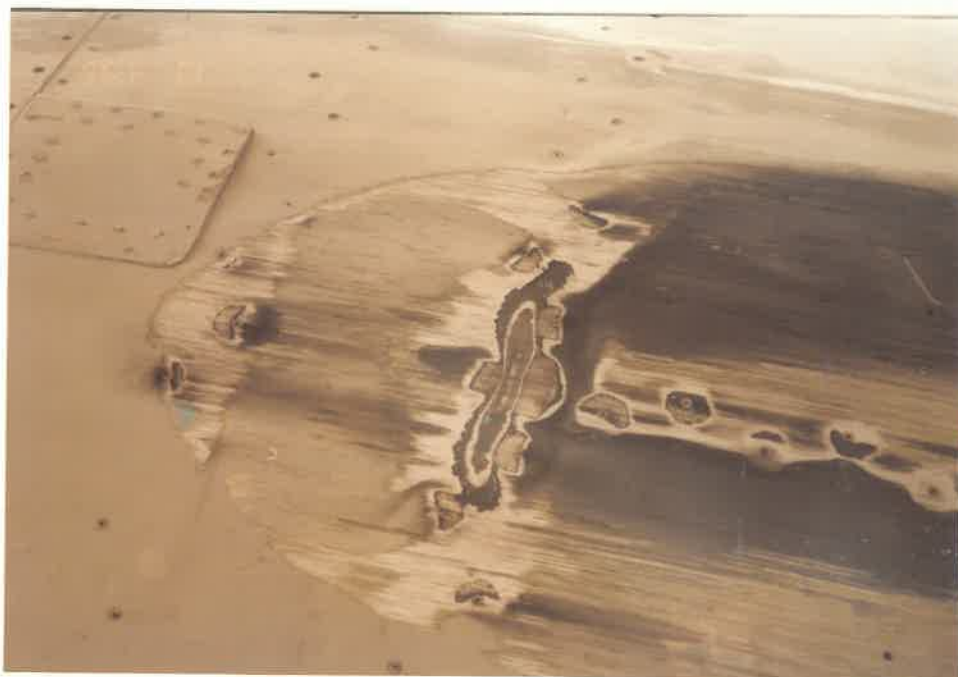
B.7

UNDER SURFACE DAMAGE OF NO.1 ENGINE

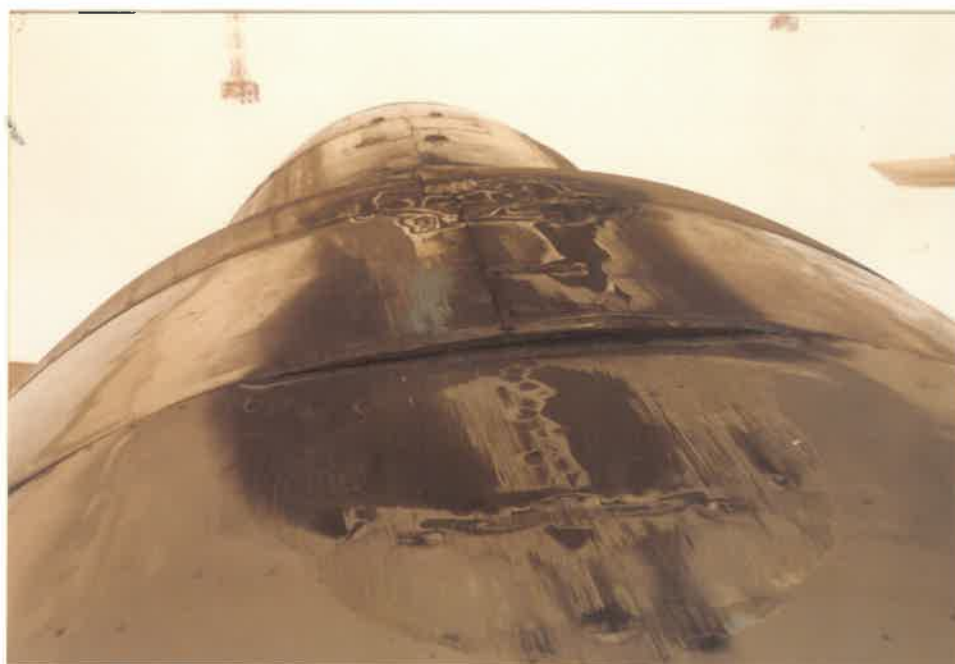
B.8

ANOTHER VIEW OF UNDER SURFACE DAMAGE OF NO.1 ENGINE
