INVESTIGATION REPORT INTO FLYING INCIDENT  
INVOLVING F-27 AIRCRAFT, REG. MARK AP-AUR,  
BOTH TYRES BURST ON LEFT HAND SIDE ON LANDING  
AT 0645 H ON 12TH DECEMBER, 1984 AT ISL. AIRPORT

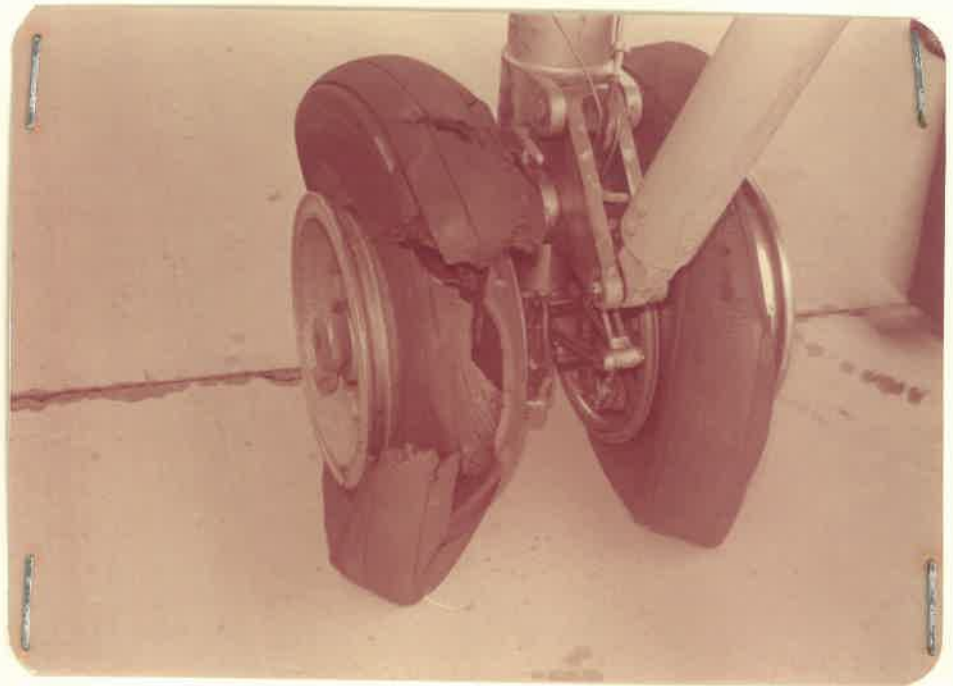
①

17-3 Both the left hand tyres on port side were found burst while starboard side outer tyre were also found burst (Appendix "G").

VARIOUS VIEWS OF PORT  
MAIN WHEEL BURST TYRES

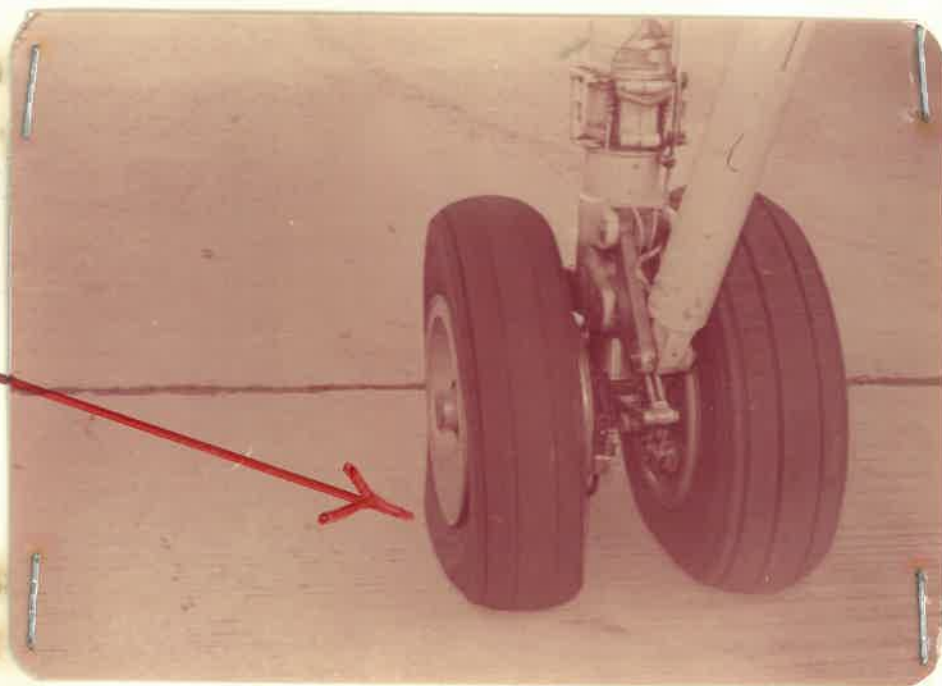
5-1-1 Port both main tyres and starboard outer tyre have burst.

STBD. OUTER  
TYRE BURST

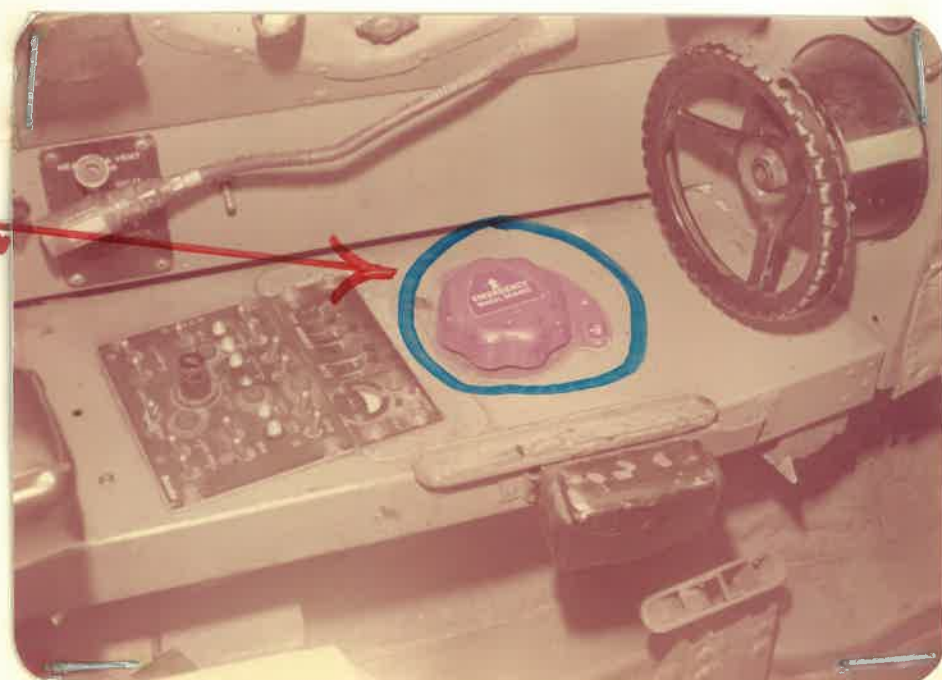
- a. Pneumatic isolating valve was in normal position.
- b. Emergency brake control knob had broken seal and was in full "OFF" position.
- c. Normal bottle pressure was 3100 PSI  
"Emergency" bottle pressure 3000 PSI.

**E**MERGENCY  
SELECTOR  
KNOB IN **"OFF"**  
POSITION  
WITH BROKEN  
SEAL.

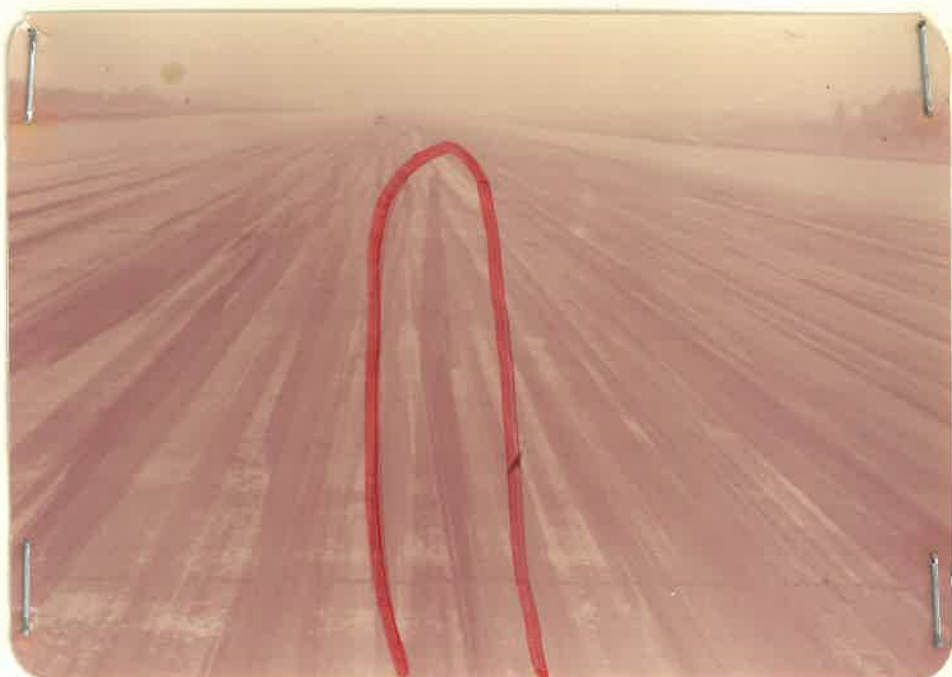
①

- 22-1 The probable cause could be due to some residual pressure trapped in wheel brake assembly, resulting in locked wheel landing.
- 22-2 Shop reports on components are awaited from PIA Engineering staff at Karachi, before any final cause is established.

SKIDDING MARKS OF PORT MAIN  
WHEEL TYRES ON RUNWAY  
VARIOUS VIEWS
