**CIVIL AVIATION AUTHORITY**

**AIRCRAFT INCIDENT INVESTIGATION M/S PAK AVIATORS**

**CESSNA- 337 REG.NO.AP-BDW WHICH OCCURRED**

**INVESTIGATION REPORT IN RESPECT OF INCIDENT TO**  
**M/S PAK AVIATORS CESSNA-337 AIRCRAFT REG NO AP-BDW**  
**OCCURRED AT WALTON AIRPORT LAHORE**  
**ON 8TH JUNE, 1996**

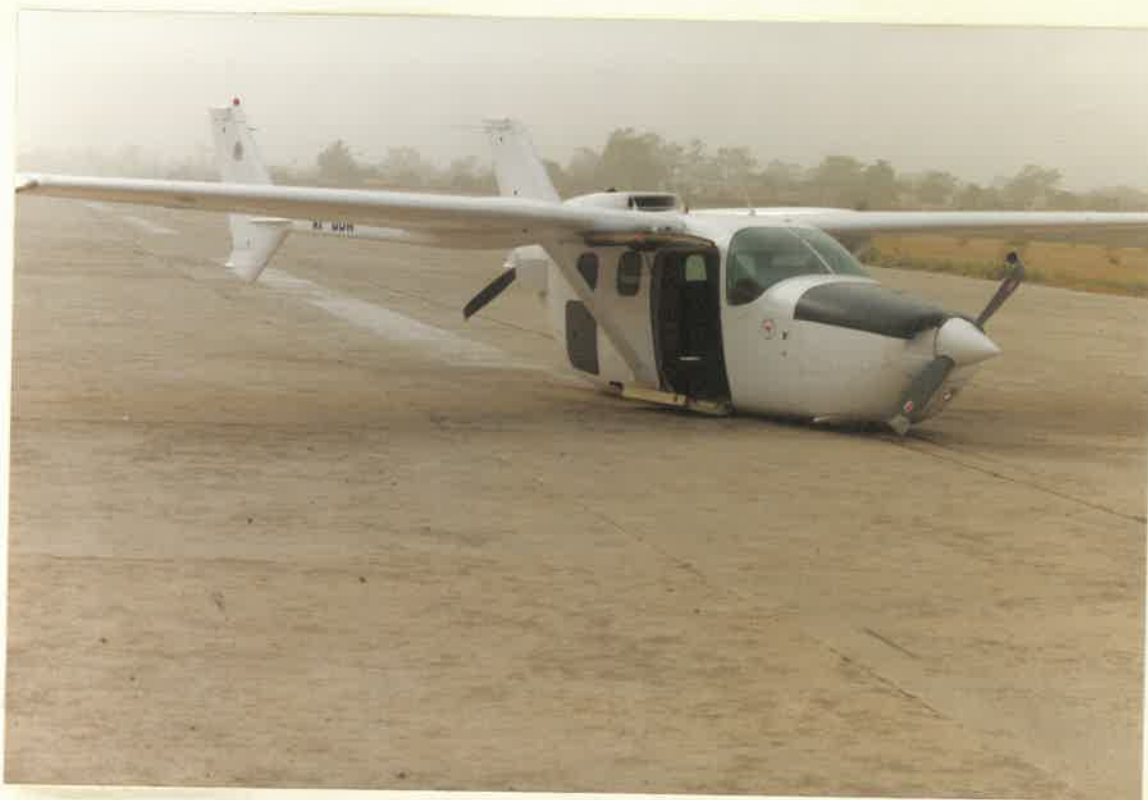
BELLY LANDING

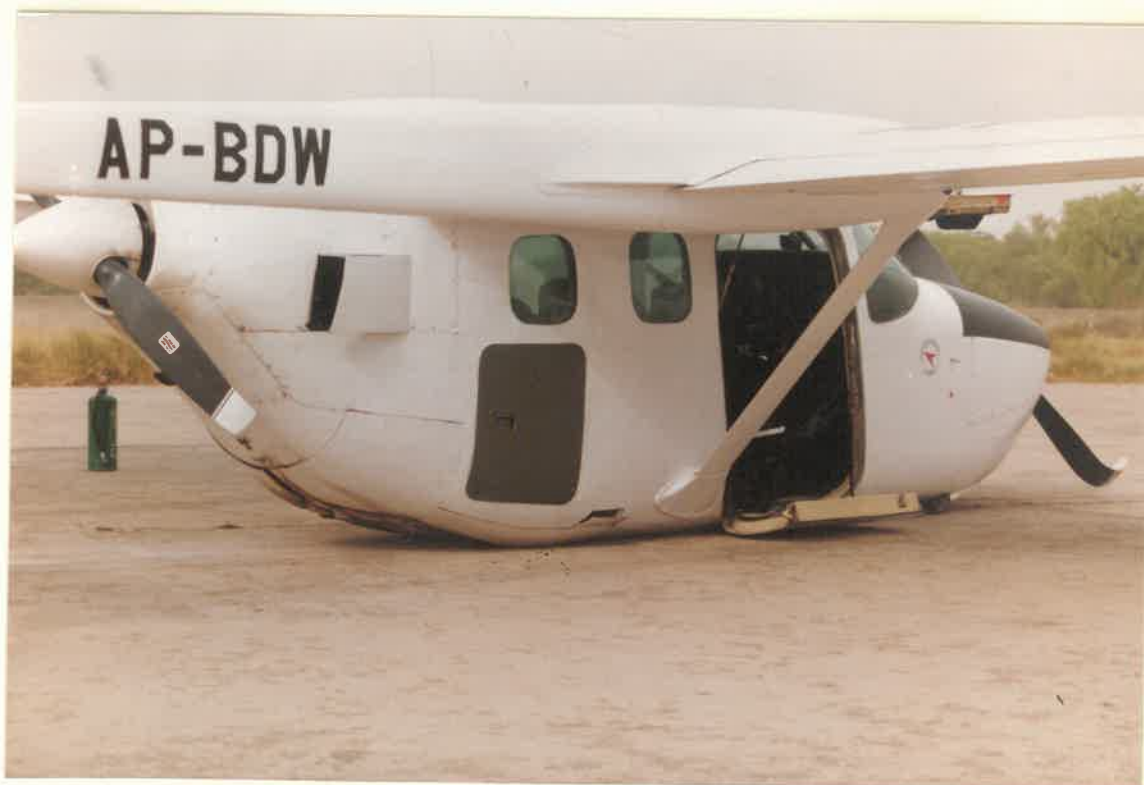
APP. B2

BELLY LANDING - ANOTHER VIEW

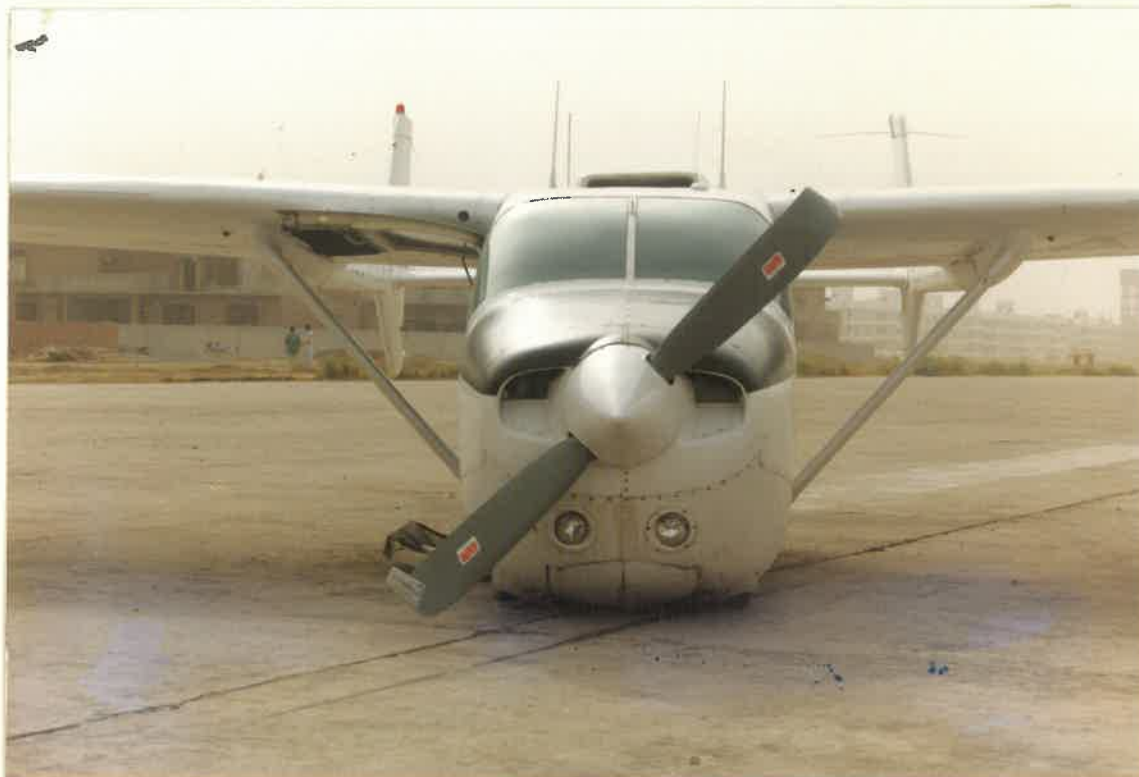
BELLY LANDING

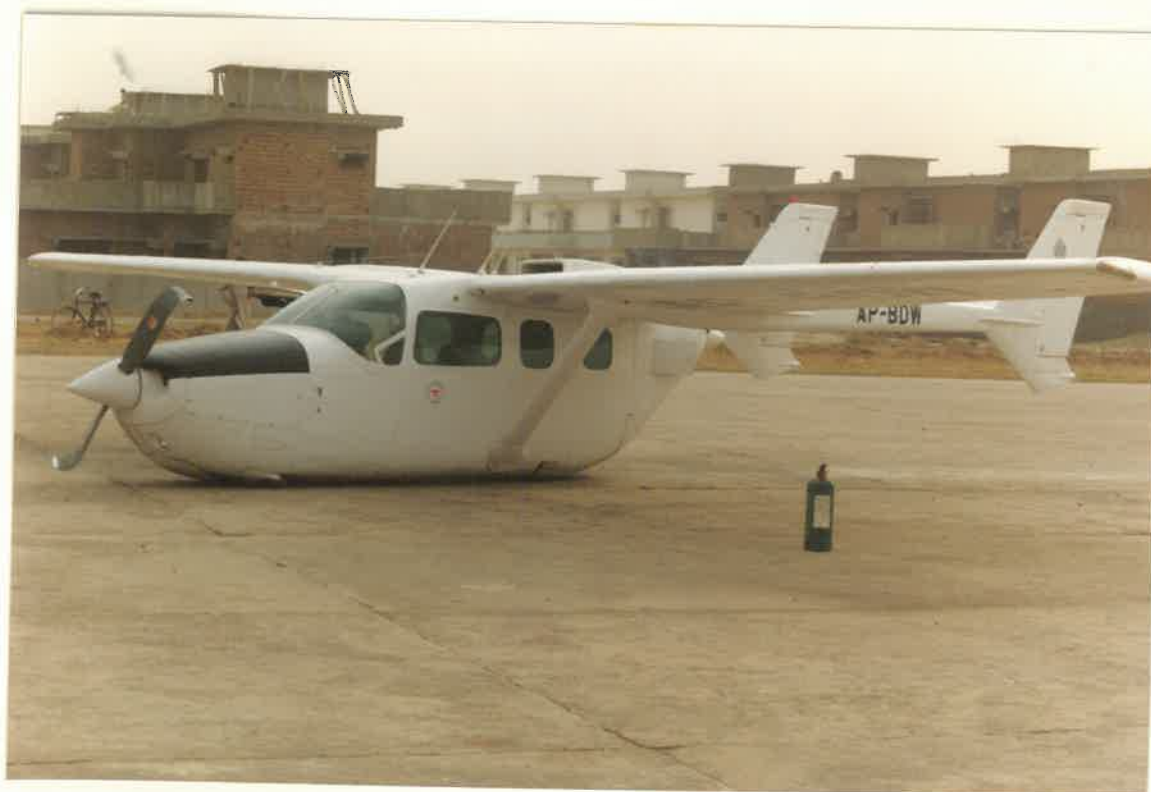
APP. B4

BELLY LANDING - ANOTHER VIEW
