**CIVIL AVIATION AUTHORITY**

**AIRCRAFT ACCIDENT INVESTIGATION M/S PIAC  
BOEING - 737 REG.NO.AP-BCE WHICH OCCURRED  
ON 21ST OCTOBER, 1997**

**QUAID-E-AZAM INTERNATIONAL AIRPORT  
KARACHI.**

**INVESTIGATION IN RESPECT OF ACCIDENT TO M/S PIAC**  
**AIRCRAFT BOEING 737 REG NO. AP-BCE OCCURRED ON 21ST**  
**OCTOBER, 1997 AT QIAP KARACHI.**

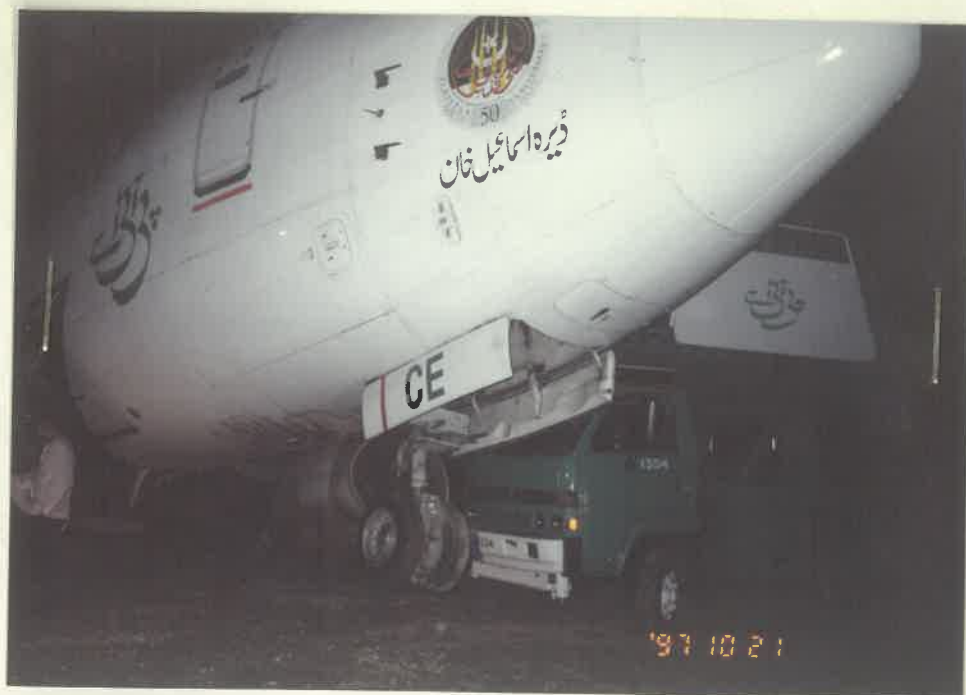
APP. B

- 5.1. B-737 aircraft Reg.No.AP-BCE sustained substantial damage as a result of this accident. (See Appendix 'B' and 'C' for photographs of the aircraft and details of damage to aircraft respectively).
