**CESSNA 185F REG # AP-AYD**

**CRASHED NEAR PISHIN (QUETTA)**

## FINAL REPORT

### CESSNA-185F, REG. # AP-AYD, BELONGING TO THE DEPARTMENT OF PLANT PROTECTION, WHICH CRASHED NEAR PISHIN (QUETTA) ON 19 APRIL 2002

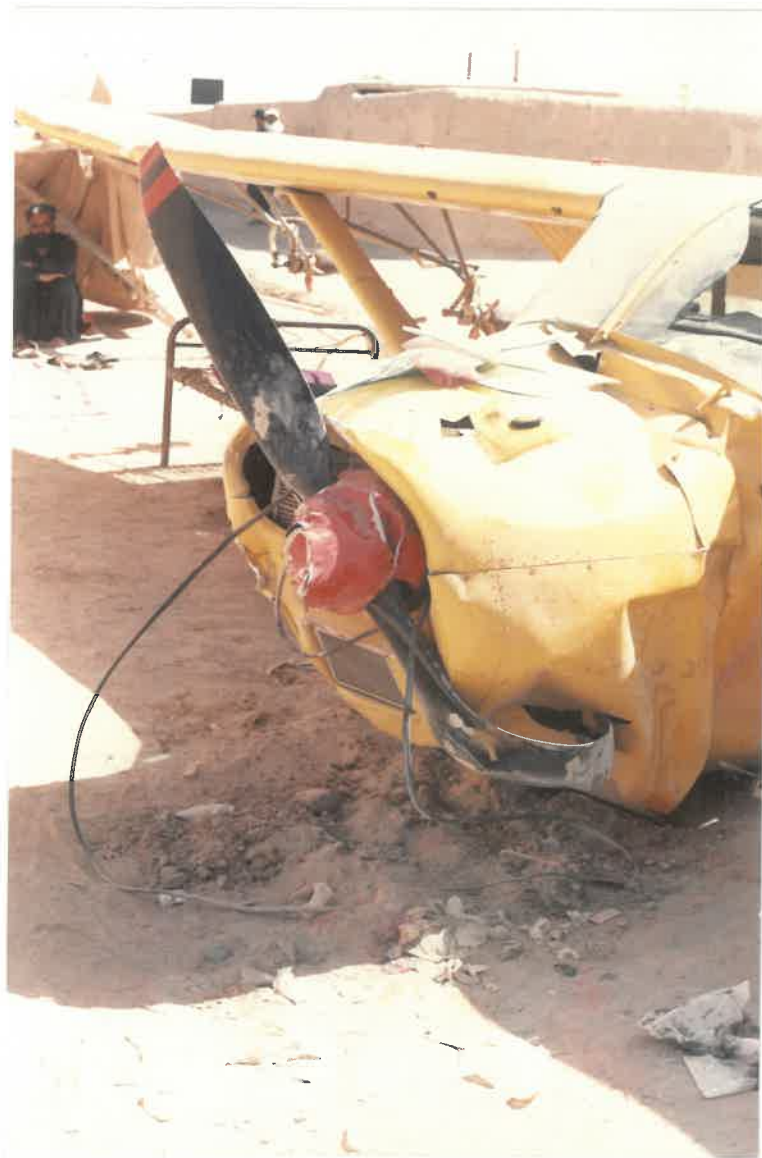
2.7.3 An electric wire was found wrapped around the propeller. This electric wire was cut at one end and snapped, i.e. pulled out from its attachment point, at the other end. A propeller moving under engine power would have cut this wire at several places and some nicks (marks) would have been evident on the leading edges of the propeller. The wreckage did not represent both these evidences. It is inferred from this that the propeller was initially wind milling without engine power till it engaged the electric wire, which stopped the propeller's rotation, when it got wrapped around the propeller shaft. This provides additional evidence of the engine having packed up resulting in the events of the crash sequence.

ELECTRIC WIRE WRAPPED AROUND THE PROP.  
INDICATIVE OF NOSE IMPACTING FIRST AT  
ABOUT 45/50° AND BEFORE THE TAIL COMING  
DOWN.

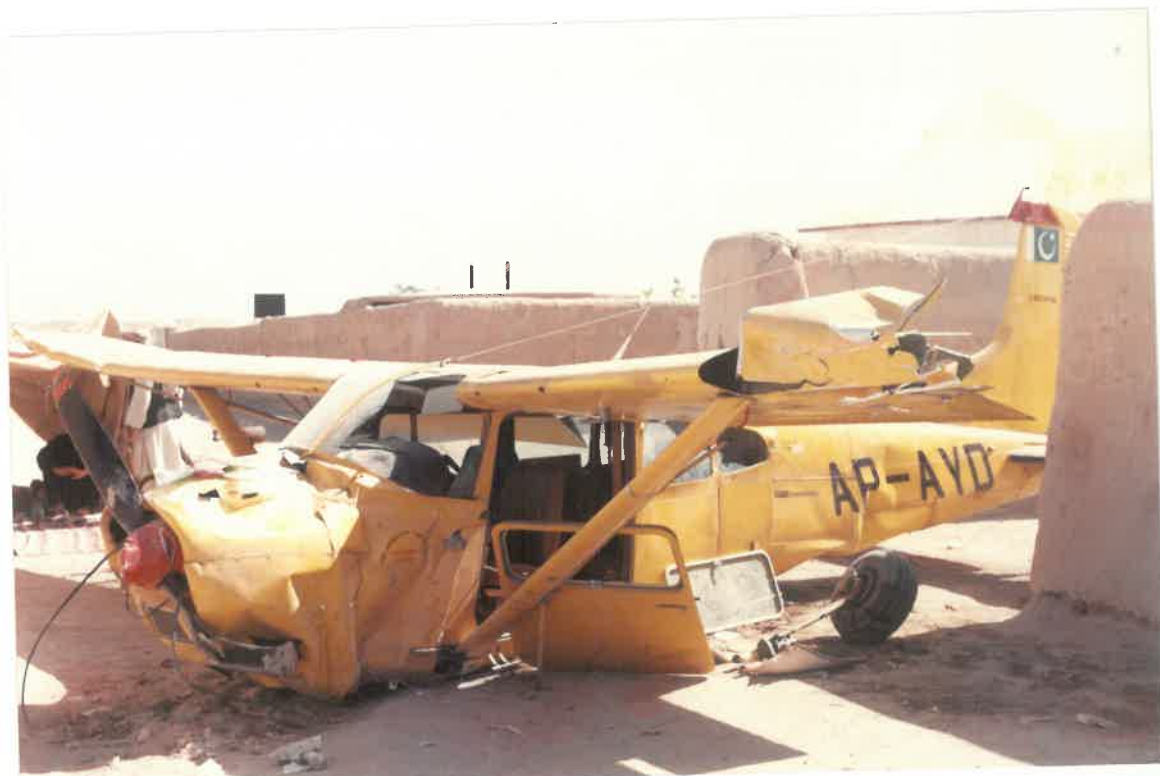
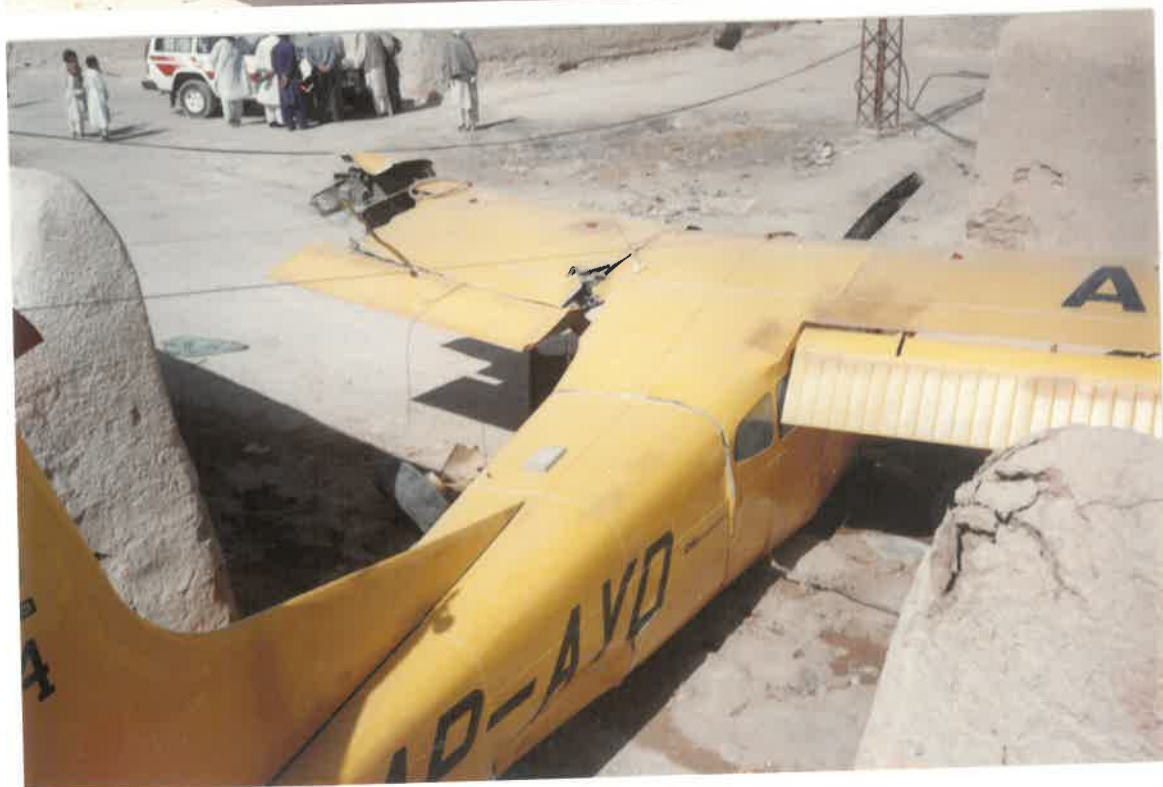
1.12.2 The wreckage was found lying due South and at a distance of about one kilometer from Pishin runway. The direction of the aircraft, where it finally came to rest, was approximately North East (about 050°).

- d. The direction in which the aircraft finally came to rest also resulted from the telephone multi-cables wrapping the aircraft. While weight and the momentum of the aircraft caused the telephone pole to bend in the direction of the final crashed position of aircraft nose, their wrapping around the aircraft caused the direction of the aircraft's flight to change from southerly to north easterly.

FINAL POSITION OF CRASHED AIRCRAFT

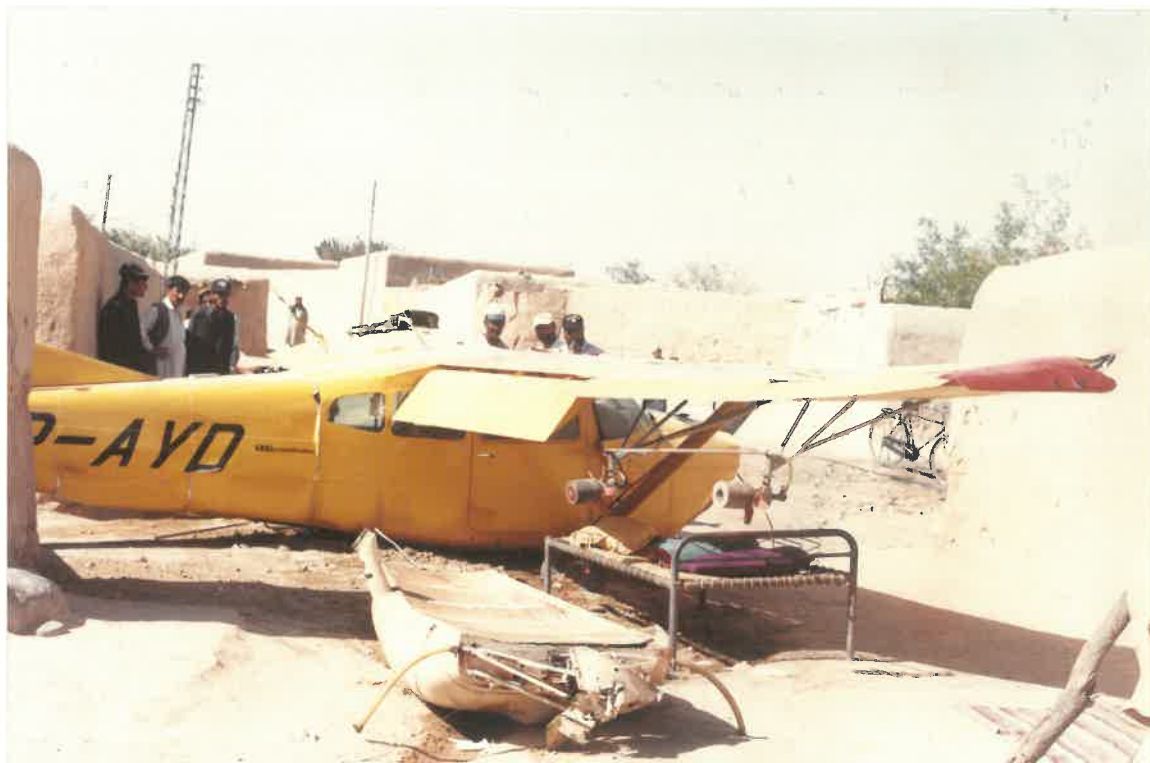
1.4.6 Pesticide tank was detached from the belly area of fuselage and found damaged.

DAMAGED AIRCRAFT WITH DETACHED PESTICIDE TANK

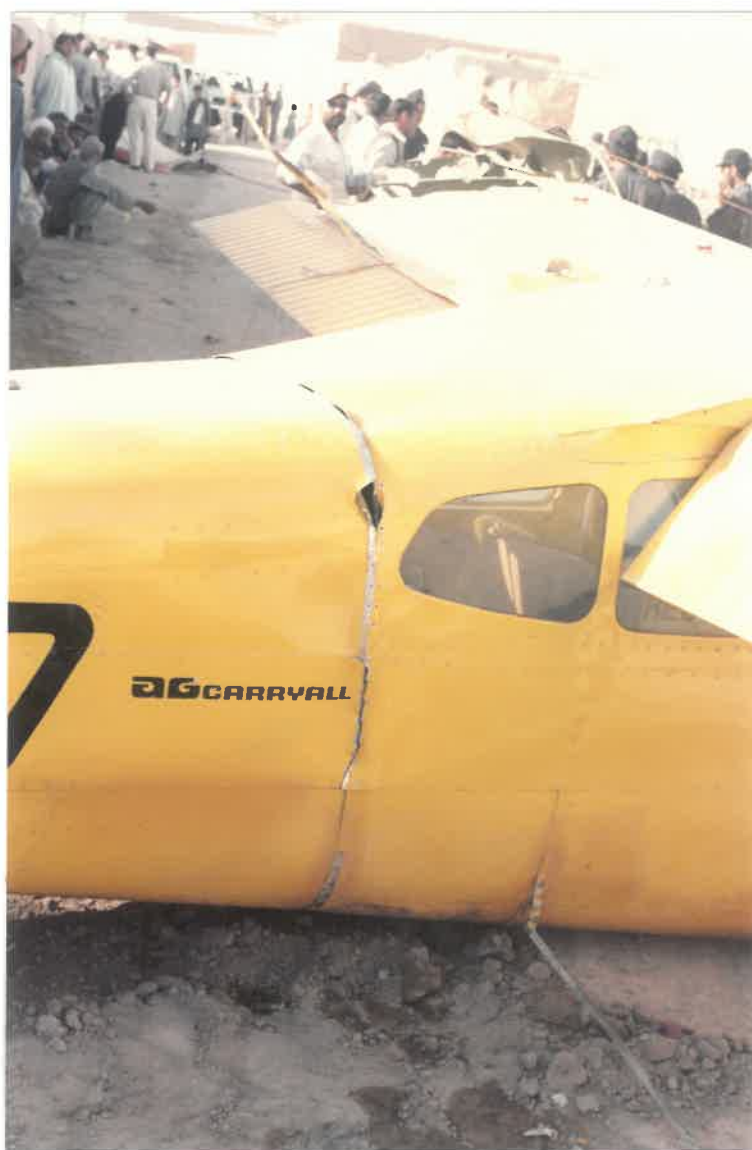
1.4.10 Fuselage severely damaged at several places.

CRACKED FUSELAGE

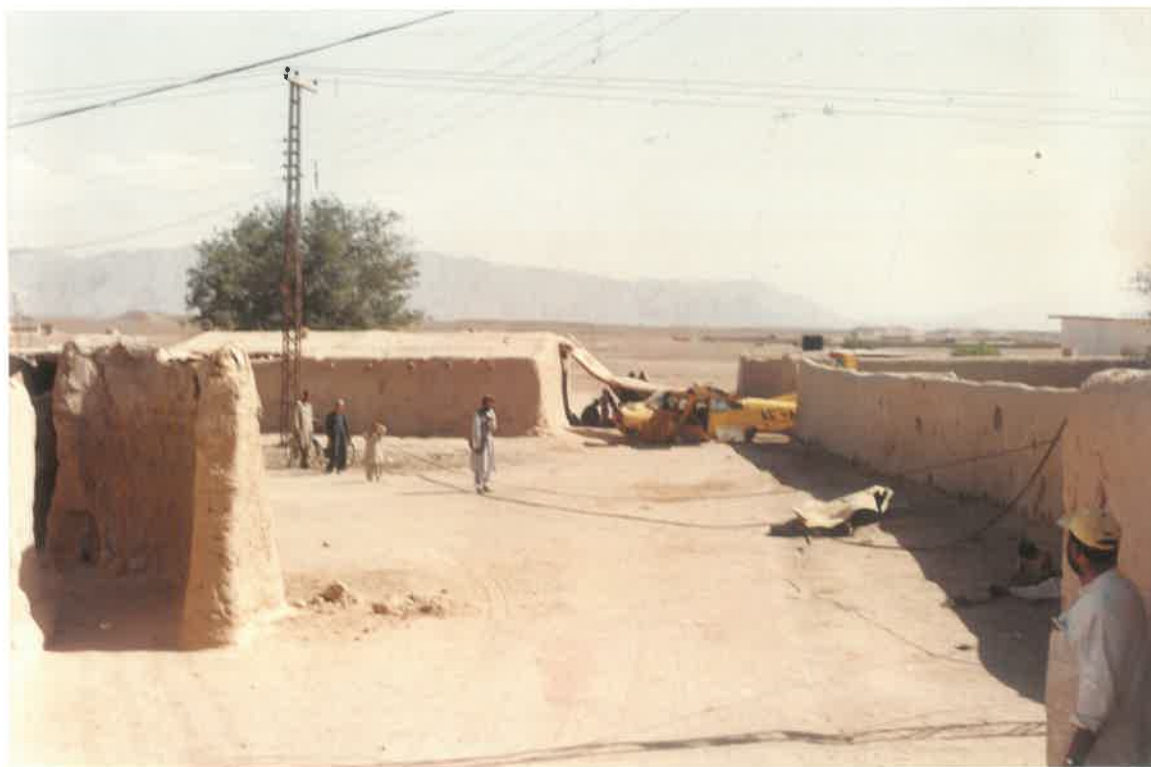
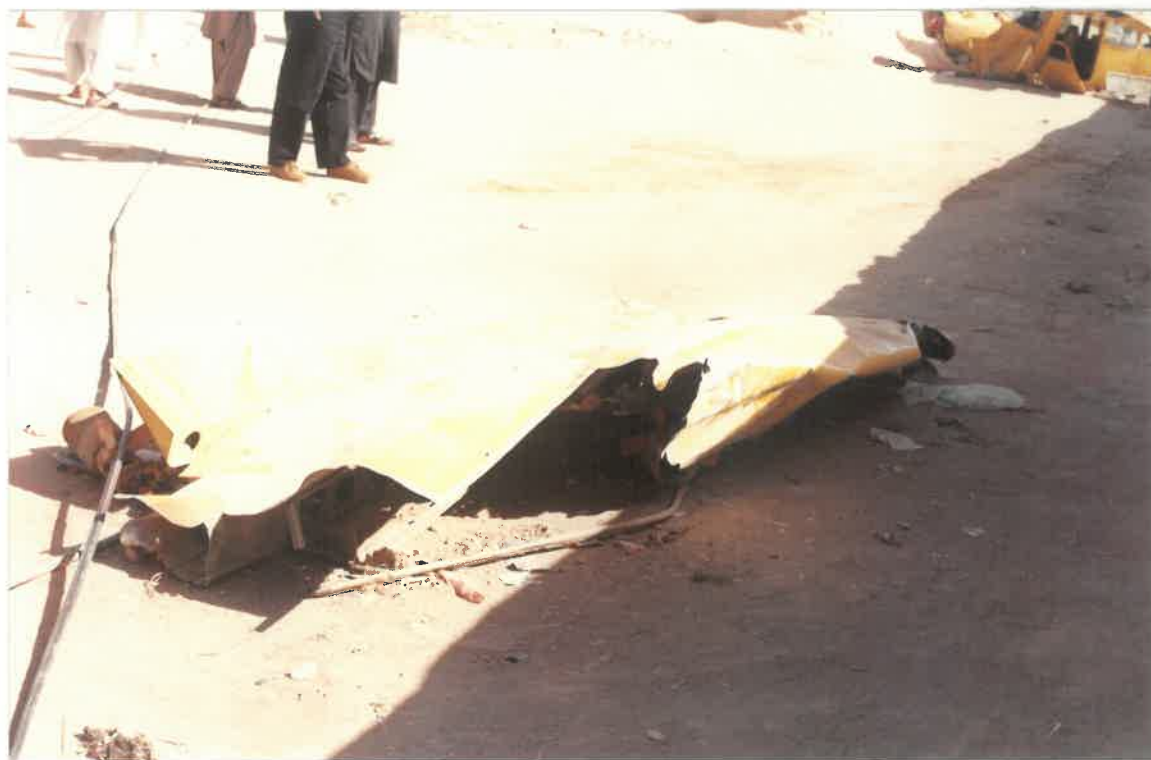
1.12.1 The wreckage of the aircraft was at one place except the left wing portion, which had sheared off and was lying about 100 feet short of the point where the aircraft finally came to rest. Although not disintegrated, the entire structure showed signs of extreme stress. The left wing spar had sheared off from a point about  $\frac{1}{4}$  distance away span-wise from the wing root. One propeller blade was bent backwards from the center, while the other was bent backwards close to the tip. The fuselage was cracked just behind the crew compartment. There were prominent dark rubber marks around the fuselage, the wings area and around the engine compartment.

PORTION OF LEFT WING LYING ABOUT 110' AWAY FROM THE MAIN WRECKAGE. WRECKAGE NOT WIDE SPARED A STALLED A/C CRASH INDICATIVE.

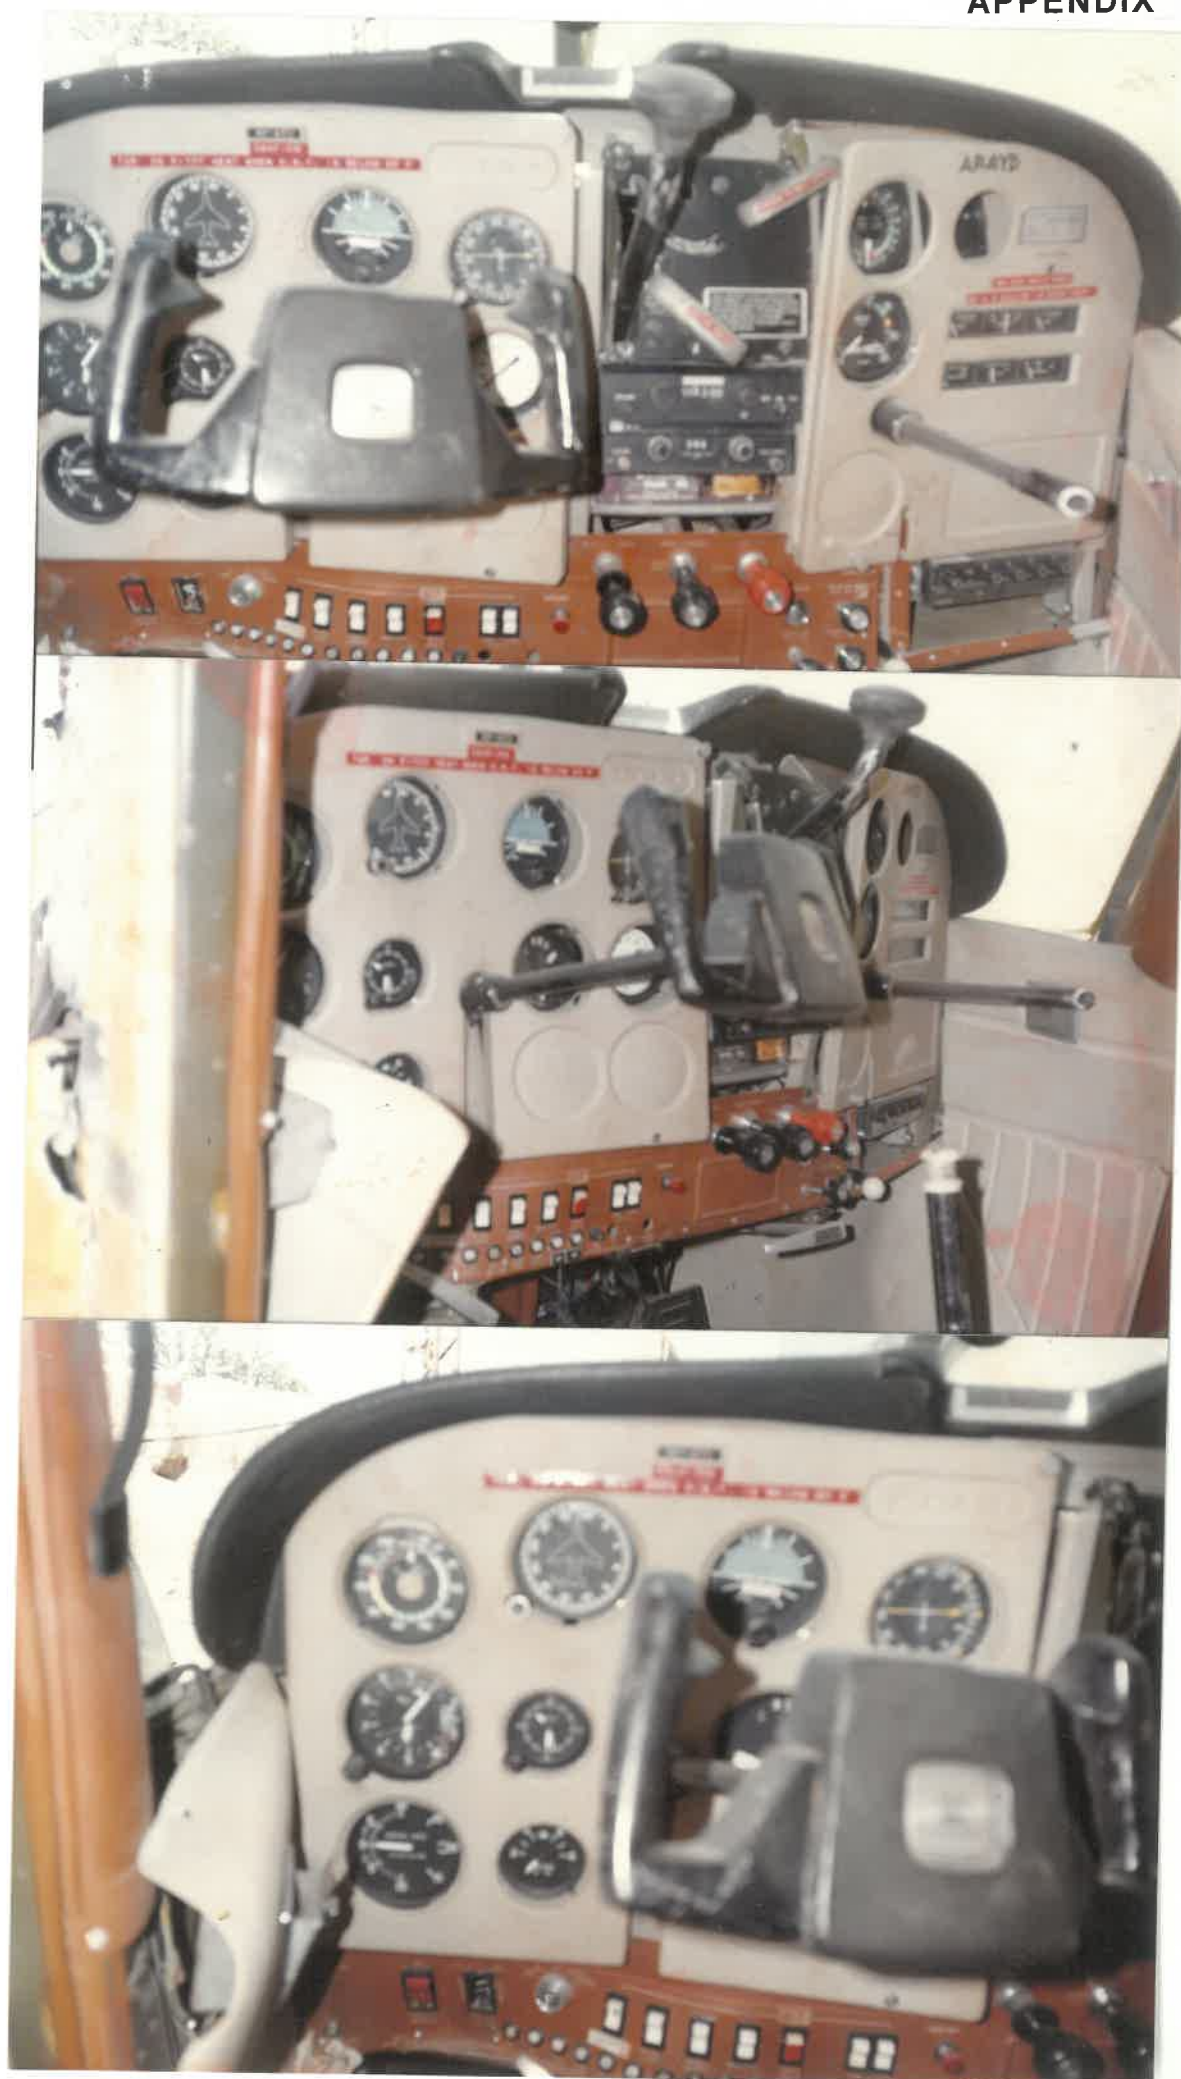
- e. This also accounts for a comparatively lower intensity of the final impact of the aircraft with ground. This is evidenced from the instruments being largely serviceable after the accident, a relatively less damaged instrument panel and finally the aircraft not disintegrating on impact.

AIRCRAFT INSTRUMENTS SEEN UNDATED

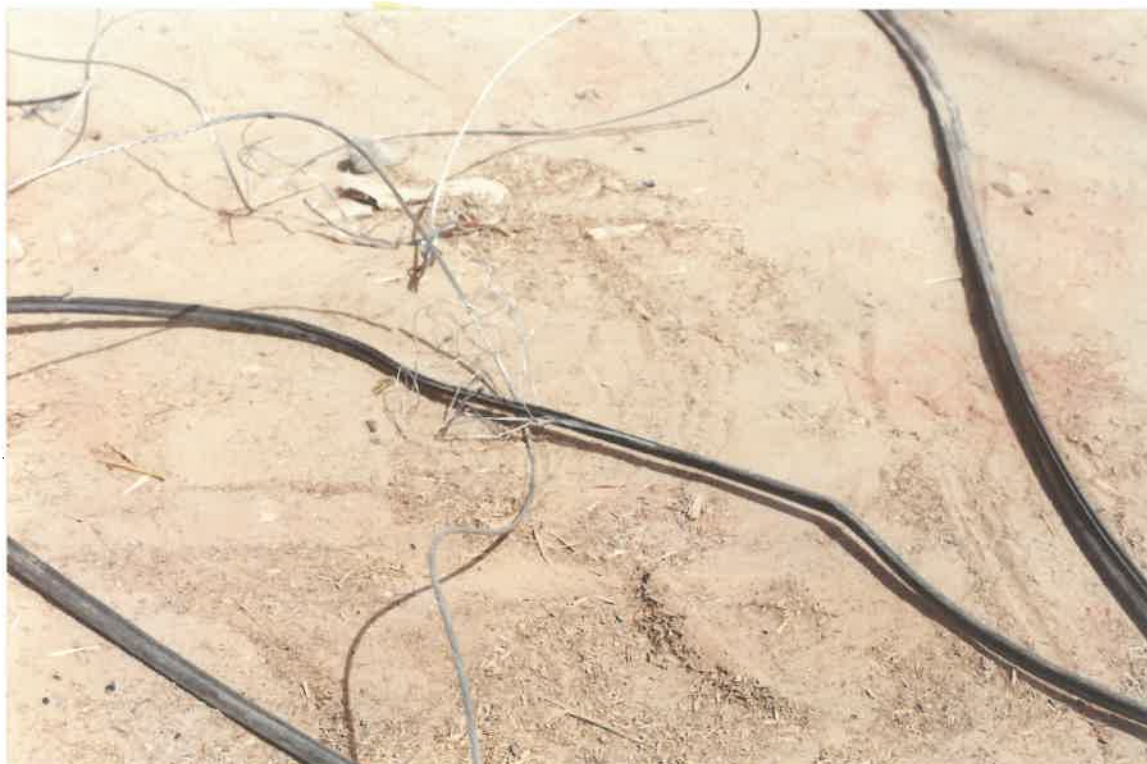
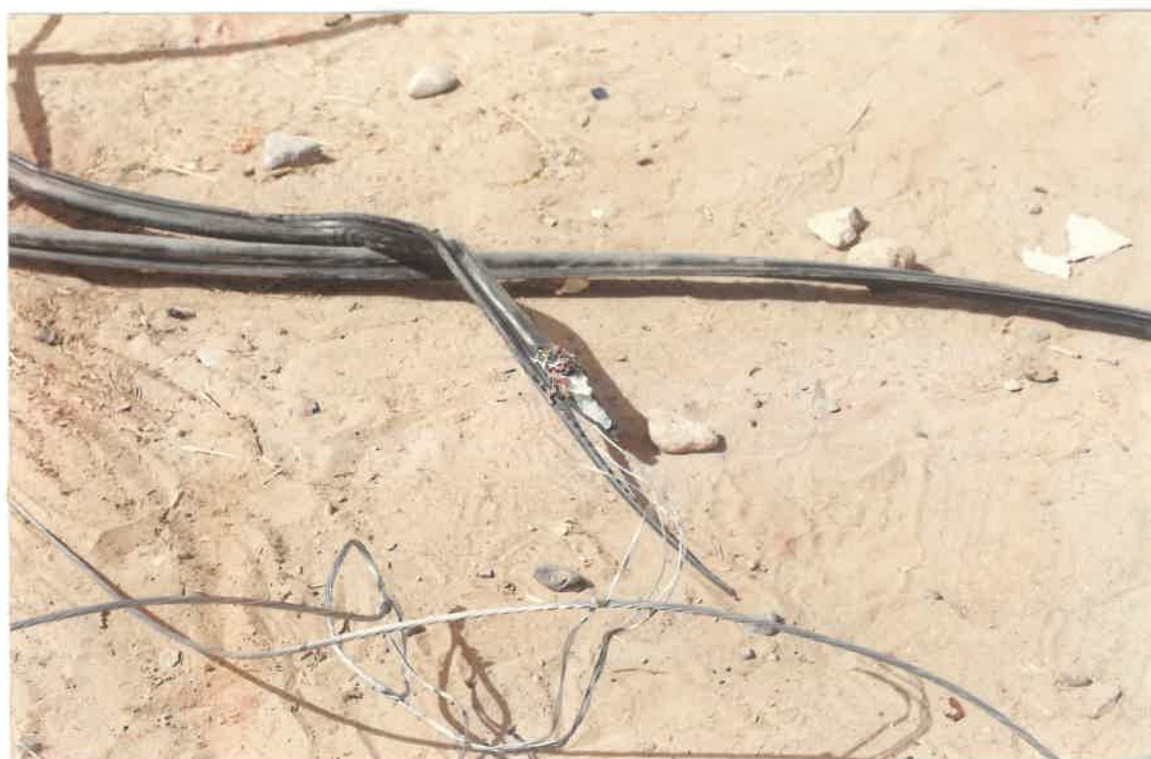
- a. The aircraft had got entangled in the two multi-cable telephone wires running across its flight path just beyond the point where the propeller cut the electric wire (which had wrapped around its propeller shaft).

**BROKEN TELEPHONE MULTICABLES**

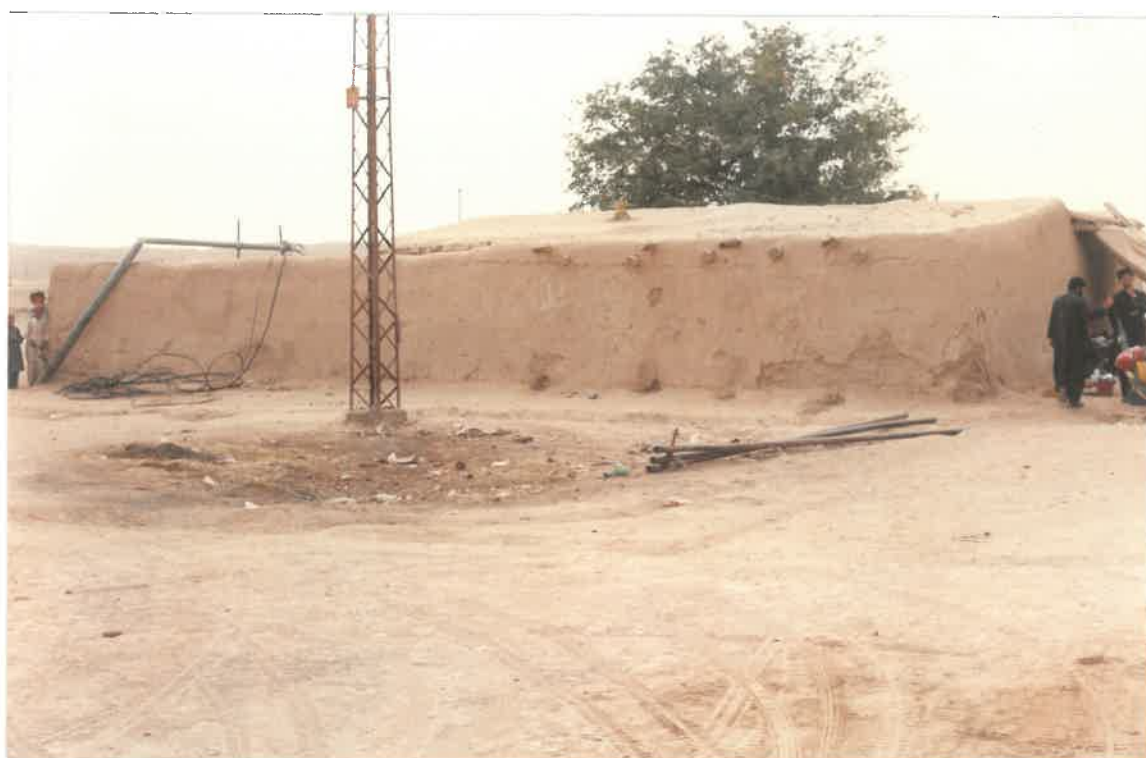
2.7.4 The bent telephone pole at the scene of the accident and the evidence of dark marks around the fuselage, wings and the cowlings were studied

**BENT TELEPHONE POLE ON LEFT EDGE INDICATIVE OF 'PULL'  
FORCE ON THE TELEPHONE MULTI-CABLE**
