# **FINAL INVESTIGATION REPORT**

**SERIOUS INCIDENT OF HYBRID AVIATION AIRCRAFT DIAMOND  
DA-42 REG NO AP-BMR REAR PASSENGER DOOR FLYING OFF  
IN AIR NEAR WALTON AIRPORT LAHORE ON 20-07-2018**

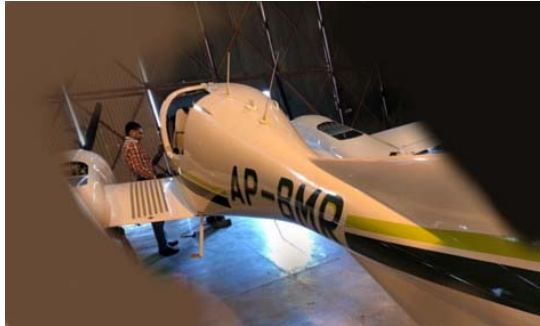
- 2.1 The aircraft and its detached door were examined at the Operator's premises next morning ie (21 July 2018). During this activity, following was discovered:-
- 2.1.1 The passenger door was missing from the aircraft.

*Passenger door missing after the incident*

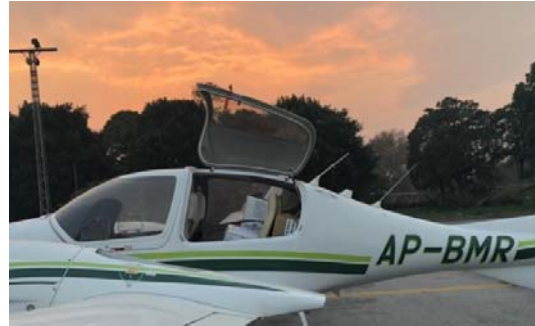
*Door intact on a serviceable aircraft*

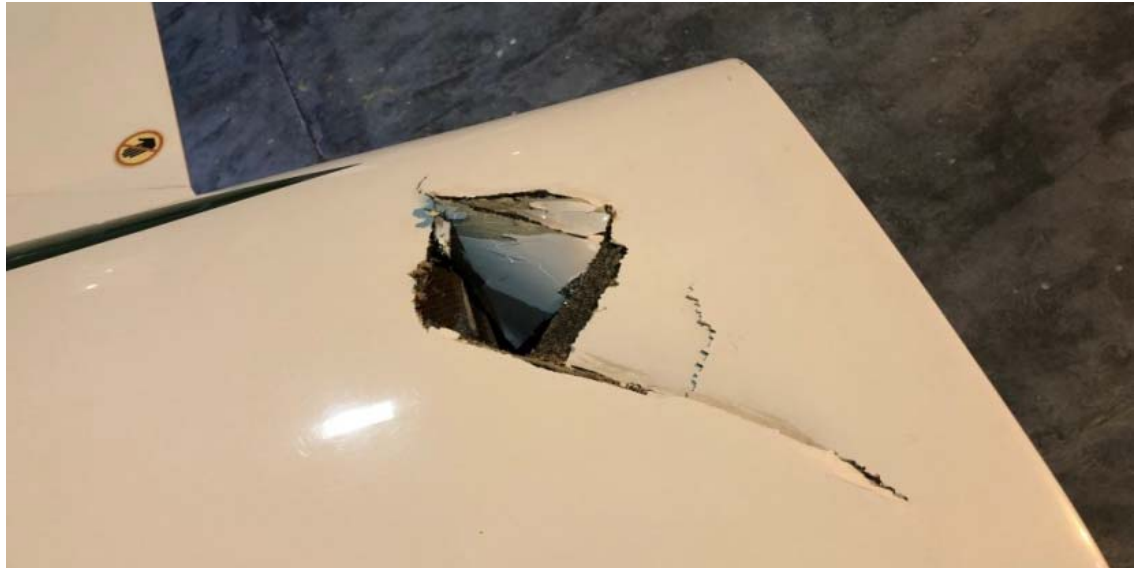
- 2.1.2 Right engine cowling was found damaged as a consequence of door flying off in the air and hitting the cowling.

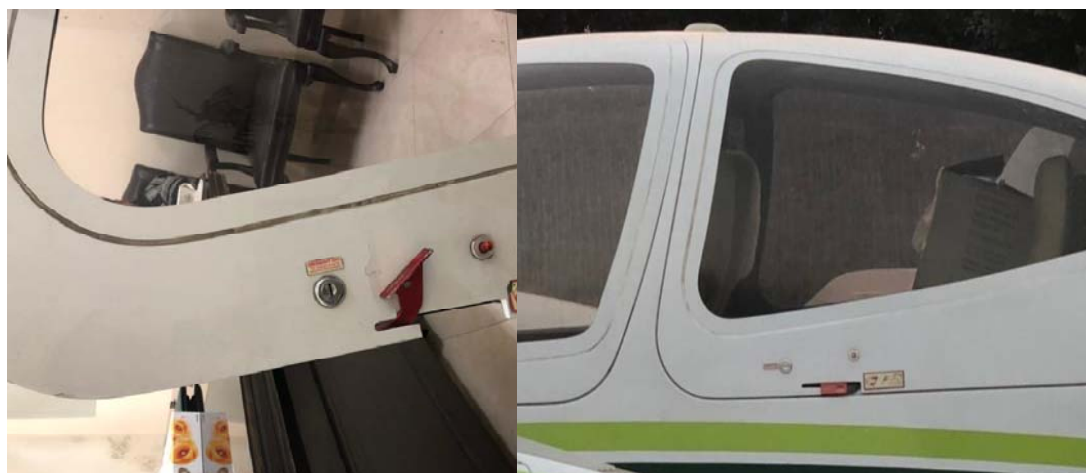
- 2.1.3 The flown off door was recovered and kept separately in a safe custody in the office of APM, Walton Aerodrome on the instructions of SIB.
- 2.1.4 Locking handle of the passenger door was observed to be de-shaped due to its impact on ground and at open position.

*Door handle found de-shaped in open position after the incident*

*Door handle in closed position on a serviceable aircraft*

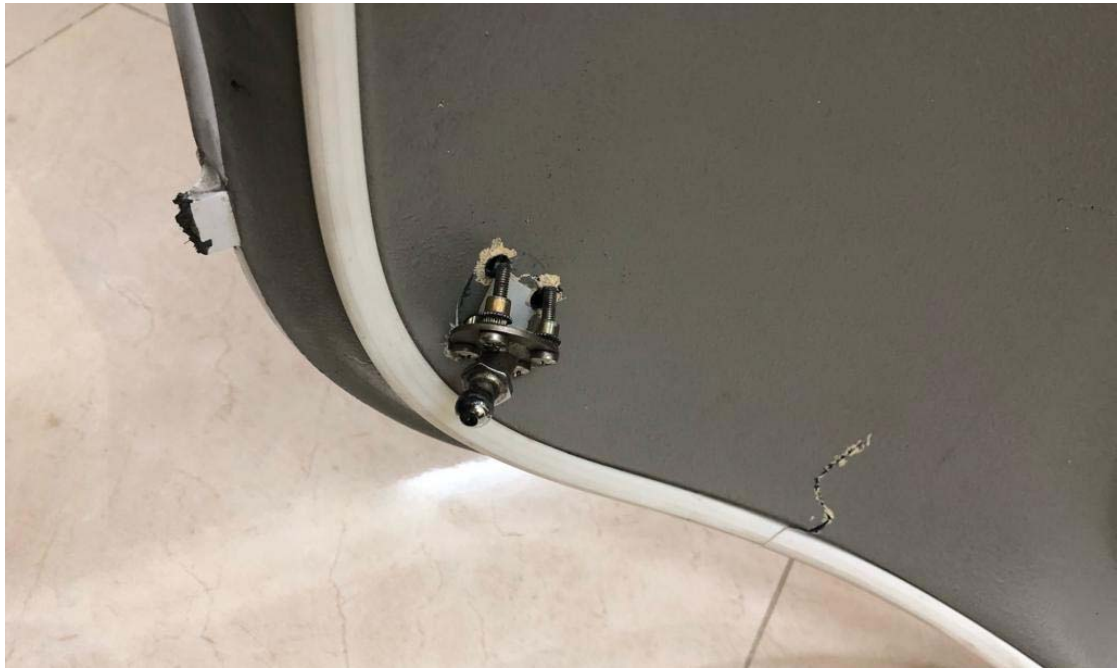
- 2.1.8 The condition of door hinge indicates that it didn't fail. It rather got sheared away from the aircraft skin. This infers that the door locking handle first got unlocked at its own and then the door flew off in the air by shearing off its hinges from the aircraft skin, as shown below:-

- 4.1 The involved Flight Instructor is to undergo DA-42 aircraft normal & emergency procedures refresher training. The compliance report may be submitted to Directorate of Flight Standards CAA Pakistan upon completion, with intimation to SIB.
- 4.2 Directorate of Flight Standards CAA Pakistan may issue instructions to General Aviation flying units for compliance of OEM recommended procedures mentioned in QRH and regulatory procedures as per PCAA approved Ops Manual and to informing ATC of any in-flight incident / abnormal situations in order to alert the emergency services.
- 4.3 DDG (Reg) CAA Pakistan may issue instructions to all General Aviation Flying Units about timely reporting of occurrences / abnormal situations to CAA Authorities as per in-vogue procedures.
