CIVIL AVIATION AUTHORITY  
ISLAMABAD AIRPORT

TO INVESTIGATE INTO THE INCIDENT/ACCIDENT  
INVOLVING FAN TRAINER 600, (GERMAN AIRCRAFT)  
REGISTRATION NO. DEATJ ON 020884 AT 1430 L.T.  
AT ISLAMABAD AIRPORT

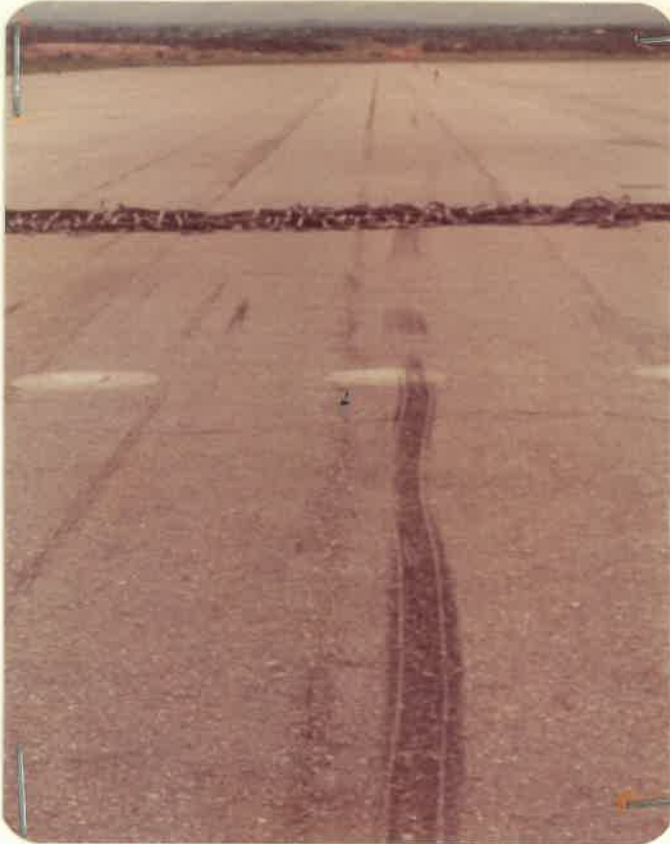
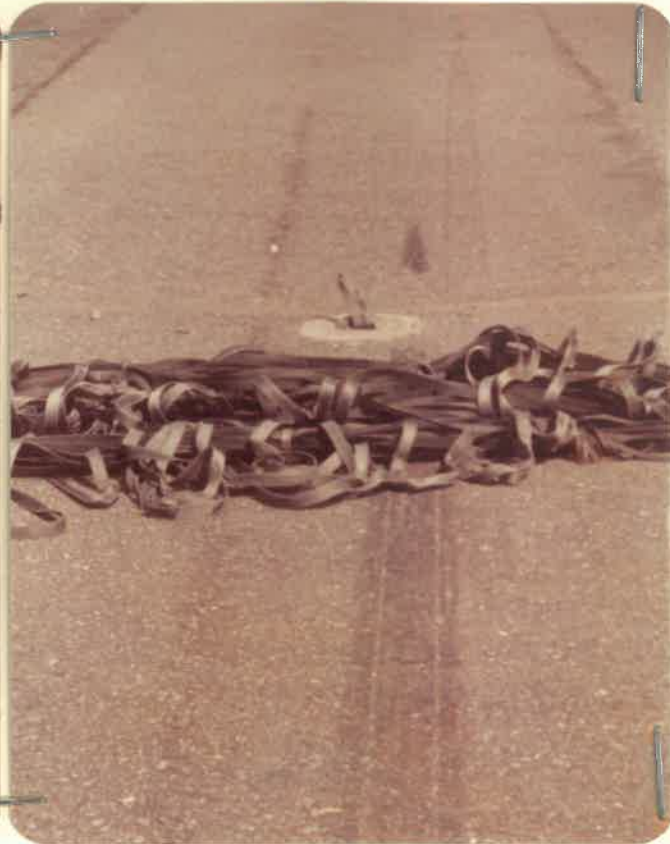
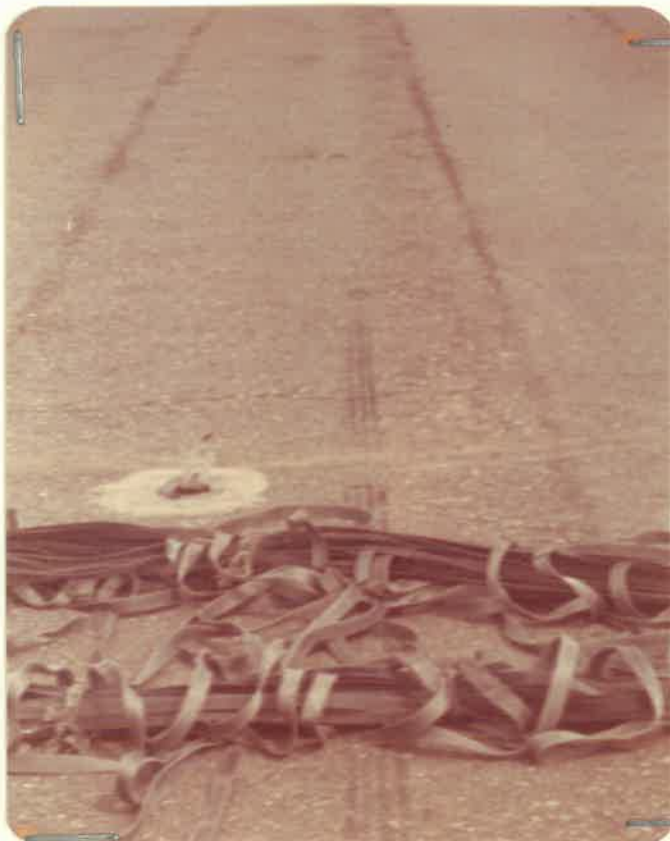
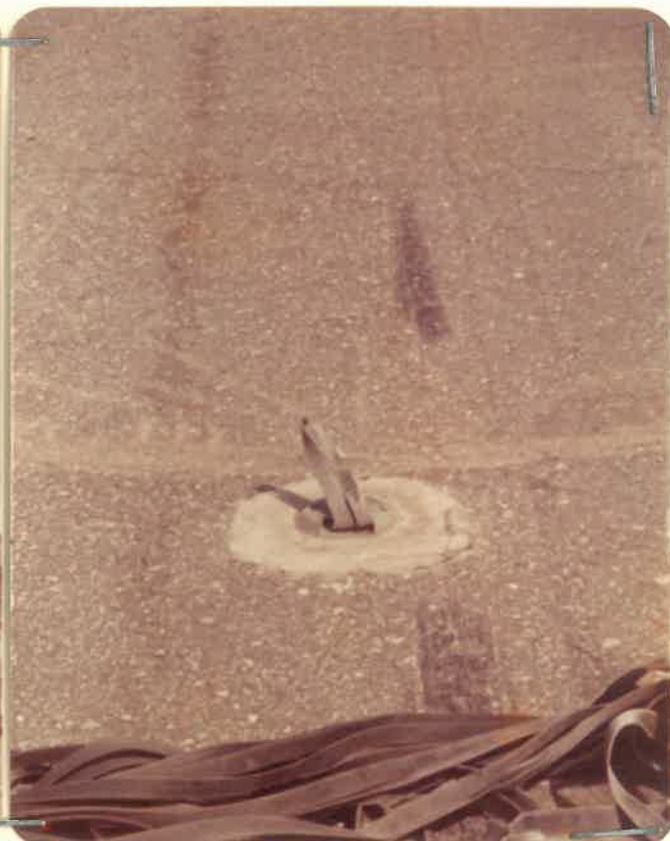
PHOTOGRAPHS SHOWING ARRESTING  
BARRIER, DAMAGE AND TYRE MARKS.

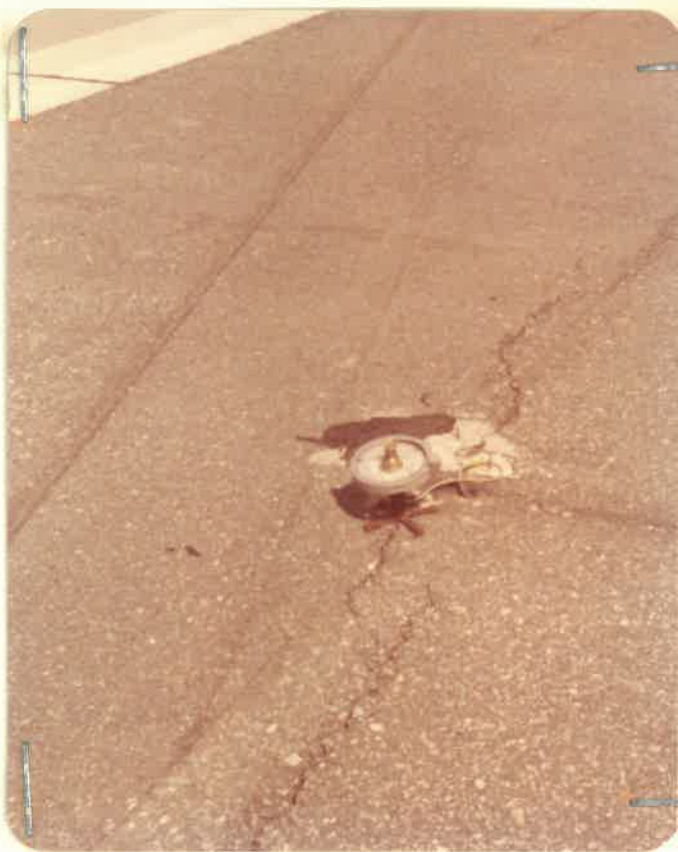
VARIOUS VIEWS OF TYRE MARKS  
ON RUNWAY, KATCHA AND BROKEN N  
RUNWAY LIGHT

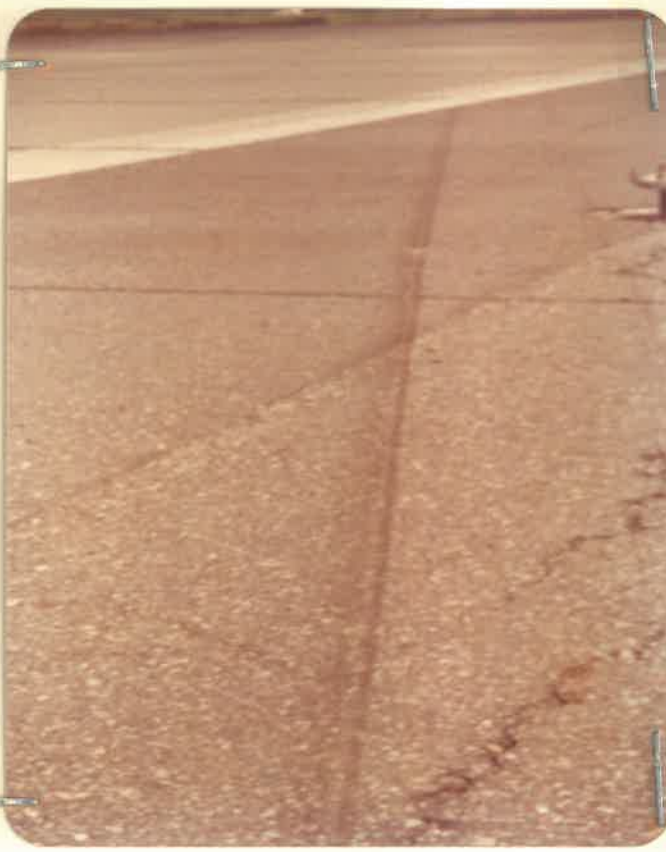
BROKEN LIGHT

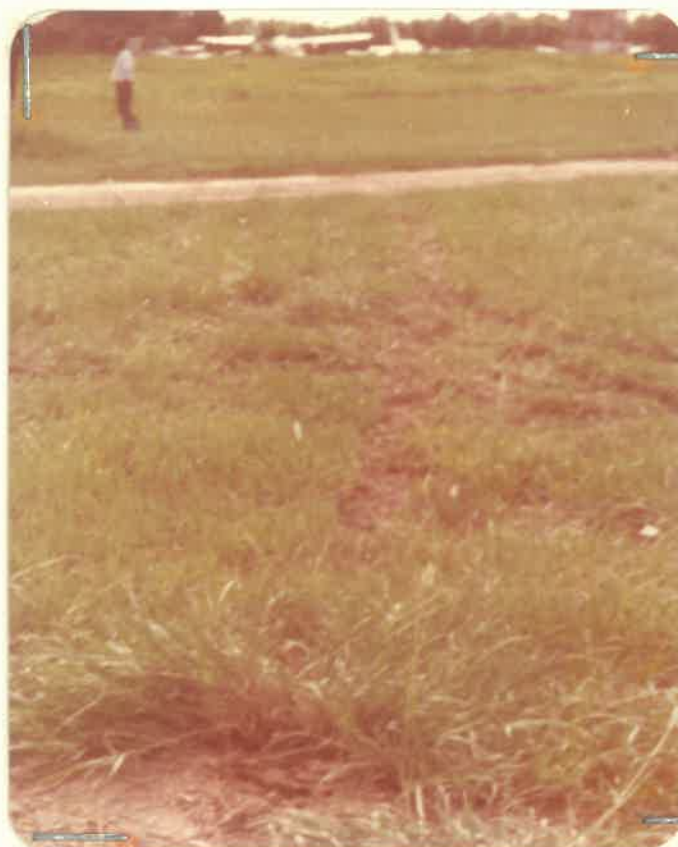
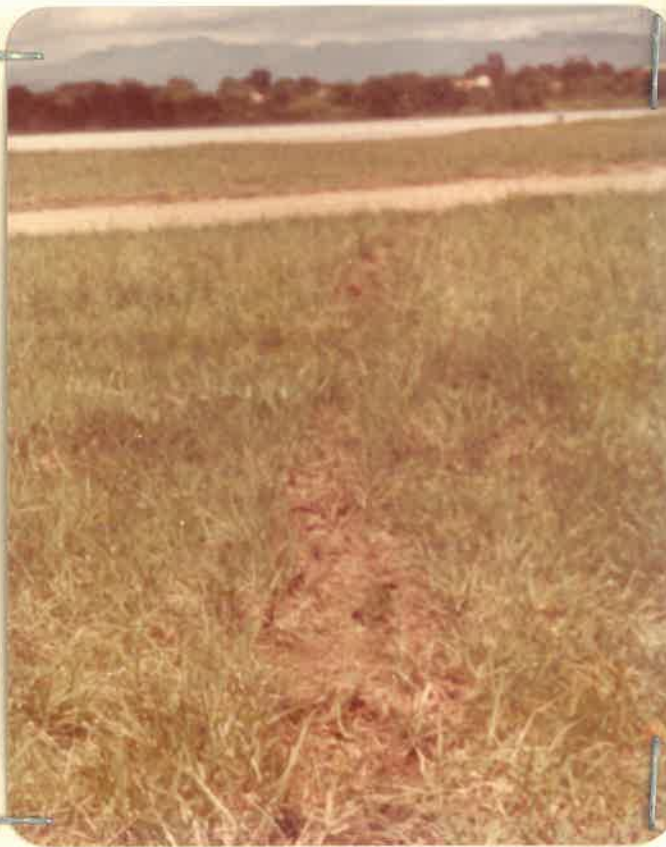
TYRE MARKS

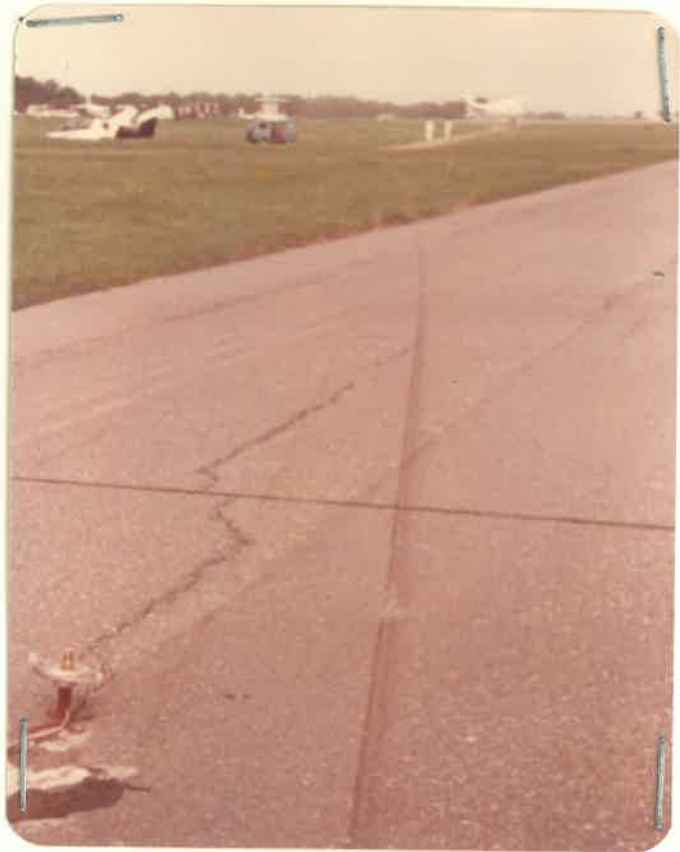
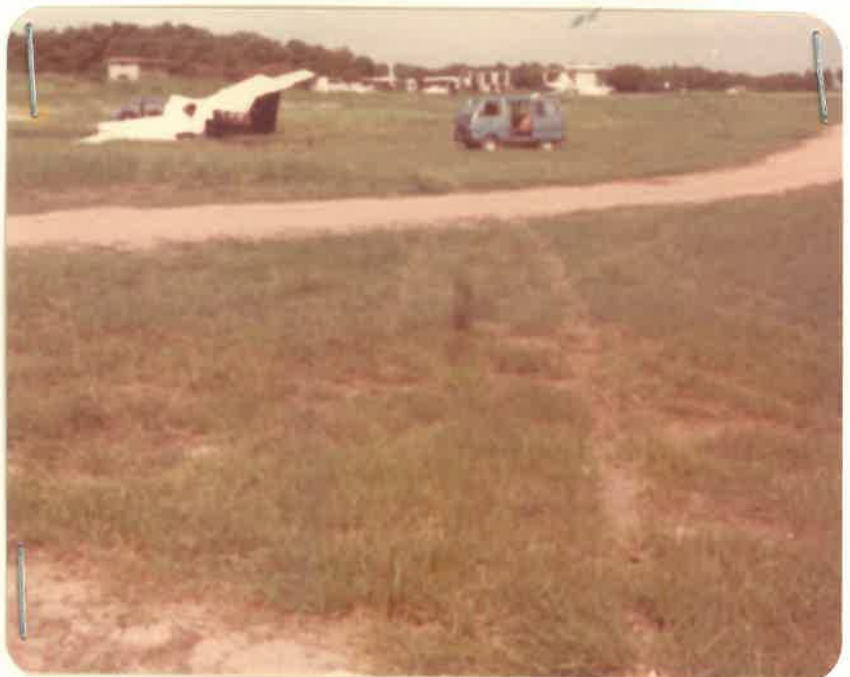
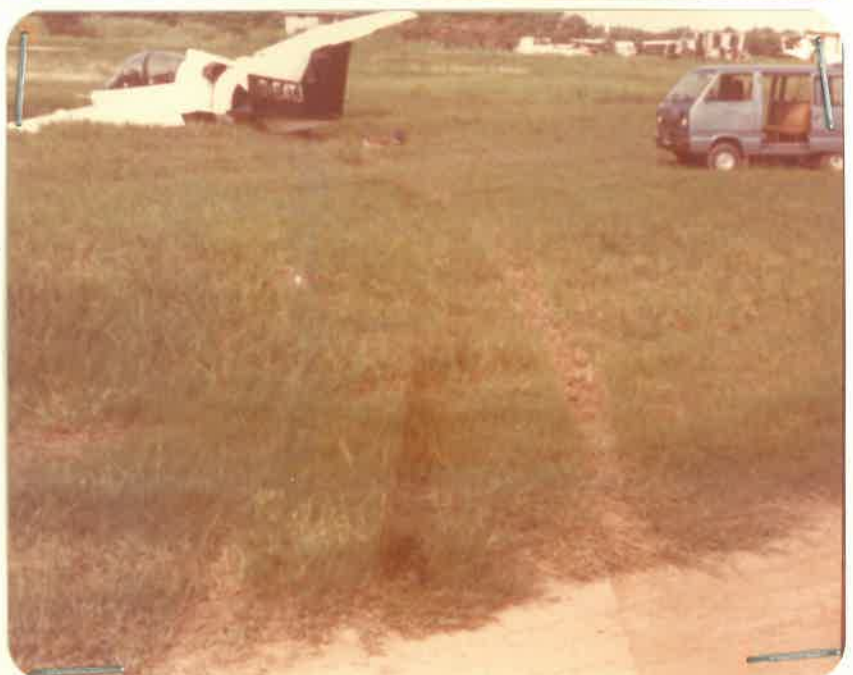
TYRE MARKS AND VARIOUS VIEWS  
OF CRASHED AIRCRAFT

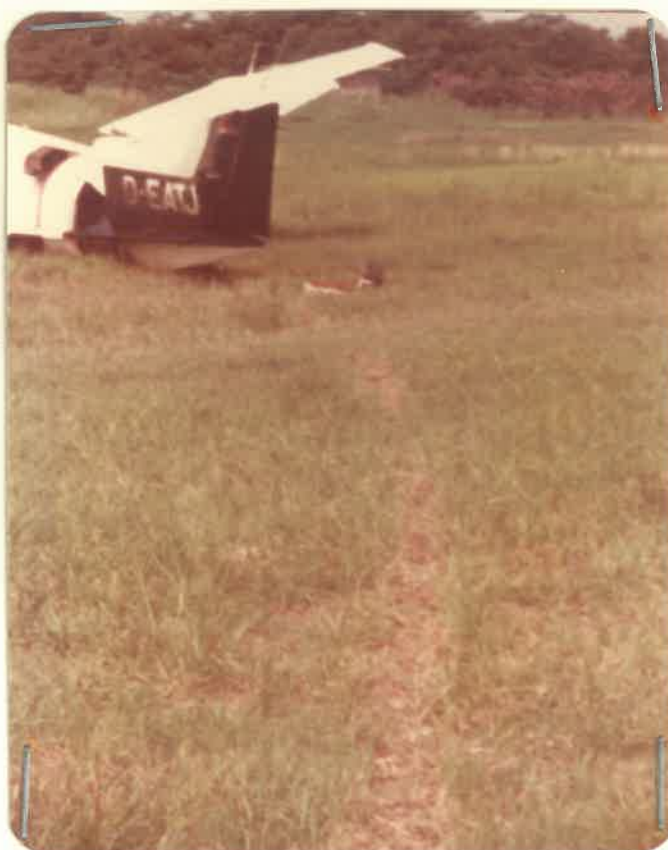
CRASHED A/c  
TYRE MARKS

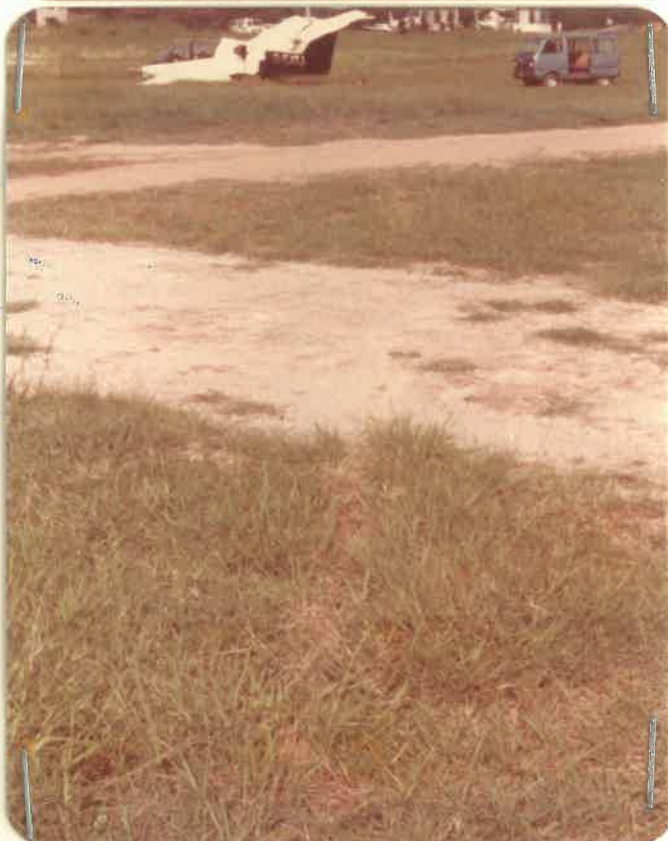
CRASHED A/c  
AND PATH IT  
FOLLOWED

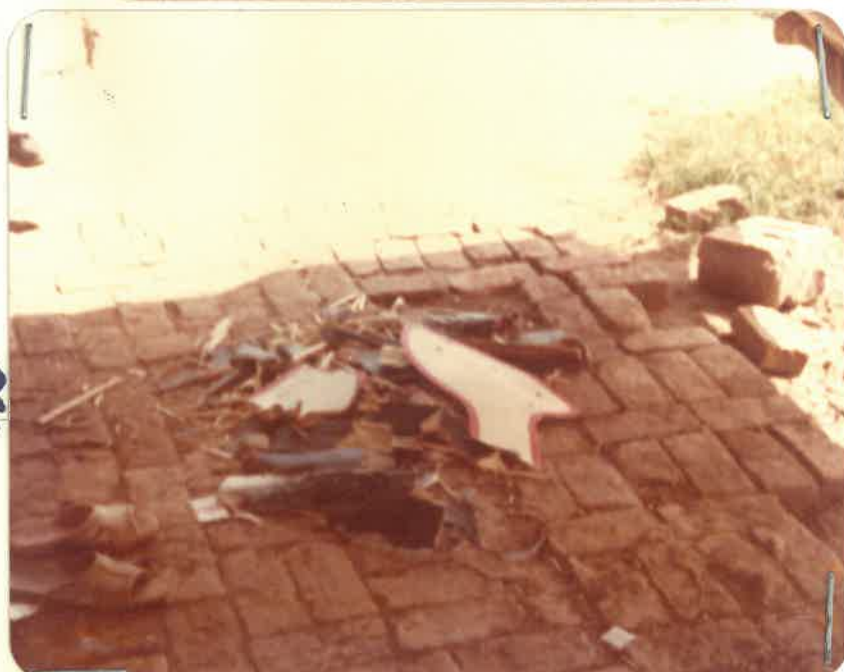
BROKEN  
PIECES  
OF  
PROPELLER

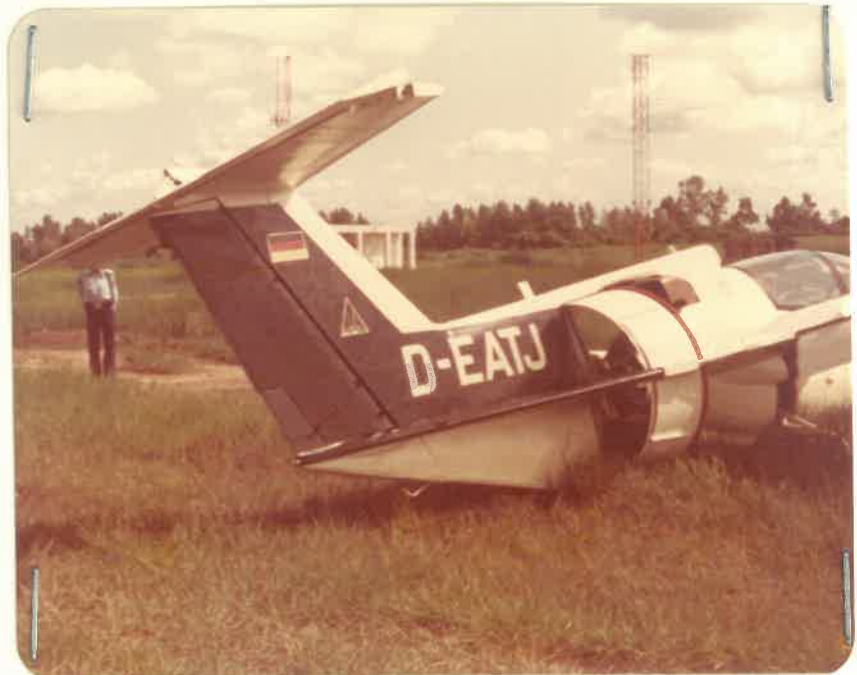
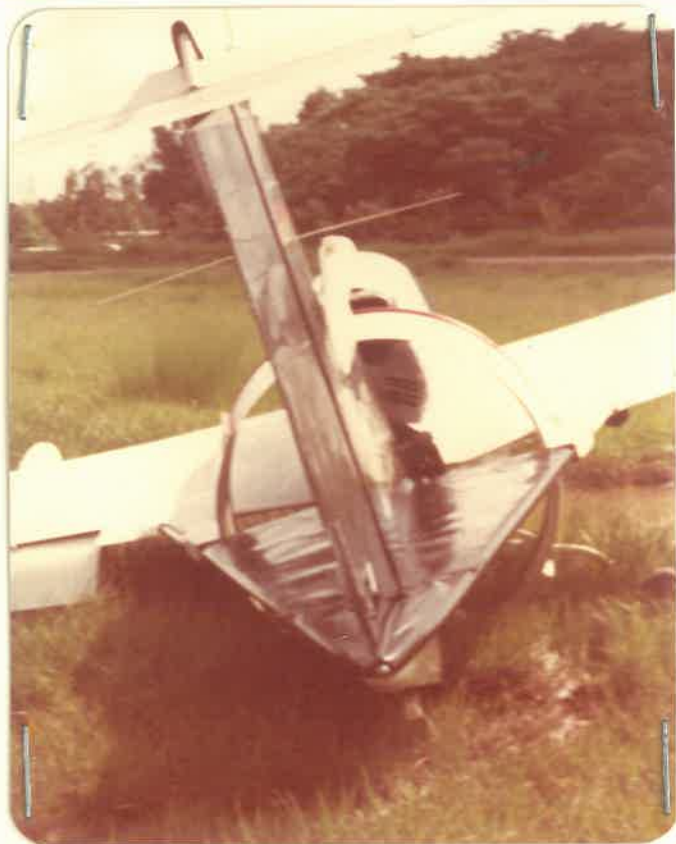
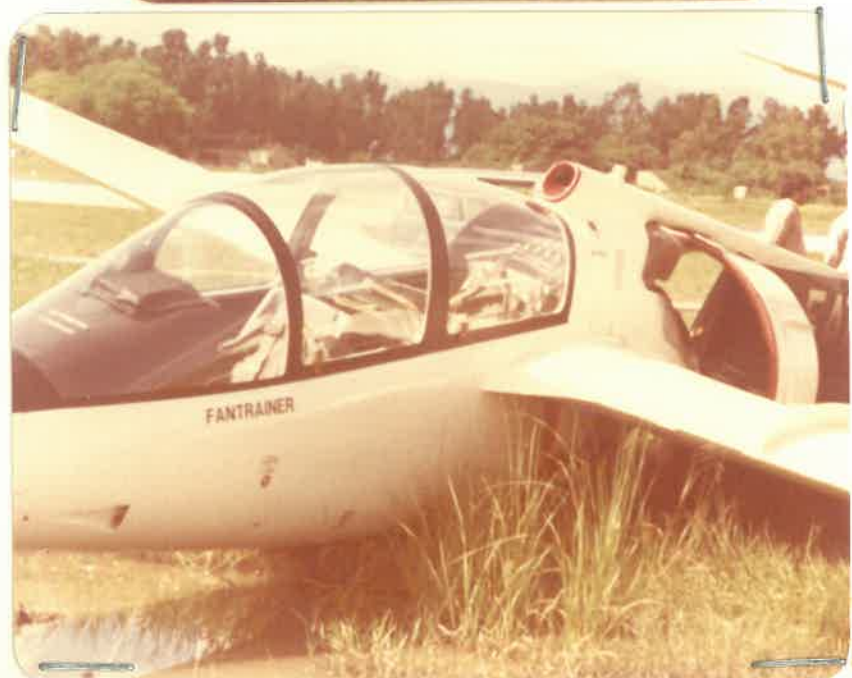
VARIOUS VIEWS OF CRASHED A/C

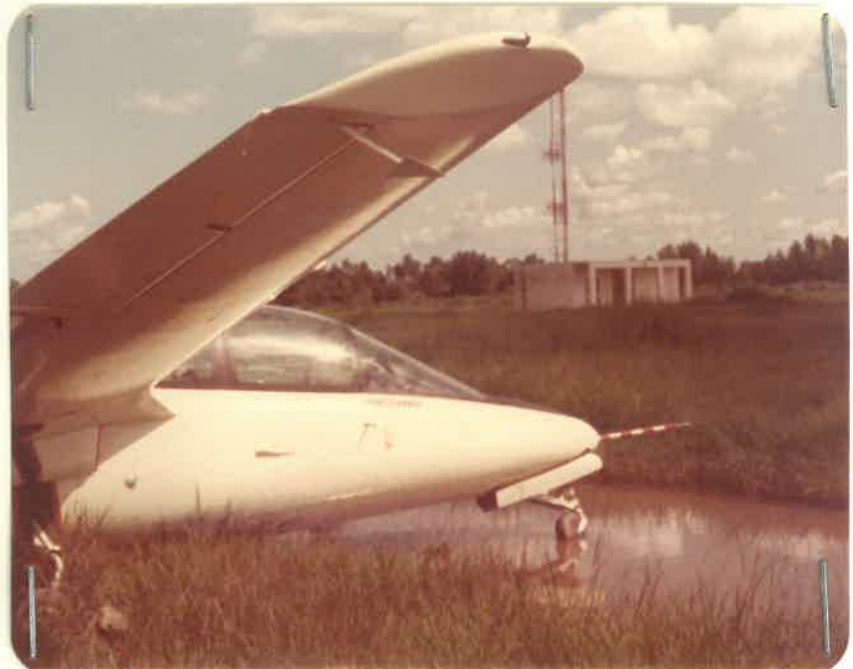
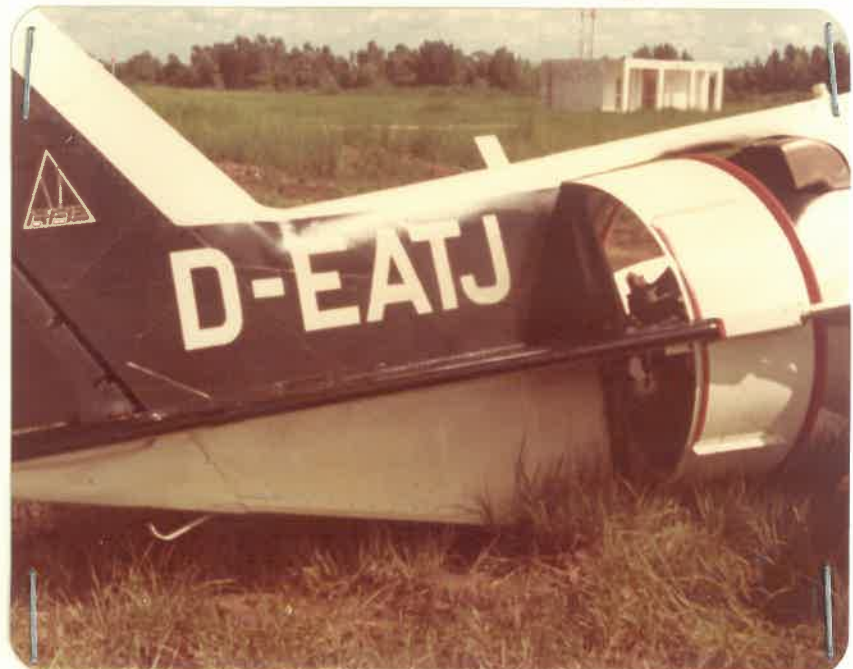
CRASHED  
A/C

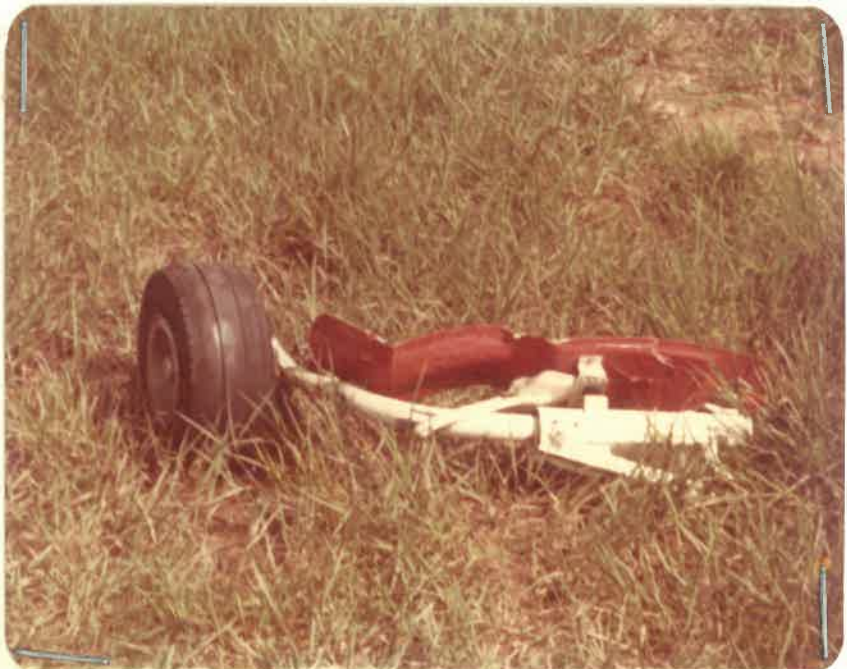
- 2-5 The left landing gear of the aircraft was entangled with the straps of the arresting barrier. This resulted in breaking of the left landing gear. After travelling for 300 yards on the runway the aircraft went to the left side of the runway on the fair weather strip and came to a stop near a pool of rain water (Appendix "A", "B", "D", "E" & "F"). The line dia-gram of the incident is shown as (Appendix "N") and photographs in (Appendix "P").

LEFT  
LANDING  
GEAR

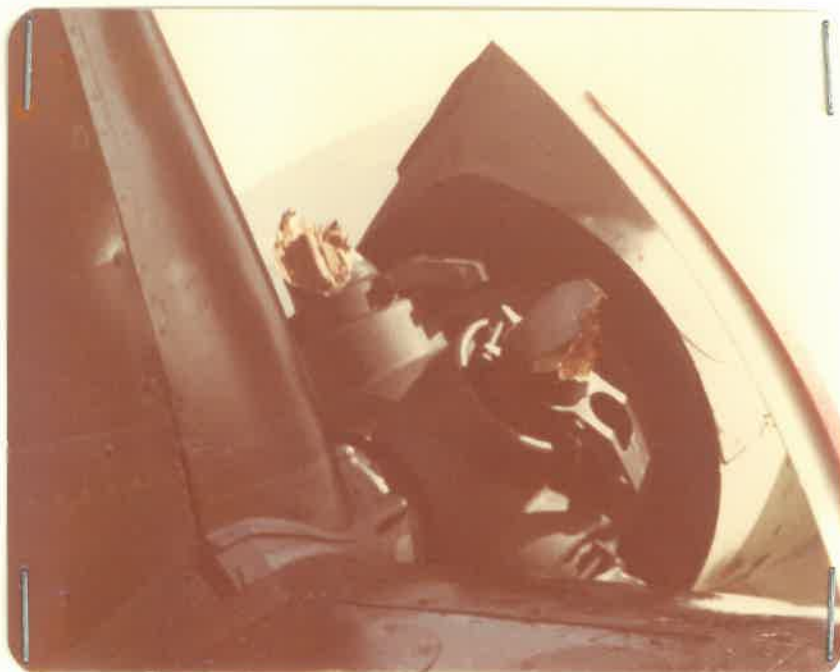
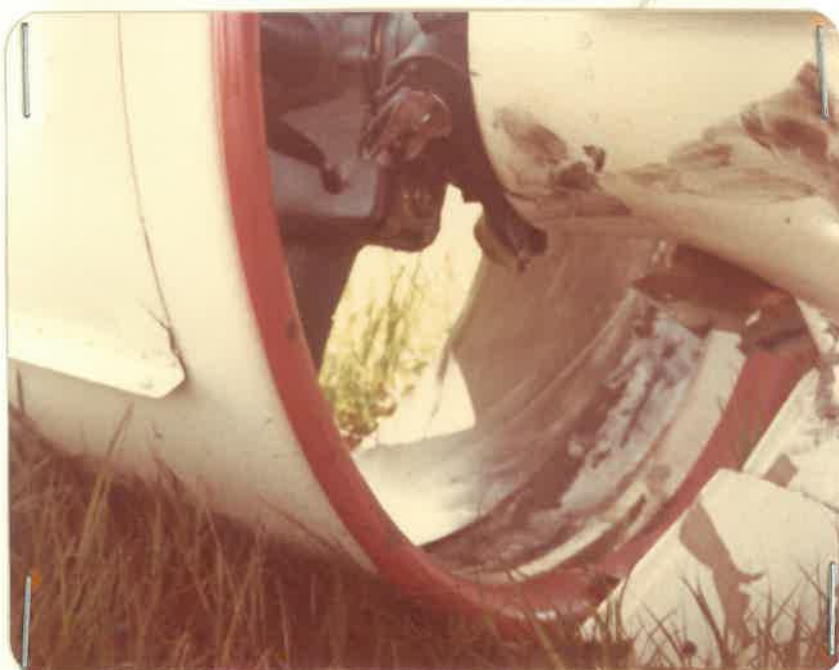
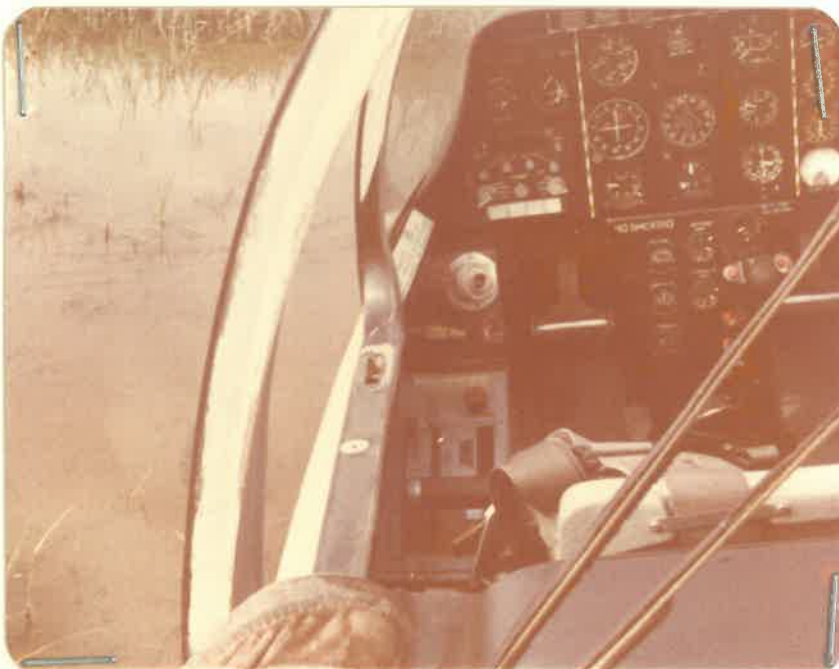
| 1-3 | <u>Damage to aircraft</u> | Left U/C broken, blades broken,<br>left wing and under surface damaged<br>(for details of damage see App. ) |

# VARIOUS VIEWS OF DAMAGED PARTS

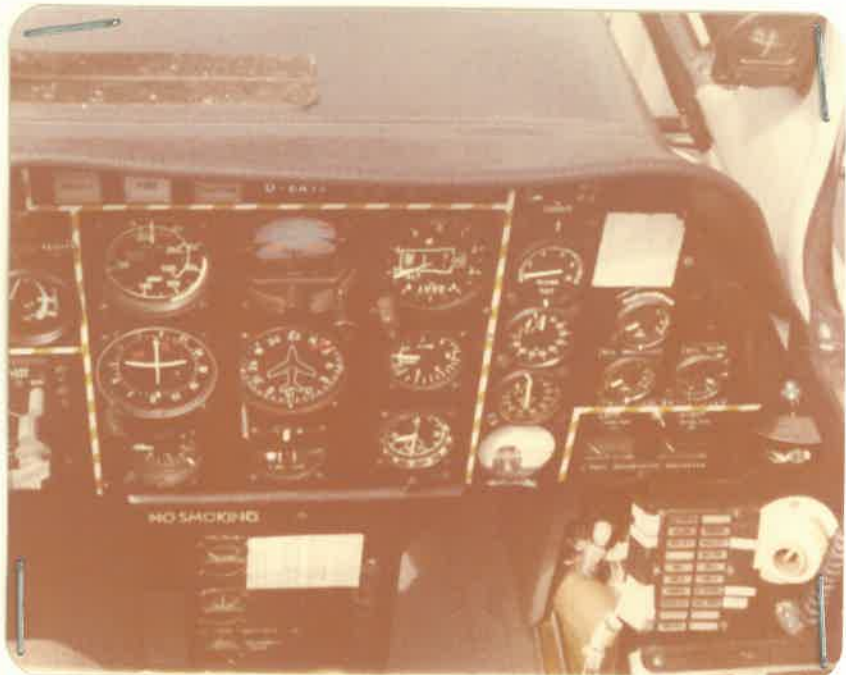
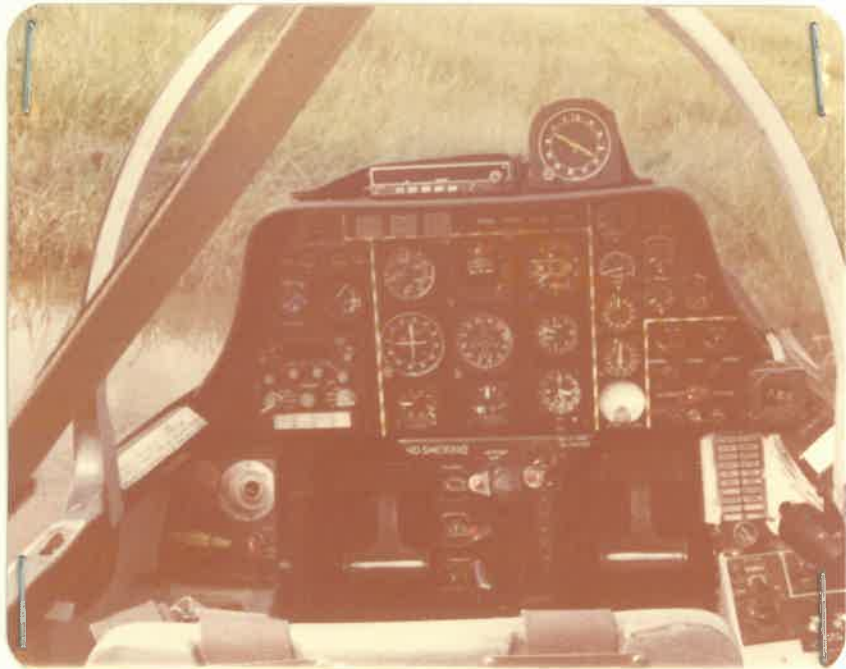
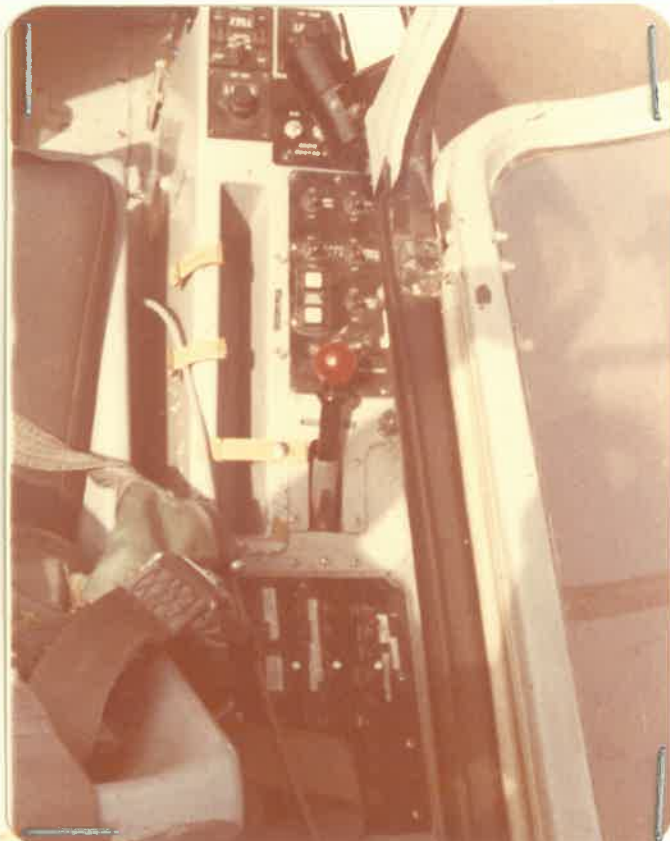
# DIFFERENT VIEWS OF INSTRUMENT PANEL
