**PAKISTAN CIVIL AVIATION AUTHORITY**  
**(SAFETY & INVESTIGATION BOARD)**

**ACCIDENT TO M/S MULTAN FLYING CLUB**  
**CESSNA – 150 AIRCRAFT**  
**REG # AP-BAS ON 01<sup>st</sup> SEPTEMBER 2012 AT**  
**MULTAN INTERNATIONAL AIRPORT, MULTAN**

## INVESTIGATION REPORT

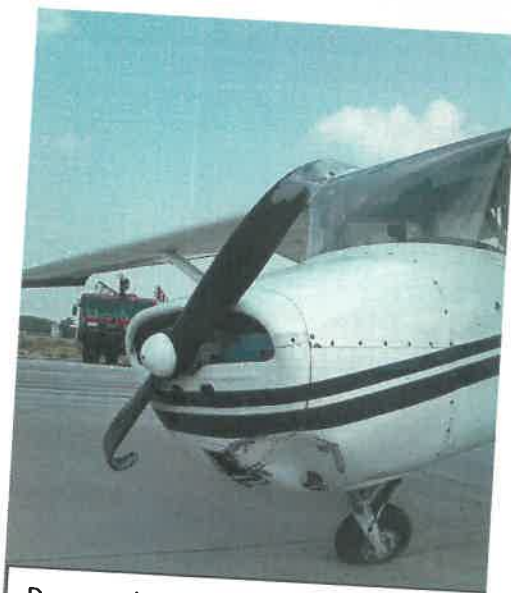
- 3.1.17 The Captain of aircraft incorrect inputs to control column aggravated the situation and resulted in touching of engine propeller along with both left and right wing tips with runway surface in addition to serious damages to landing gears and airframe / structure of aircraft.

Damaged Propeller and Nose area

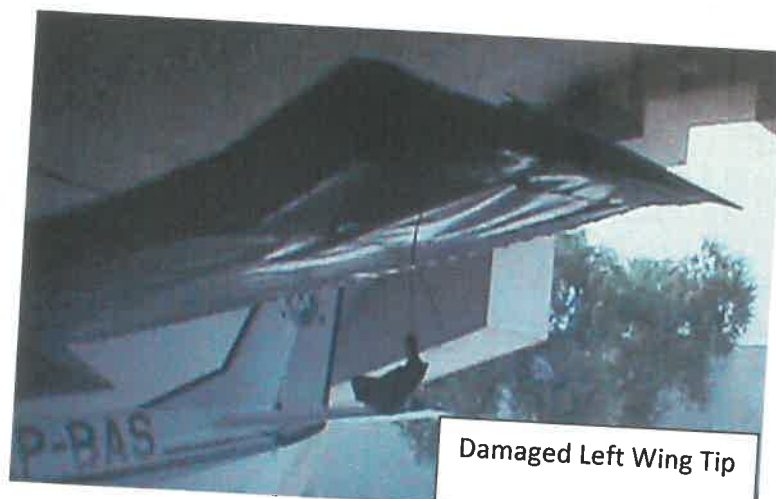
1.13 **Impact Information:** Aircraft touched down on its nose landing gear, damaging severely the nose landing gear. As a result of nose landing gear hitting the ground / runway surface first, the aircraft bounced and entered into porpoise. The aircraft experienced extreme uneven loading on landing gears which resulted in nose landing gear collapse along with extensive damage to main landing gears and buckling of fuselage behind main landing gears area . During porpoise, the left and right wing tips of the aircraft also came in contact with the ground / runway surface which resulted in damage to both the wing tips.

Damaged Left Wing Tip
