# **FINAL INVESTIGATION REPORT**

**SERIOUS INCIDENT (TCAS – RA) BETWEEN EMIRATES  
FLIGHT UAE600, BOEING 777-31H(ER) AIRCRAFT,  
REG. NO. A6-ENK (SECTOR OMDH TO OPRC) AND  
MILITARY AIRCRAFT ON 13-07-2018**

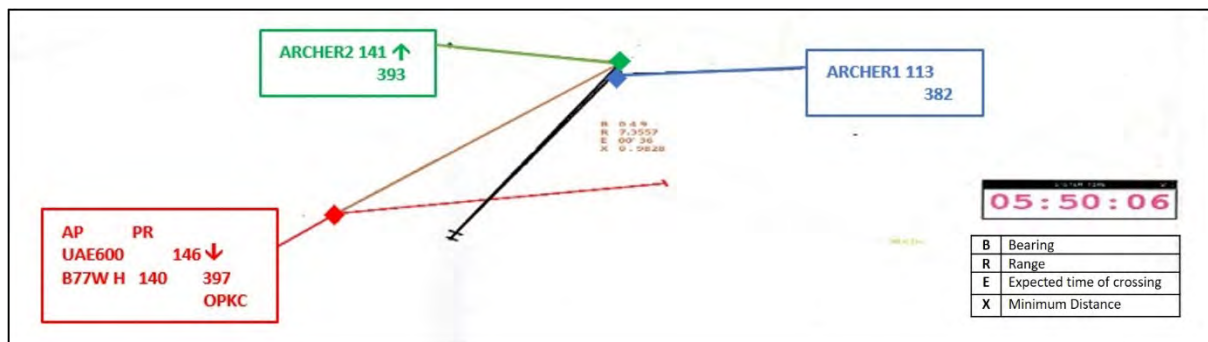
Figure 2 Presence of military traffic in climbing phase out of FL141

1.1.6. At 05:50:06 h, UAE600 reported traffic at 3 o'clock (which was actually 10 o'clock) just 200 ft below, upon which Approach Controller informed UAE600 about the Military traffic maintaining FL120, crossing from left to right.

2.1.5. At 05:50:06 h, UAE600 reported traffic at 3 o'clock (which was actually 10 o'clock) just 200 ft below, upon which Approach Controller informed UAE600 about the Military traffic maintaining FL120, crossing from left to right whereas Military traffic was passing through FL141 for higher although it was restricted to FL120.

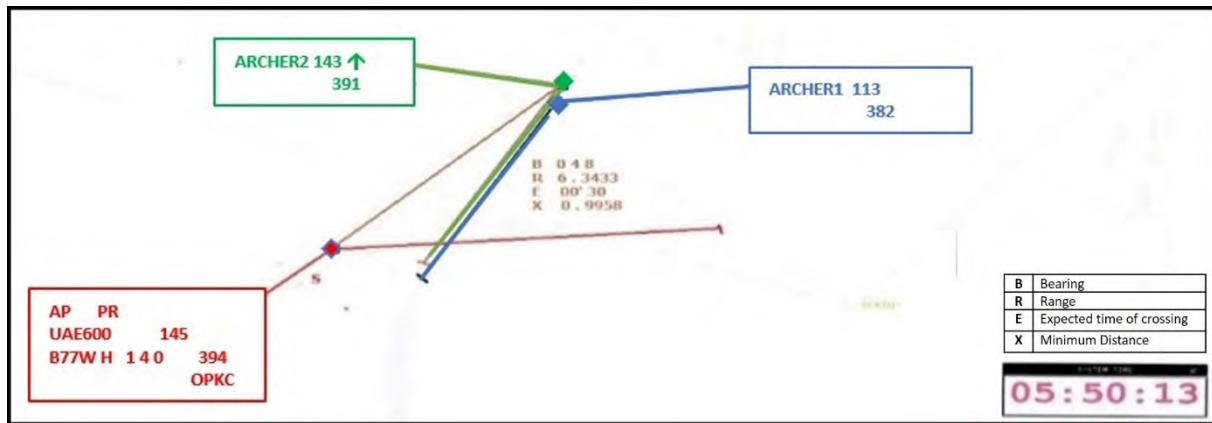
Figure 3 UAE600, reported TCAS – RA

1.1.7. At 05:50:17 h, UAE600, reported and initiated TCAS – RA climb.

1.1.11. At the time of incident, minimum vertical separation of 200 ft and lateral 6.3 NM existed between UAE600 and ARCHER-2 Military aircraft<sup>3</sup>.

<sup>3</sup> Refer Figure 3

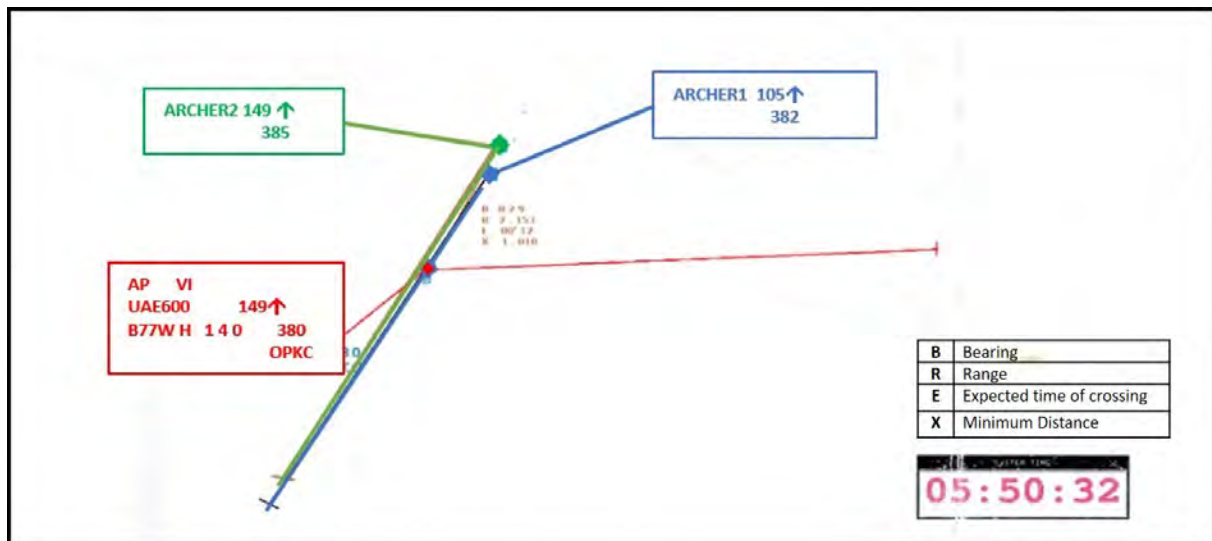
Figure 4 Traffic insight and clear of conflict

1.1.8. At 05:50:32 h, UAE600 informed “traffic insight and clear of conflict”.

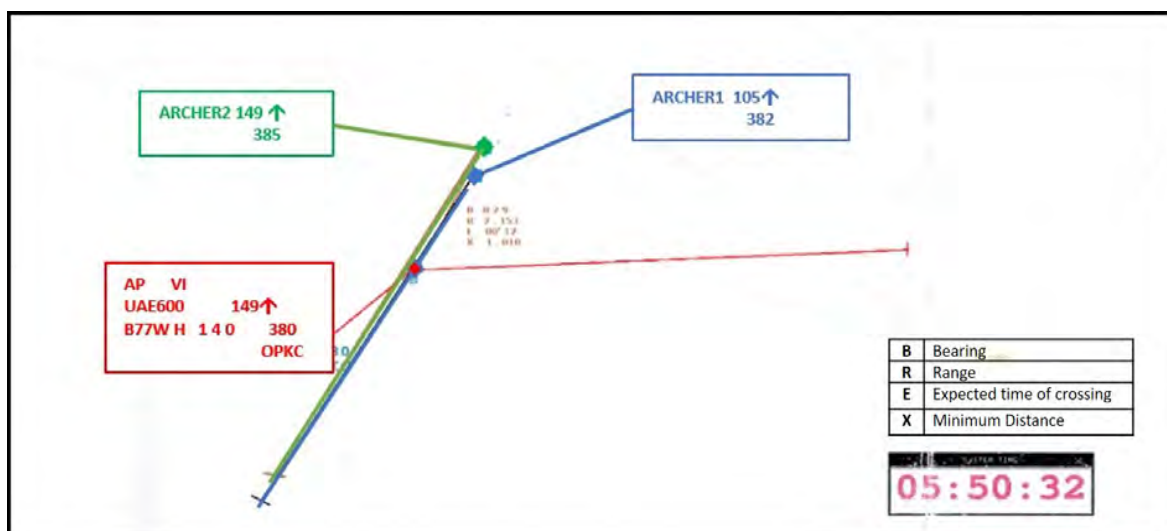
Figure 8 Traffic insight and clear of conflict

2.1.9. As per the available record, ARCHER-2 climbed to FL149 from FL133 while approaching close to UAE600 on a crossing track. UAE600 was also crossing FL 149 while initiating RA climb to higher level, which may have resulted in activation of TCAS – RA.

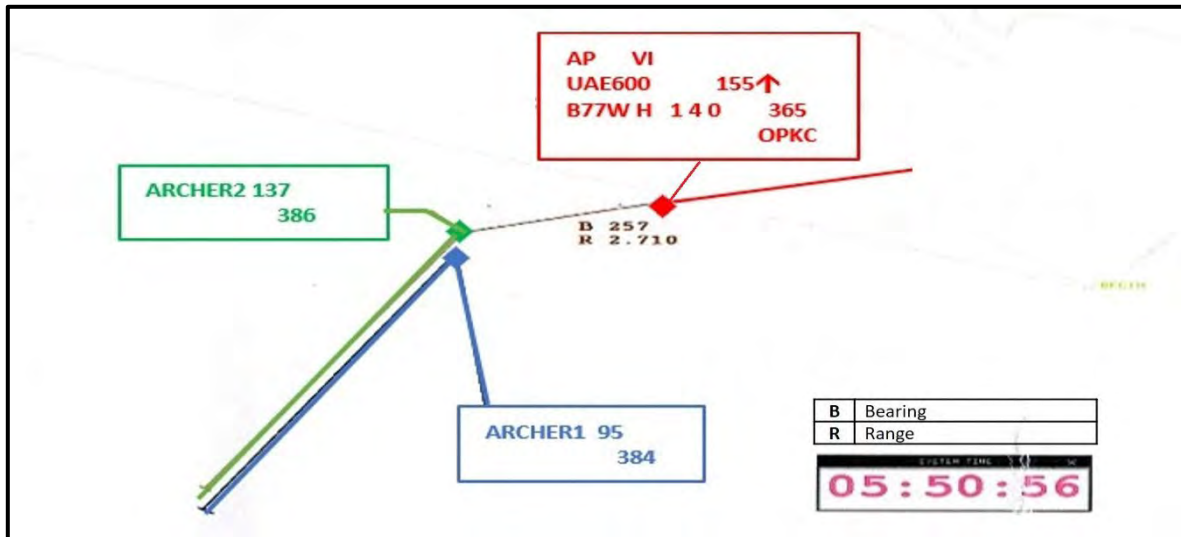
Figure 9 Climbed up to FL155 in response to TCAS – RA

2.1.10. UAE600 climbed up to FL155 in response to TCAS – RA.
