# **FINAL INVESTIGATION REPORT**

**SERIOUS INCIDENT OF M/S SHAHEEN AIR INTERNATIONAL**  
**NL-224 (SECTOR DXB – ISB) A320 AIRCRAFT, REG. NO.**  
**AP-BLK DATED 25-02-2018**

## FINAL REPORT

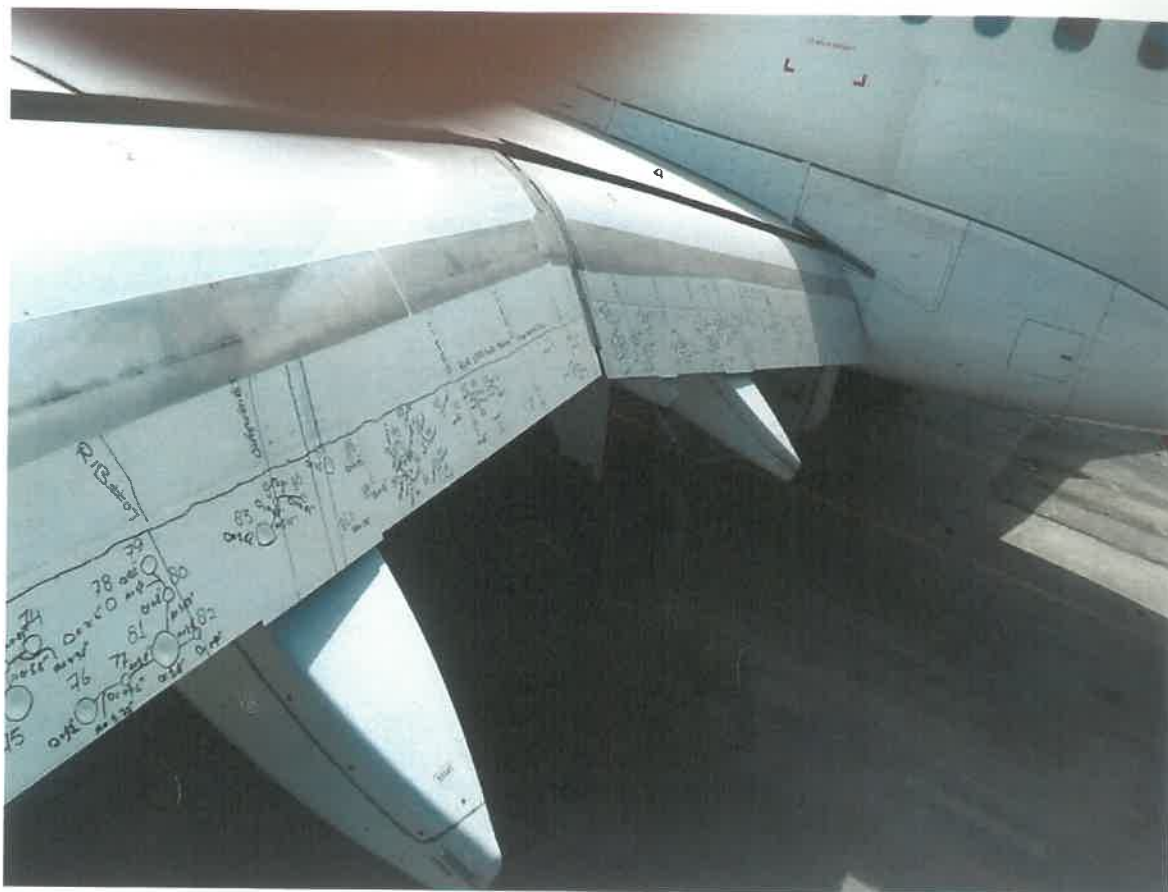
- 2.1.5 It was evident from the weather report that the aircraft was subjected to hail hits while aircraft was on ground and scheduled for flight NL-706 dated 24<sup>th</sup> February, 2018 (Medina – Islamabad).

- 2.1.12 After arrival of NL-224 dated 25<sup>th</sup> February, 2018, during Transit Check, following 674 dents were observed by M/s Shaheen Air International Maintenance Organization (SEAMS) at Islamabad and aircraft was grounded for maintenance. The majority of dents were detected on the upper surfaces i.e. Flaps, Wings, Horizontal Stabilizer

- 4.1 The Captain was physically present in the aircraft during Hailstorm, he should have called for Post Hailstorm checks and also an entry to this effect should have been in Tech Log.
- 4.2 The damage was detected after the 3<sup>rd</sup> flight which posed serious safety concerns for every subsequent flight of the aircraft in the same damaged state.

5.1 An advisory is to be issued by Flight Operations M/s SAI to all pilots regarding this incident/ finding and outcome of this investigation for better decision making.

5.2 Directorate of Flight Standards, PCAA may issue necessary instructions as deemed appropriate, while considering already existing procedures on the subject, for making aircrew responsible to conduct post hailstorm checks /inspections in such cases.
