**FINAL REPORT**

**SERIOUS INCIDENT OF M/S PIAC FLIGHT PK-352**  
**BOEING 737-300 AIRCRAFT, REG # AP-BEH ON**  
**20<sup>TH</sup> FEBRUARY, 2012 AT QIAP, QUETTA**

### INVESTIGATION INTO SERIOUS INCIDENT OF M/S PIAC FLIGHT PK-352 BOEING 737-300, REG # AP-BEH (SECTOR KHI – UET – ISB) AT QIAP, QUETTA ON 20<sup>TH</sup> FEBRUARY, 2012

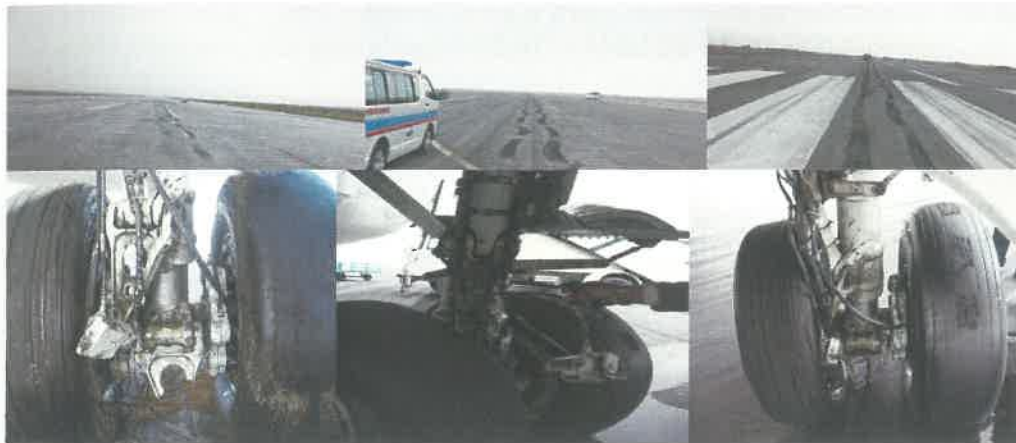
- 2.2.2.1 After the occurrence the survey of accident site was conducted on 22<sup>nd</sup> February, 2012 and all the evidences were preserved through digital photography. The pictorial view of the site is as follows:

2.2.5.5 A number of small metal pieces of shimmy damper and torsion links were found along with the marks of tyres on runway.

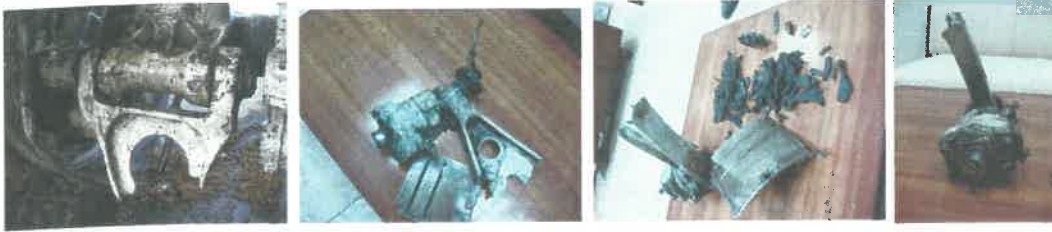
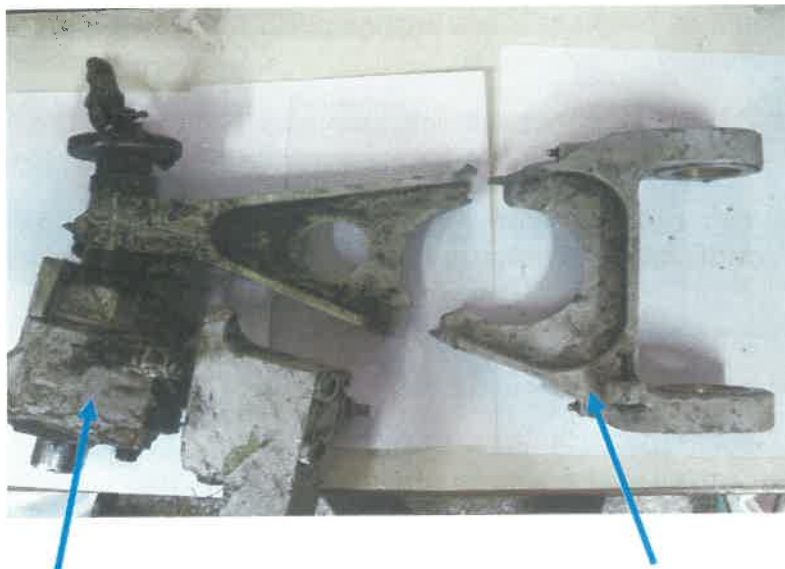
2.2.5.2 Torsion Links of left Main Landing Gear (MLG) and Shimmy Damper assembly were found broken. Upper Torsion Link P/N : 65-67963-3, Serial No. P02287 was found broken from the apex joint, and Lower Torsion Link P/N : 65-46102-21, Serial No. 4026 from its larger lightening hole.

2.2.5.3 Shimmy Damper, P/N : 65-44771-3, Serial No. P-926-92 was found damaged and Compensator was found separated from the Shimmy Damper.

2.2.5.6 Hydraulic hoses of Brake and Shimmy Damper assemblies were also found damaged, which were consequential to torsion links' breakage.

**Damper and Compensator**

**Lower Torsion Link**

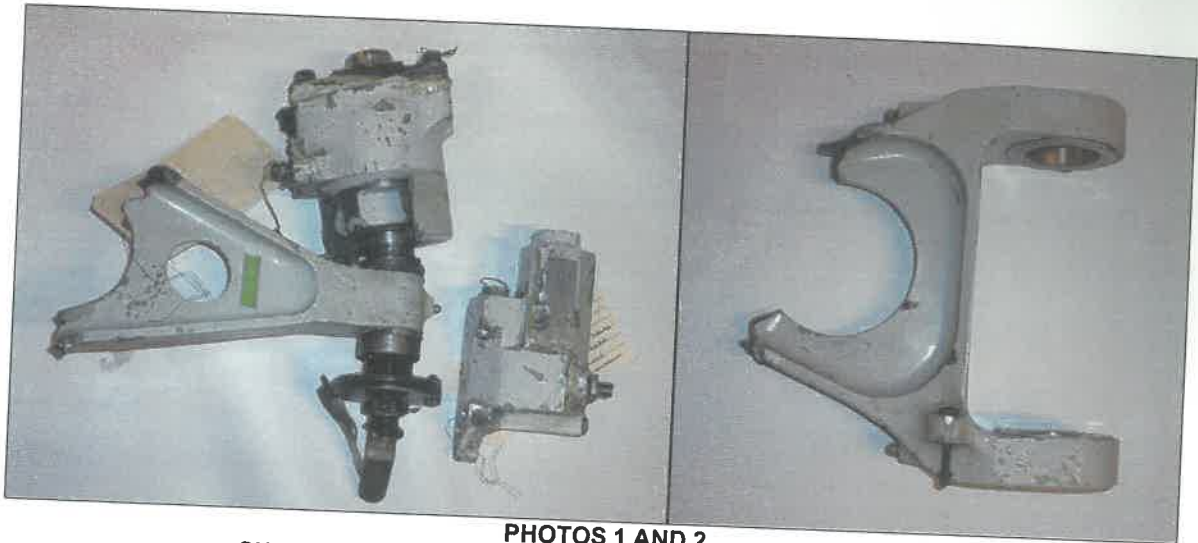
- 3.2.4 Both the spherical bushings installed at the apex joint of the lower torsion link were fractured. The grease on fractured surfaces suggested that they might have been damaged prior to the event.

- 3.2.5 The piston and thrust washers exhibited excessive wear.
- 3.2.6 The most likely cause of torsion links breakage has been determined to be excessive play at the apex joint.

**PHOTOS 1 AND 2**  
**SHIMMY DAMPER AND LOWER TORSION LINK - AS RECEIVED**

- 6.1 All operators are to ensure that apex joints on Boeing 737-CL airplanes are carefully maintained as per the Maintenance Planning Document (MPD) item B32-11-00-6C-1/-2.

- 6.2 All operators are to ensure that free play check of the torsion link apex joint is carried out on every 1C interval as per AMM 32-11-81/501 and all other in-service limits are checked as per AMM 32-11-51.

- 6.3 M/s PIAC engineering is to review, prescribe and implement the periodicity of disassembling the apex joint on Boeing 737-CL airplanes to examine wear of the spherical thrust washers, the damper piston and mating torsion link bushing.

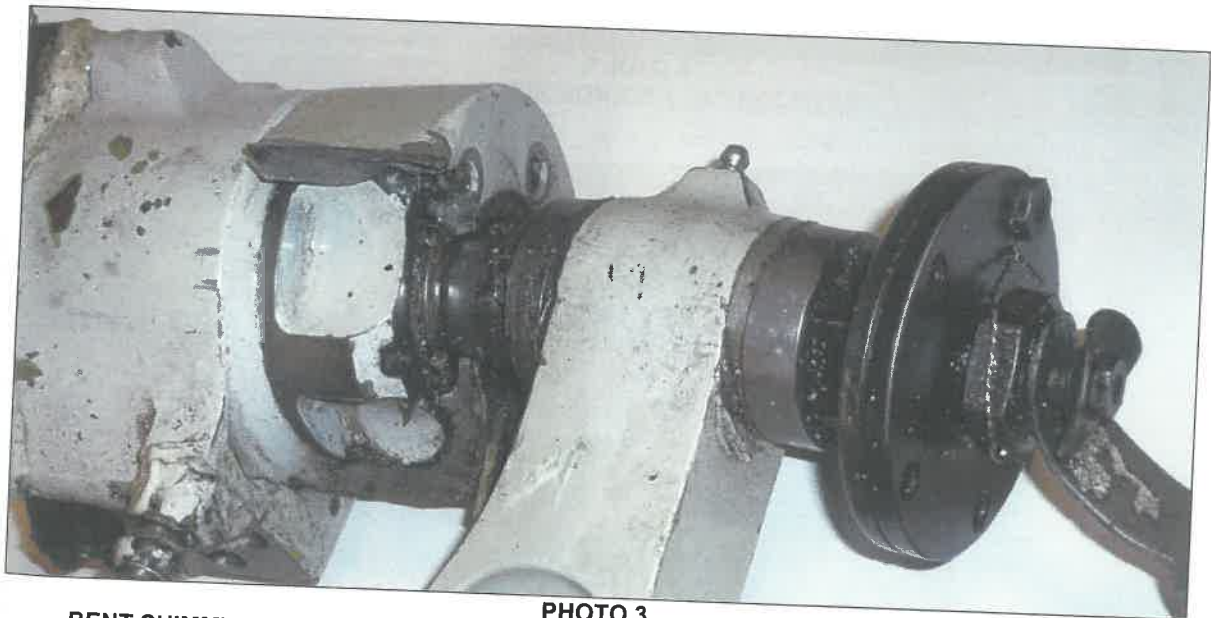
- 3.2.2 The broken torsion links and shimmy damper were examined and analysed by M/s Boeing.
- 3.2.3 Both links fractured as a result of ductile overload and not fatigue.

**PHOTO 3**  
**BENT SHIMMY DAMPER PISTON AND FRACTURED UPPER TORSION LINK - AS RECEIVED**

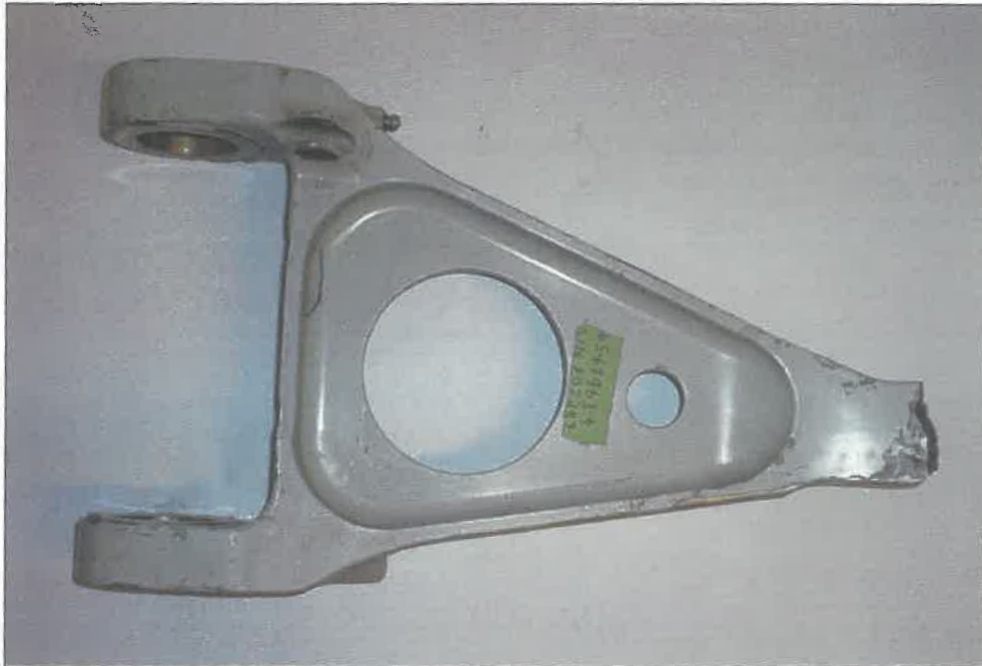
**PHOTO 4**  
**UPPER TORSION LINK - AS RECEIVED**

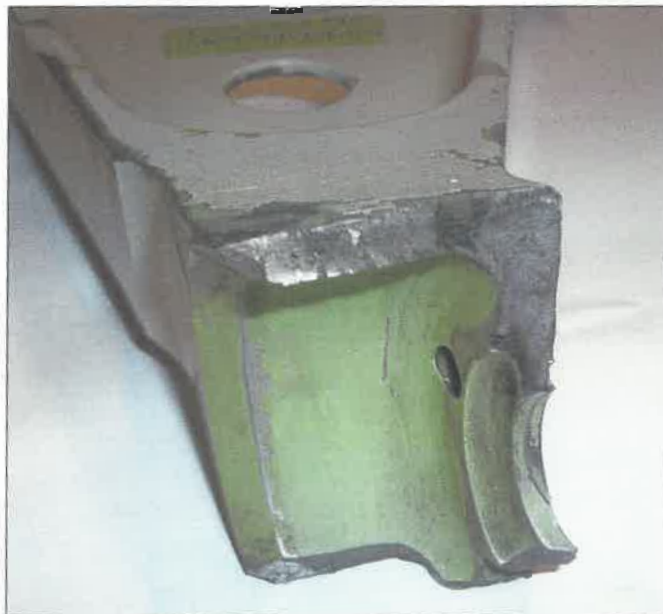
**PHOTO 5**  
**UPPER TORSION LINK - AS RECEIVED**
