## **FINAL INVESTIGATION REPORT**

**SERIOUS INCIDENT (SMOKE IN COCKPIT)  
PAKISTAN AVIATORS & AVIATION FLIGHT NST1  
GULFSTREAM G-200 AIRCRAFT REG NO. AP-NST  
AT ALLAP, LAHORE ON 31 MAY, 2022**

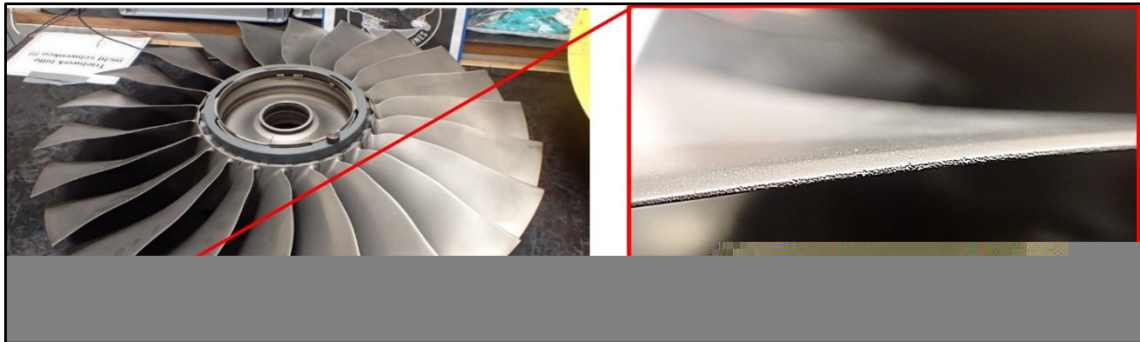
1.6.6.1. **Fan of Low Pressure (LP) Rotor Balancing Assembly** - Minor erosion and nicks were found at blade leading edges.

Figure 1 LP Rotor Balancing Assembly (Fan) and Erosion on Fan Edges

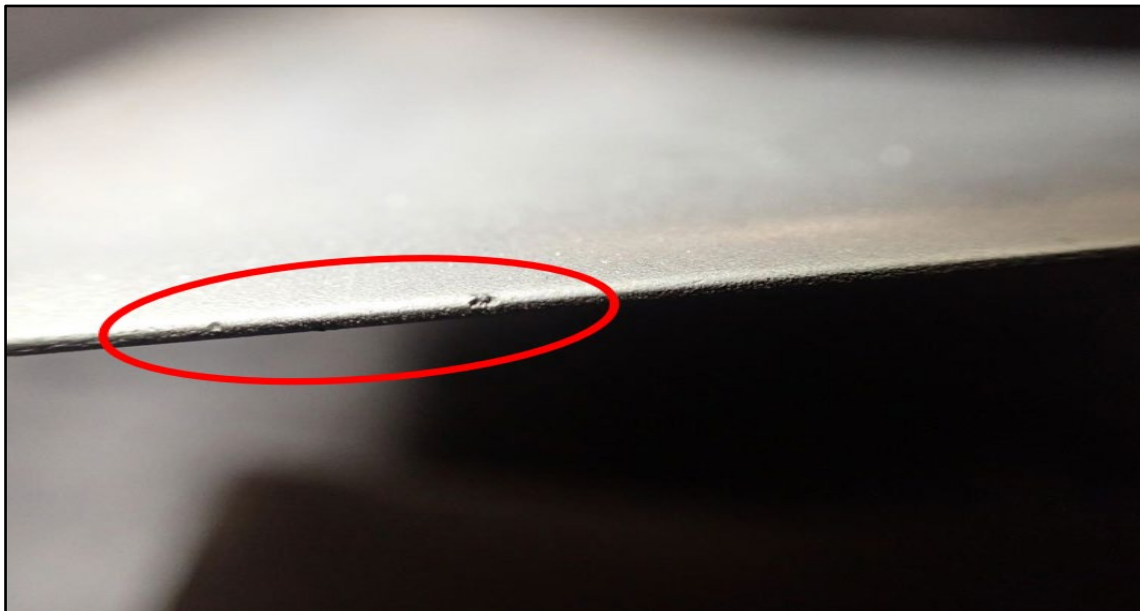
Figure 2 Nick Marks on LP Rotor Balancing Assembly (Fan)

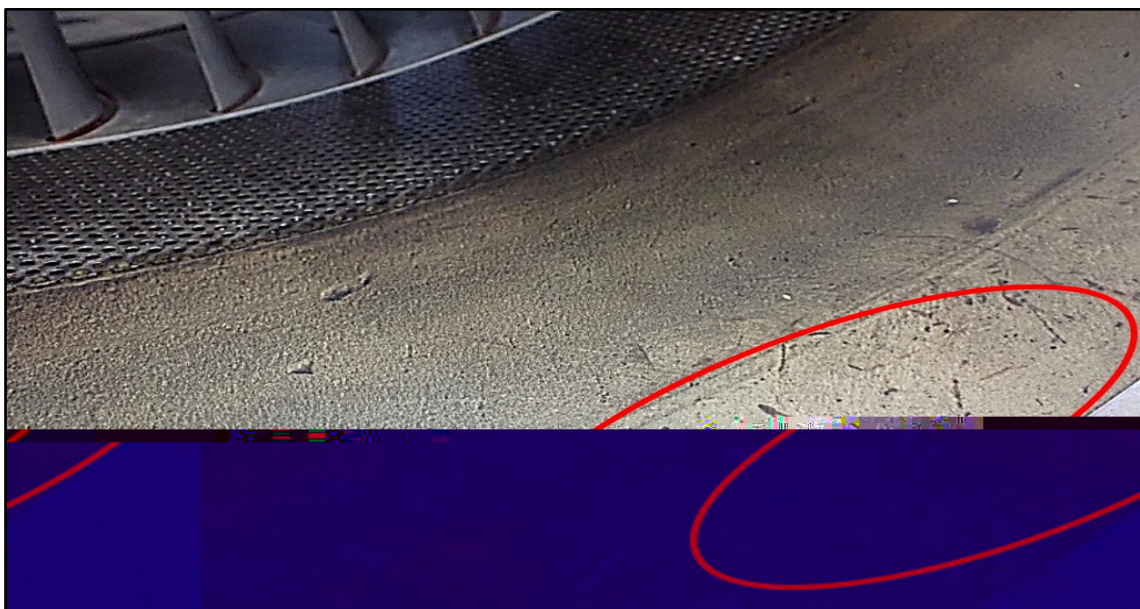
1.6.6.2. **Fan Case Assembly**- Deterioration of abradable coating was found.

Figure 3 Scratch marks on Fan Case Assembly

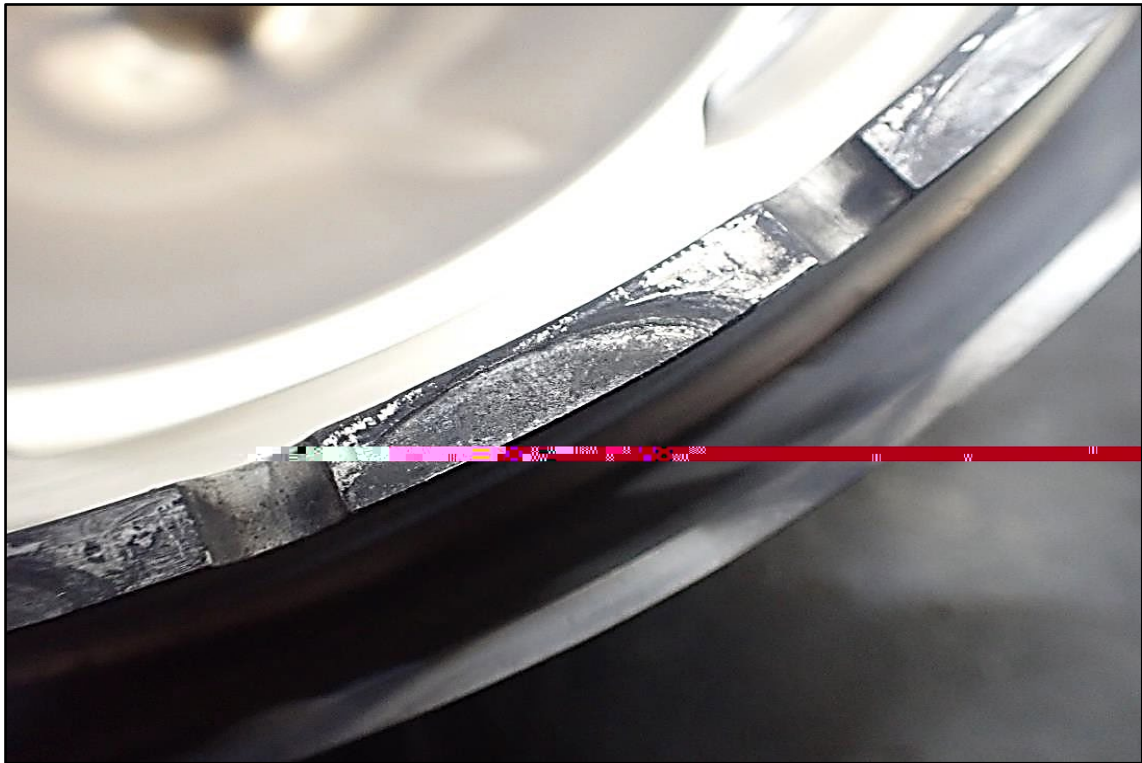
Figure 4 Compressor Inlet Cone

- 1.6.6.3. **Compressor Inlet Cone** - Fretting wear at fan blade contact faces was found.

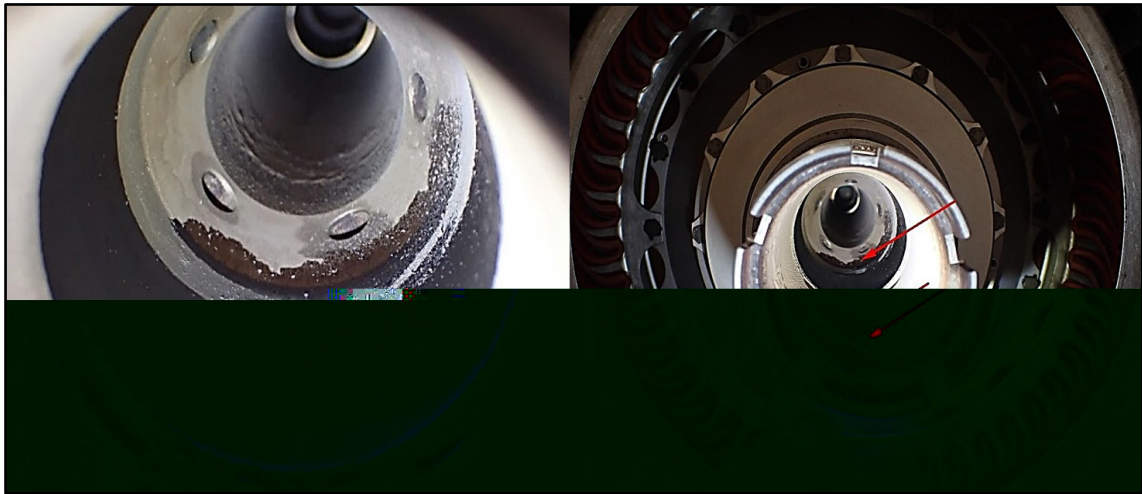
Figure 6 LC Shaft Assembly Rear and Front

1.6.6.5. **Low Compressor (LC) Shaft Assembly** – It was revealed during investigation inner cavity was oil wetted with sandy deposits.

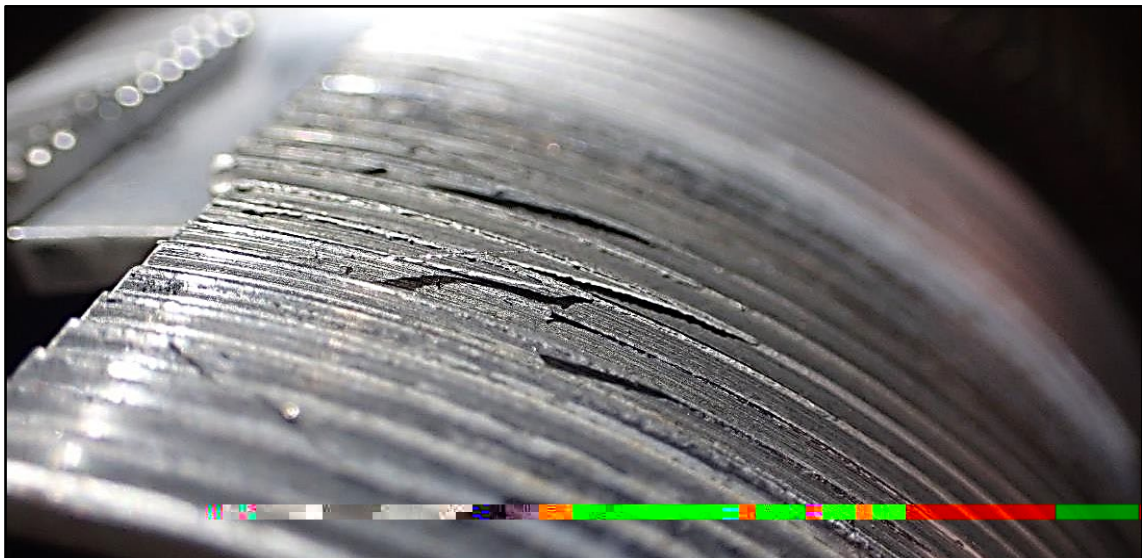
Figure 7 LC Shaft Assembly (close-up)

1.6.6.6. **LC Shaft Assembly** - Damaged threads were found.

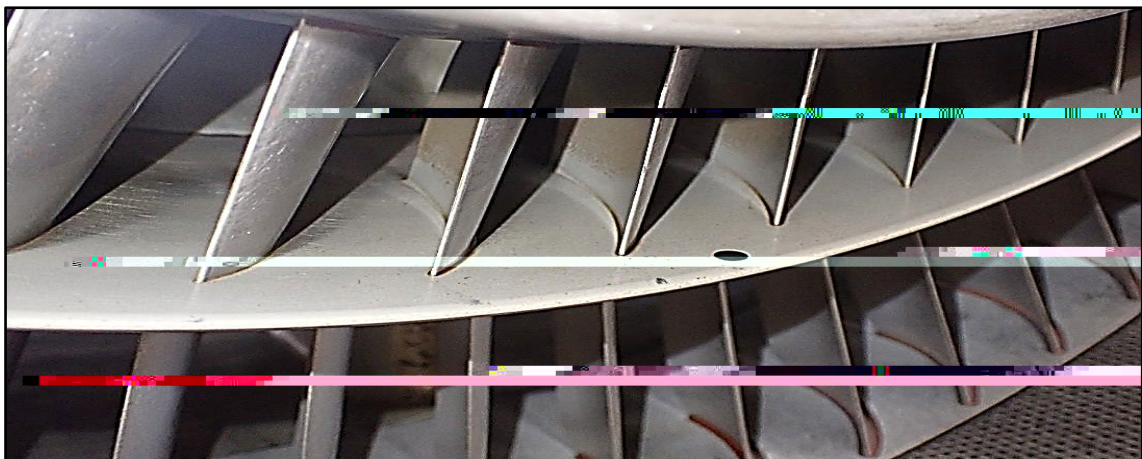
Figure 8 Compressor Inlet Vane Assembly

1.6.6.7. **Compressor Inlet Vane Assembly** - Oil wetted vanes were present.

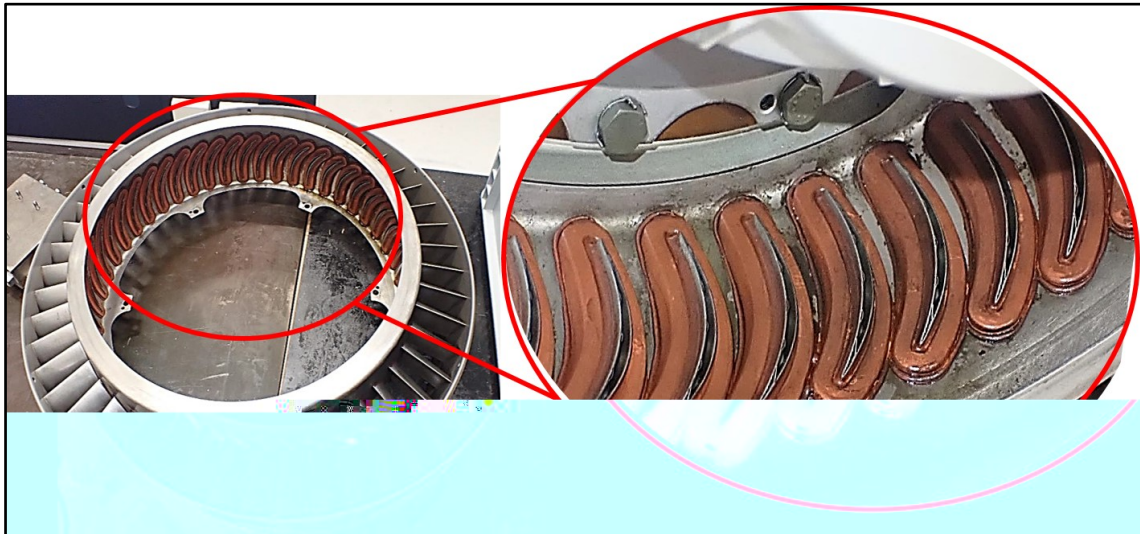
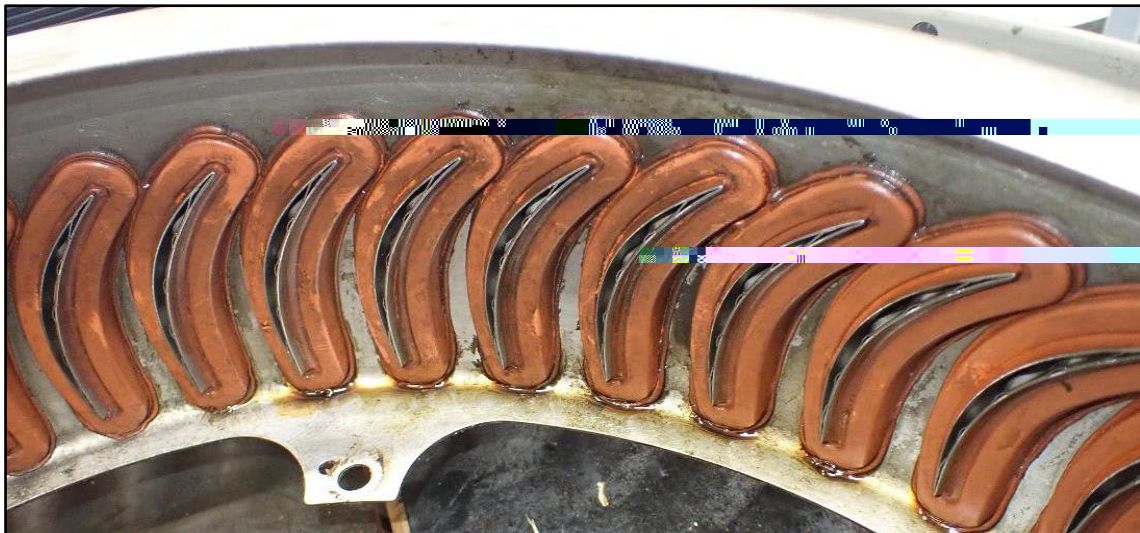
1.6.6.8. **Compressor Inlet Vane Assembly** - Inner shroud was found oil wetted.

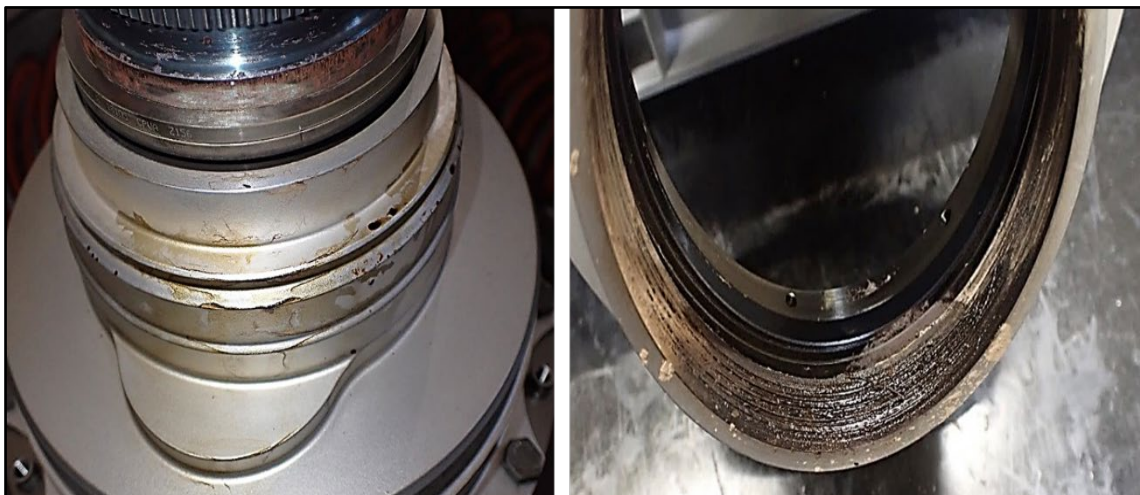
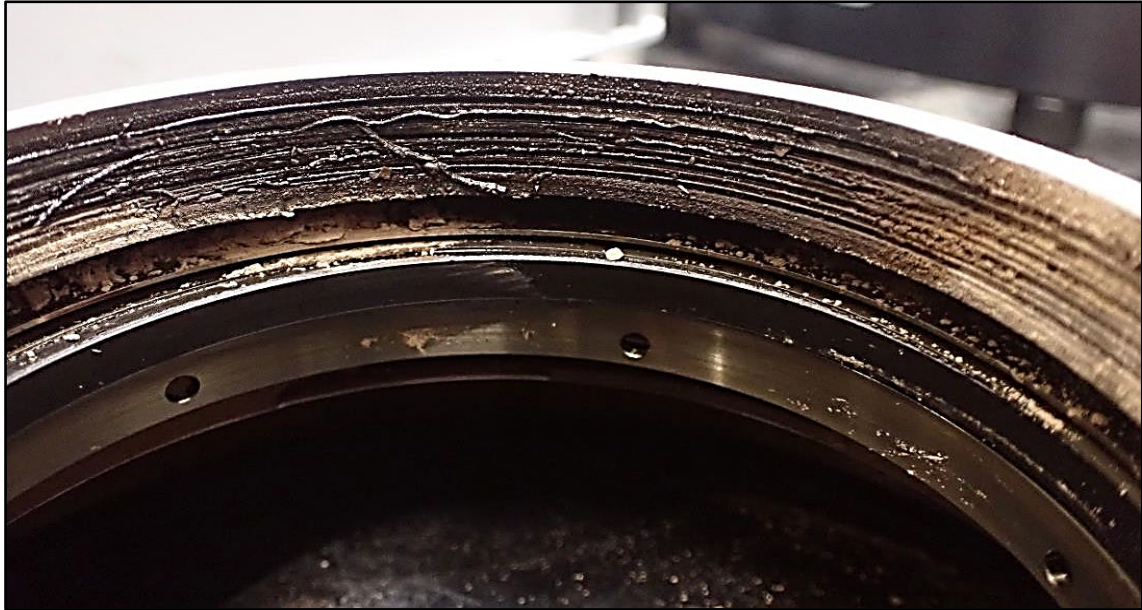
1.6.6.9. **Bearing No.1 Cover** - Signs of oil leakage was found.

3.1.1.5. Disassembly inspection revealed the main source of oil leakage from the No.1 bearing polymer seal. Additional oil staining was noted on various other mainline seals; however, the staining was not located at the sealing surfaces and is not believed to be a contributing factor in the event.

3.1.1.7. The smoke ingress into the cabin was a result of a worn / degraded No.1 bearing air / oil seal, which resulted from an ingress of abrasive particulate.

3.2.1.1. The premature wear of the No.1 bearing cover air / oil seal due to exposure to a severe dusty and polluted environment permitted ingress of oil into the gas path.

4.1.1.1. Review and revise the compressor wash interval policy to account for actual environmental operating conditions, including increased wash frequency or condition-based washing for aircraft operating in dusty or polluted routes.

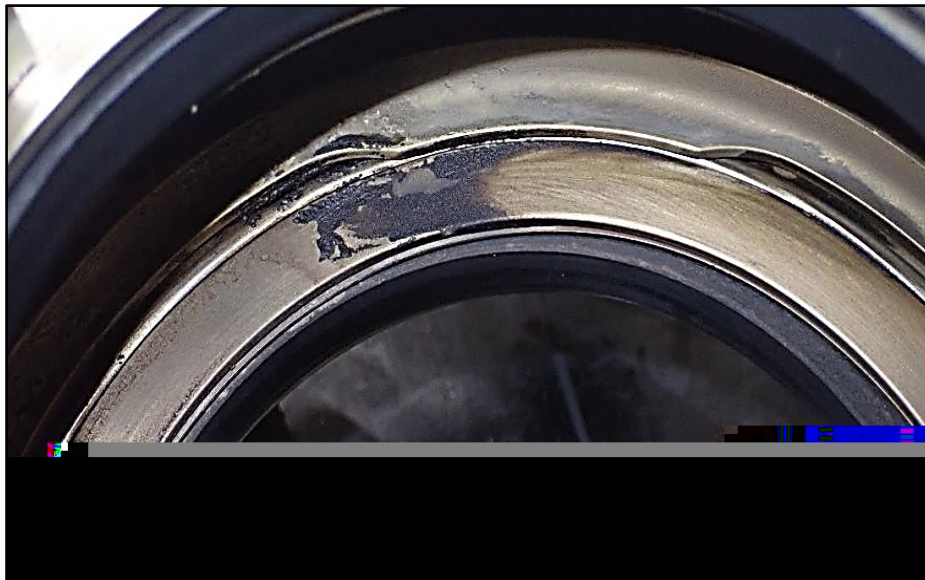
1.6.6.10. **Inter-shaft Seal Housing Assembly** - Sandy deposits, signs of oil staining were found.

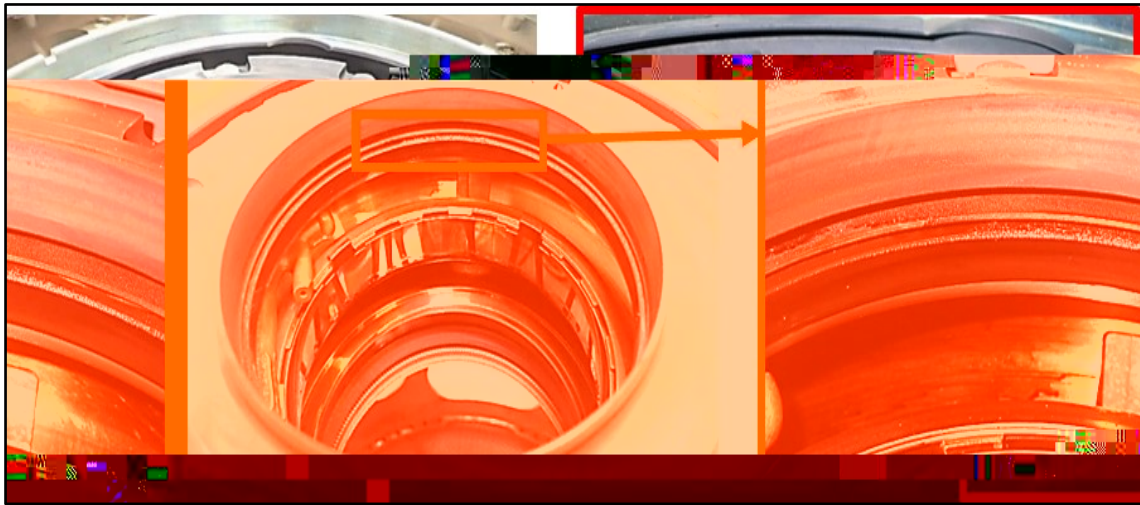
Figure 15 Bearing No.3 Rear Cover Installation

1.6.6.11. **No.3 Bearing Rear Cover Installation** - Oil carbon deposits, signs of oil staining were found.

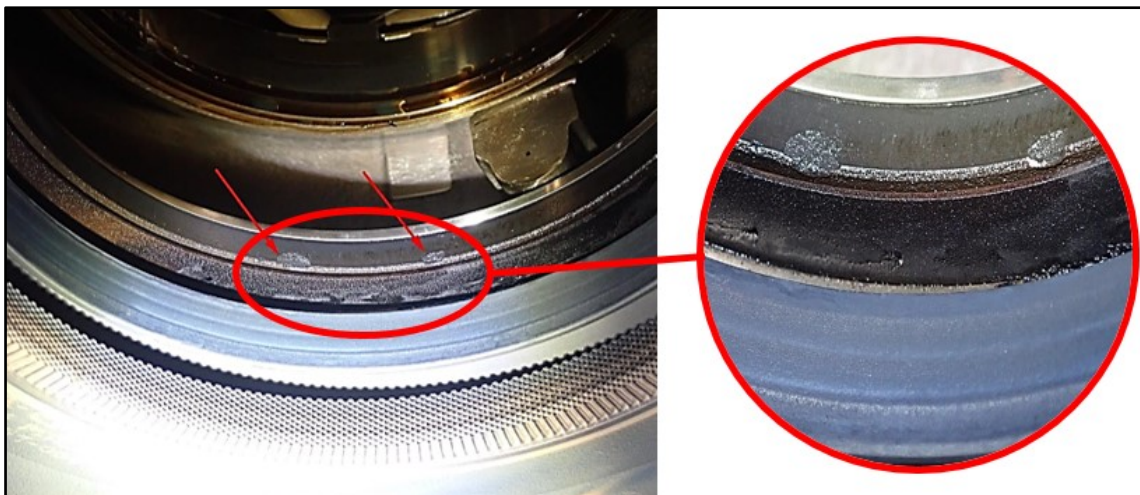
1.6.6.12. **Bearing No.3 Front Cover Installation** – Oil staining and chips on the edge of the front carbon seal element were found.

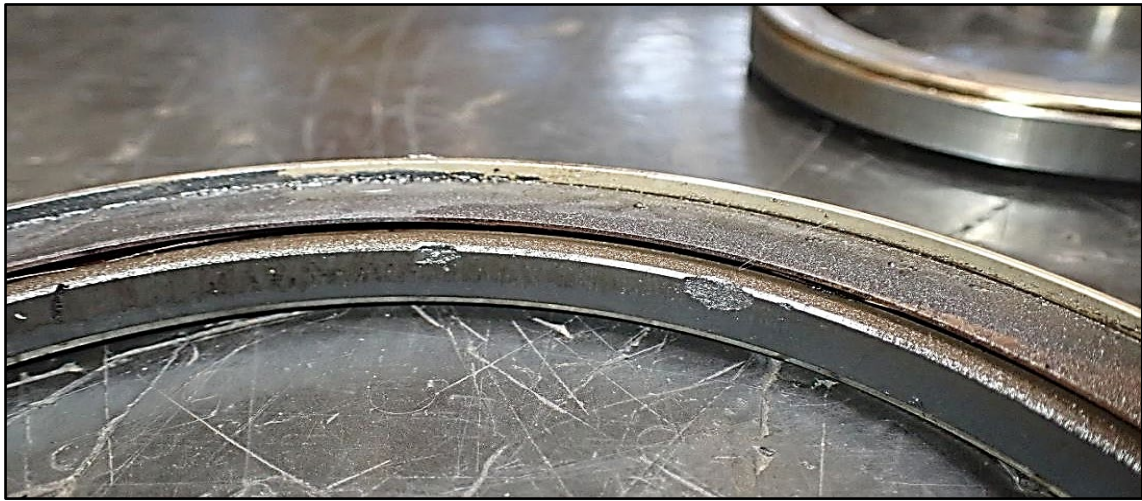
Figure 18 Bearing No.3 Front Carbon Seal

1.6.6.13. **Bearing No.3 Front Carbon Seal** - Staining and chips on the edge of the front carbon seal No.3 bearing carbon seal element were found.

1.6.7. Oil staining of varying severity was present on the inter-shaft and the No. 3 and No. 4 carbon seals. In addition, localized chipping was observed on the No. 3 bearing front carbon seal element. Inspection identified significant wear and deterioration of the No. 1 bearing cover polymer seal. This condition provided a plausible leakage path for oil migration into the gas path, leading to the smoke in cockpit scenario. The premature degradation of the No. 1 bearing cover polymer seal is assessed to be consistent with prolonged exposure to abrasive particulates, such as sand and pollution, which may have accelerated seal wear.

approximately 40 % of the sealing surface, thus the chips of the No. 3 front carbon seal and the staining observed on the known sealing surfaces of the carbon seals is not considered a contributor.

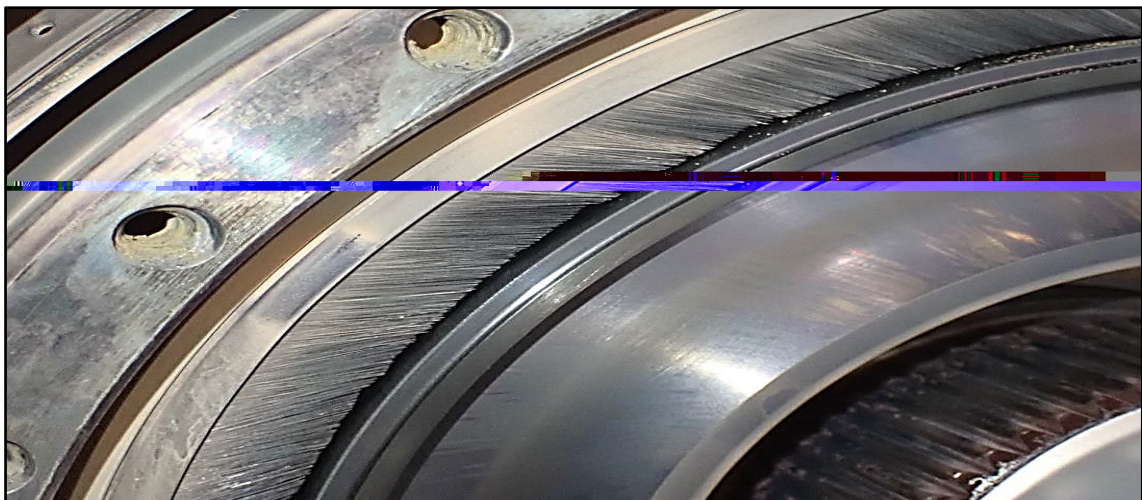
Figure 19 HP Turbine Air Seal (Large Brush Seal)

1.6.6.14. **High Pressure (HP) Turbine Air Seal (Large Brush Seal)** - Worn bristles was found.

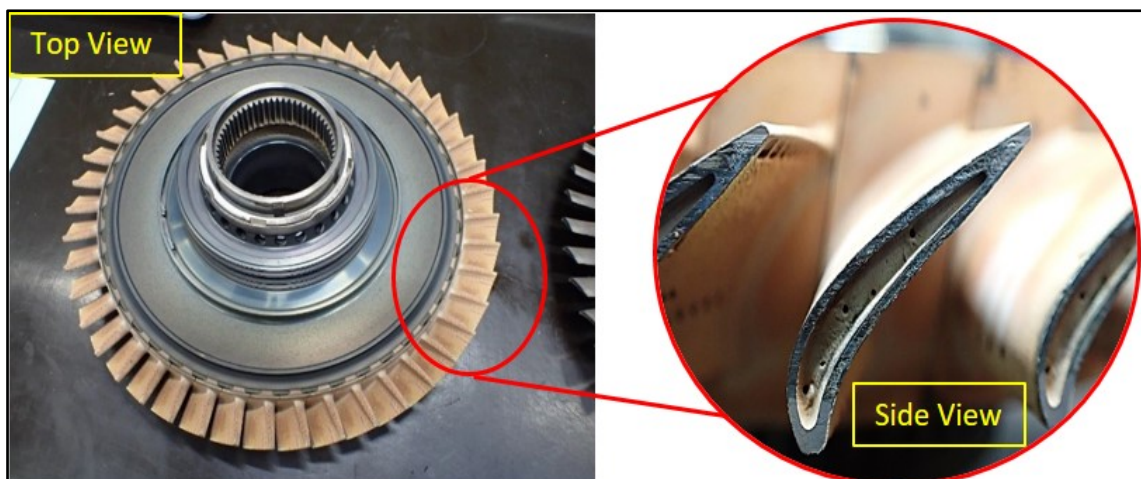
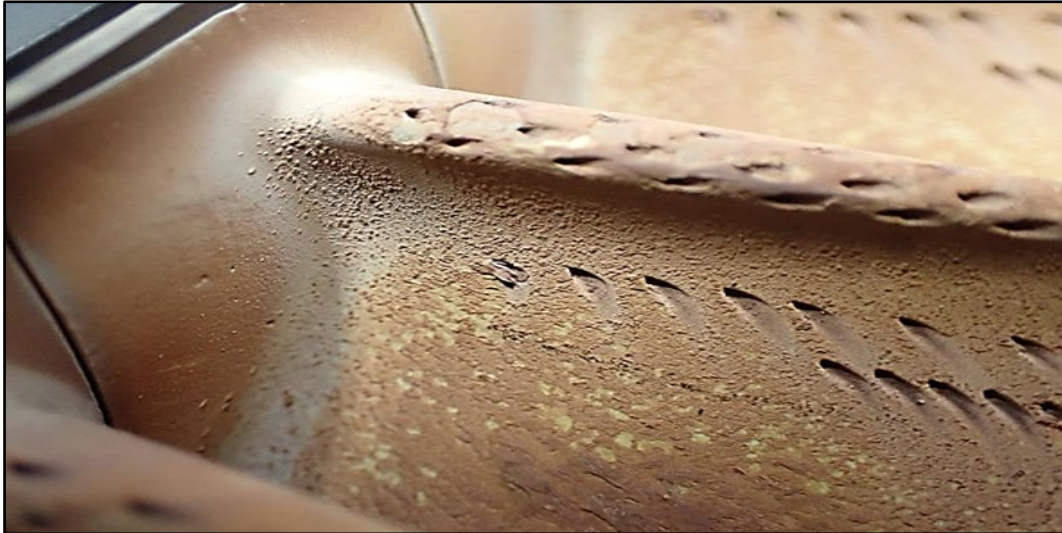
1.6.6.15. **1<sup>st</sup> Stage HP Turbine Disk Assembly** - Blade tip rubbing, sandy deposits and coating deterioration were found.

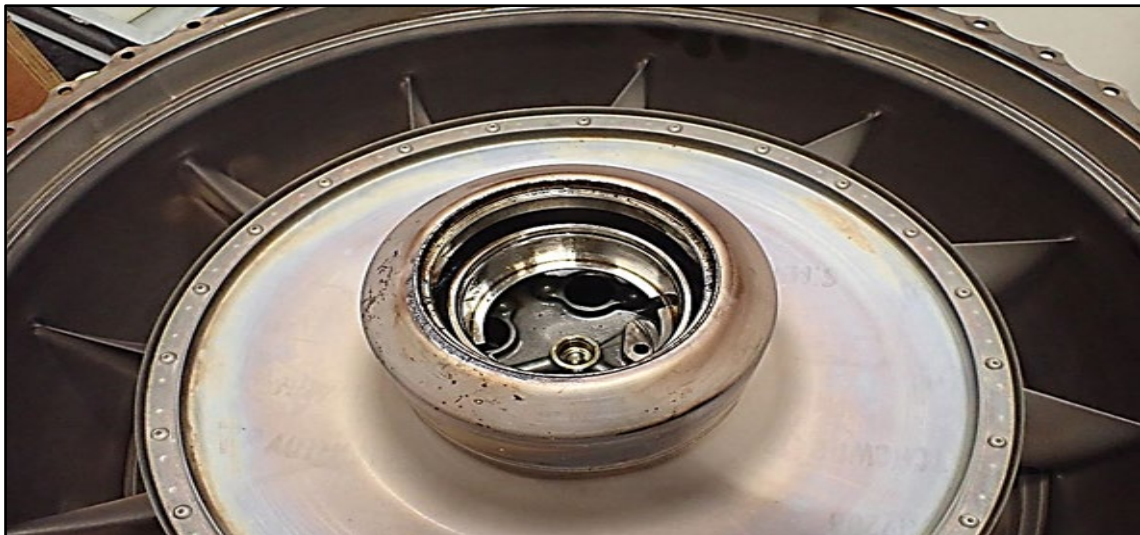
Figure 22 Turbine Exhaust Case Assembly

1.6.6.16. **Turbine Exhaust Case Assembly** - Signs of oil staining was found.

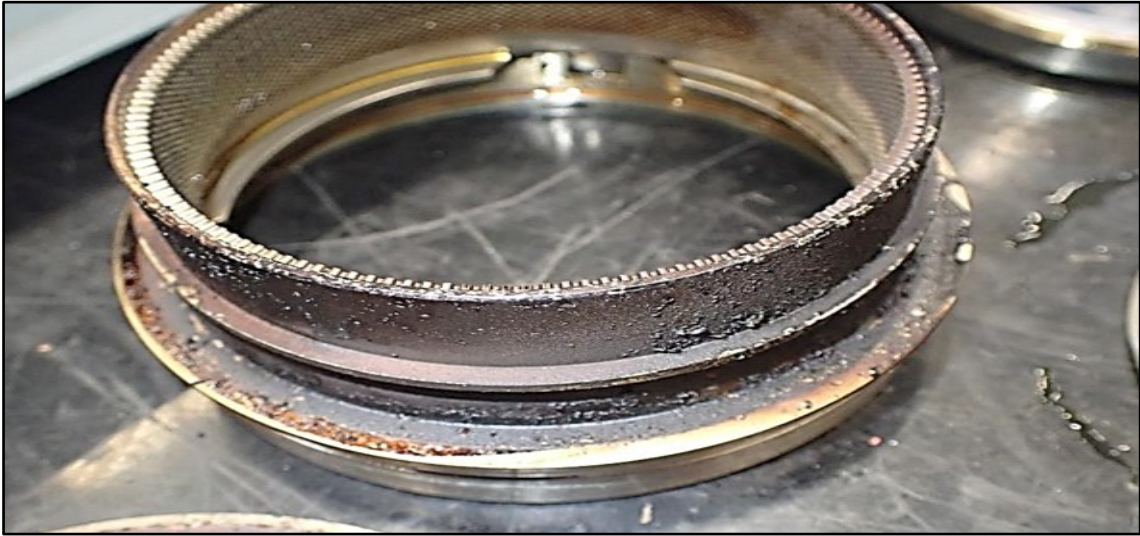
Figure 24 Bearing No.4 Carbon Seal

1.6.6.18. **Bearing No.4 Carbon Seal** - Cooked oil - signs of oil staining was found.

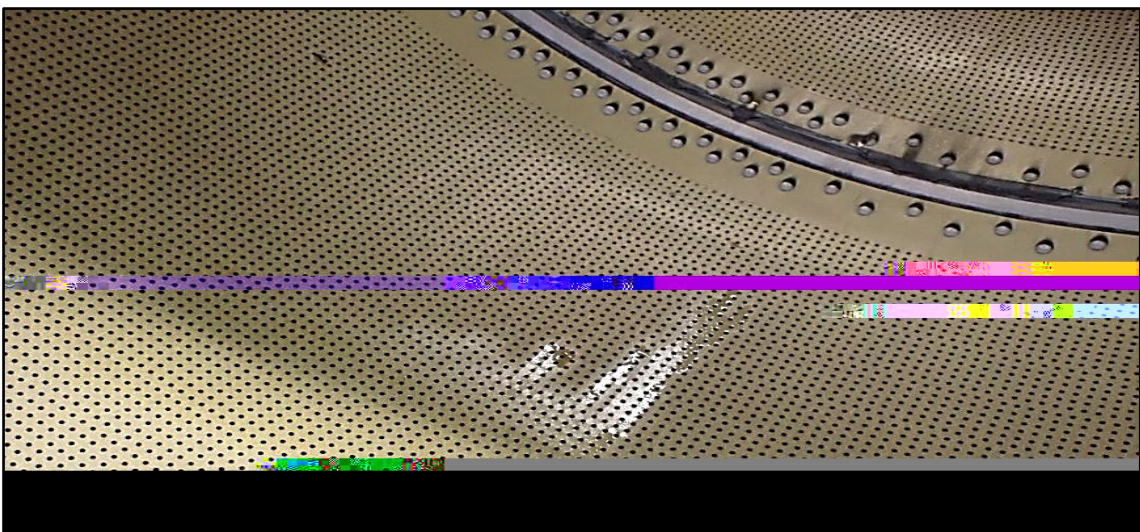
Figure 26 Rear Outer B/P Duct

1.6.6.20. **Rear Outer B/P Duct** - Rear Outer B/P Duct was found oil wetted.
