# FINAL INVESTIGATION REPORT

SERIOUS INCIDENT OF M/S PIAC FLIGHT PK-785 (ISB-LHR), B777-200ER  
AP-BGJ FIRE / SMOKE IN FWD GALLEY OVEN # 3 DATED 05<sup>TH</sup> APRIL, 2017

SERIOUS INCIDENT OF M/S PIAC FLIGHT PK-353 (PEW – KHI), B777-200ER  
AP-BGK HEAVY SMOKE / FIRE INSIDE OVEN AT POS: FW D#2  
DATED 23<sup>RD</sup> MAY, 2017

## FINAL REPORT

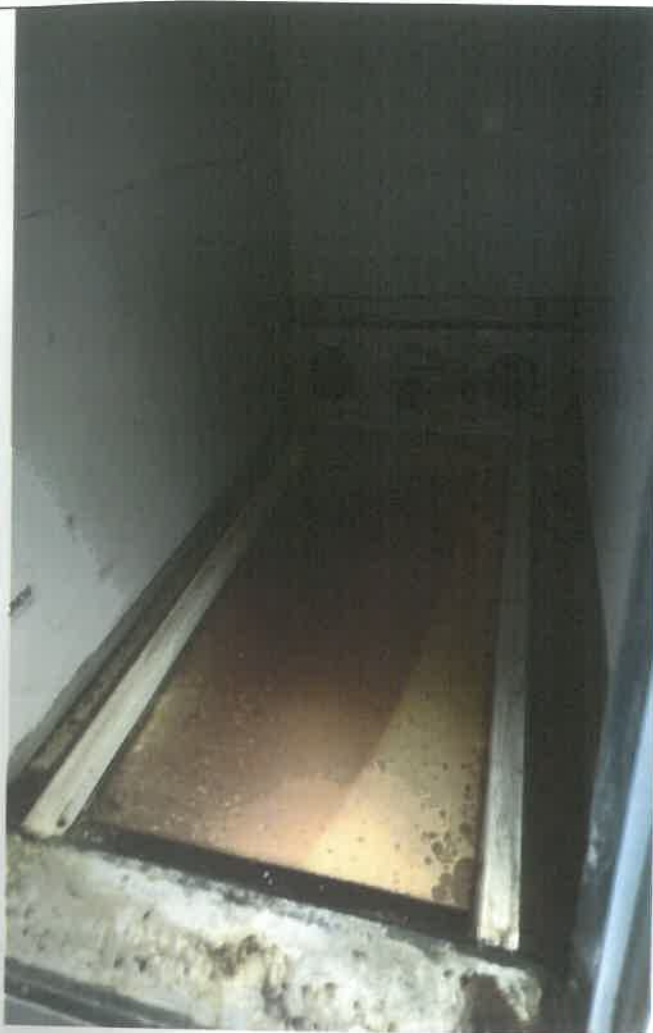
- 2.1. **Case-I (AP-BGJ, Oven S No. 06-02-0897 dated 05/04/2017).** Physical condition of the oven was found to be very dirty. On opening the door, the unit was found blackish with burnt edible oil. The Overheat protector was found not tripped and after powering it ON, heavy grinding noise was observed. Once its fan cover was removed, the fins of the Impeller fan were found broken and melted. No signs of rubbing found on the fan cover and the fan was rotating freely by hand.

- 2.2.3. All the faults which were seen during the investigation make this oven Beyond Economical Repair (BER).
  - 2.2.4. The OEM concluded that the root cause for this occurrence was burnt food / grease inside the oven cavity caused by irregular cleaning and maintenance. The cleaning and maintenance intervals are given in the corresponding component maintenance manual CMM25-36-83 Rev.4.

A good quantity of remains of Edible Oil at bottom of removed Oven

- 4.1 Engineering Staff of all operators to be briefed to ensure that all onboard Ovens are adequately cleaned as per already laid down procedures in true letter and spirit.

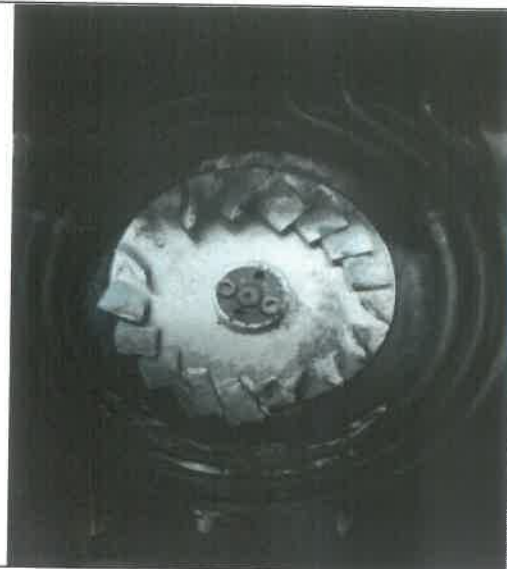
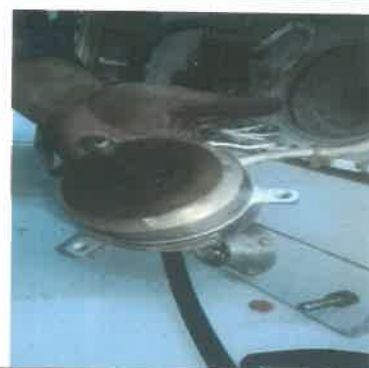
Damaged Fins of the Impeller

- 3.1.1 The Oven pertaining to the Case-I was declared beyond economical repair by the OEM.
- 3.1.2 The OEM concluded that Oil splashes lead to the fire inside the oven which ultimately damaged the impeller fan.

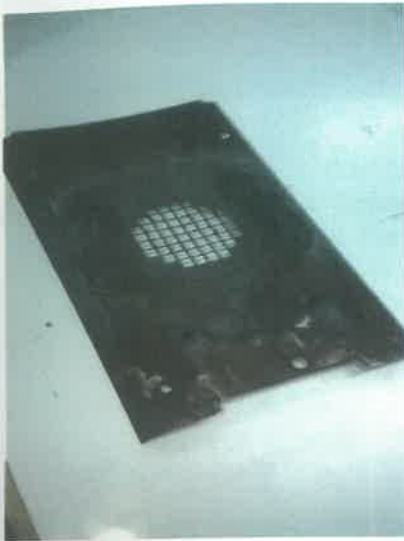
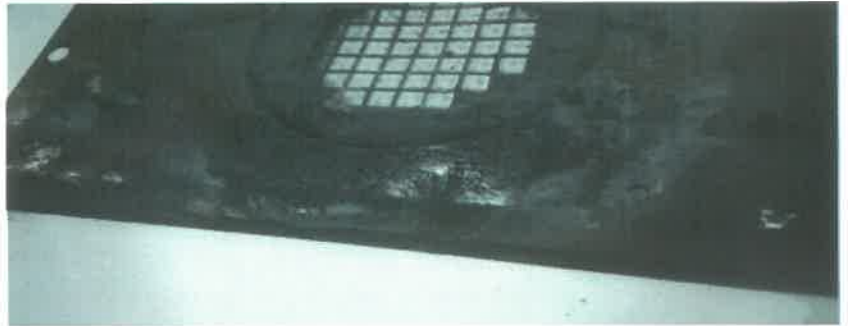
- 2.3. **Case-II (AP-BGK, Oven S No. 03-11-0258 dated 23/05/17).** The oven was taken to the Electrical Shop at M/s PIAC. Following are the details of technical investigation into this case:
- 2.3.1. The Overheat Protector (OHEA) light indicator was showing **"Over Heat"** on the Oven Control Module (OCM). After resetting the Overheat protector, the (OHEA) message disappeared.
  - 2.3.2. Door was opened for visual inspection. During visual inspection, clear signs of overheat / burnt marks observed inside the oven cavity.
  - 2.3.3. Then unit was operated on SELL (OEM) test bench where it was found operational with slight noise. All 03-modes of the operation were checked and found satisfactory.
  - 2.3.4. The Oven was then disassembled & inspected. The baffle plate was opened and oil deposits were found behind the baffle plate at 3'O & 9'O clock positions (as shown in the pictures

Baffle plate with clear sign of oil

- 3.1.4 In the Case-II, again heavy traces of oil were found inside the oven as well as behind its baffle plate. This indicated that the oven was never subjected to prescribed cleaning procedure for quite some time.

- 4.2 The Engineering department of M/s PIAC should devise a one-time campaign for the cleaning of ovens cavity & inspection / installation of damaged door seals. As a long term preventive plan, the Engineering department to plan & implement a schedule program for an overhaul cleaning of the ovens cavities in accordance with recommendations of OEM.

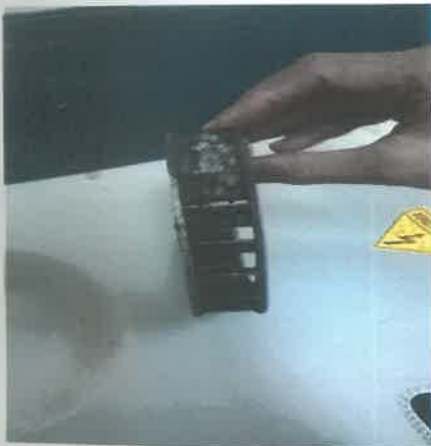
below). The Impeller was removed from the motor & oil deposits were found even on the fins of impeller. With Impeller removed, motor was found moving freely.

- 2.3.5. The fins of impeller were intact. There were no rubbing signs found in between impeller & the baffle plate.

Impeller

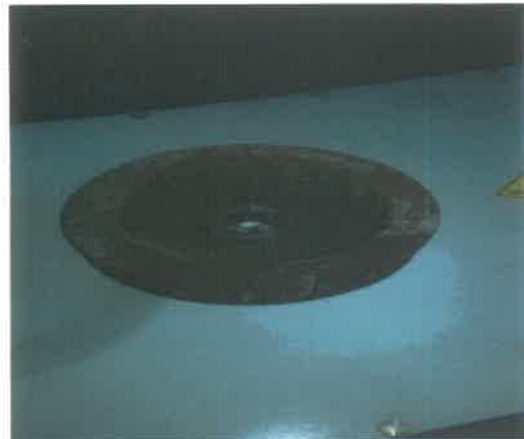
Motor Serviceable

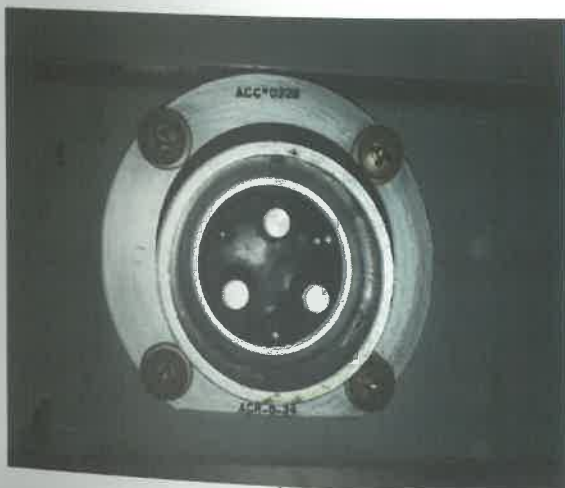
Connector with no abnormality

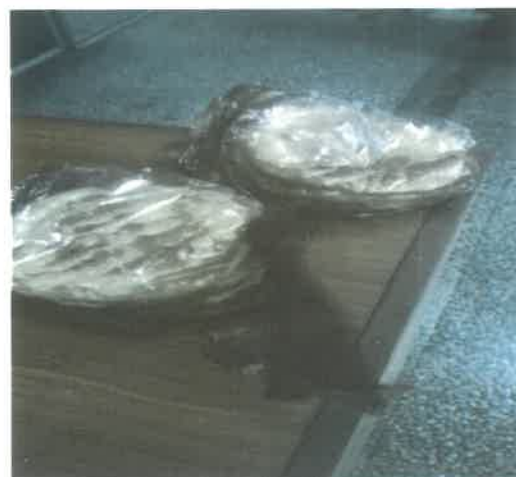
Roti (Naan) with burnt plastic
