**CIVIL AVIATION AUTHORITY, PAKISTAN  
SAFETY & INVESTIGATION BOARD**

**SERIOUS INCIDENT: REJECT TAKE OFF  
PK-717 B-747 COMBI AP-BAK AT ISLAMABAD  
ON 21 JULY, 2003**

**Authority: Director General of Civil Aviation Authority  
Memorandum # HQCAA/1901/286/SIB dated 21-07-03  
Civil Aviation Authority, Pakistan**

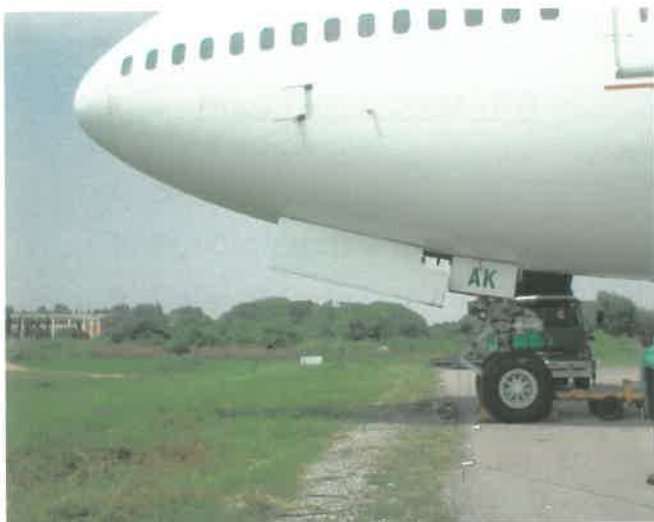
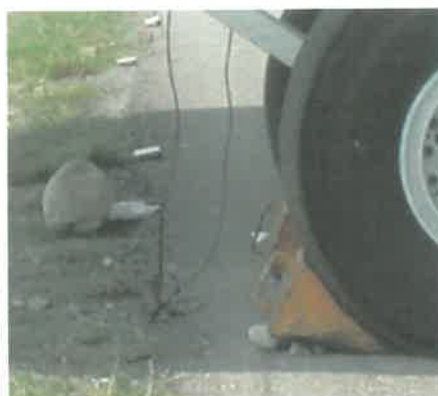
**Nose Tyre approx 2 ft  
from end of the RW**

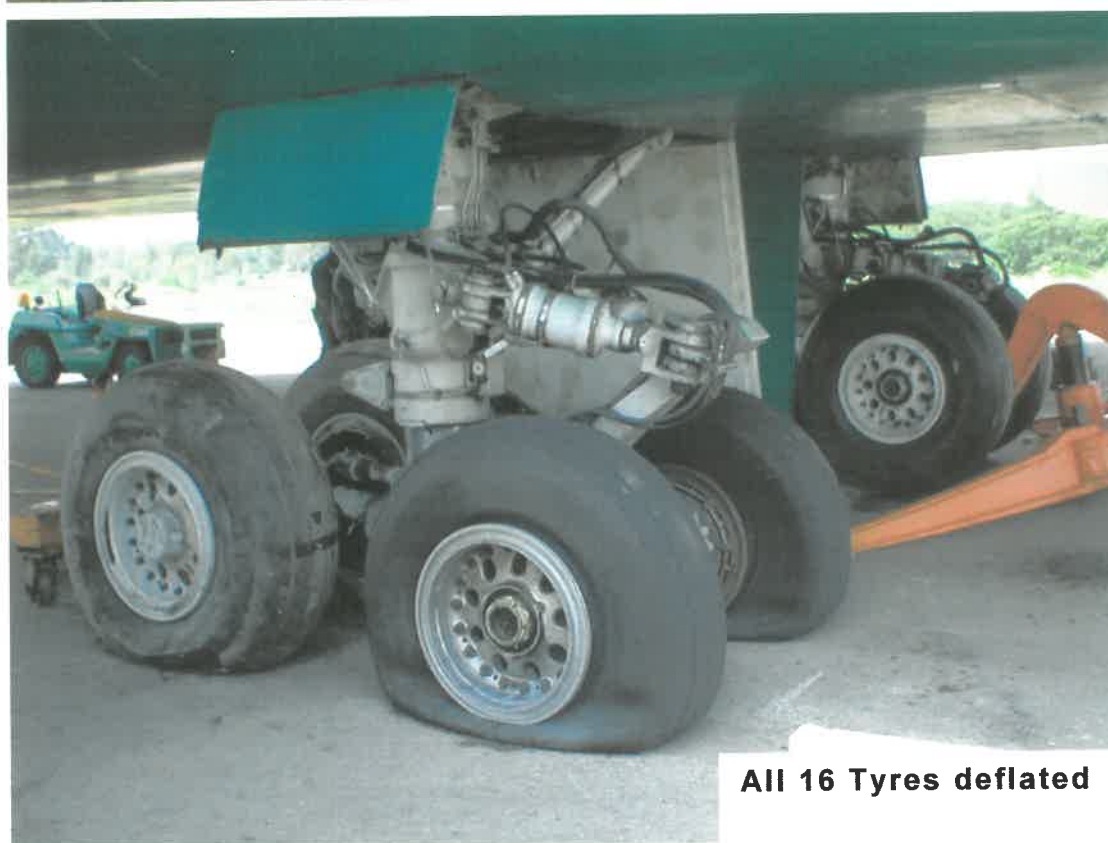
**All 16 Tyres deflated**

26. **Damage Report.** There was no damage to the aircraft in the incident except all 16 tyres deflated after the incident due to safety design feature. The Boeing 747-240B has 16 main landing gear wheels and two nose landing gear wheels. All tyres are inflated with nitrogen and are installed with fusible plugs. By applying excessive brakes, the temperatures on all the main tyres increased, due to which the plugs melted. The nitrogen gas is then released into the atmosphere. The tyre markings started at approx 7,000 ft (4,000 ft to go).
