## **FINAL INVESTIGATION REPORT**

**INVESTIGATION INTO SERIOUS INCIDENT OF M/S  
SAI FLIGHT NL-736 (SECTOR RUH-LHE) A330  
AIRCRAFT, REG NO. AP-BKN EXPERIENCED  
ENGINE NO. 1 ANOMALY ON  
06<sup>TH</sup> SEPTEMBER 2014**

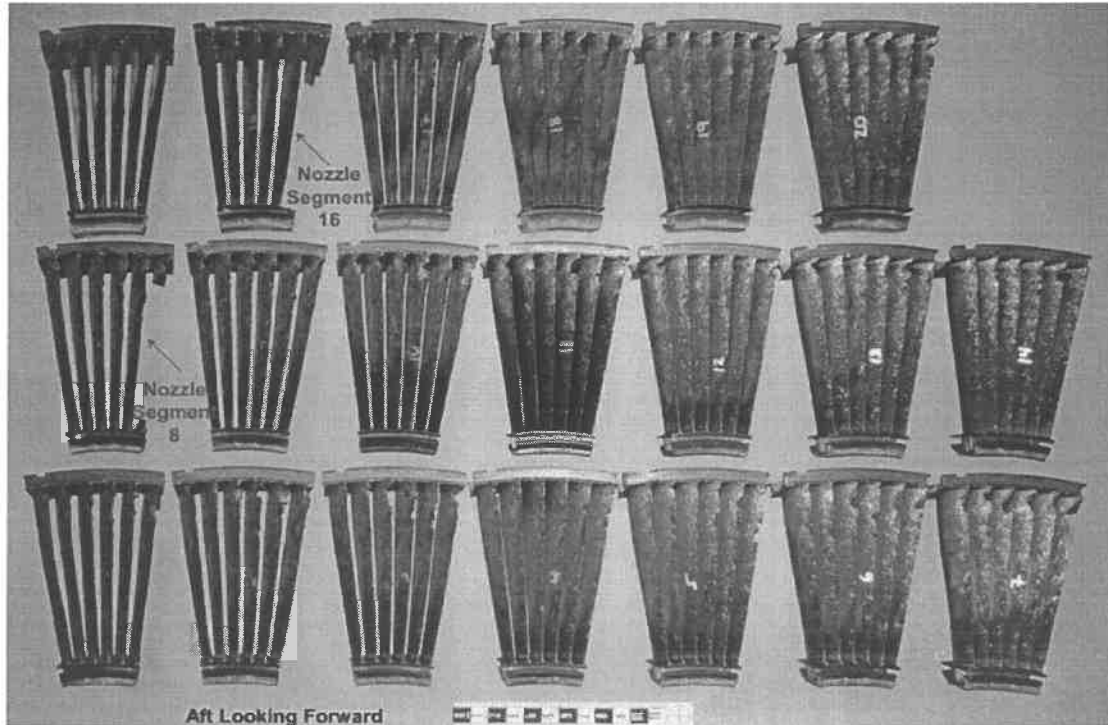
2.4.2. The teardown examination showed that nozzle segments 8 and 16 had fractured airfoils number 6.

2.4.3. Nozzle segment 8 and 16 had fractured the lead airfoils. Remaining airfoils had damage at the trailing edges, near the outboard ends. This damage pattern was consistent with secondary damage.

**The set of LPT stage 4 nozzle segments submitted for  
Metallurgical Analysis**

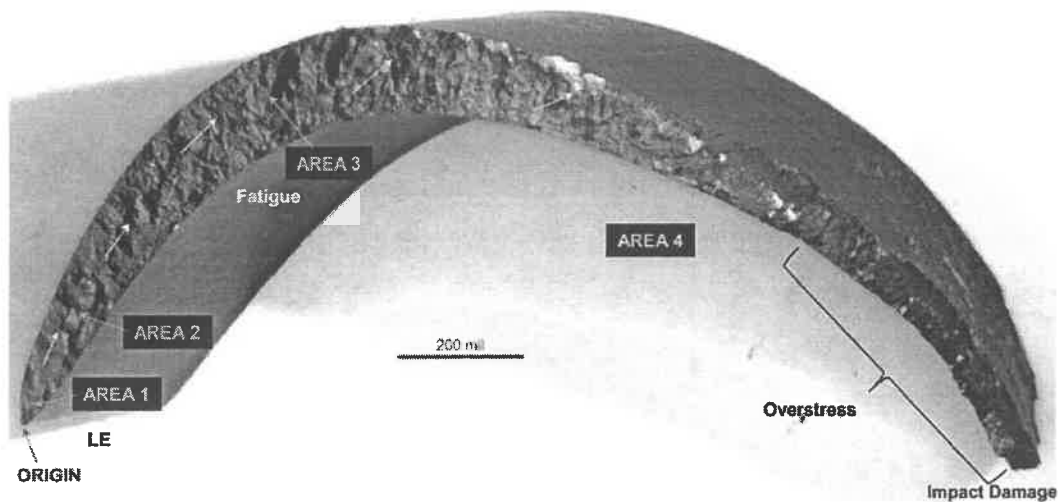
2.4.4. The nozzle segments 8 and 16 fractured and liberated airfoils number 6 approximately 0.8 and 1.7 inch inboard of the outer bands, respectively.

2.4.5. In addition, in nozzle segment 8, adjacent airfoil 5 was also cracked approximately 0.85 inch from the band.

2.4.7. Visual examination showed that both outboard fractures of nozzle segments 8 and 16 were planar, axial, and consistent with fatigue.

**High magnification view of airfoil 6 of nozzle segment 8 showing fatigue crack initiation at leading edge and fatigue across the majority of the airfoil. (Indicated areas documented in SEM in GE Metallurgical Report)**

2.4.9. SEM examination of both outboard fractures showed initiation at the leading edge and propagation with fine, feathery features throughout, consistent with low-alternating stress, high-cycle fatigue (HCF) growth.

5.1 The manufacturer (GE Aviation) is to issue Engine Shop Manual changes to reduce the occurrence of these events by reducing the allowable wear on rail 8 on the LPT case from 0.020" to 0.010" thus requiring the rail to be repaired at engine shop visit.

5.2. As a long term corrective action GE Aviation to release a rail 8 shim. The intent of the shim will be to reduce the wear rate further and reduce the need to repair the case in the future by replacing the shim at Shop Visit (SV) and not repairing the case rail.

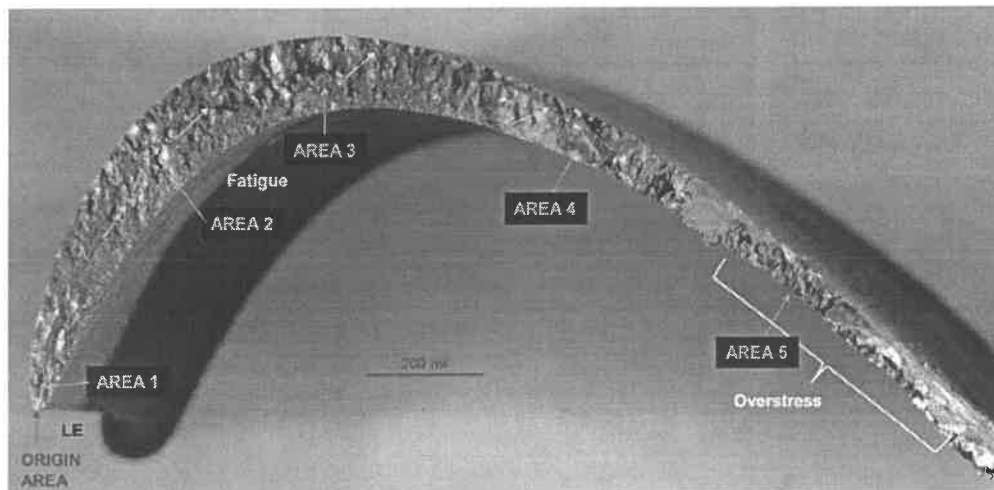
2.4.6. Nozzle segment 16, also cracked adjacent airfoils 5 and 4 approximately 0.6, and 1.25, inch inboard of the outer band. No other nozzle segment airfoils were cracked in the set.

**High magnification view of airfoil 6 of nozzle segment 16 showing fatigue crack initiation at leading edge and fatigue across the majority of the airfoil. (Indicated areas documented in SEM in GE Metallurgical Report)**

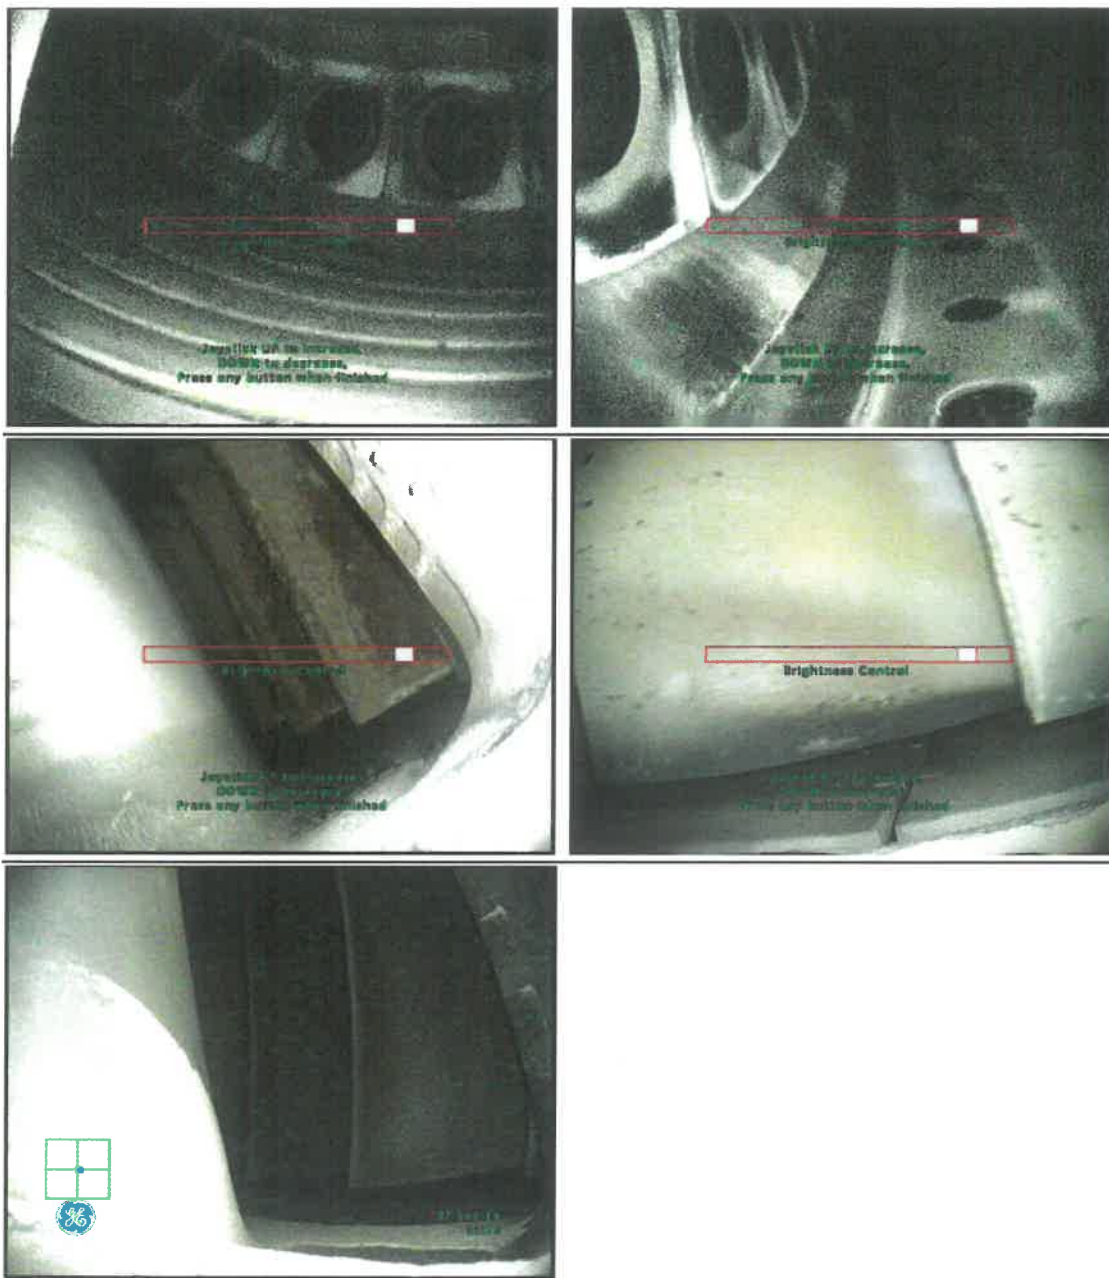
### General Observations:

- vii. Combustion liners in satisfactory condition.
- viii. “HP” NGV’s in satisfactory condition.
- ix. H.PT Blades stages in satisfactory condition.
