# AIRCRAFT ACCIDENT INVESTIGATION REPORT

PIA FOKKER F-27 AP - AUX  
NEAR PESHAWAR INTERNATIONAL  
AIRPORT  
ON  
23RD OCTOBER 1986

FATAL FLYING ACCIDENT INVOLVING PAKISTAN INTERNATIONAL  
AIRLINES FOKKER F-27 AIRCRAFT REGISTRATION AP-AUX THAT  
OCCURRED 2.5 NAUTICAL MILES SHORT OF THE THRESHOLD OF  
RUNWAY 35 PESHAWAR INTERNATIONAL AIRPORT ON 23RD OCT.,  
1986 AT 2049 HRS (PST) WHILST THE AIRCRAFT WAS OPERAT-  
ING SCHEDULED DOMESTIC PASSENGER FLIGHT PK-672 FROM  
LAHORE TO PESHAWAR

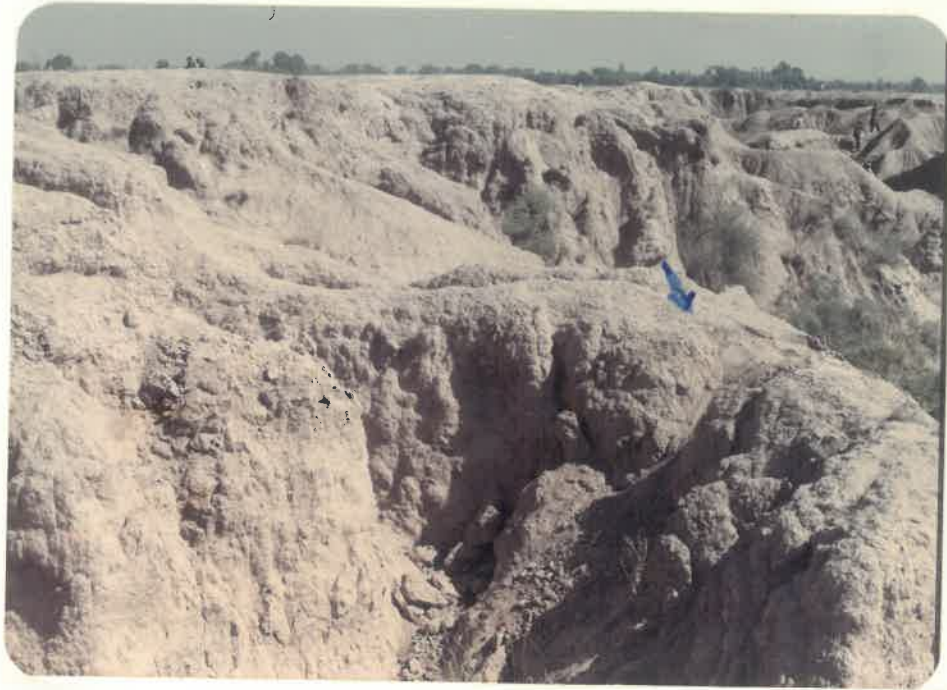
APP "L<sub>1</sub>"

18.7. **Ground Marks.** Examination of ground marks at the scene of the accident indicated that the aircraft first impacted the ground with the starboard main wheels a little below the edge of a nullah which it had just crossed. Check back along the approach path of the aircraft did not reveal any signs of impact earlier than this impact. This impact of the wheels caused the wheel assembly and the main landing gear strut alongwith the lock strut to break away from the aircraft, and the hub rim of the starboard outer wheel to break. The next part of the aircraft to strike the ground was the bottom surface of the fuselage, and it was established from subsequent examination of the wreckage that the bottom of the

FIRST POINT OF IMPACT (ARROW) WHERE RIGHT MAIN WHEEL IMPACTED.

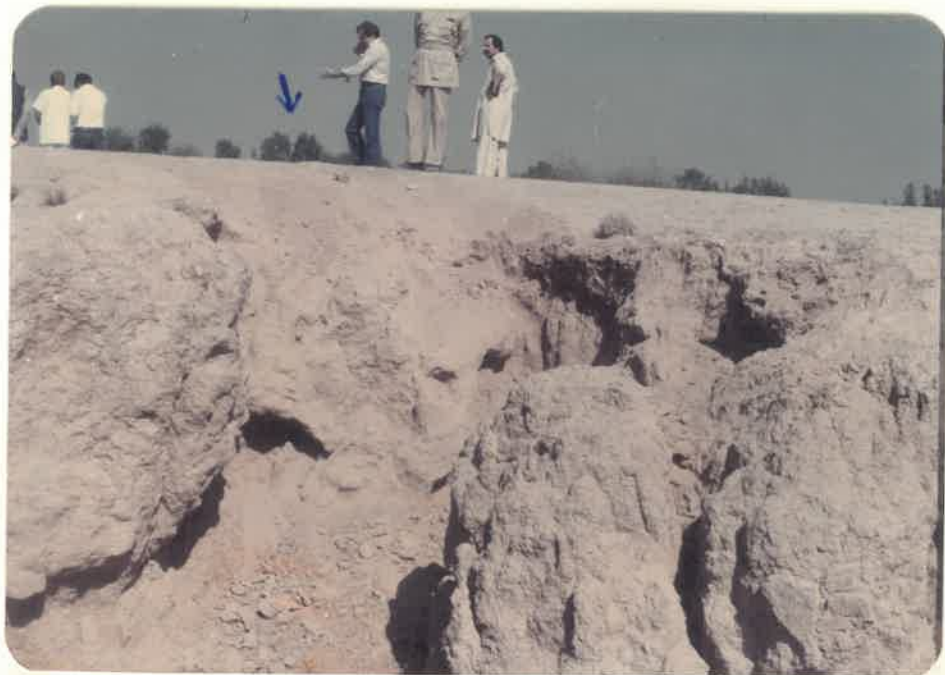
APP "L<sub>2</sub>"

ARROW POINTS TO MARKS MADE BY THE REAR UNDER SURFACE OF THE FUSELAGE. TOILET DRAIN WAS FOUND AT THIS POINT.

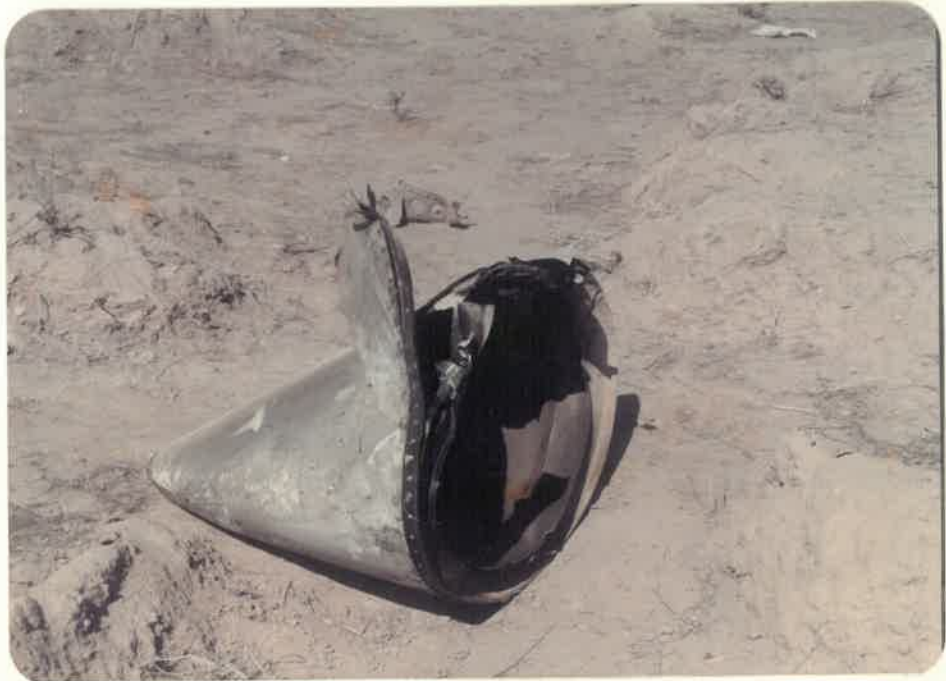
APP "L3"

TAIL CONE OF RIGHT ENGINE NACELLE WHICH WAS RIPPED OFF WHEN STRUCK BY SOME PART OF THE RIGHT MAIN LANDING GEAR WHICH BROKE OFF ON FIRST IMPACT.

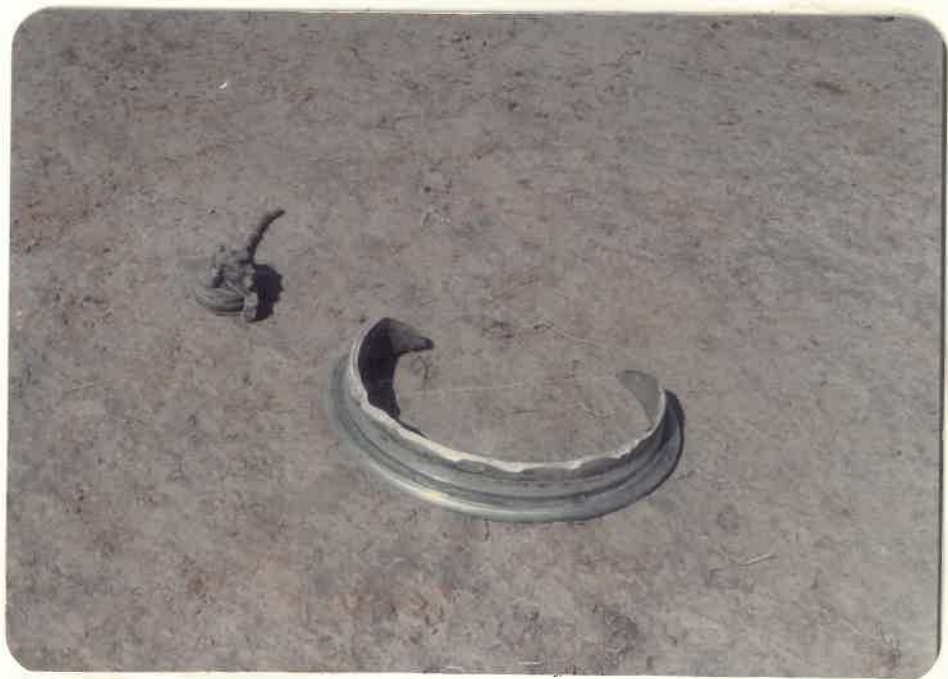
APP "L4"

18.8.12. Small pieces of metal were found just ahead of the initial impact point of the starboard wheel. This metal was identified as metal from the broken rim of the starboard landing gear outboard wheel hub. This indicates that the rim failed on initial impact and is suggestive of a high rate of descent at the time of impact. Some shims from the right main landing gear were also found at the same point. A piece of broken rim of the starboard gear out board wheel hub was located ahead and slightly to the right at a distance of 132 feet from the initial impact point of the wheel (See Appendix "G"). The main landing gear strut was found to the right of the center line of the wreckage trail at a point about 450 feet from the initial impact point. The tyre of the right out-board main wheel was lying in the wreckage trail some 550 feet from the initial impact point. The remainder of the broken hub, with the complete wheel including the tyre of the inboard main wheel still attached to the oleo portion of the starboard main landing gear had come to rest in a field at a point 100 feet to the right of tail portion (Empennage) and about 160 feet beyond the wreckage. This was the piece of wreckage which had travelled the furthest along the wreckage trail, and probably flew through the air from the initial impact point to the position in which it was found. (See Appendix "G").

RIM OF THE RIGHT STARBOARD MAIN WHEEL. FAILURE OCCURRED TO OUTBOARD WHEEL ON INITIAL IMPACT.

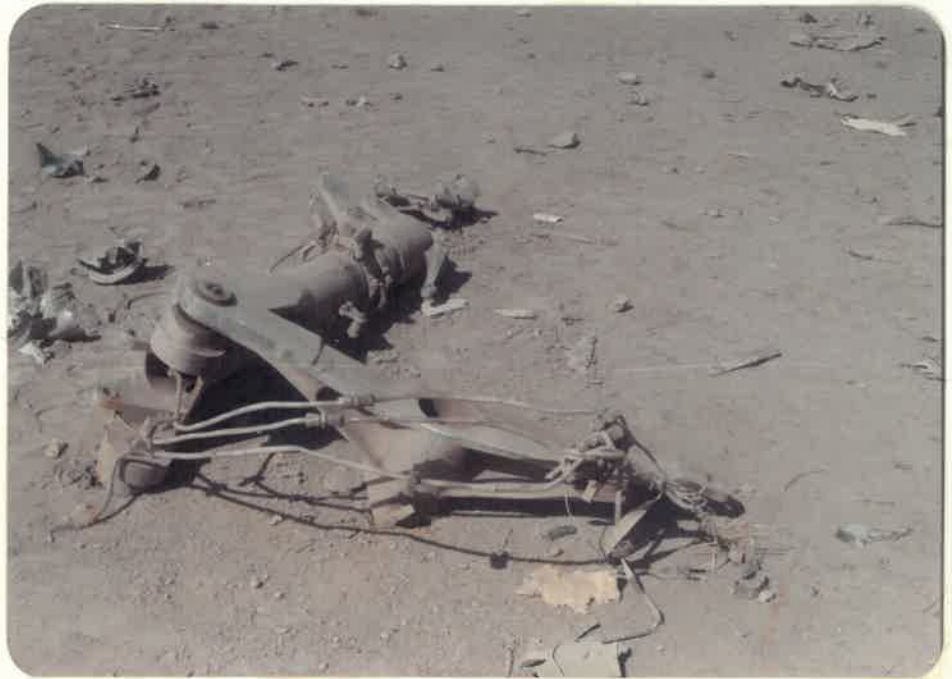
APP. "L5"

18.8.8. It was determined from an examination of all parts of the starboard main landing gear that the gear was extended and locked down at the time of initial impact with the ground. The damage was consistent with such a condition. The lock strut of this gear was found separate from the main landing gear strut and was found folded with no damage to the lock.

STARBOARD MAIN LANDING GEAR STRUT WHICH  
BROKE OFF ON INITIAL IMPACT.

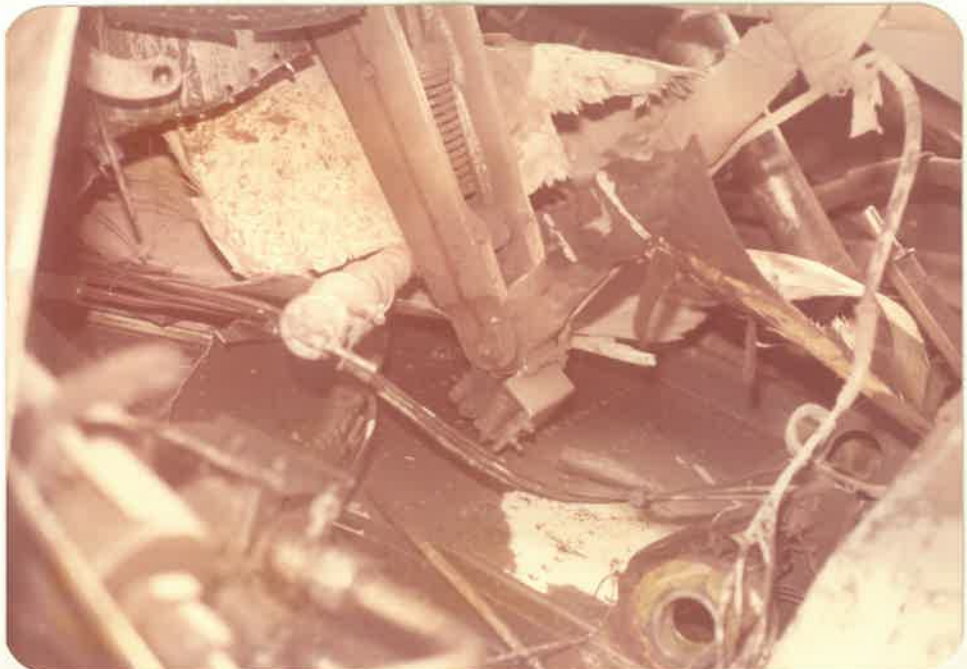
APP "L6"

VIEW OF STARBOARD MAIN GEAR DOWN LOCK  
IN UNLOCKED CONDITION.

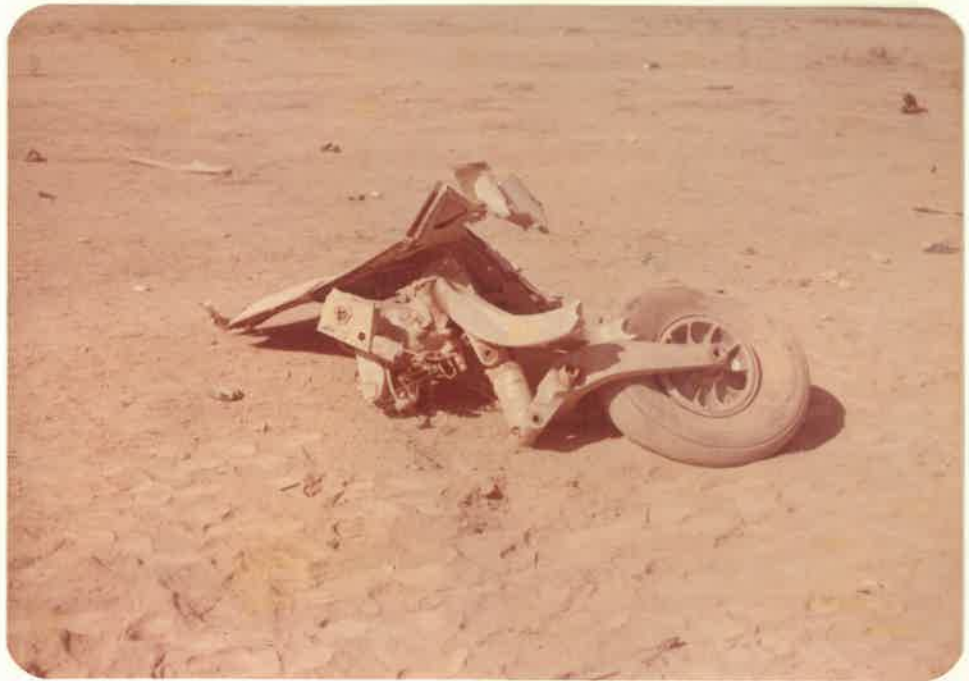
APP "L7"

18.8.9. The nose gear main assembly and the nose gear up lock were found short of the main wreckage and ahead of the second impact mark. The nose gear had broken as the result of heavy impact forces at the time of second impact of the aircraft with the ground in a nose down attitude (See Appendix "L" for damage).

VIEW OF NOSE LANDING GEAR WHICH WAS DAMAGE AT SECOND IMPACT. NOSE GEAR DAMAGE INDICATES IT WAS DOWN AND LOCKED AT TIME OF THIS IMPACT

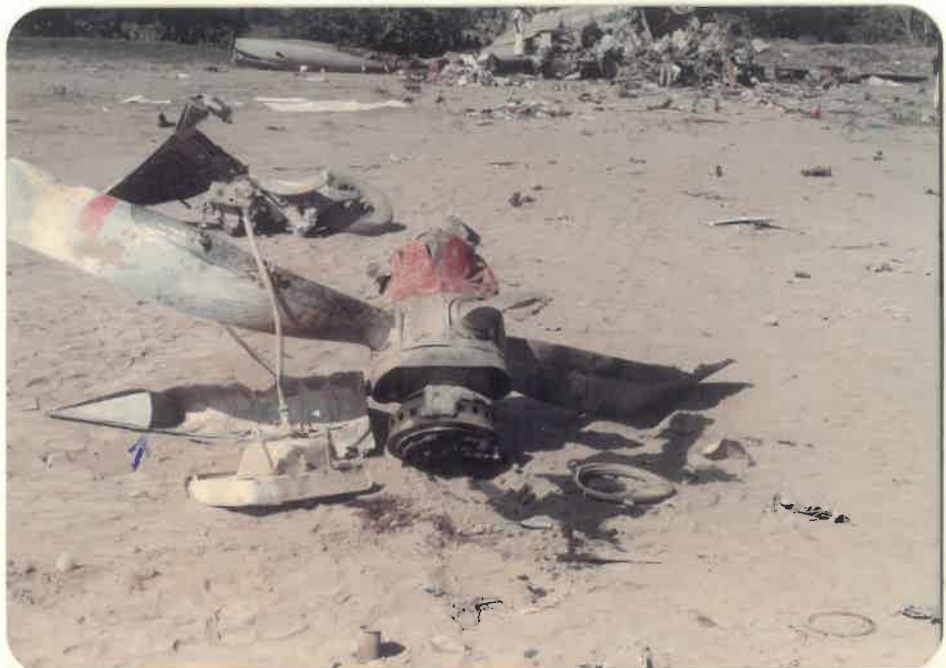
APP "L8"

VIEW OF LEFT ENGINE PROPELLER. ENGINE WAS DEVELOPING POWER WHEN BLADES CONTACTED THE GROUND AFTER SECOND IMPACT AS THE AIRCRAFT WAS NOSING OVER.

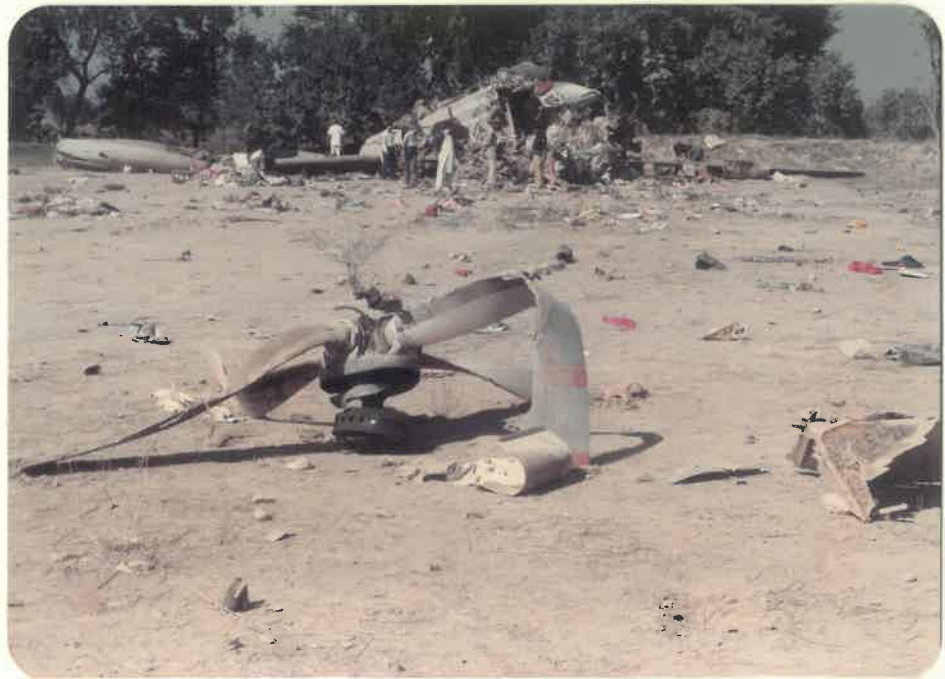
APP "L<sub>9</sub>"

VIEW OF RIGHT ENGINE PROPELLER. ENGINE WAS DEVELOPING POWER WHEN BLADES CONTACTED THE GROUND AFTER SECOND IMPACT AS THE AIRCRAFT WAS NOSING OVER. MAIN WRECKAGE CAN BE SEEN IN THE BACKGROUND.

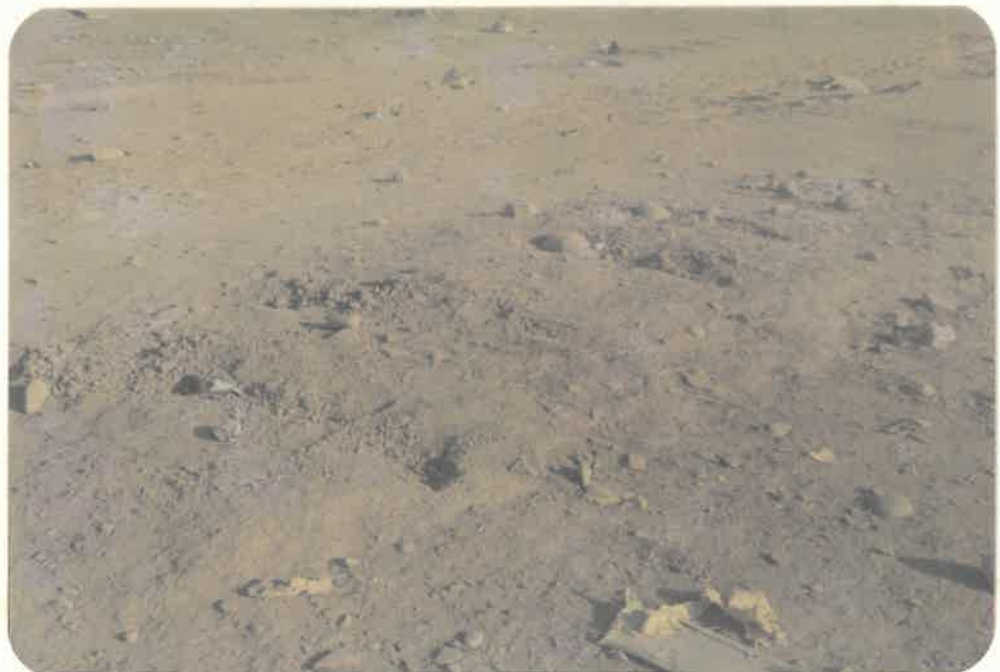
APP "L<sub>10</sub>"

18.8.5. The propeller slash marks found at the second impact point indicated that both the engines were operating with power at the time of this occurrence. Examination of the propeller at the scene of accident and later strip examination of both engines and propellers confirmed that the engines were developing

SLASH MARKS MADE BY LEFT PROPELLER BLADES ALL FOUR BLADES STRUCK THE GROUND.

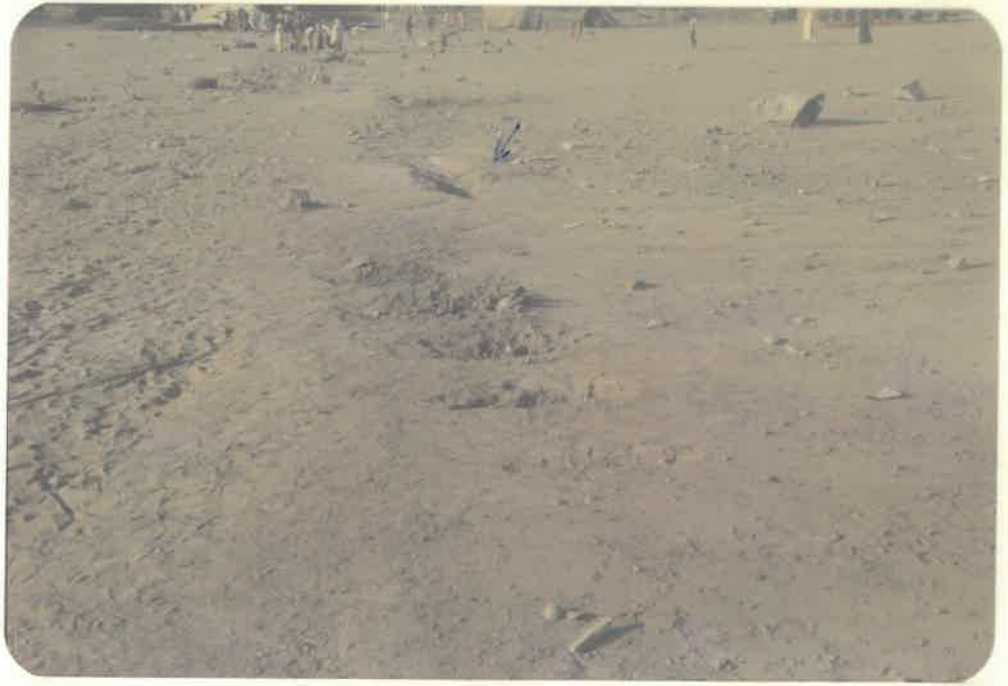
APP "L11"

SLASH MARKS MADE BY RIGHT PROPELLER BLADES. ARROW INDICATES POINT WHERE THE SPINNER DUG INTO THE GROUND AS THE AIRCRAFT WAS NOSING OVER AFTER SECOND IMPACT WITH THE GROUND.

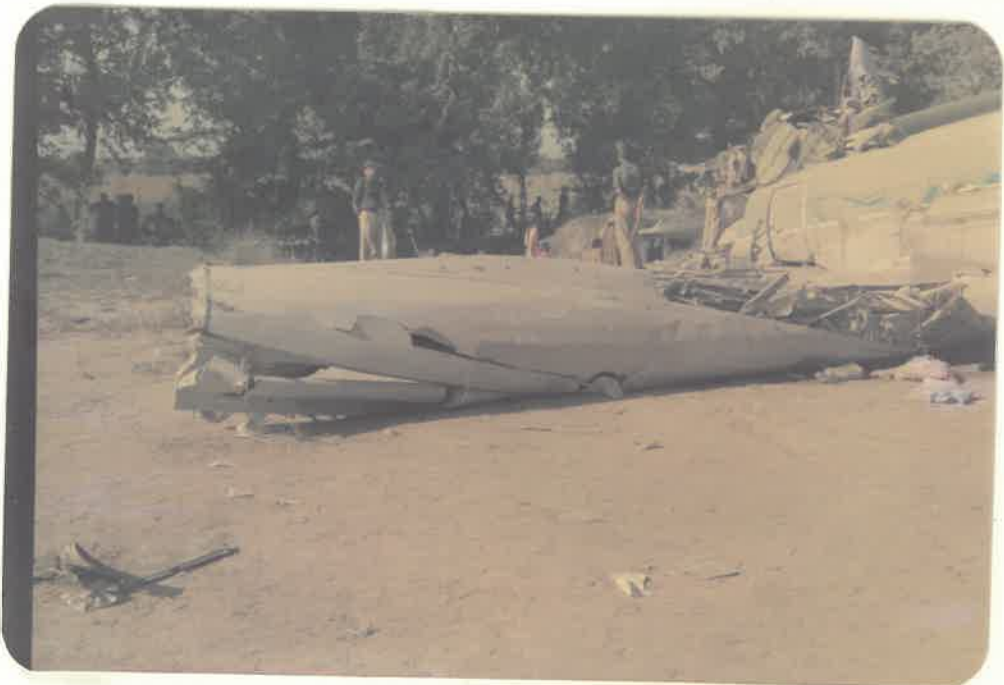
APP "L12"

VIEW OF THE DAMAGED LEADING EDGE OF THE LEFT WING WHICH OCCURRED WHEN THE WING CONTACTED THE GROUND DURING THE NOSE OVER AFTER SECOND IMPACT. WING IS INVERTED AND BENDING IS TOWARDS THE LOWER SURFACE.

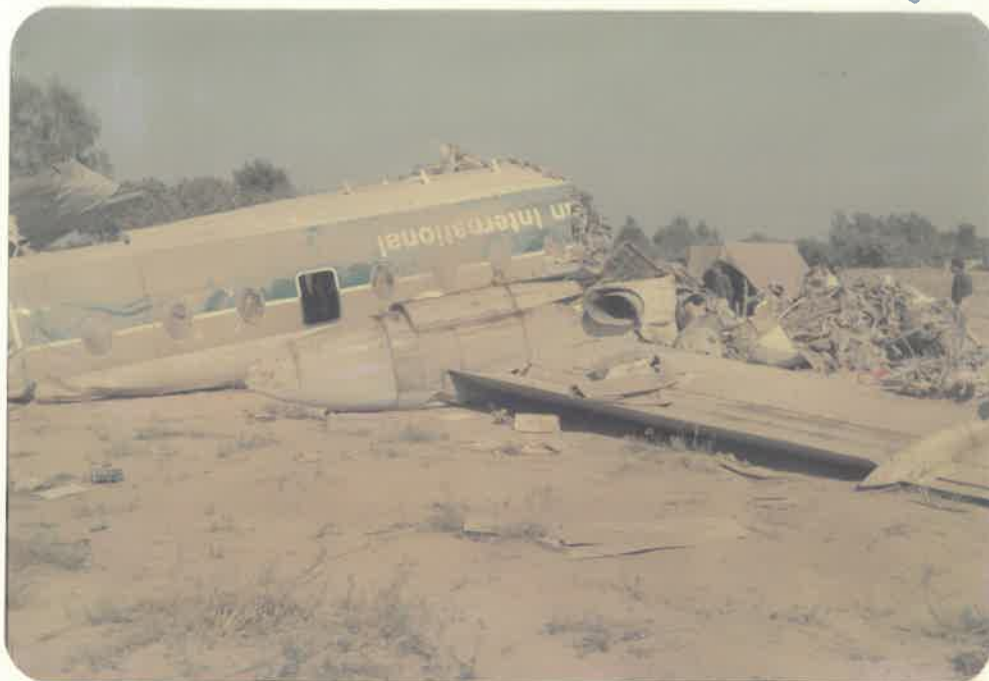
APP "L13"

18.8.10. The left main landing gear doors on the No.1 engine nacelle were found to be almost closed. The complete left main landing gear assembly was found retracted inside the nacelle, with the down lock strut folded, and the uplocks open. There was no indication of impact damage to the left main landing gear assembly or its locks. This gear had obviously not impacted the ground during first impact or subsequently during the second impact and nose over. This raised a doubt as to the position of the landing gear at the time of impact. However, on obtaining the CVR <sup>data</sup> rear out it was obvious that the landing gear had not been raised by the Flight Crew prior to the first impact. This was confirmed by the damage to the starboard main landing gear, which was the first part of the aircraft to strike the ground. The damage sustained by this landing gear is consistent with damage that would occur with the landing gear down and locked. Failure of the starboard main gear strut resulted in a force being applied in the correct direction to unlock the up lock and thus permit the lock strut to fold. Failure of the starboard main strut and down lock strut caused a failure of the pneumatic pressure lines to the down lock piston of the main jack of the starboard

VIEW OF THE FUSELAGE, LEFT WING AND LEFT ENGINE NACELLE. NOTE THE UNDAMAGED TAIL CONE. AND THE LANDING GEAR DOORS ALMOST CLOSED. THE UNDAMAGED LEFT MAIN LANDING GEAR ASSEMBLY OF THE AIRCRAFT WAS FOUND IN AN UNLOCKED CONDITION IN THE NACELLE. THE ENGINE HAD BEEN SEVERELY CRUSHED. NOTE ALSO FLAPS IN THE 26 DEGREE DOWN POSITION. THE CRUSHED COCKPIT AND GALLEY AREA CAN BE SEEN TO THE RIGHT.

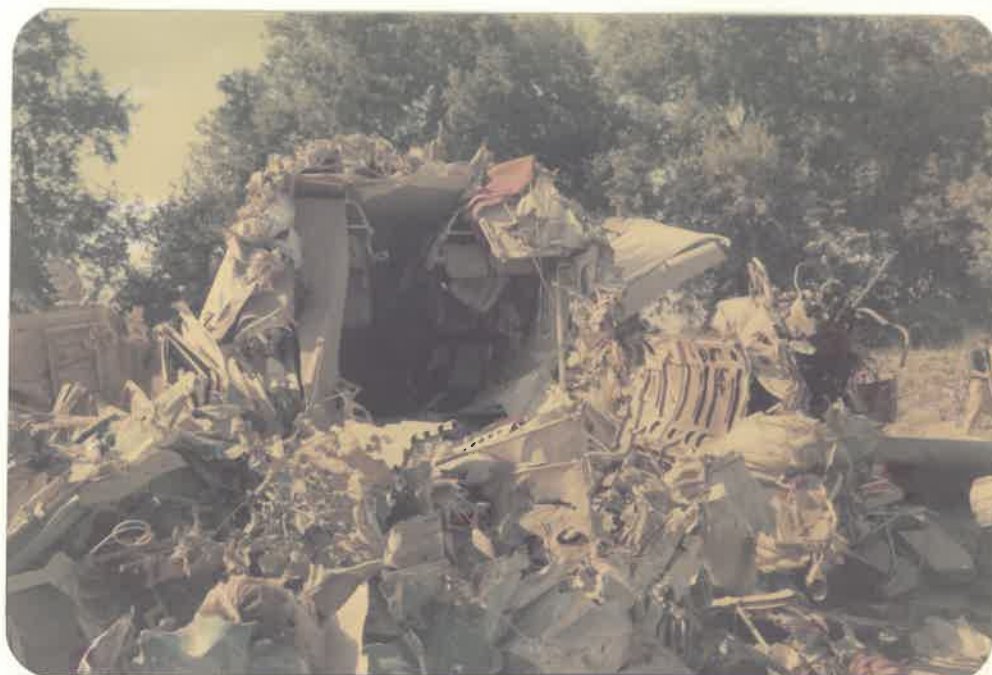
APP "L14"

A VIEW FROM THE FRONT OF THE AIRCRAFT. NOTE THAT DAMAGE OCCURRED DURING THE SECOND IMPACT AND SUBSEQUENT NOSE OVER AND EXTENDS TO THE FIRST ROW OF PASSENGER SEATS AT THE FORWARD END OF THE CABIN.

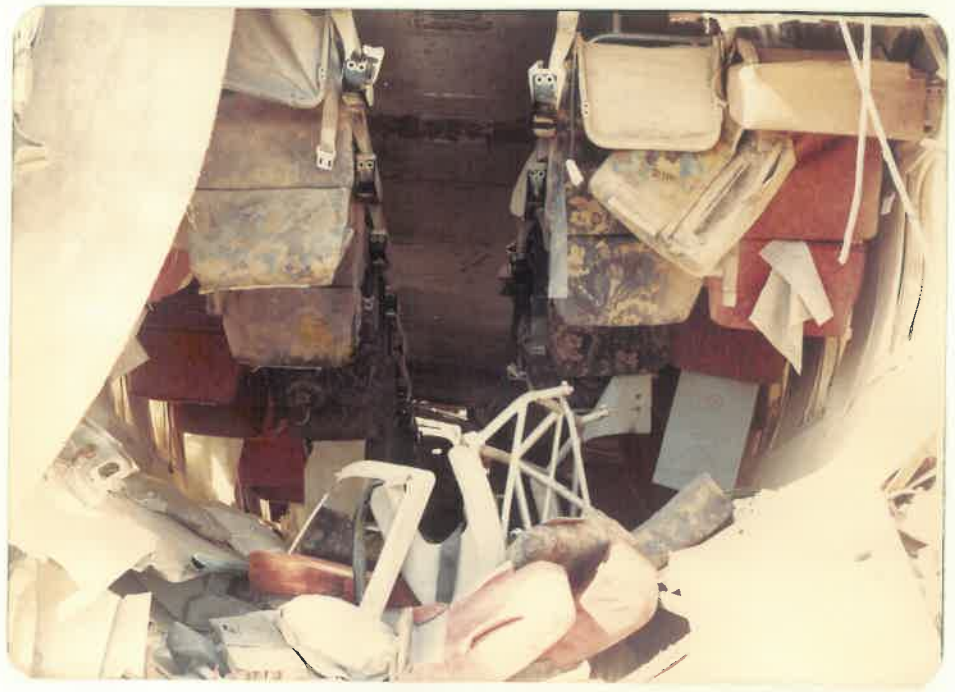
APP "L15"

A VIEW OF THE INSIDE OF THE CABIN

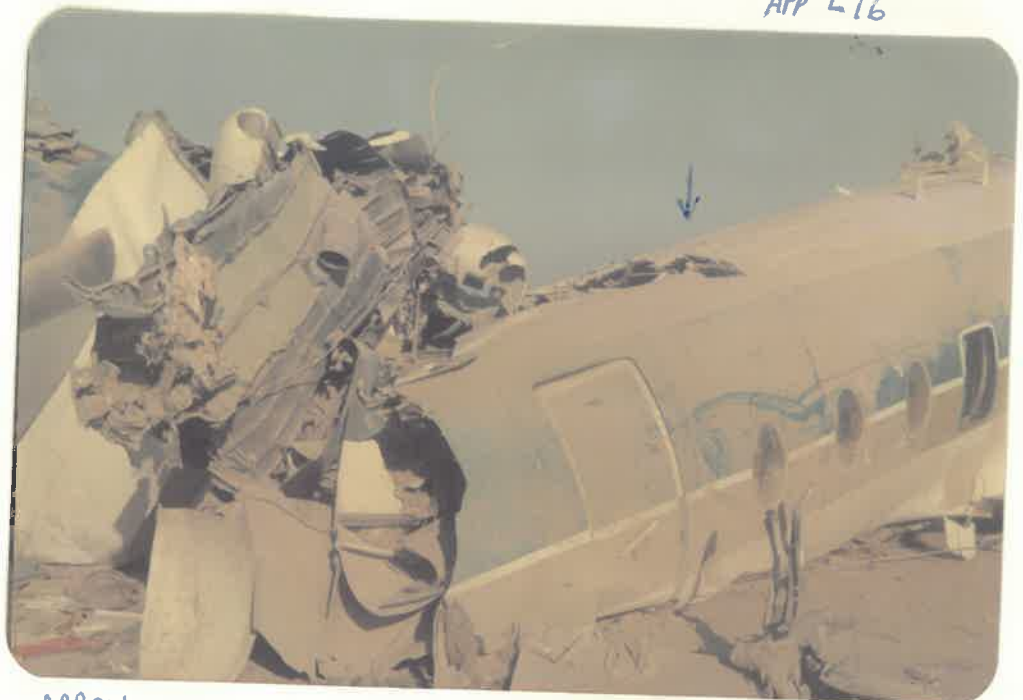
APP "L16"

18.8.4. The fuselage with wings attached was found lying inverted. The empennage was still attached by control cables and electrical cables to the fuselage, and was at the rear of the airframe. The empennage was almost upright and the condition of the fin demonstrated the fact that the empennage was twisted through about 180 degrees when the aircraft nosed over onto its back. The damage evident on the left tail plane and elevator was indicative that this part struck the ground at some stage during the second impact, whilst the complete empennage was twisted to about 90 degrees in relation to its normal position on the fuselage. This condition of the empennage confirmed that serious damage had occurred ahead of the empennage during initial impact of the aircraft with the ground. It was noted that the fuselage lower surface skin had been torn rearward from station 12975 to station 17680. This damage was caused at the time of initial impact of the aircraft with the ground. Other than this area there was no evidence that the undersurface of the fuselage had contacted the ground. (See photographs at Appendix "L" and also See Appendix "F").

ARROW INDICATES DAMAGE TO THE REAR UNDERSURFACE OF THE FUSELAGE. THIS DAMAGE PROCEEDS BACK TO A POINT JUST AHEAD OF THE EMPENNAGE. THE FUSELAGE IS INVERTED WHEREAS THE EMPENNAGE IS FIN UP. IT WAS TURNED THROUGH 180 DEGREES.
