# AIRCRAFT INCIDENT INVESTIGATION REPORT

PIA BOEING 737 AP-BCD  
ISLAMABAD INTERNATIONAL  
AIRPORT

25TH JULY, 1990

LANDING INCIDENT AT ISLAMABAD INTERNATIONAL AIRPORT ON  
25TH JULY 1990 INVOLVING PIA BOEING 737 AIRCRAFT  
REG. MKS. AP-BCD WHILST OPERATING SCHEDULED  
DOMESTIC PASSENGER FLIGHT PK-388 FROM  
LAHORE TO ISLAMABAD

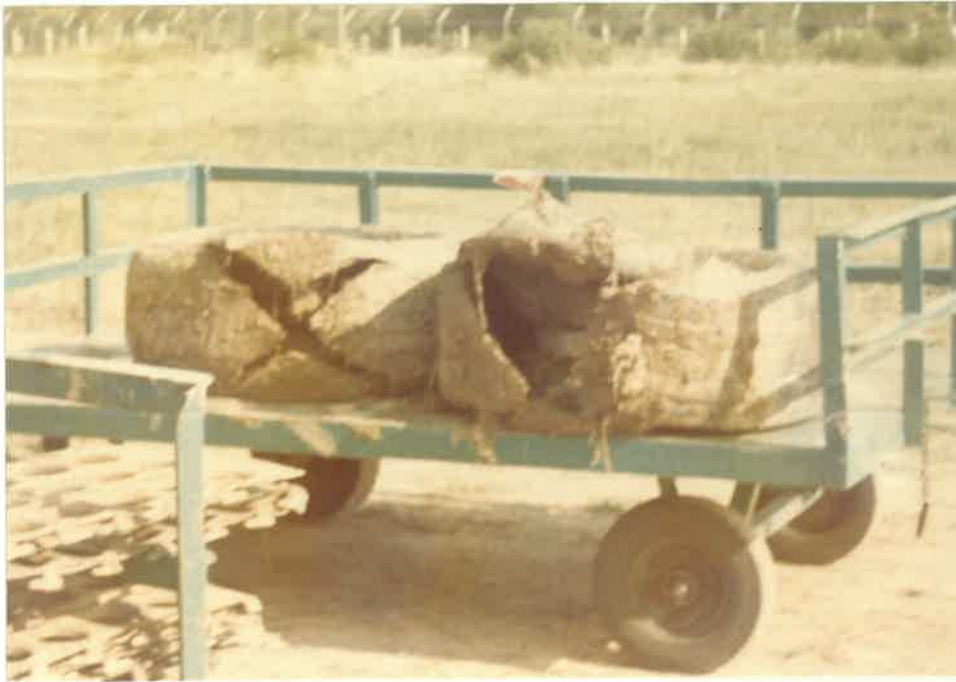
APP. B5

roll, the Pilots felt that the aircraft was not decelerating. This was due to hydroplaning since it was raining heavily and the runway condition was wet. This is also evident from the flat spots on the tyre which eventually burst (App. 'B<sub>5</sub> - B<sub>6</sub>') This was caused as the rubber on the flat spots due to friction thinned off and the tyre could not hold the internal air pressure.

- 6.6. The aircraft failed to decelerate and stop on the main runway due to approach at high speed, and aquaplaning.
- 6.7. Flat spots on the tyres were found from where they eventually burst during the landing roll.
