INVESTIGATION REPORT INTO AN ACCIDENT IN  
WHICH G.P.U. NO. 645 HIT FOKER AIRCRAFT  
REG. NO. AP-AUX, ON 101184 AT 0640 HRS.  
AT ISLAMABAD AIRPORT

APPENDIX "M"  
DAMAGE TO F-27, AP-AUX AND  
G.P.U. 645

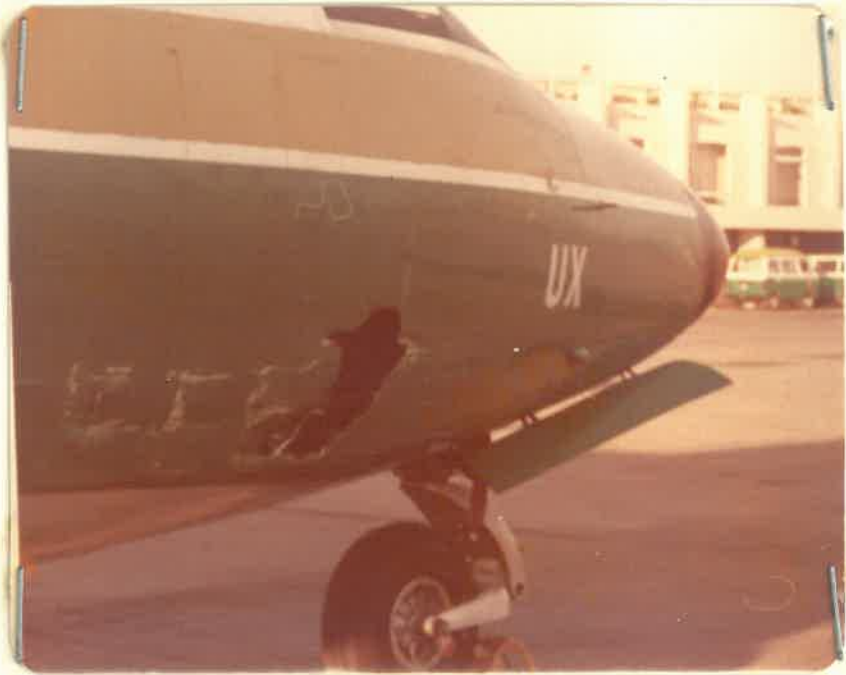
④

DAMAGE TO F-27, AP-AUX
