# **FINAL INVESTIGATION REPORT**

## **SERIOUS INCIDENT (TCAS – RA) REPORTED BY CHINA SOUTHERN AIRLINE FLIGHT CSN5237, BOEING 777-F1B AIRCRAFT, REG NO. B2072 (GUANGZHOU – RIYADH) ON 14<sup>TH</sup> MARCH, 2024**

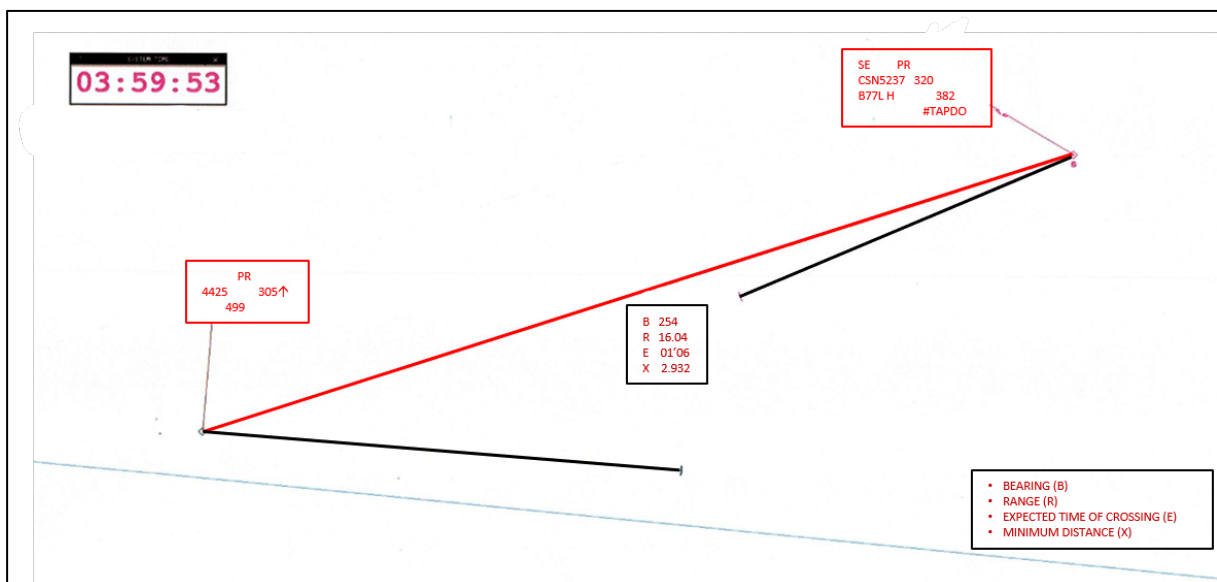
Figure 7 Military Traffic in Climbing Phase FL300 for Higher

2.1.8. At 03:59:53 h, Surveillance East Controller tried to pass traffic information observed on Radar Display to CSN5237 regarding fighter aircraft Squawking A4425 16 NM reciprocal to CSN5237 in climbing phase passing FL300 for higher.

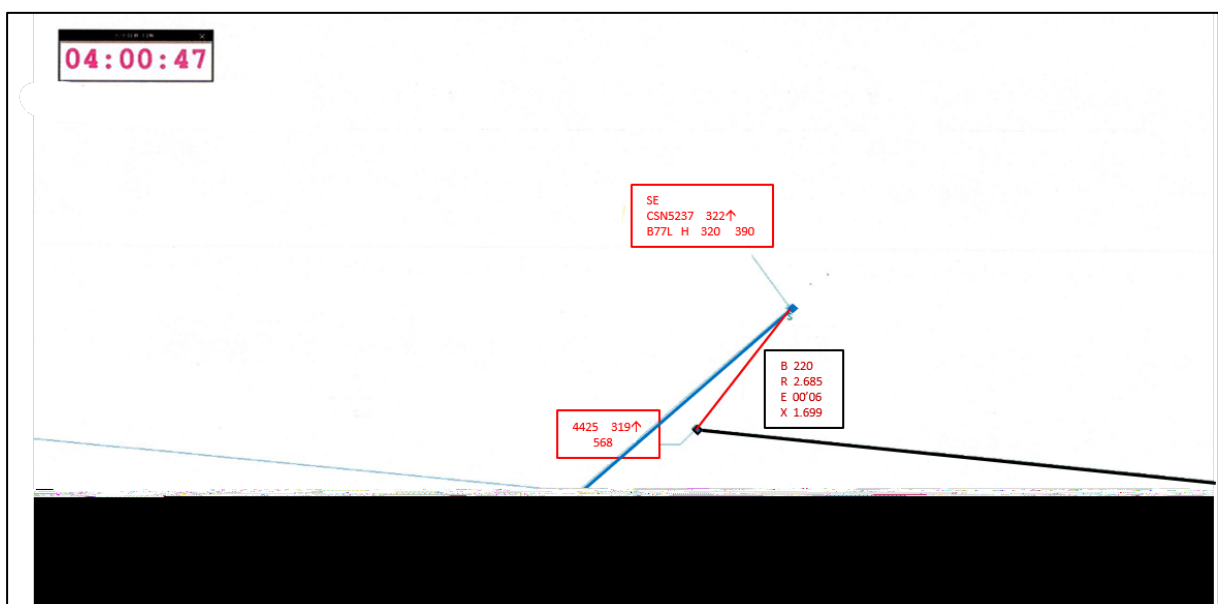
Figure 9 CSN5237 executed TCAS-RA Climb

2.1.10. At 04:00:47 h, as per Radar Screenshots CSN5237 executed TCAS-RA climb while fighter was still in climbing phase crossing FL319 at 2.6 NM.

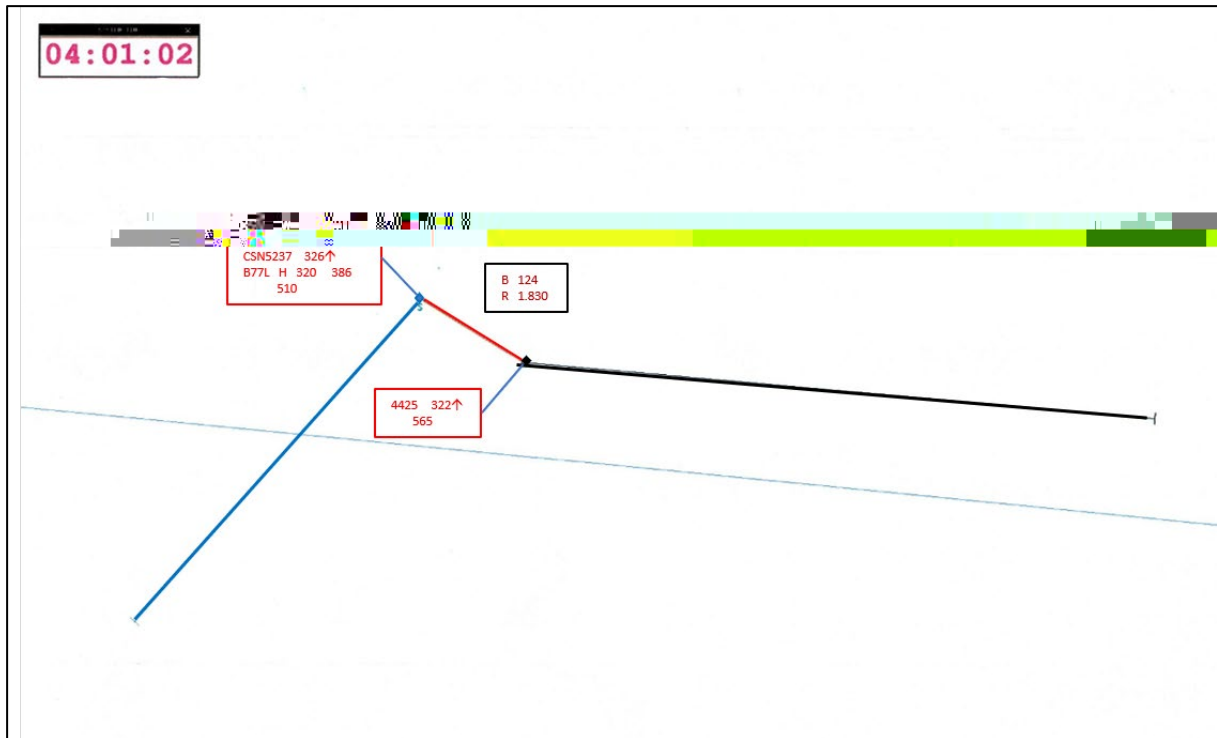
Figure 10 Fighters Climb up to FL322

2.1.11. At 04:01:02 h, military aircraft had climbed up to FL322 with separation of only 1.8 NM with CSN5237 which was climbing through FL326.

2.1.16. At 04:04:37 h, Bholari ATC Controller acknowledged that military traffic was instructed to remain at FL300 and below and it had violated the instructions.

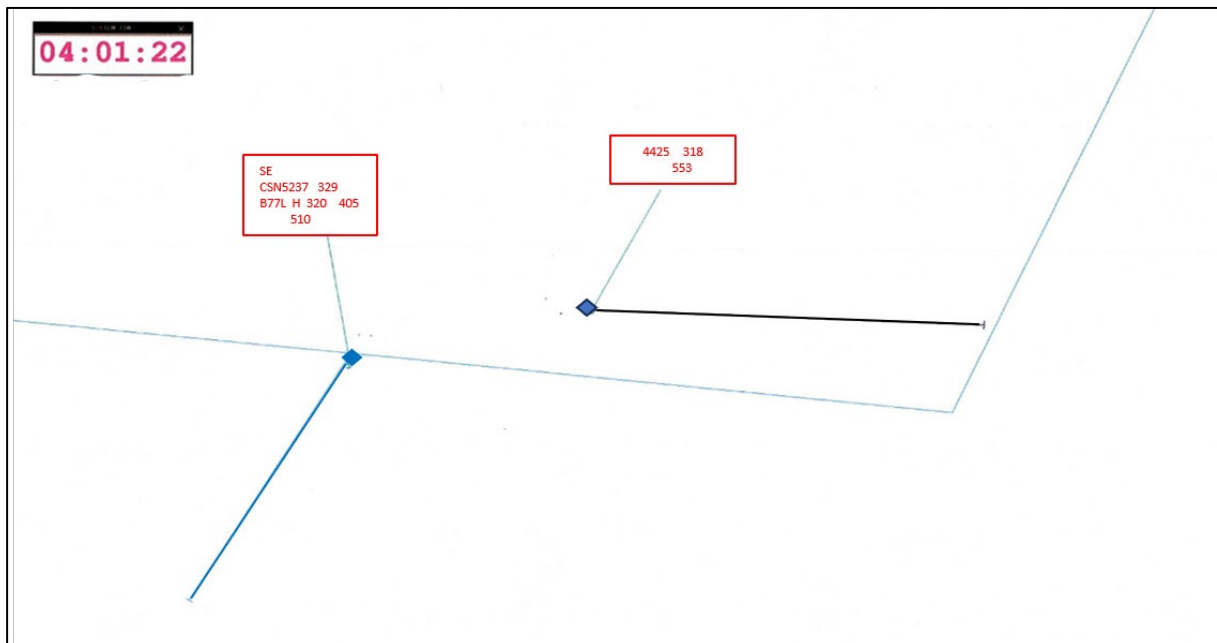
Figure 11 CSN5237 Climb up to FL330

2.1.12. At 04:01:10 h, CSN5237 reported having executed a TCAS – RA manoeuvre climb to FL330 and was descending back to FL320.

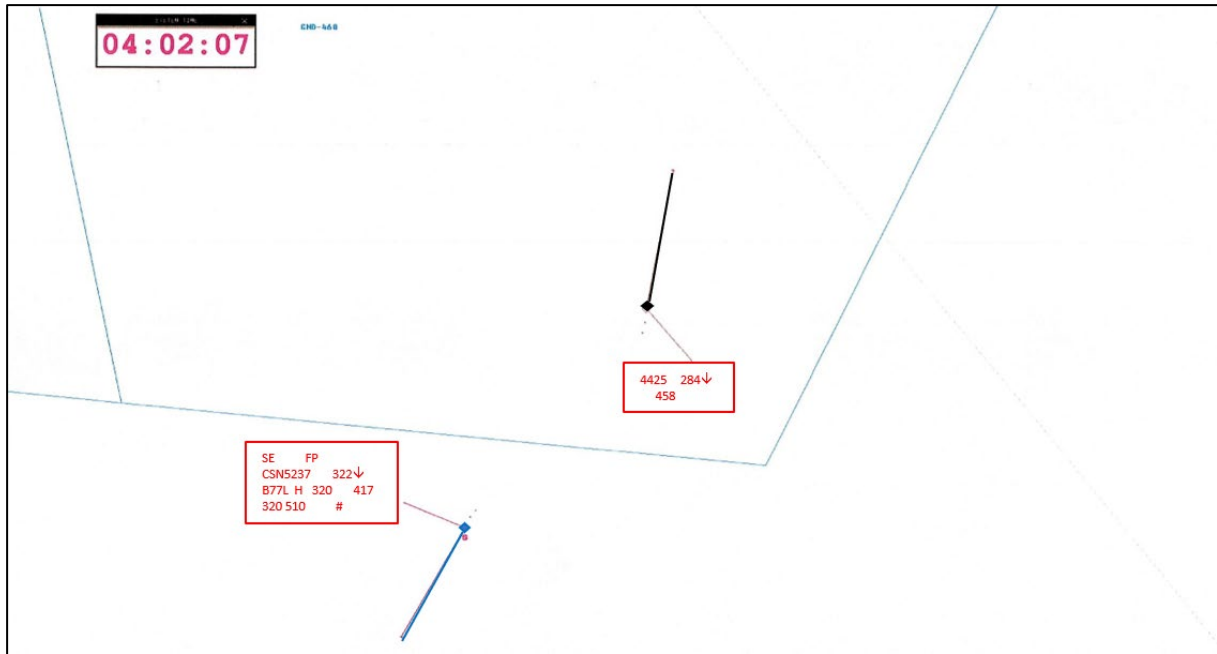
Figure 12 CSN5237 descending back to FL320

2.1.13. At 04:01:39 h, CSN5237 again reported that it had climbed to FL330 due to TCAS-RA manoeuvre and was now back to FL320.

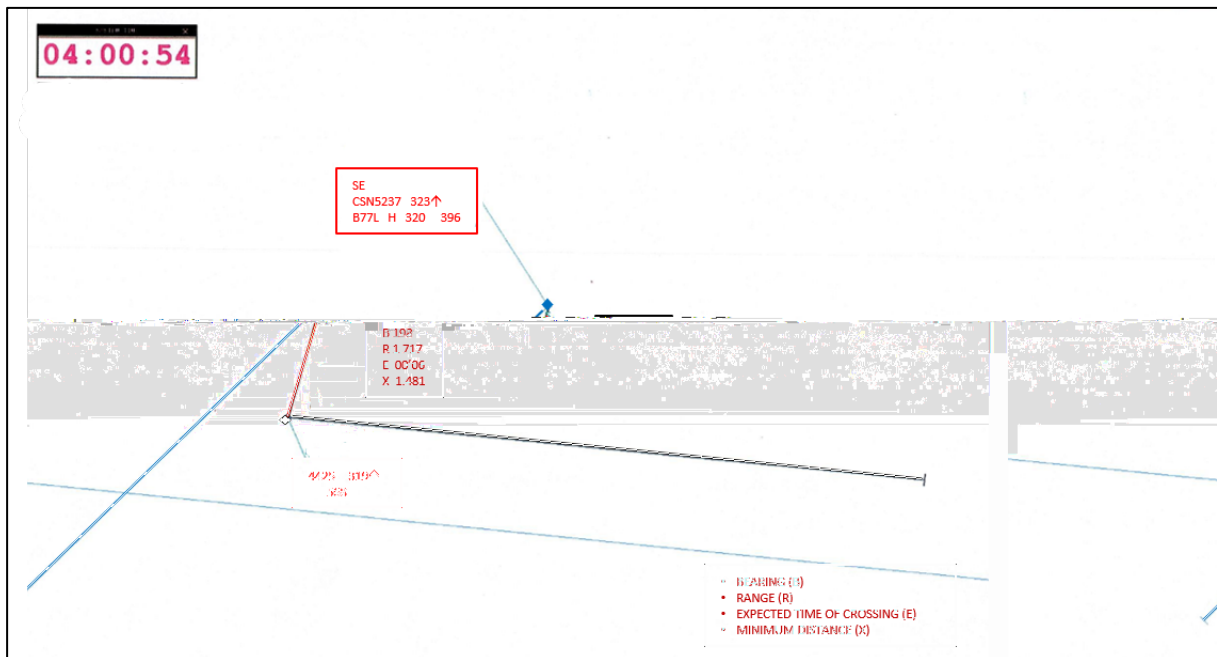
Figure 13 Vertical and Lateral Separation

2.1.14. The closest separation between both aircraft was 400 ft vertical and 1.7 NM lateral.
