INVESTIGATION REPORT ON THE INCIDENT TO M/S  
BURRAQ AVIATION CESSNA-180 REG.MK. AP-AOU  
WHICH OCCURRED ON 9TH JULY,1987 AT BHAWALPUR  
AIRPORT

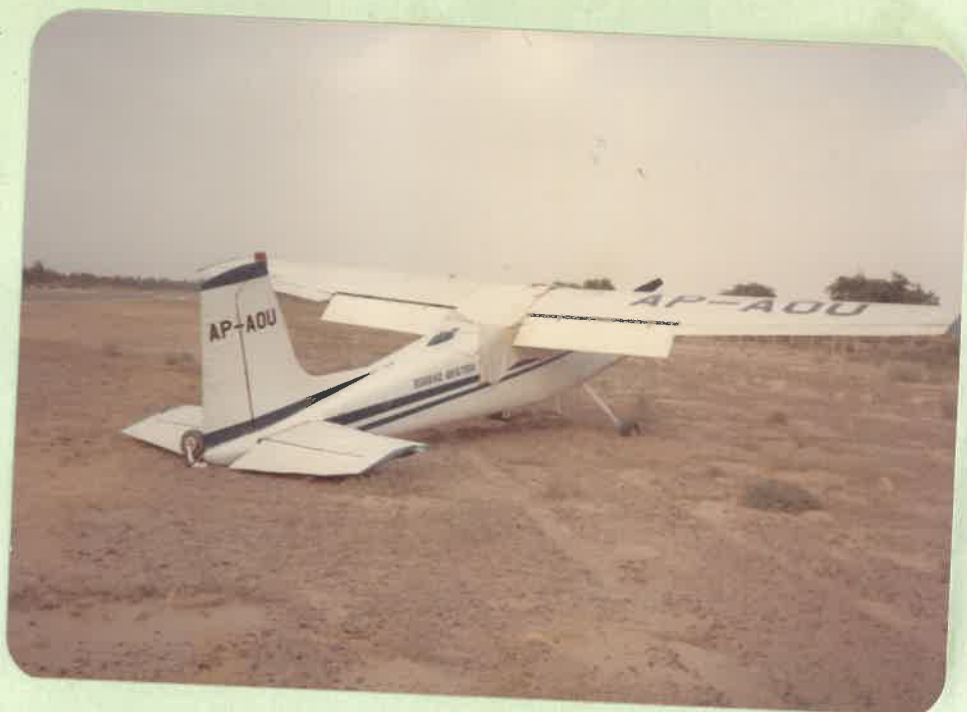
APP "L1"

- 17.3. The aircraft was identified as C-180 bearing Nationality and Registration Marks AP-AOU. It was found lying at a distance of approximately 2000 ft from the threshold of runway 26 (Runway in use) in the Kutchha at 100 ft from the eastern edge of the runway. The aircraft was facing 140°. The tail wheel was twisted up on the left side and the wreckage was resting on main gears and the tail section.

AIRCRAFT RESTING ON MAIN GEARS AND TAIL SECTION.

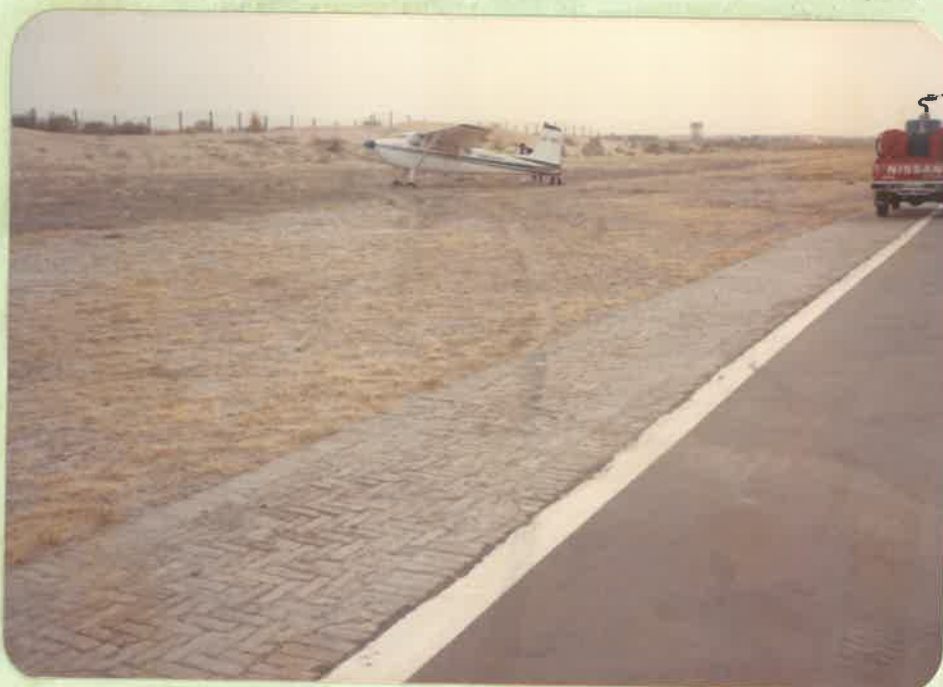
APP "L2"

- 19.3. Captain Anwar Ansari although trained on Harvards, has been a helicopter pilot during most of his service in the Air Force. After a gap of 18 years he started flying fixed wing aircraft. His experience on tail wheelers (60 hrs current flying) is limited specially commercial/passenger flying which requires proper load management during all phases of flight. During landing the aircraft swung left very gradually as the tyre tracks show in the photograph at (appendix 'L'). The pilot being in-experienced on tail

TYRE TRACKS SHOWING WHERE THE AIRCRAFT LEFT THE RUNWAY

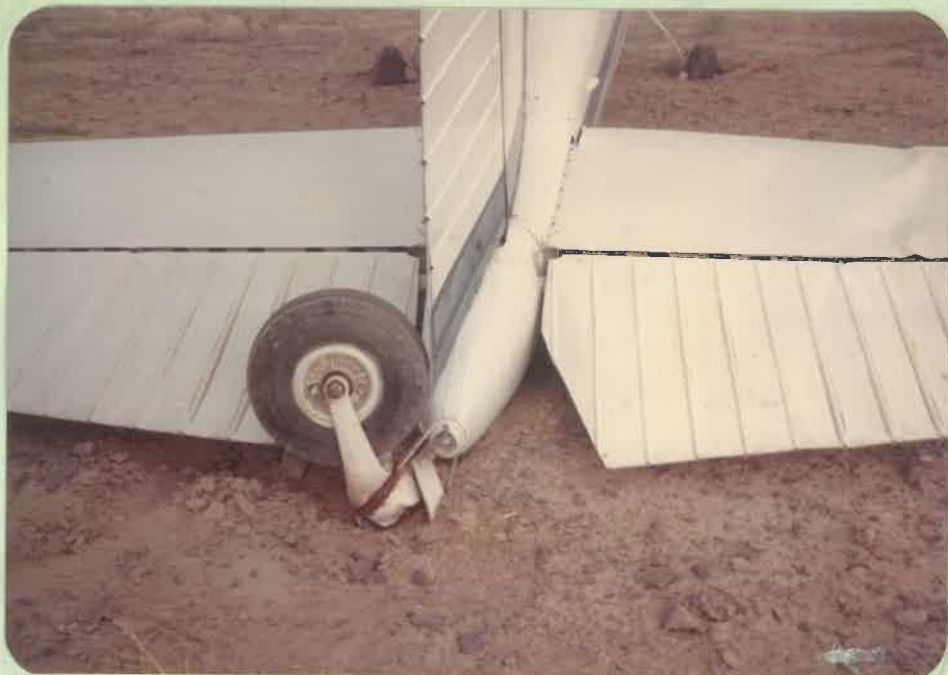
APP "L3"

wheel aircraft took corrective action by applying right rudder only. The rudder not being very effective at slow speeds the aircraft did not straighten out from the swing. The pilot instead of applying opposite brake sat with right rudder fully depressed & let the aircraft swing in to the kutcha till it came to a stop by itself. The right wing tip touched the ground and the tail wheel due to side loads bent to the left and upwards.

TAIL WHEEL DUE TO SIDE LOADS BENT TO THE LEFT AND UPWARDS

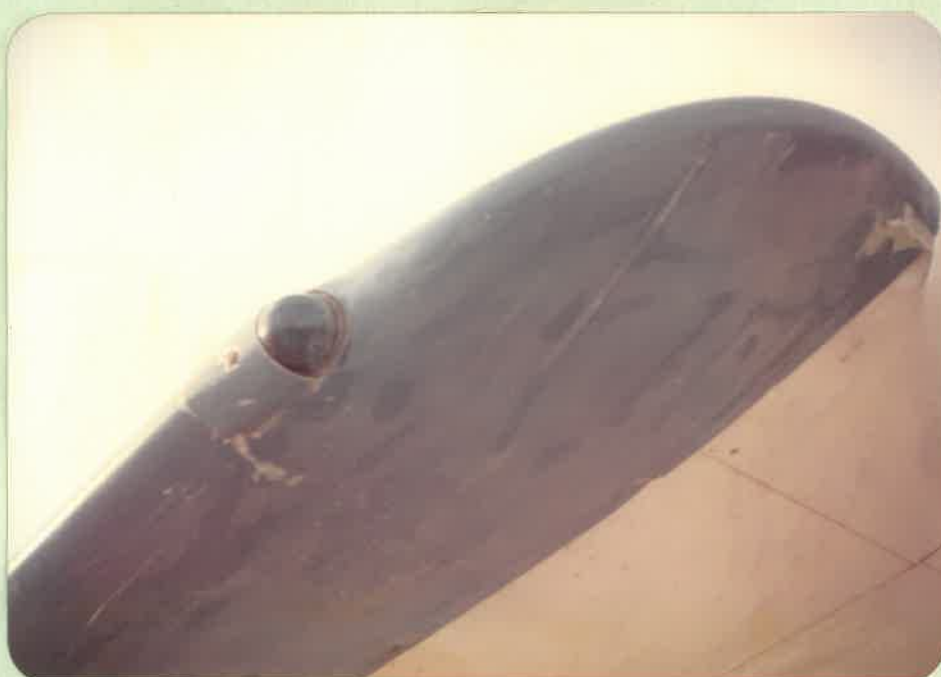
APP "L4"

SCRAPE MARKS SHOWING RIGHT WING TIP TOUCHED THE GROUND.

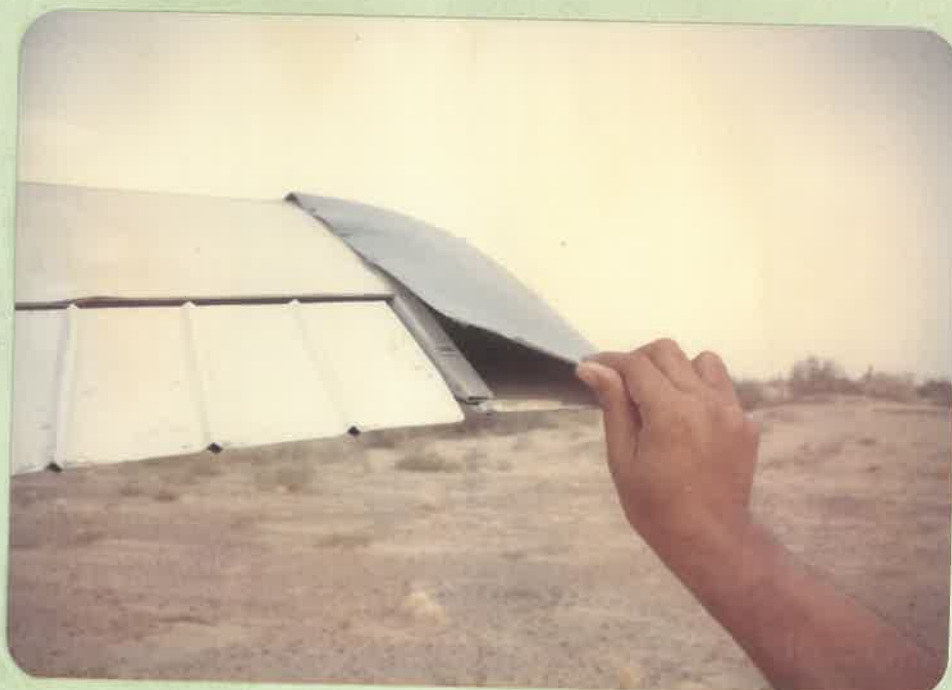
APP "L5"

ANOTHER VIEW OF RIGHT WING TIP WHERE THE REVETS ARE MISSING.

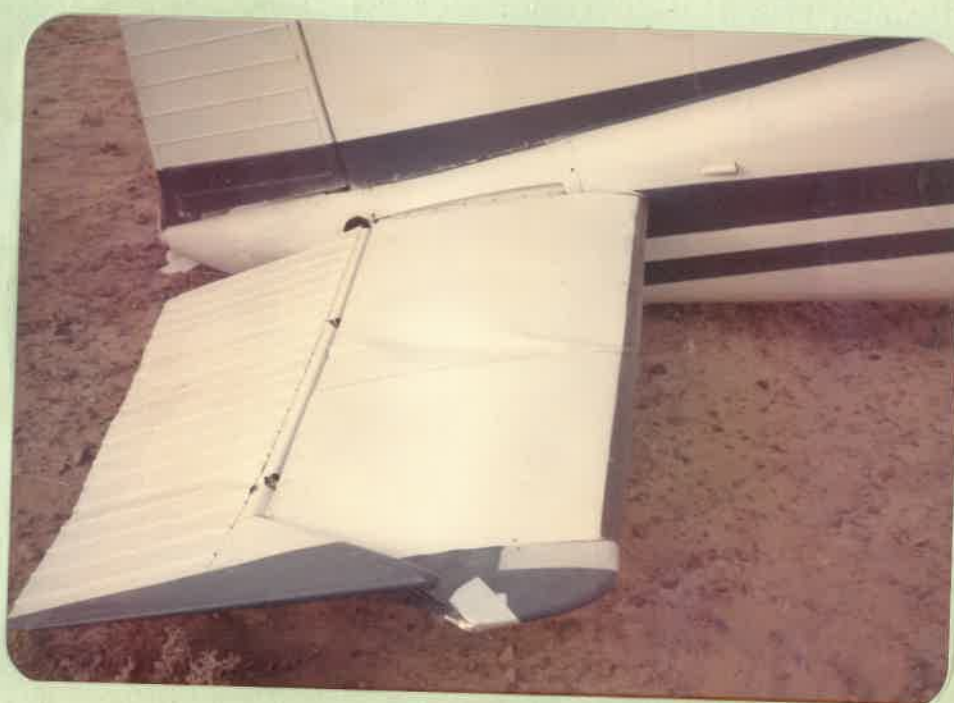
APP "L6"

RIGHT SIDE TAIL SECTION DAMAGED AND BENT

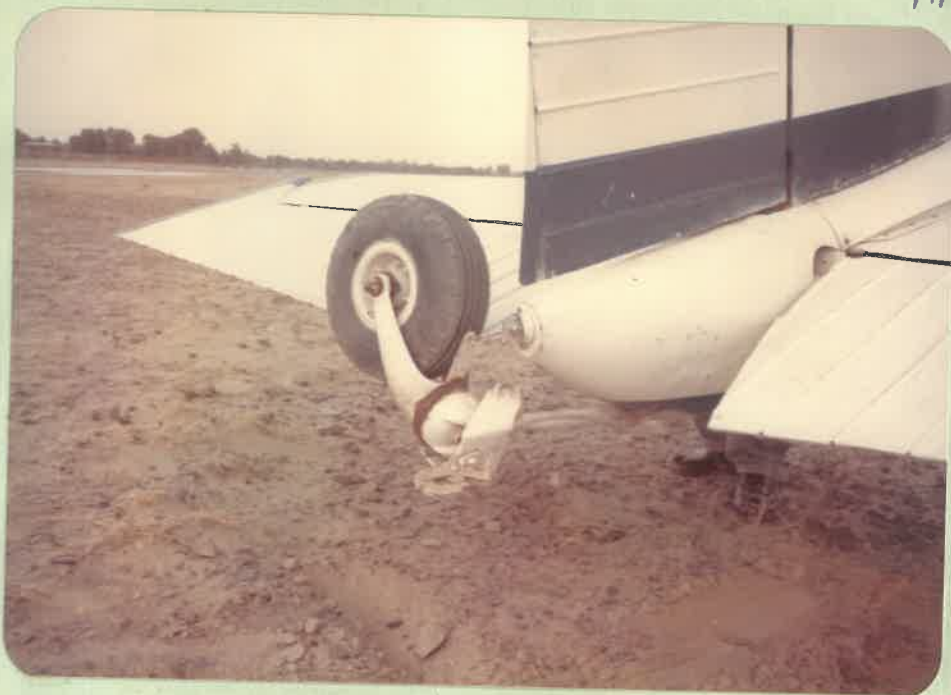
APP L 7"

ANOTHER VIEW OF THE DAMAGE TO THE TAIL WHEEL.

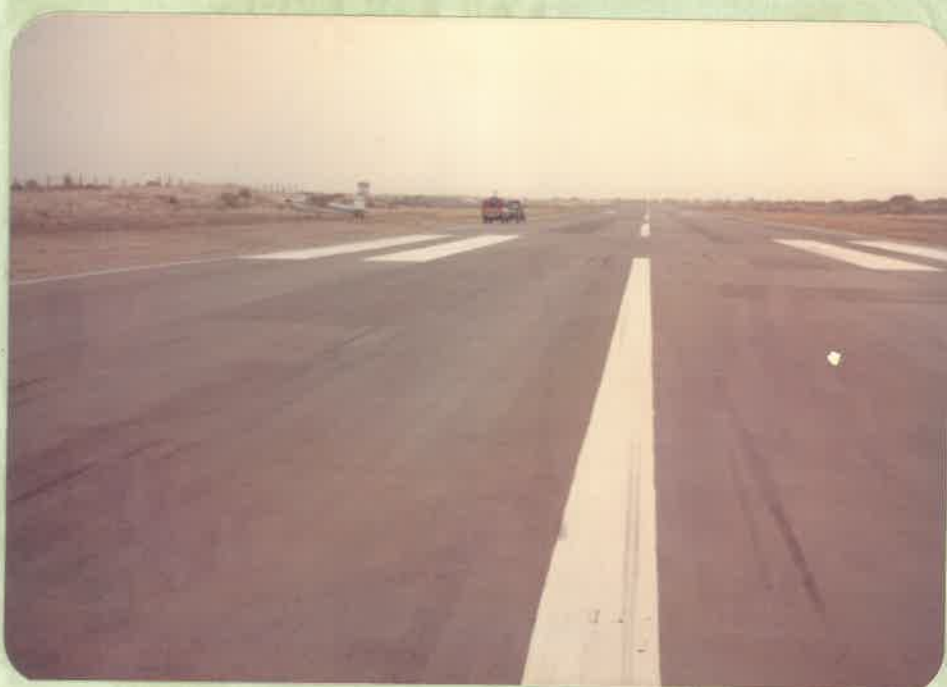
APP L 8"

- 19.4. The prevailing surface wind at the time of landing was 235 /10Kts. The aircraft has a tendency to align itself into the wind due to weather vane effect. Since the wind was from the left, the aircraft nose moved left into the wind. The C.G. of the aircraft being aft, the swing tendency was further assisted and the aircraft continued to swing to the left. The failure of the pilot to use brakes or or power to control the swing is a major factor in this accident.

TYRE TRACKS SHOWING AIRCRAFT SWING TO THE LEFT.
