## **FINAL INVESTIGATION REPORT**

### **SERIOUS INCIDENT OF PAKISTAN INTERNATIONAL AIRLINES FLIGHT PIA 517, ATR 72-500 AIRCRAFT, REGISTRATION NO. AP-BKY AT PANJGUR AIRPORT ON 10<sup>TH</sup> NOVEMBER, 2018**

Dated: 8<sup>th</sup> March, 2024

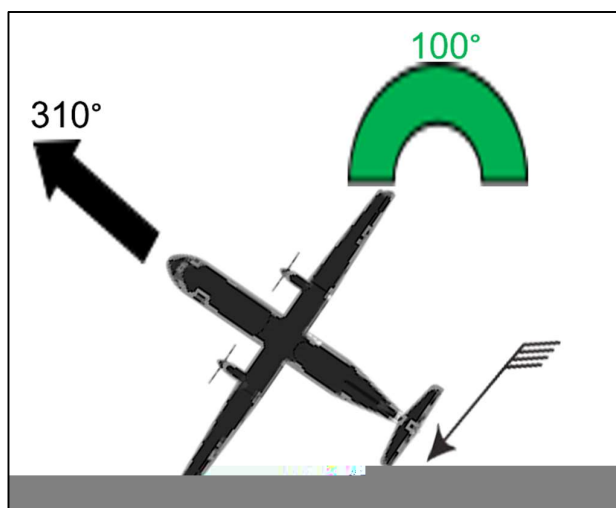
Figure 4 Wind Details

2.2.5 The wind reported at Panjgur at 0300 h was 050° 10 kt. As the aircraft was Landing from R/W 31, the wind constituted a tail wind component for the aircraft.

2.2.6 The tail wind component for the aircraft is calculated as follows:

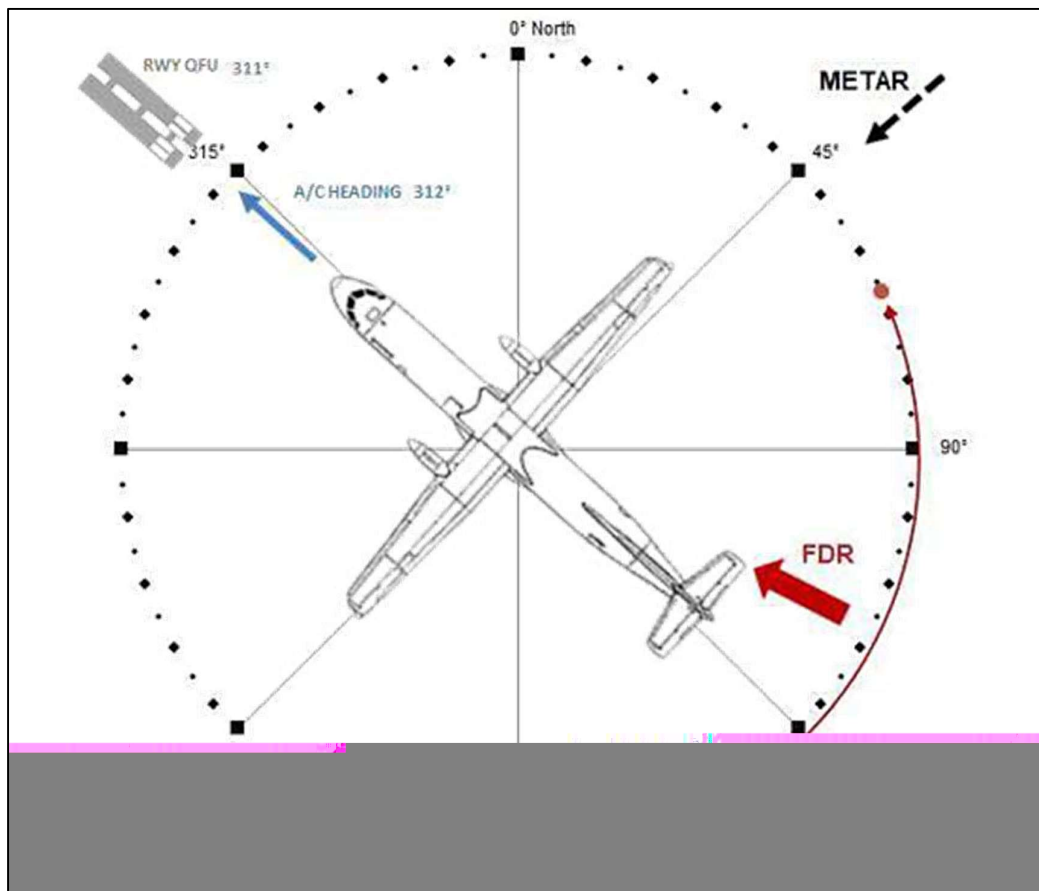
Figure 10 Average Wind 500 ft TO 50 ft

2.6.8 Just short of entering R/W at 03:05:24 h, the speed continued to increase from 124 kt with speed exceedance at 130 ft AGL being the highest recorded, i.e. 27 kt which was announced by the FO and acknowledged by the Captain; however, approach was still continued. This higher IAS on approach resulted in higher True Airspeed (TAS) due to high density altitude, thereby resulting in a very gradual reduction of the IAS itself.

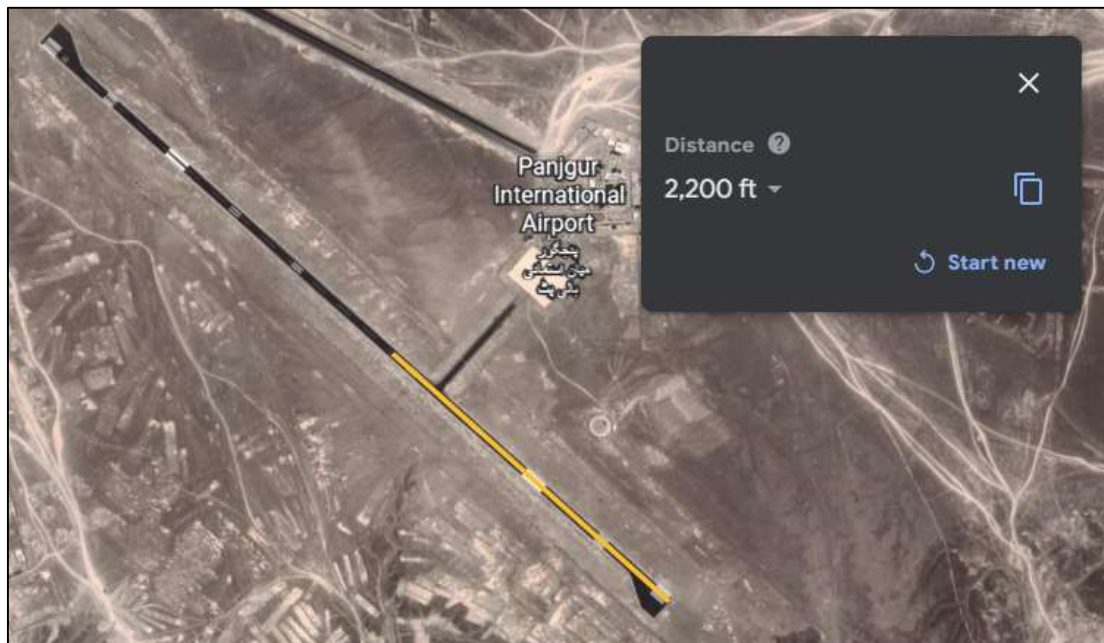
Figure 12 Aircraft Touchdown Distance at Panjgur Airport R/W

2.8.1 As a result of higher speed coupled with tail wind, the aircraft float was longer than anticipated. The Captain realized this and assisted the aircraft in touching down which resulted in a firm Landing. At 03:05:40 h, the aircraft touched down 2,200 ft down the R/W at 116 kt (GS 131 kt) with 2,800 ft remaining to stop the aircraft. The tail wind contributed towards high GS which translated into longer Landing Roll and greater momentum. Additionally, higher speeds also resulted in greater energy absorption by the brakes which could result in brakes overheating or ultimately brake failure.

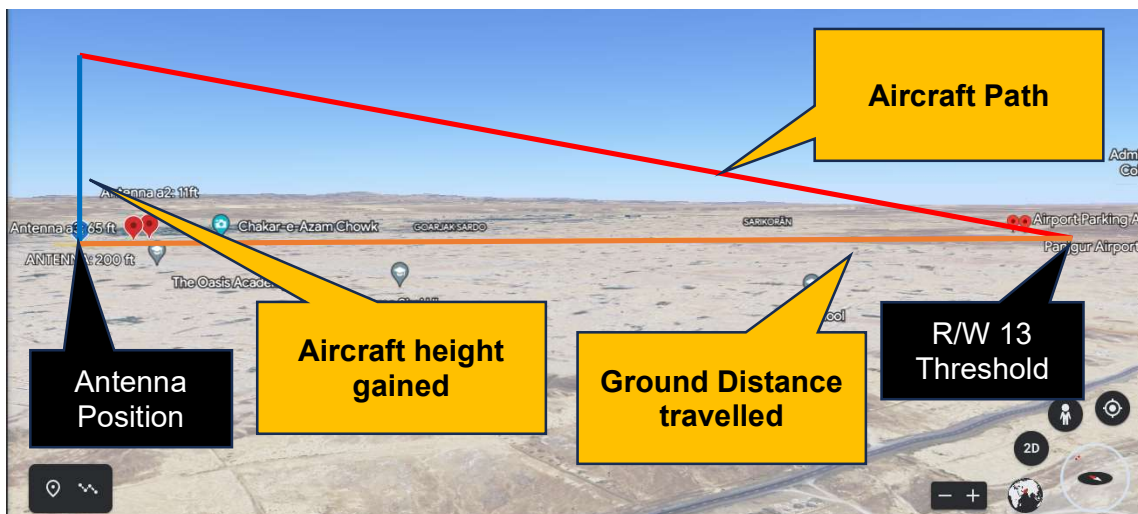
Figure 15 Height Calculation

2.9.8 In case it is assumed that the aircraft got airborne at the edge of the threshold of R/W 13, the aircraft height is calculated as follows:
