**CIVIL AVIATION AUTHORITY**  
**KARACHI, PAKISTAN**

**AIRCRAFT INCIDENT INVESTIGATION**

**INVESTIGATION REPORT: M/S SCHON AIR (PVT) LTD.**  
**CESSNA -152 AIRCRAFT REG NO AP-BES WHICH HAD**  
**AN INCIDENT ON 3RD FEBRUARY, 1996**  
**AT KARACHI AIRPORT.**

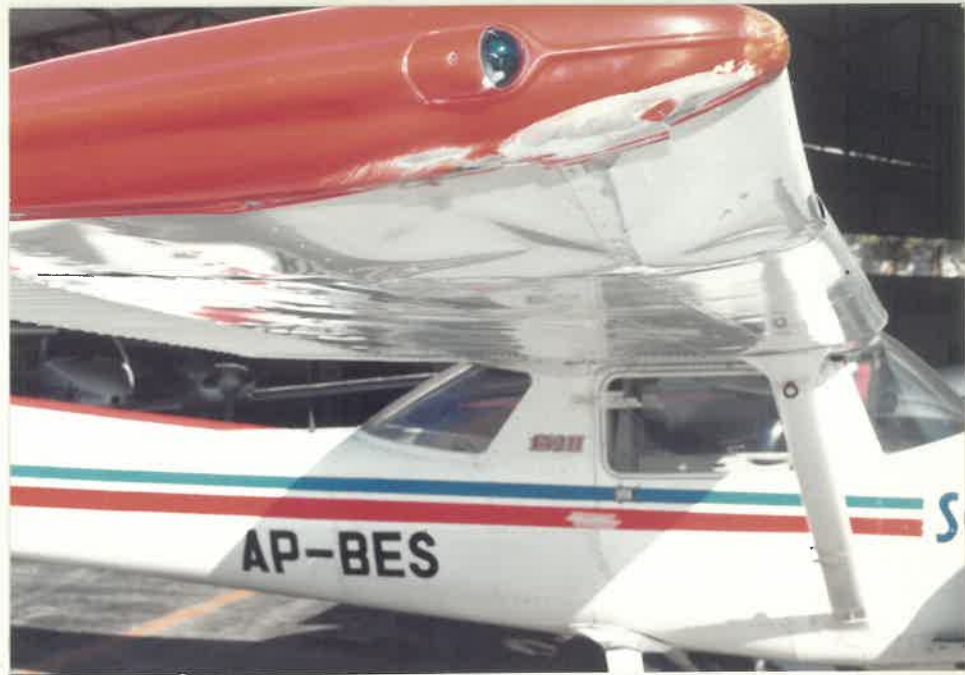
APP E1

RIGHT WING DAMAGE

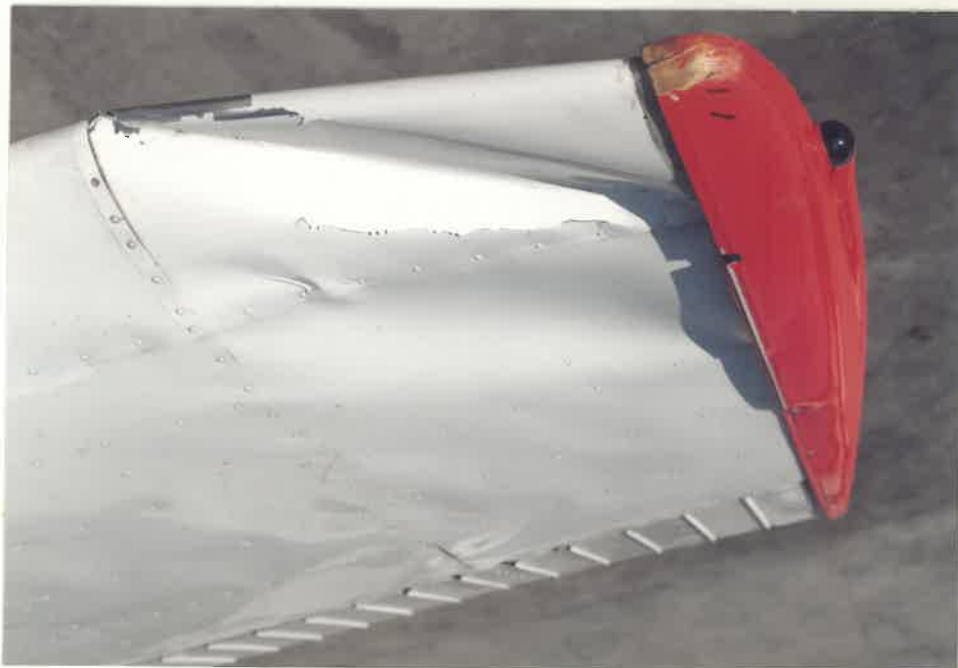
APP E2

RIGHT WING TIP DAMAGE

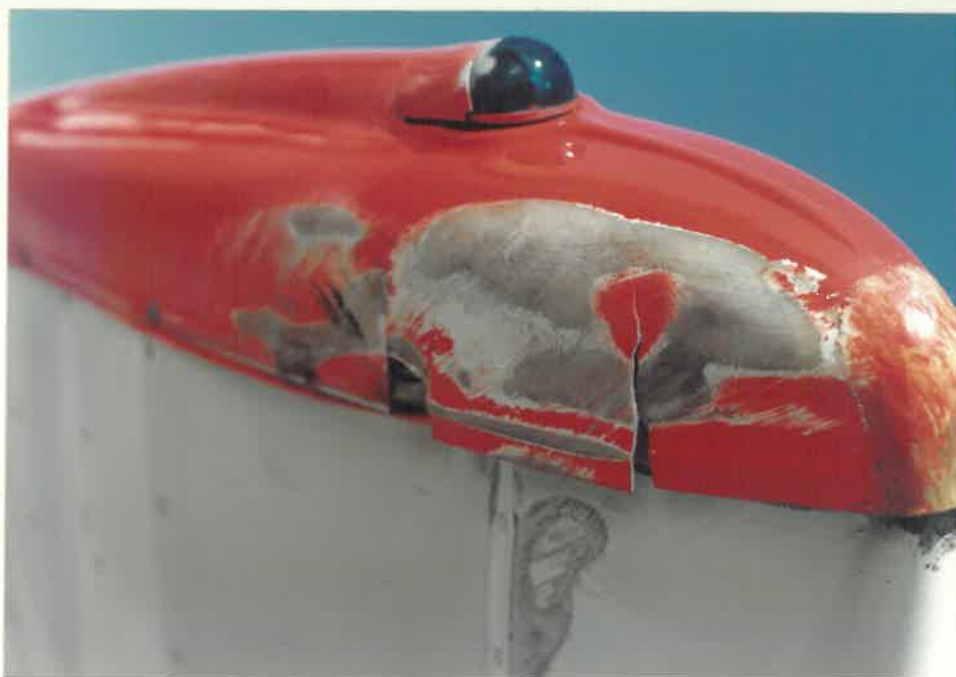
APP. "E3"

RIGHT WING TIP DAMAGE ANOTHER VIEW

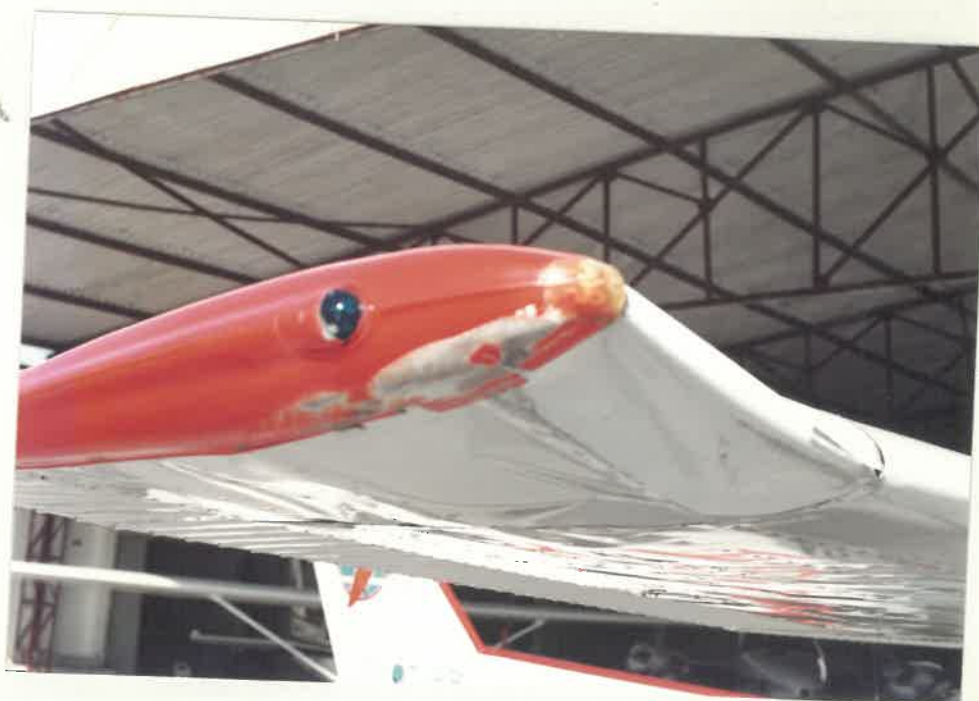
APP. "E4"

RIGHT WING TIP TWISTED

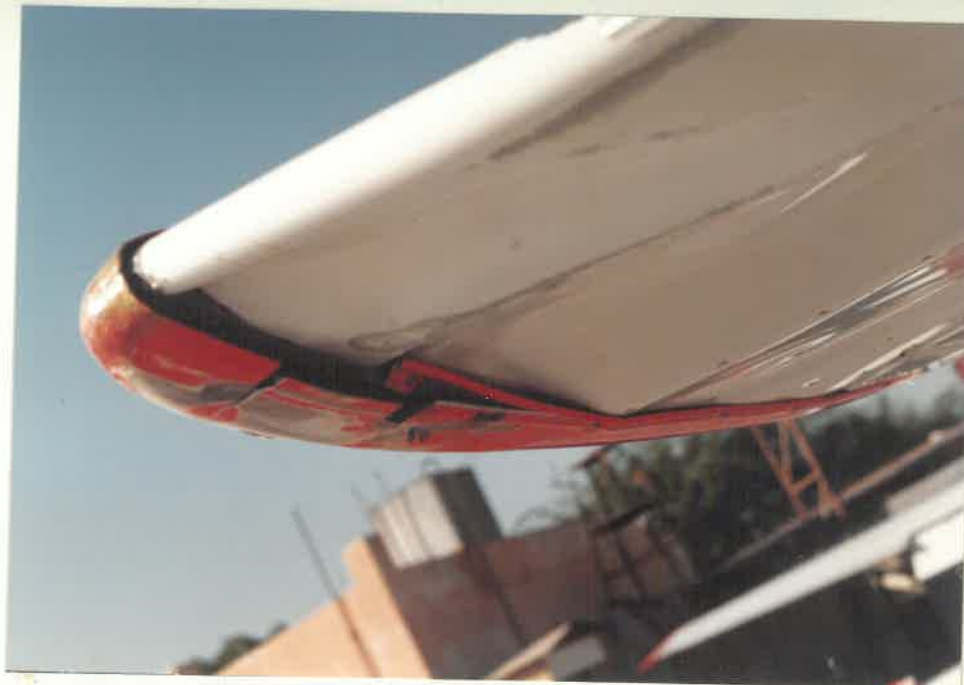
APP. E5

RIGHT WING UNDER SURFACE SCRATCHED AND BUCKLED

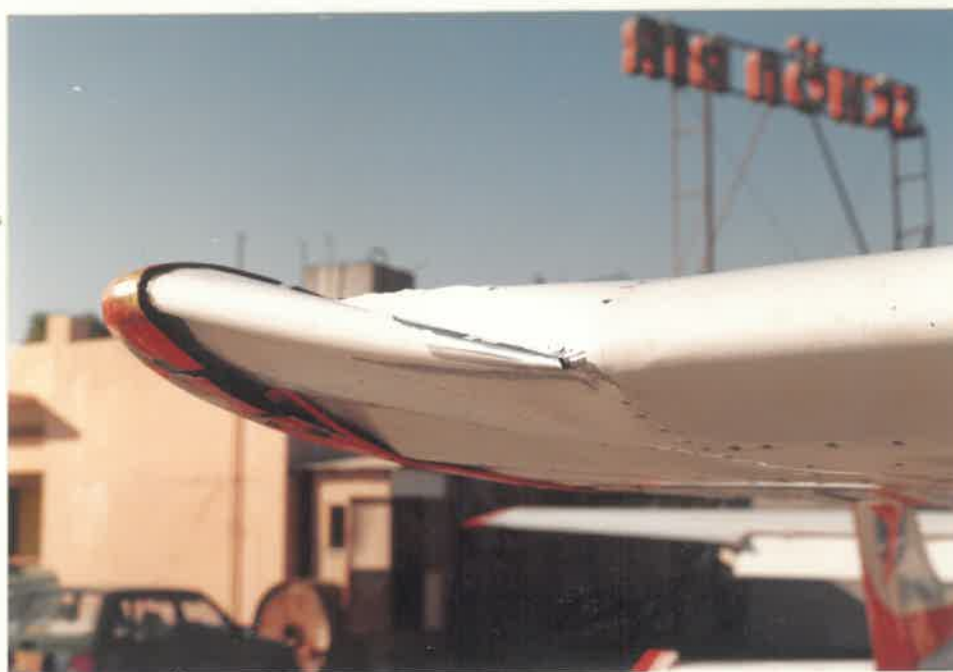
APP. E6

RIGHT WING TWISTED AND BUCKLED

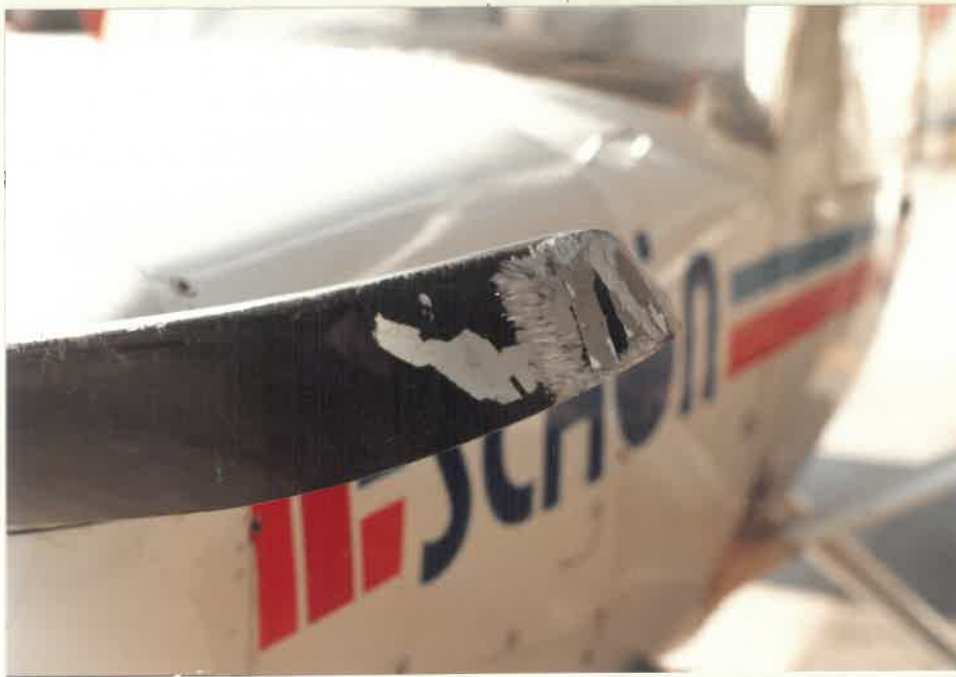
APP. E7"

DAMAGED PROPELLER BLADE

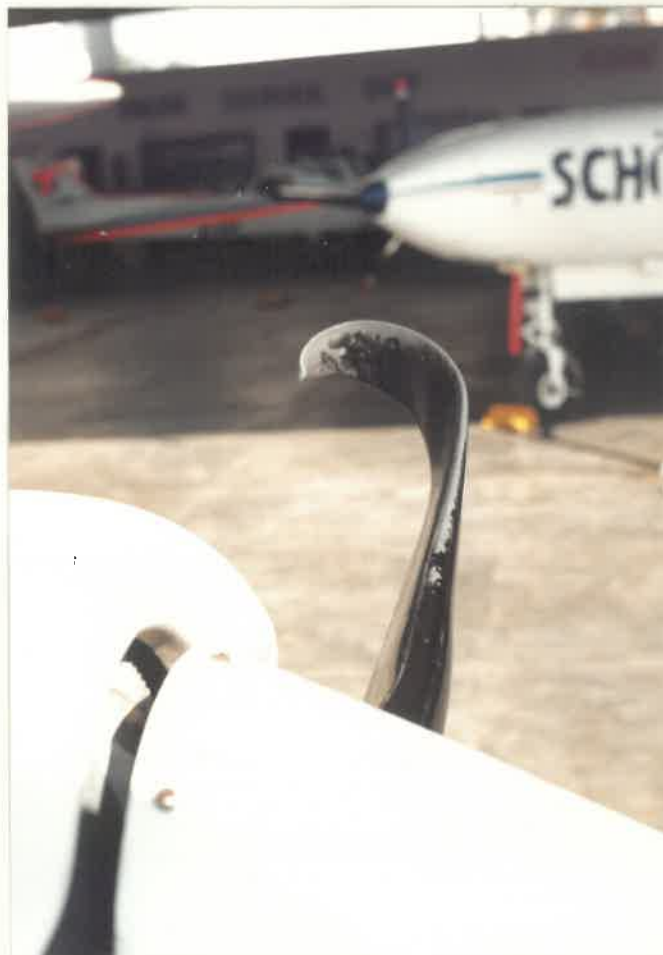
APP. E8"

DAMAGED PROPELLER

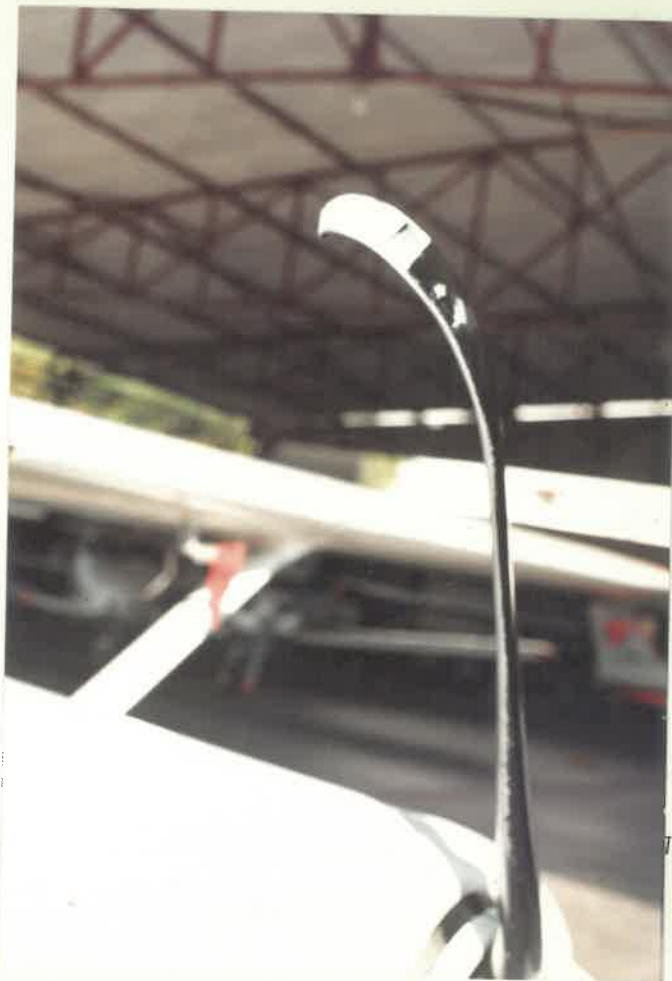
APP. "E9"

DAMAGE PROPELLER BLADE ANOTHER VIEW

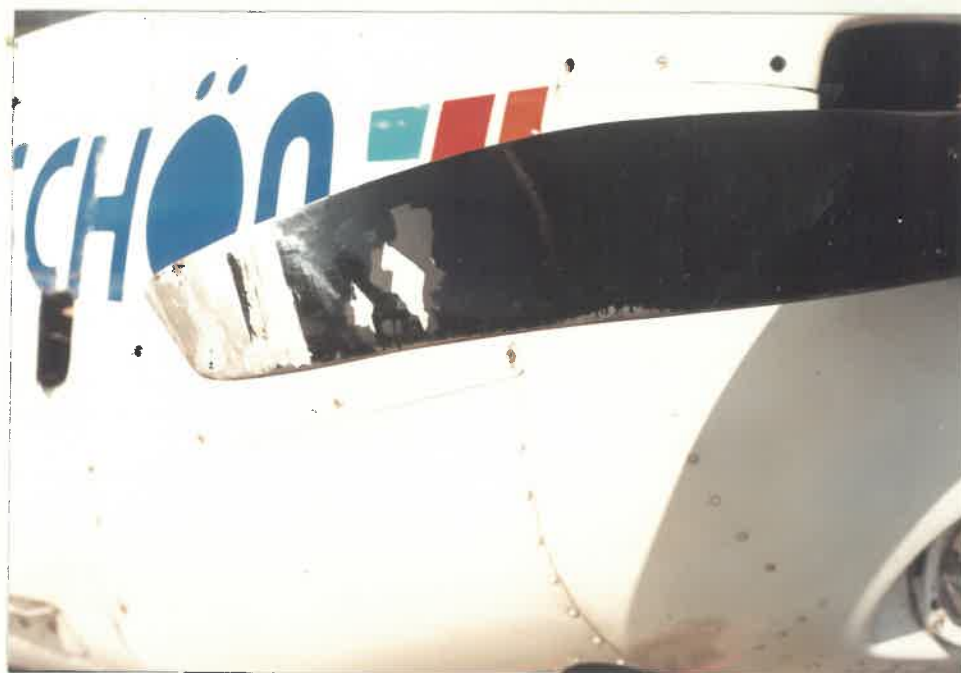
APP. "E10"

DAMAGED PROPELLER BLADE ANOTHER VIEW

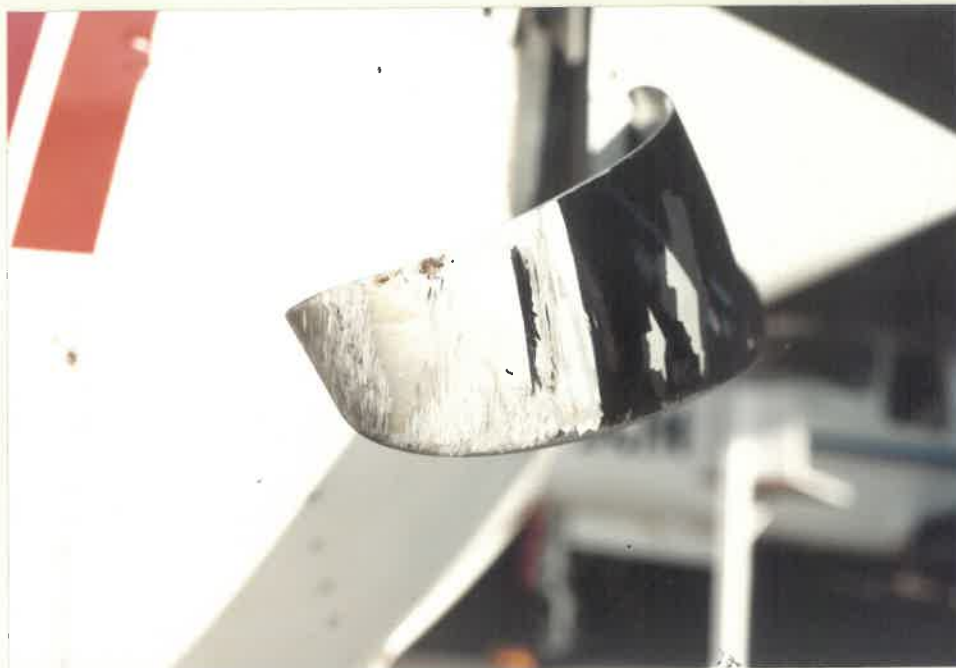
APP. E11

DAMAGED PROPELLER BLADE

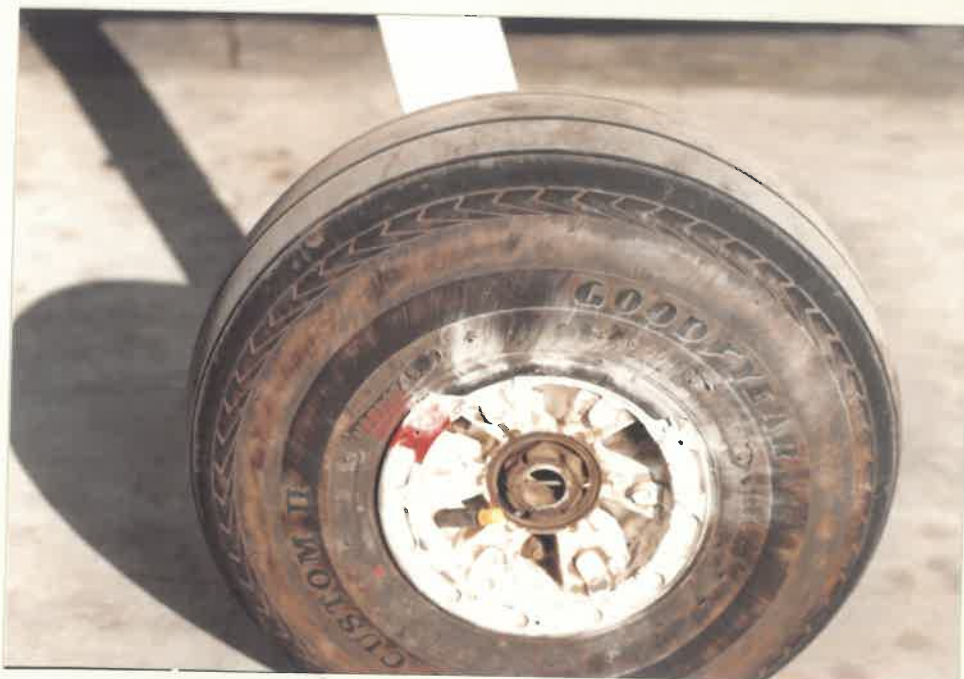
APP. E12

RIGHT MAIN WHEEL HUB CRACKED
