***SAFETY & INVESTIGATION BOARD  
PAKISTAN CIVIL AVIATION AUTHORITY***

**AIRCRAFT ACCIDENT INVESTIGATION REPORT**

**AP-BDX CESSNA-172 XP**

**FORCED LANDING NEAR MULTAN  
DUE TO FUEL STARVATION**

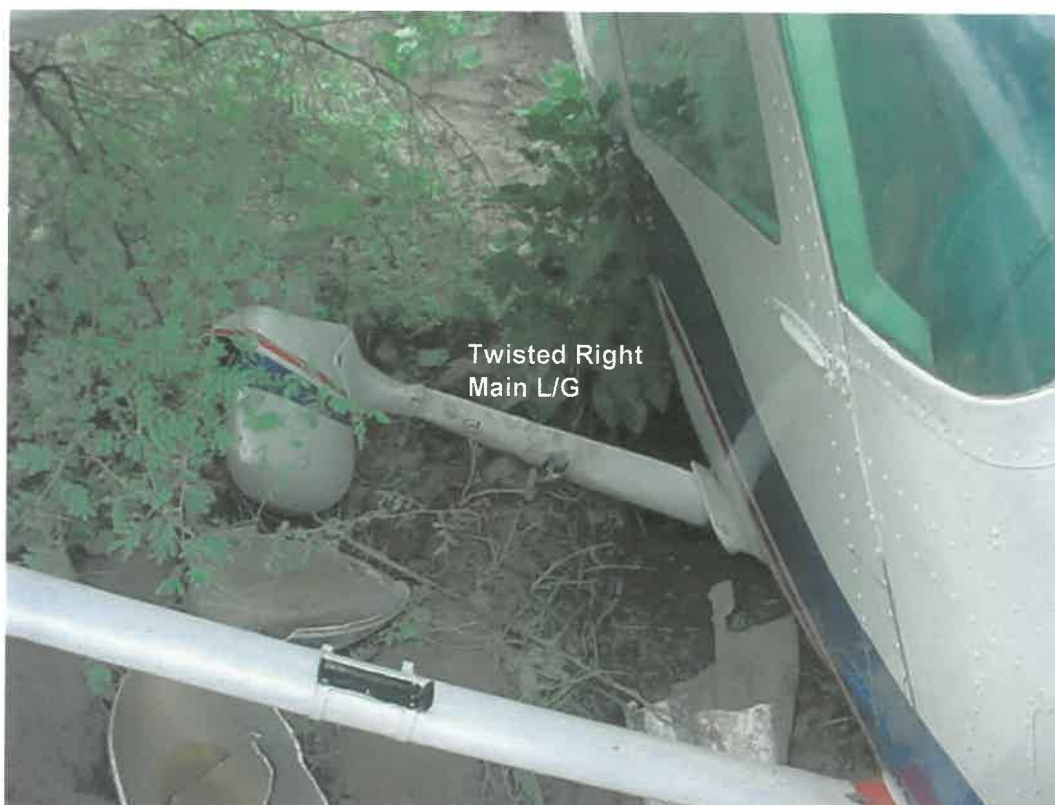
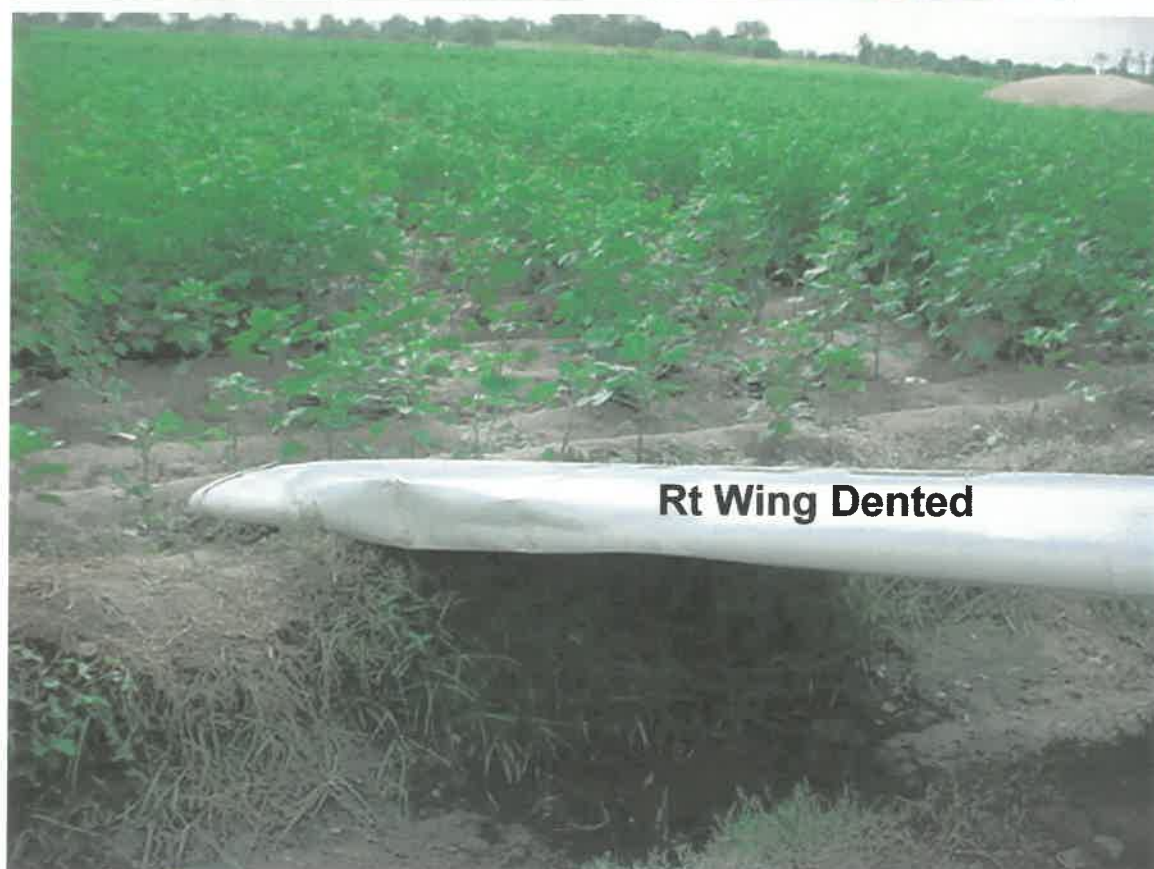
Right hand wing: A deep dent on the leading edge of the wing.  
Upper and lower skin of the wing was wrinkled.  
Tip fairing broken.

**Horizontal Stabilizer.** Right hand stabilizer front and rear spars were fractured and skin was ruptured. Leading edge upper skin of elevator was cracked. Static wick from left hand elevator was missing.

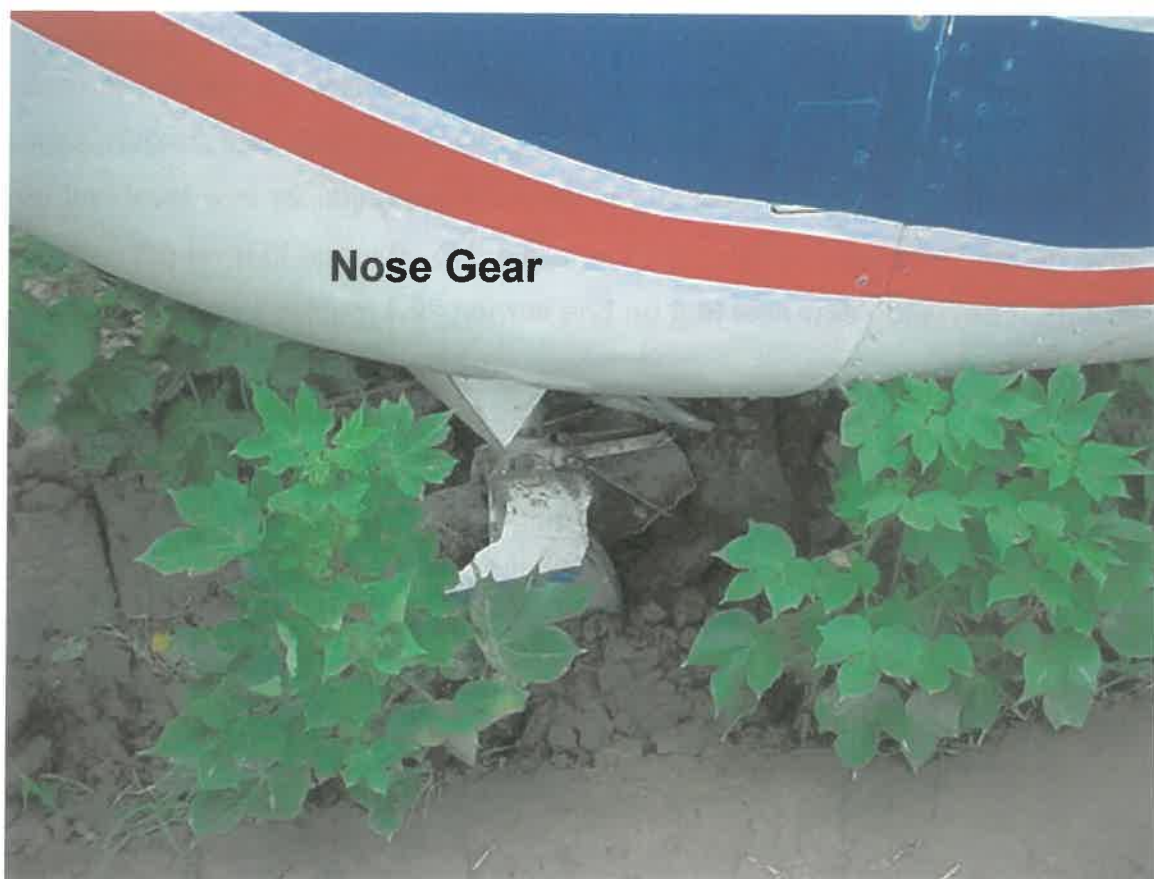
**Nose Gear**

**LANDING GEARS.** Right hand landing gear fairing was broken. In board forging cross bolt was sheared and gear turned about 60 degree up. Fairings of all three landing gears were broken.

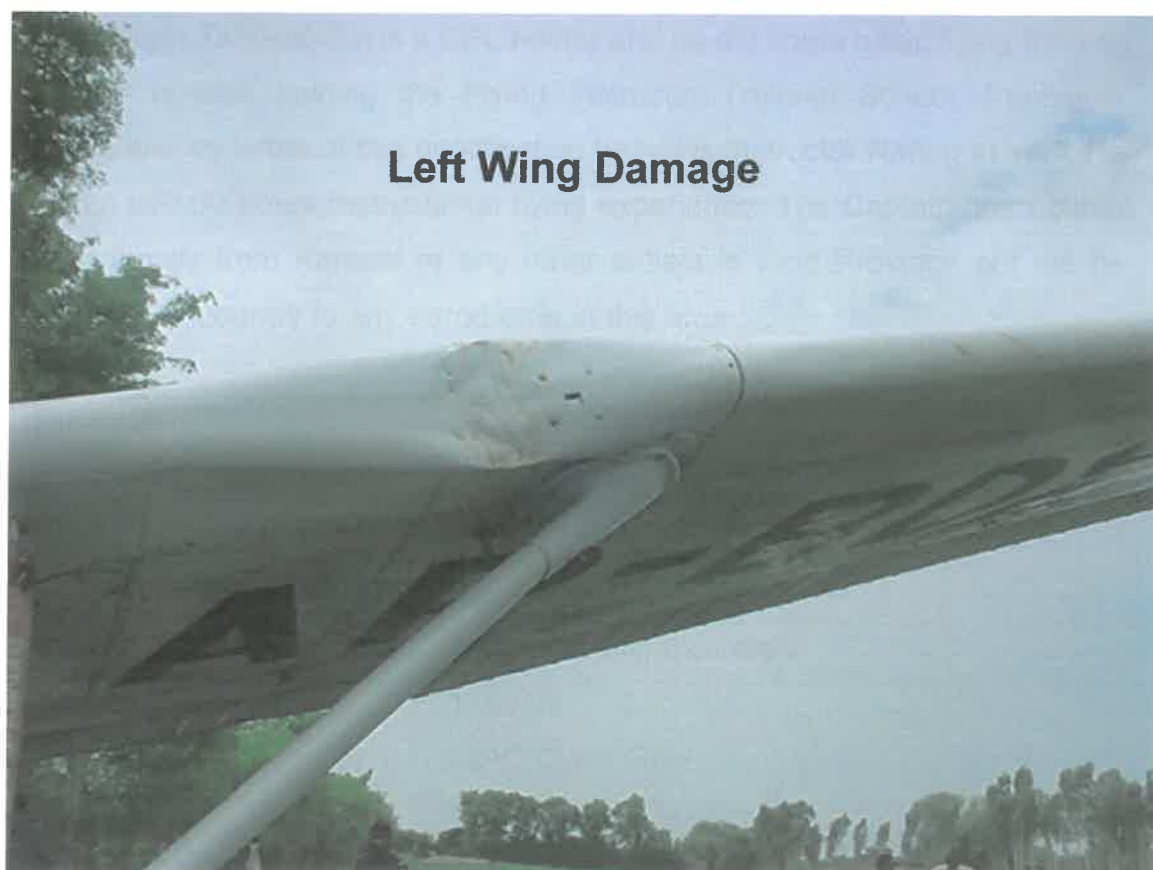
**Left Wing Damage**

Two dents on leading edge  
Several rivets on leading edge sheared  
Stall warning pick up broken.  
Wing Tip fairing and Nav.light broken.

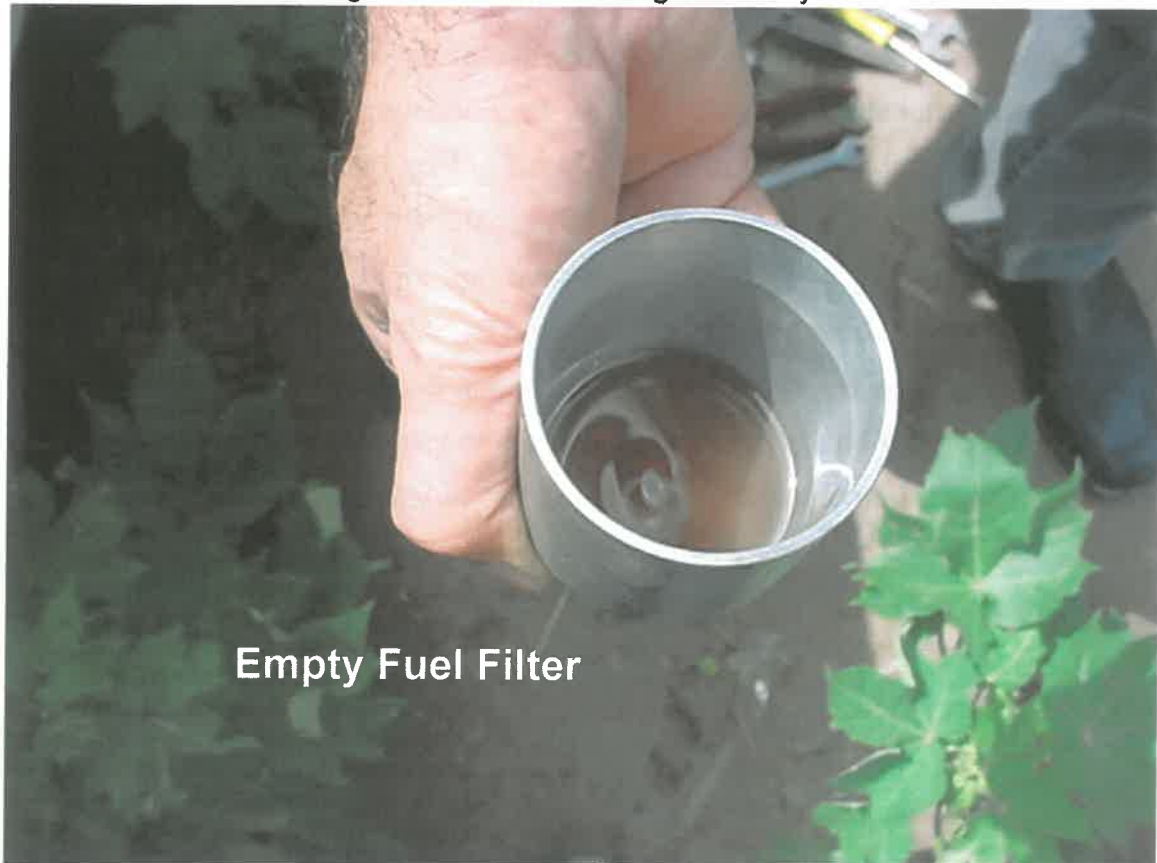
23. **Fuel Starvation.** On battery power left tank fuel gauge read below zero. In view of the empty tanks, presence of fuel in the lines and fuel filter was checked. The closing of fuel cock in the cockpit traps the remaining fuel in the line to fuel filter sump. Some contaminated residual fuel was found below the level of engine fuel system inlet, indicating interrupted fuel supply due to starvation. The opening of fuel cock in the cockpit also did not release any fuel in the fuel filter, confirming fuel starvation to engine fuel system.
