**CIVIL AVIATION AUTHORITY**

**AIRCRAFT INCIDENT INVESTIGATION**

**INVESTIGATION IN RESPECT OF INCIDENT TO**  
**M/S PIAC AIRBUS REG NO. AP-BBM OCCURRED ON**  
**16TH AUGUST, 1996 AT KARACHI AIRPORT.**

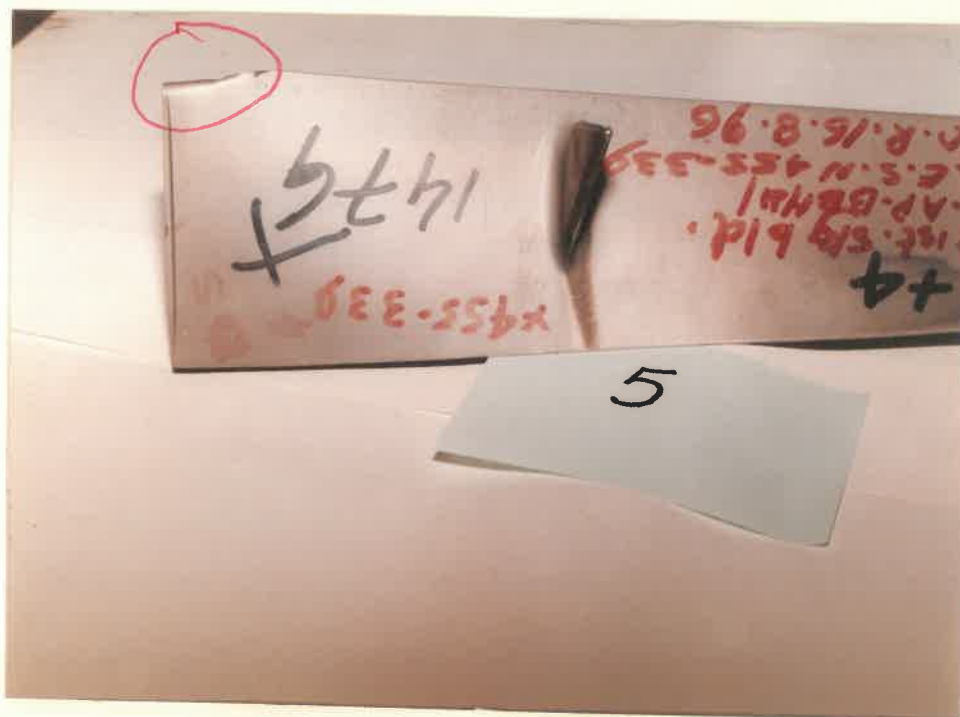
APP. 'B'1

32. After accomplishing BSI on No.1 engine Engr Rais Khan observed damage on five first stage compressor blades out of which one blade had evidence of material tear at the tip of the leading edge by about 3/4 inch which is not permissible in accordance to Page 202 Chapter 72-31-00 of Airbus Maintenance Manual(Ref App 'F'). Hence Engr. Rais entered subject discrepancy in the log book and No.1 engine SNo. 455339 was removed.
33. The Board after examining the evidence of damage on blade marked No. 5(Ref App B1&B2) and the limits given in Airbus Maintenance Manual Page 202, Chapter 72-31-00 is of the view that engine removal under the circumstances was justified and Engr. Rais Khan along with Engr. Yousaf adopted right course of action.

36. The Board after examining the distressed blade that was damaged beyond limit was of the opinion that subject blade was damaged beyond limit in accordance to Page 202 Chapter 72-31-00 of Airbus Maintenance Manual. (Ref Appendix 'F'). As such, the action taken by Engr. Rais Ahmed Khan by logging an entry to that affect was correct and subject engine was rightly removed from the wing. Additionally, the Board observed that Mr. Dye had two opinions on the subject of release of engine for further operation with the stressed blade that was damaged beyond limit and both these opinions he gave after examining the blades physically. Therefore, under the circumstances it appears to the Board that Mr. Dye was not sure of his opinion on the subject which is in gross violation of the limitations given by the company in the Maintenance Manual and the matter needs to be resolved by physically sending the affected blades to GE USA.

the manufacturer in the Airbus Maint Manual Page-202/203 Chapter 72-31-00. The damage to blade (Ref Appendix B1 & B2) was beyond limits.

FIRST STAGE COMPRESSOR BLADE LEADING EDGE  
TEARED - 3/4 INCH BEYOND LIMITS OF MM.

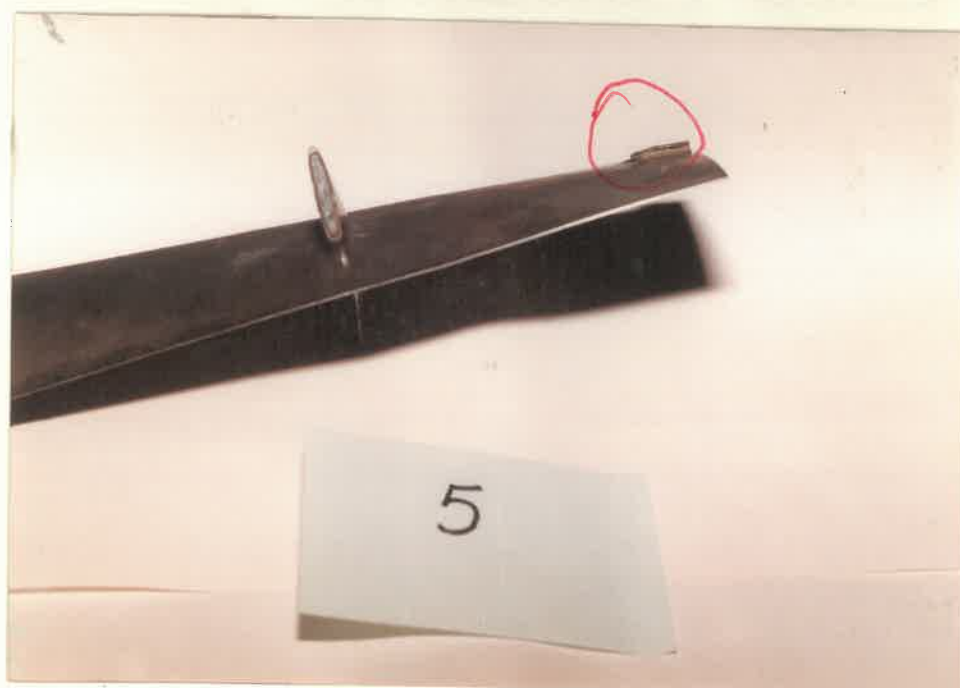
APP. 'B'2

FIRST STAGE COMPRESSOR BLADE LEADING EDGE  
TEARED - 3/4 INCH BEYOND MAINT MANUAL LIMIT

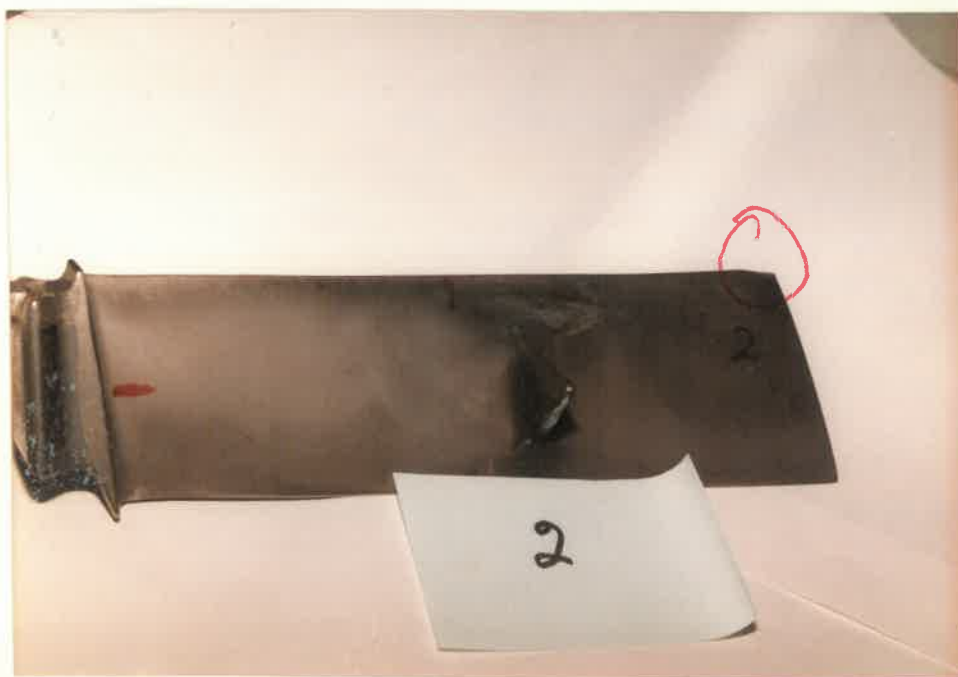
APP. 'B3

ANOTHER 1ST STAGE COMP BLADE DAMAGE

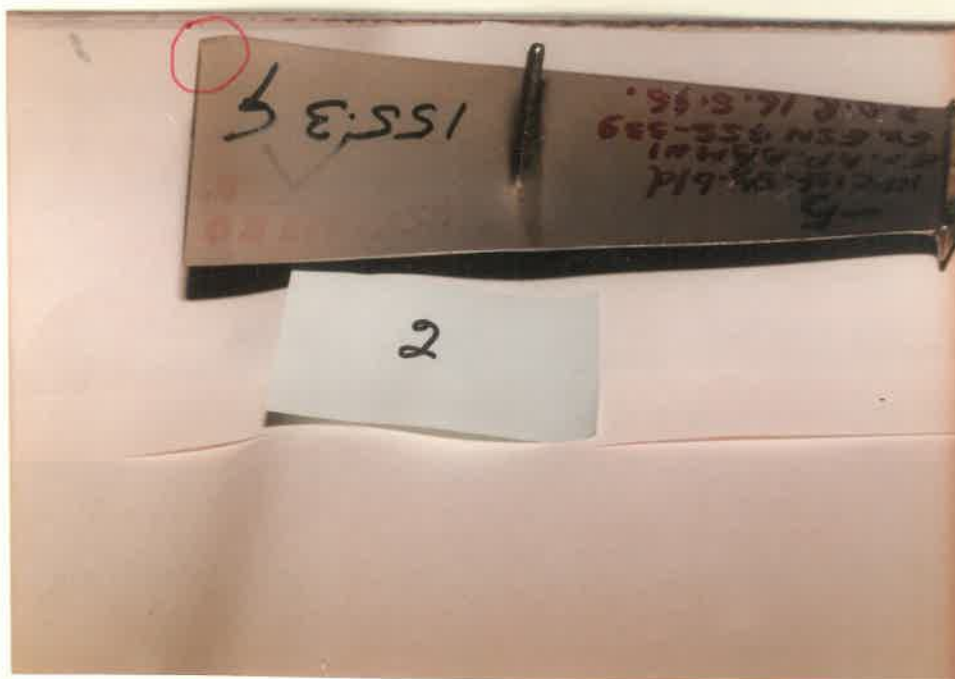
APP. 'B4

ANOTHER 1ST STAGE COMP BLADE DAMAGE

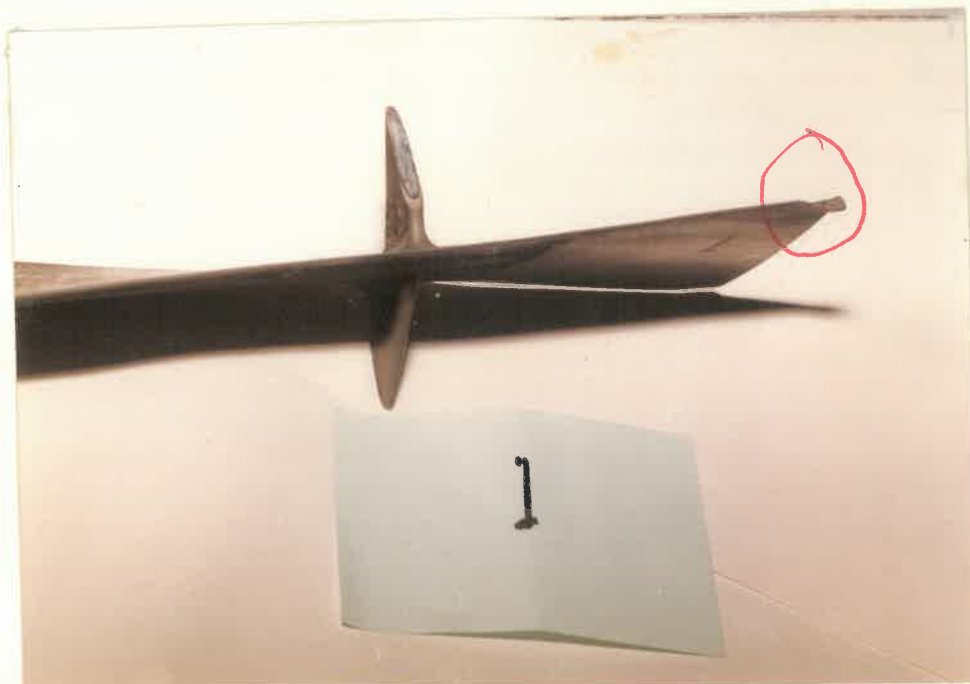
APP. 'B'5

FIRST STAGE COMP BLADE DAMAGE

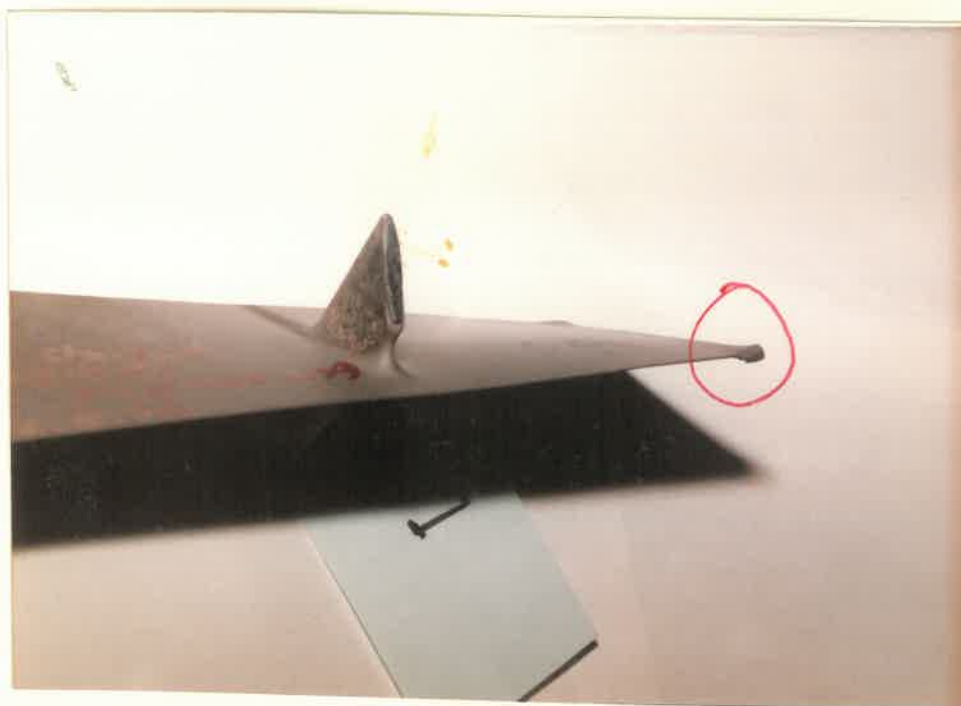
APP. 'B'6

FIRST STAGE COMP. BLADE DAMAGE

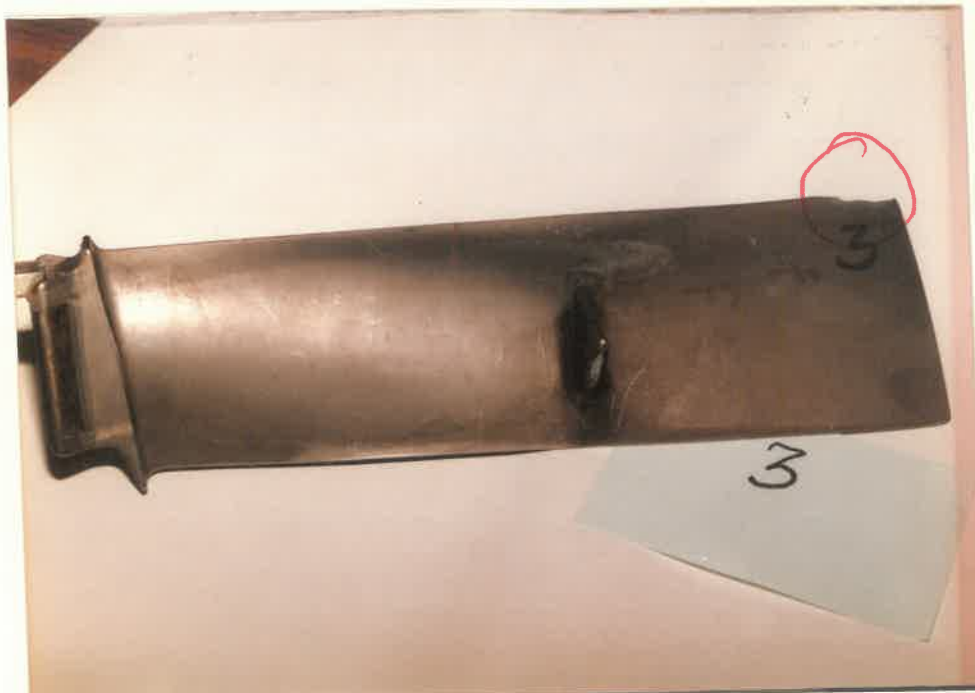
6  
APP. 'B'7

ANOTHER 1ST STAGE COMP BLADE DAMAGED

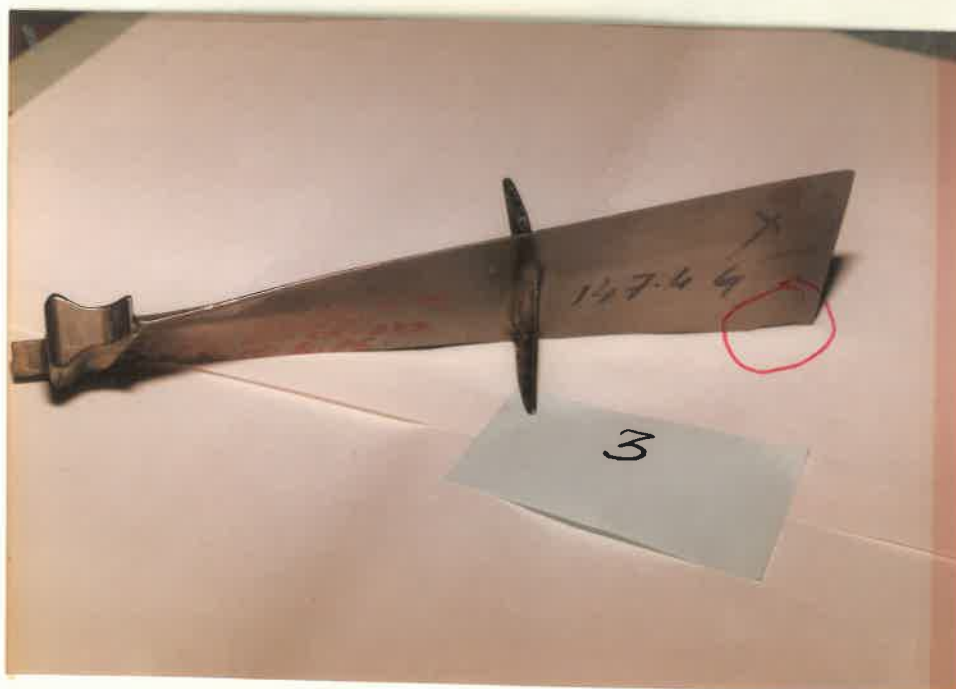
APP. 'B'8

ANOTHER 1ST STAGE COMP BLADE DAMAGED

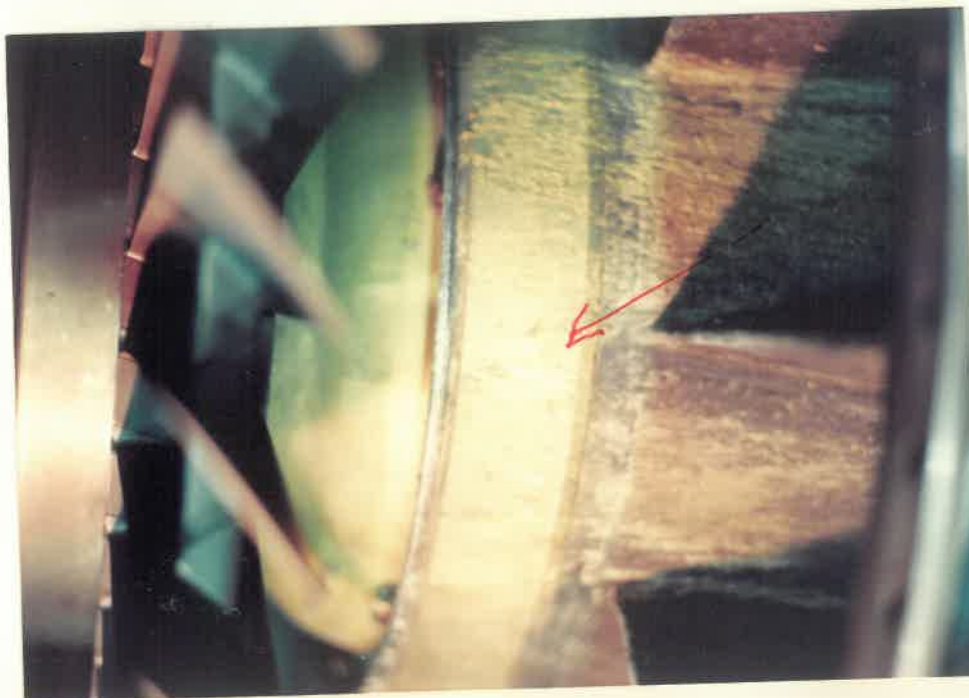
APP. 'B'9

EVIDENCE OF BIRD INGESTION IN THE ENGINE IN TAKE

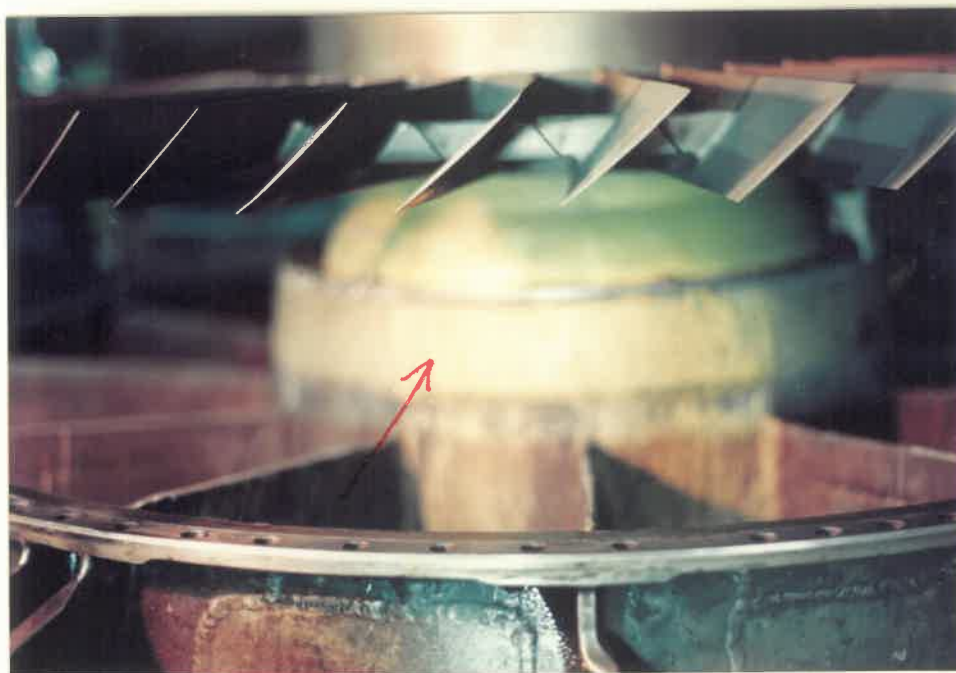
APP. 'B'10

ANOTHER VIEW OF EVIDENCE OF BIRD INJECTION  
IN THE ENGINE IN TAKE

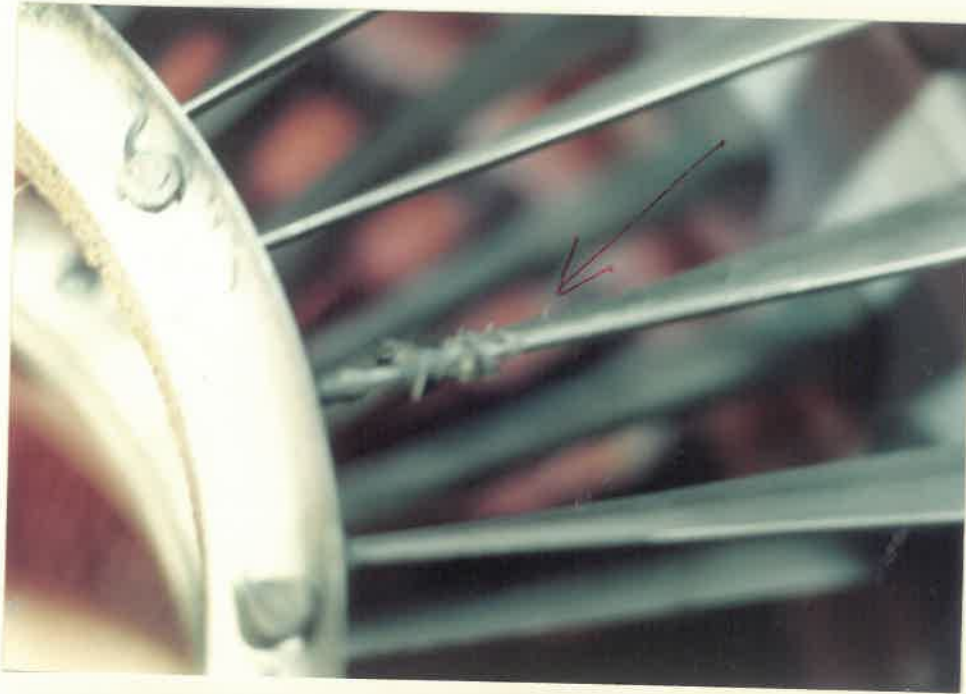
APP. 'B'11

18.4. Few bird feathers at the outer end of outlet guide vanes. (Ref Appendix B11 to this report)

EVIDENCE OF BIRD FEATHERS IN THE ENGINE IN TAKE

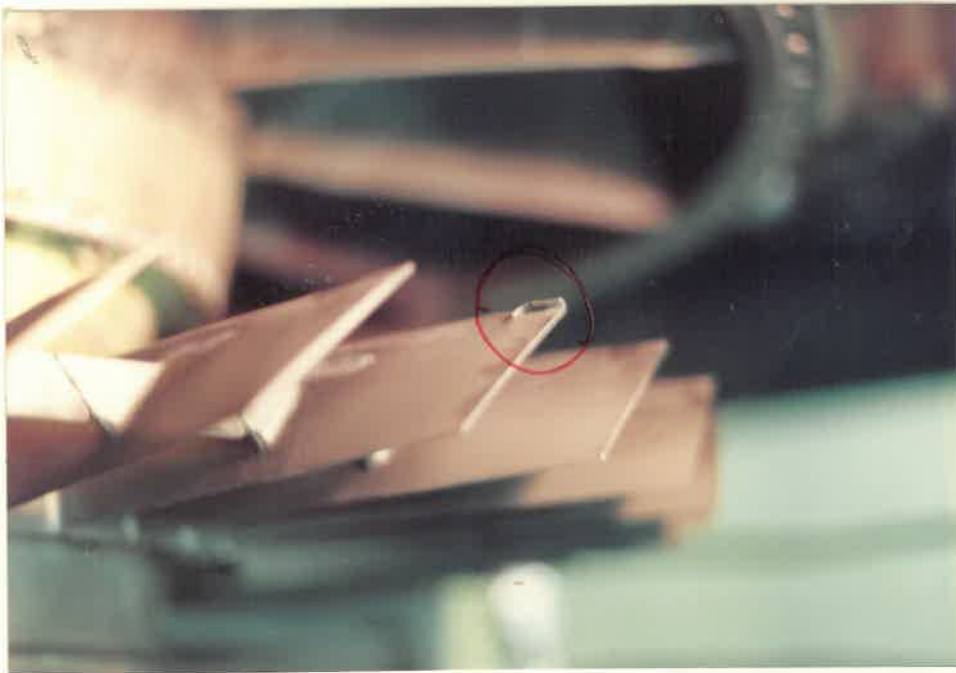
APP. 'B'12

1ST STAGE COMP BLADE DAMAGE

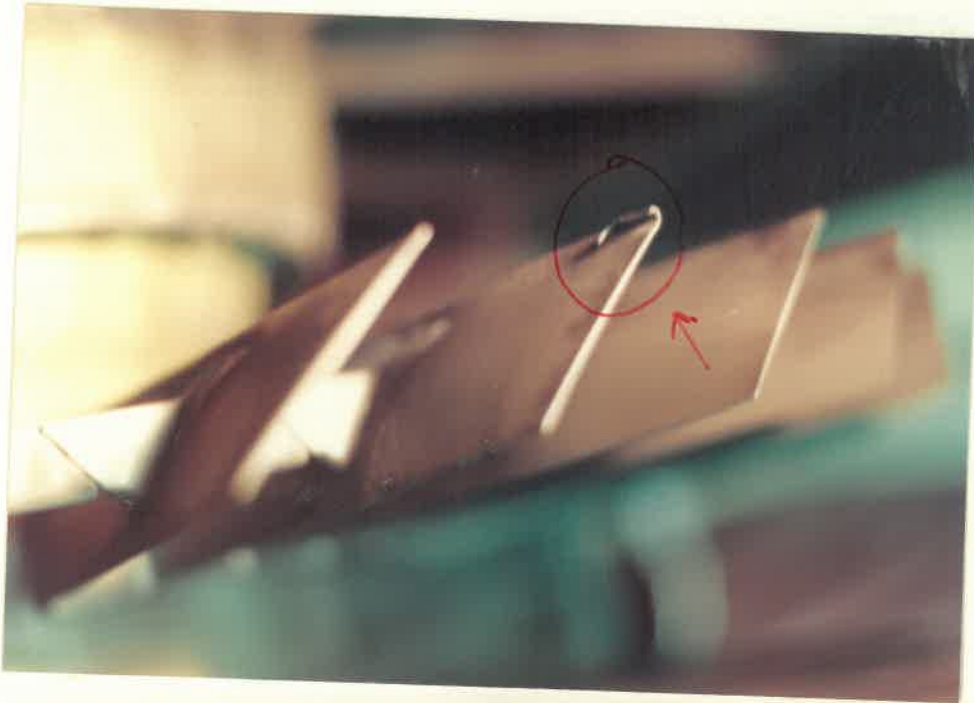
APP. 'B'13

EVIDENCE OF BLADE DAMAGE 1ST STAGE COMP BLADE

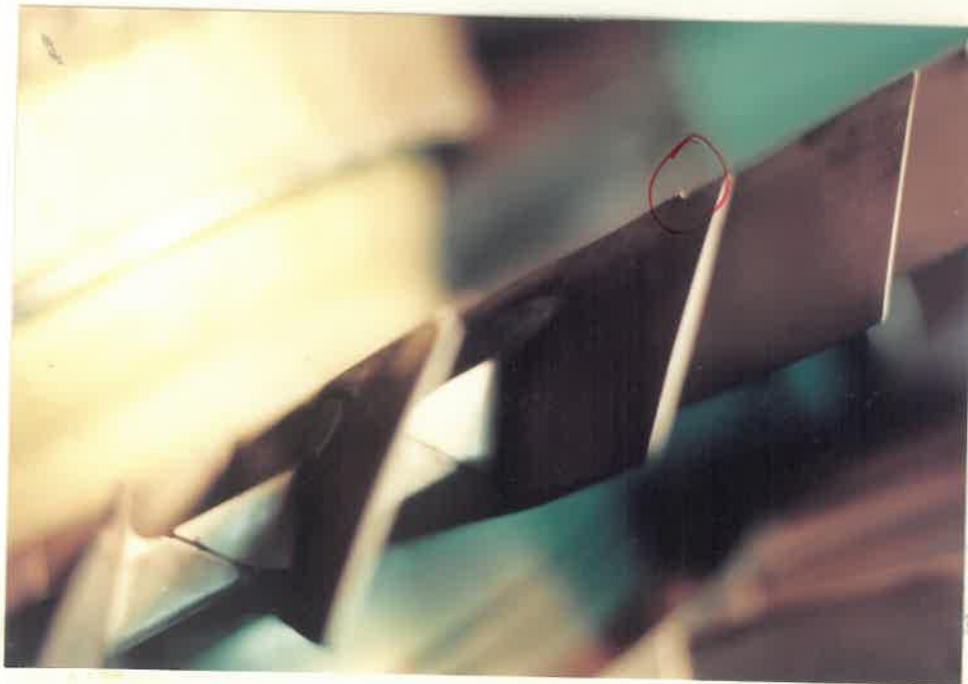
APP. 'B'14

EVIDENCE OF DAMAGED BLADE

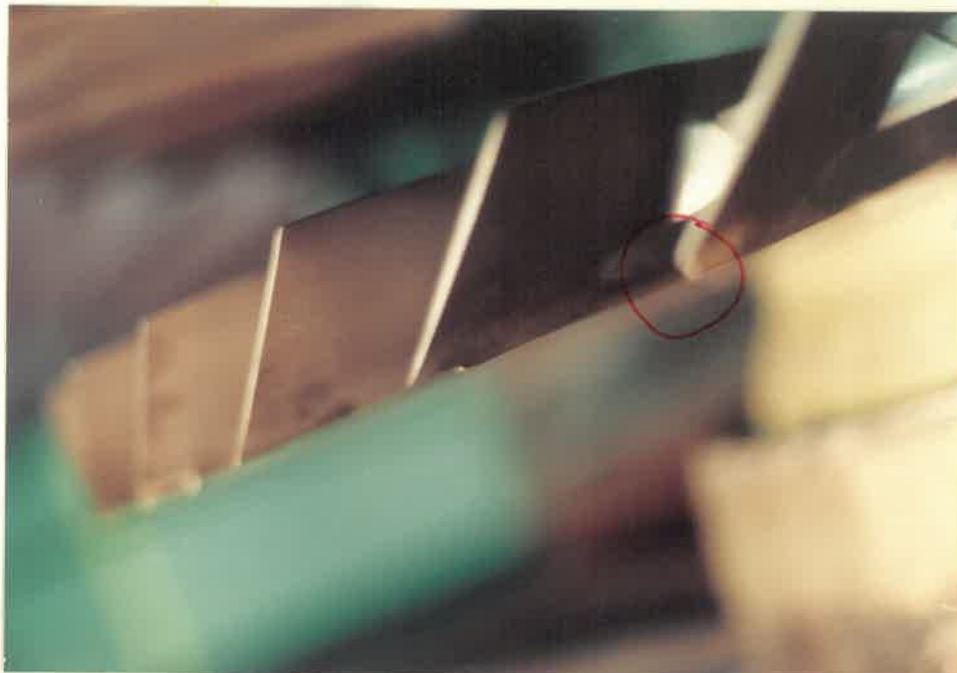
APP. 'B'15

EVIDENCE OF DAMAGED BLADE

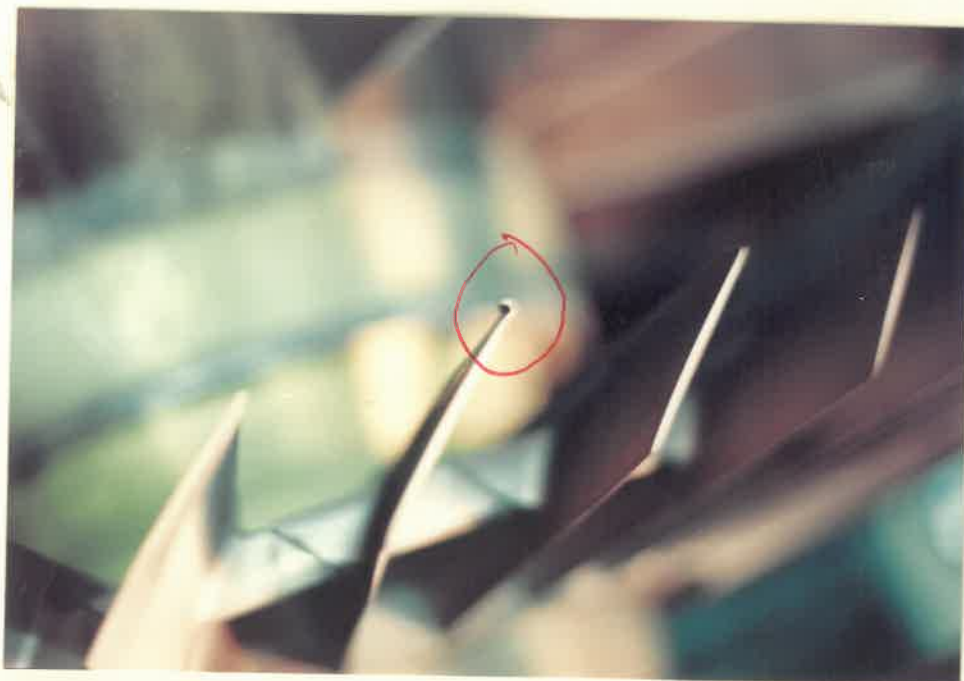
APP. 'B'16

EVIDENCE OF ANOTHER BLADE DAMAGED
