**CIVIL AVIATION AUTHORITY**

**AIRCRAFT INCIDENT INVESTIGATION M/S PIAC**

**BOEING 747 REG.NO.AP-BCN WHICH OCCURRED**

**ON 13TH APRIL, 1996**

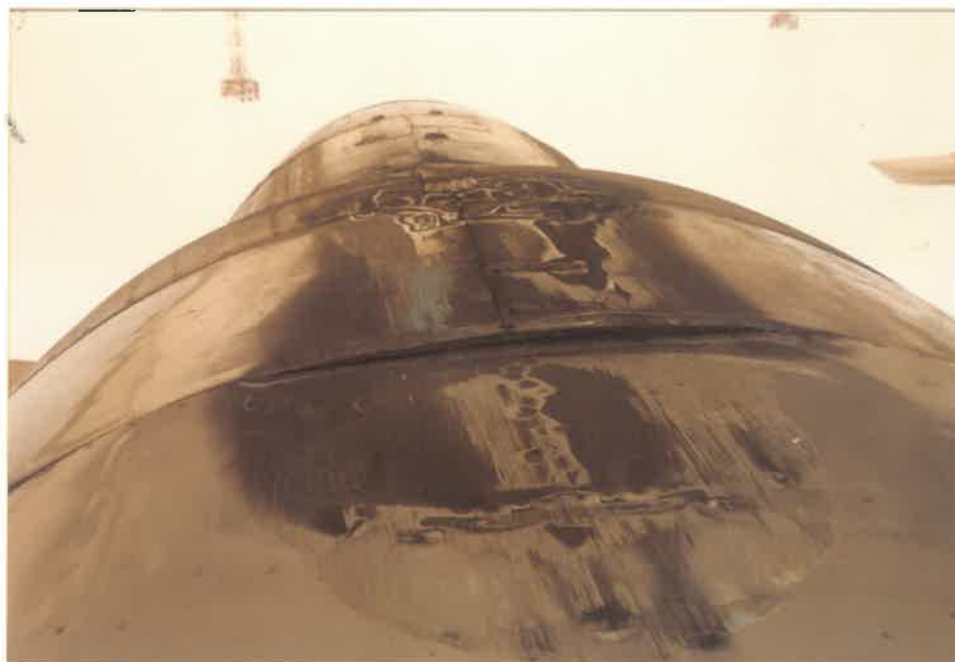
**B.8**

ANOTHER VIEW OF UNDER SURFACE DAMAGE OF NO.1 ENGINE
