**CIVIL AVIATION AUTHORITY**

**AIRCRAFT INCIDENT INVESTIGATION**

**B-737 AP-BCB**

INCIDENT OF BOEING - 737-340 AIRCRAFT AP-BCB WHILE  
OPERATING PK-380 ON 11-8-93 AT ISLAMABAD AIRPORT

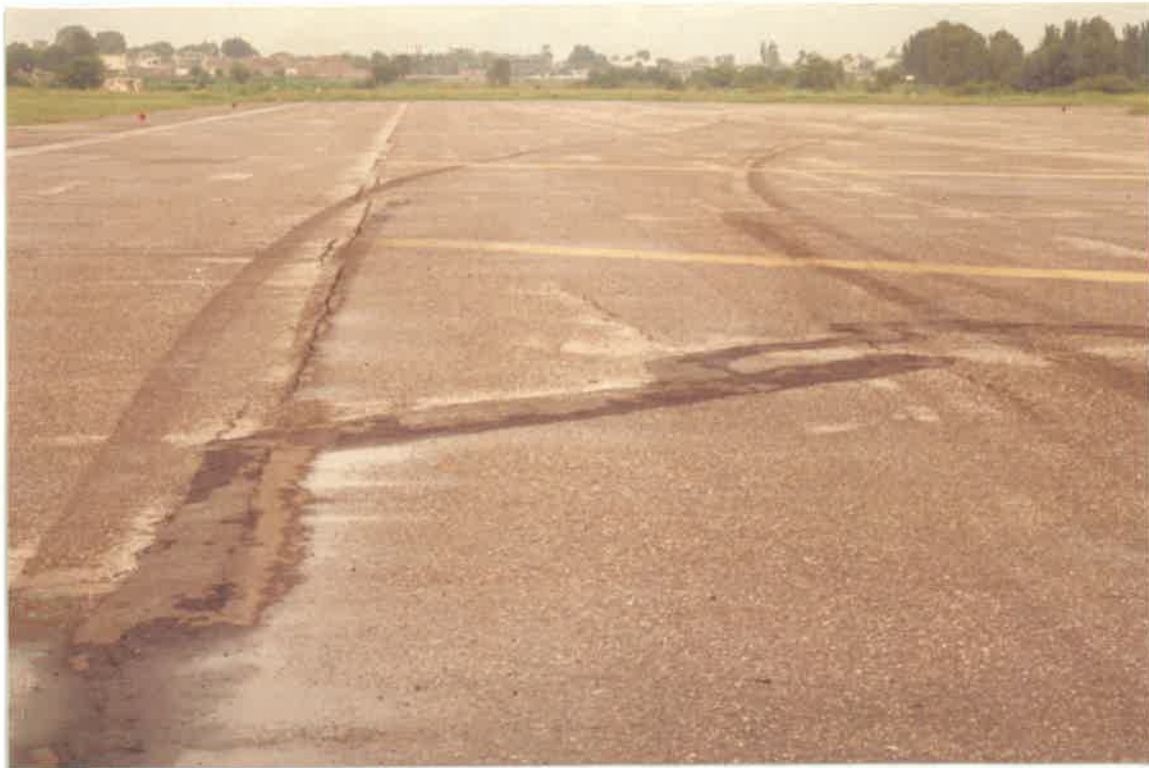
APP. 'C'  
10F 6

- 18.6. At about 500 ft before end of the runway aircraft veered to left of centre line because of skidding. There were wear marks of all four wheels on the over-run area of runway. Both the inboard wheels had scuffing and then burst. After bursting marks of only outer wheels were there. Both inboard wheels locked simultaneously and burst together. Both had similar scuffing. It would be worth mentioning here that scuffing is caused by wheel locking on a dry runway. The wheel locking was due to partially unserviceable antiskid system and hard braking. The outer wheels did not get locked because antiskid protection was still available to these. Captain made left turn on the dubmle of over-run area and started back tracking. After reaching about 1,000 ft on runway 12; he was stopped by CAA fire tender and was informed that tyres on both inboard main wheels have burst. Aircraft was, therefore, parked on runway and the passengers disembarked there from normal exit through passenger stairs. Neither the inboard tyres were hot nor their

Both main landing gears wheels (both inner and outer) marks on over-run area.

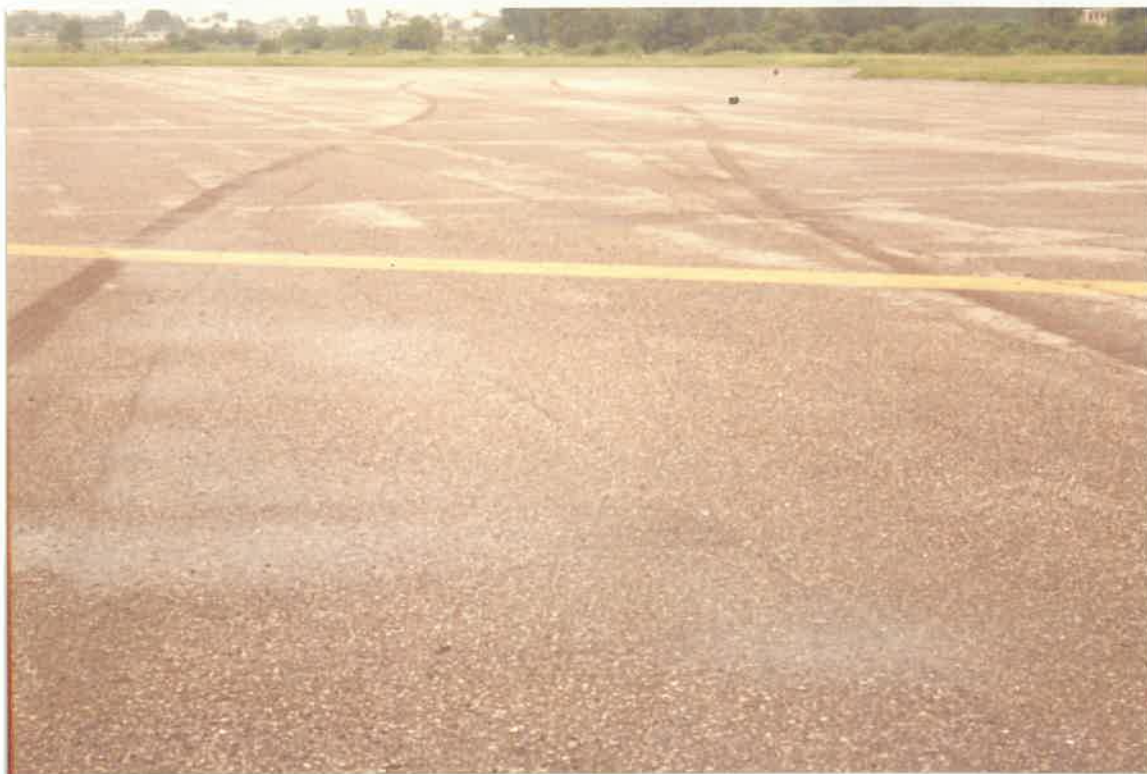
APP. C'  
2 of 6

Both main landing gears wheels (outer only) marks upto end of over-run area.

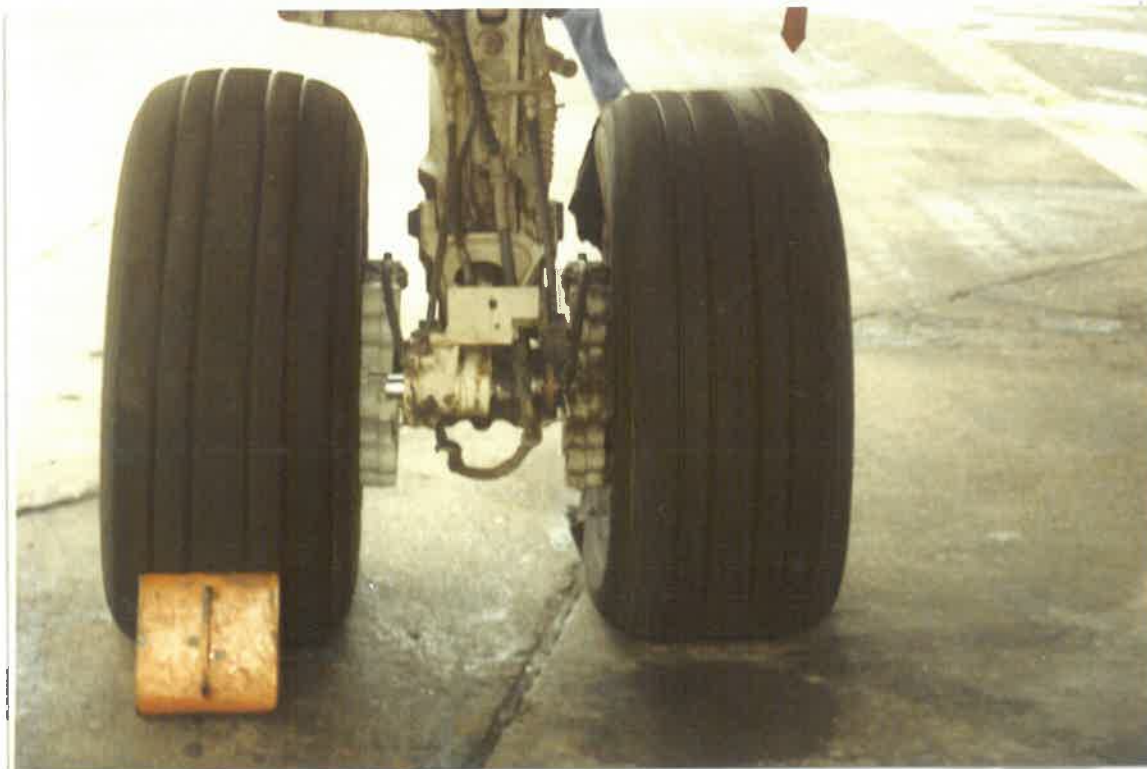
19.16. Due to partial un-serviceability of antiskid system both inboard wheels got locked. This resulted in scuffing and then bursting of tyres on these wheels.

Left main landing gear wheels with inboard tyre burst.

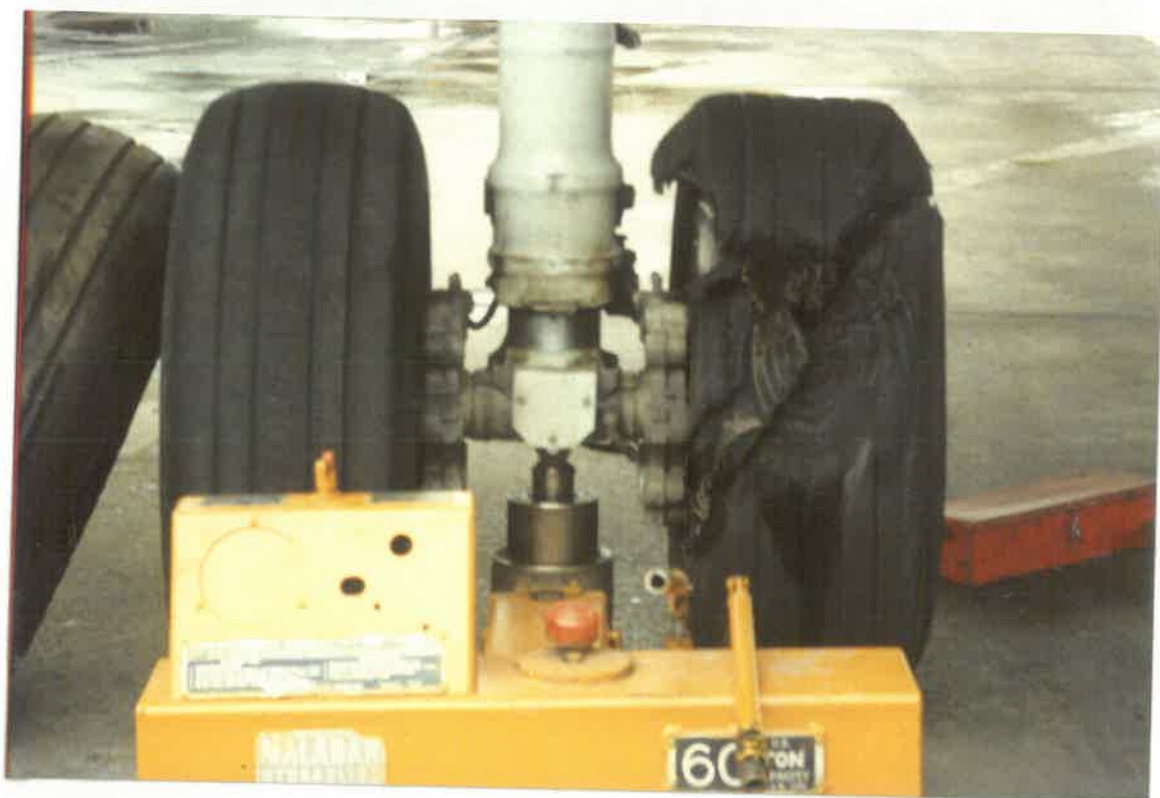
APP. 'C'  
3 of 6

Left main landing gear wheels with inboard tyre burst and scuff.

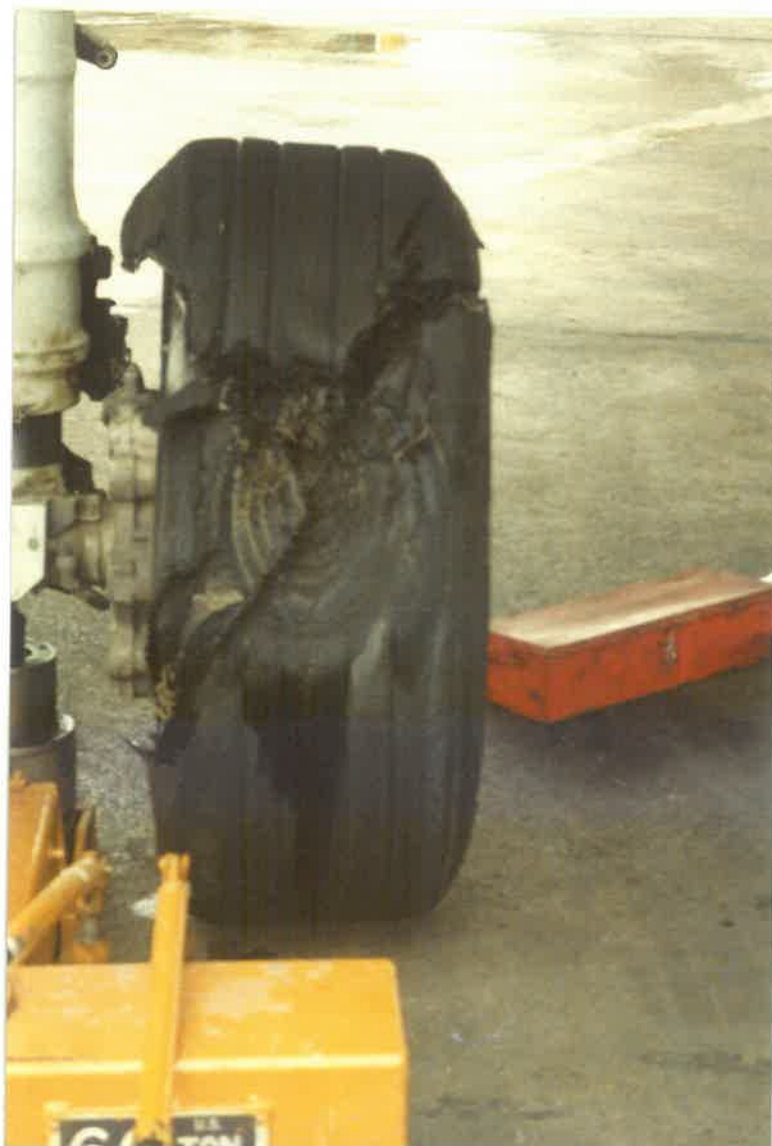
APP. 'C'  
4 of 6

Left main landing gear inboard tyre burst (close up).

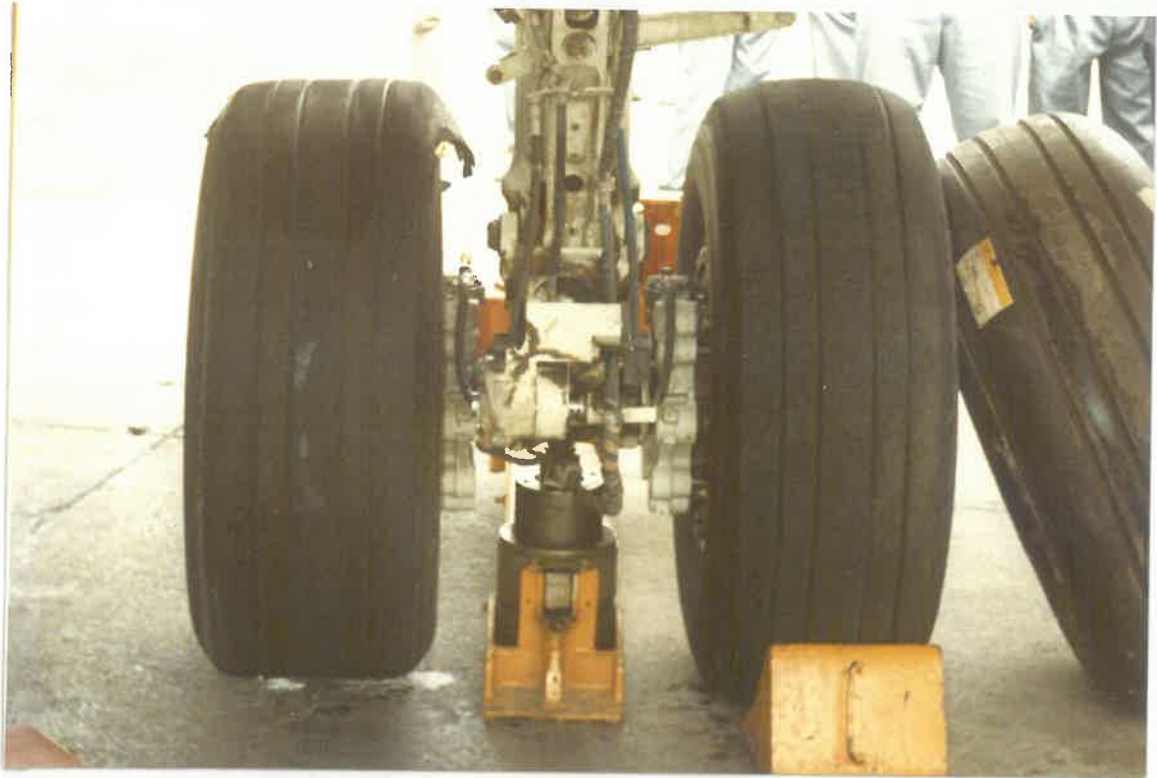
APP. 'C'  
5 OF 6

Right main landing gear wheels with inboard tyre burst.

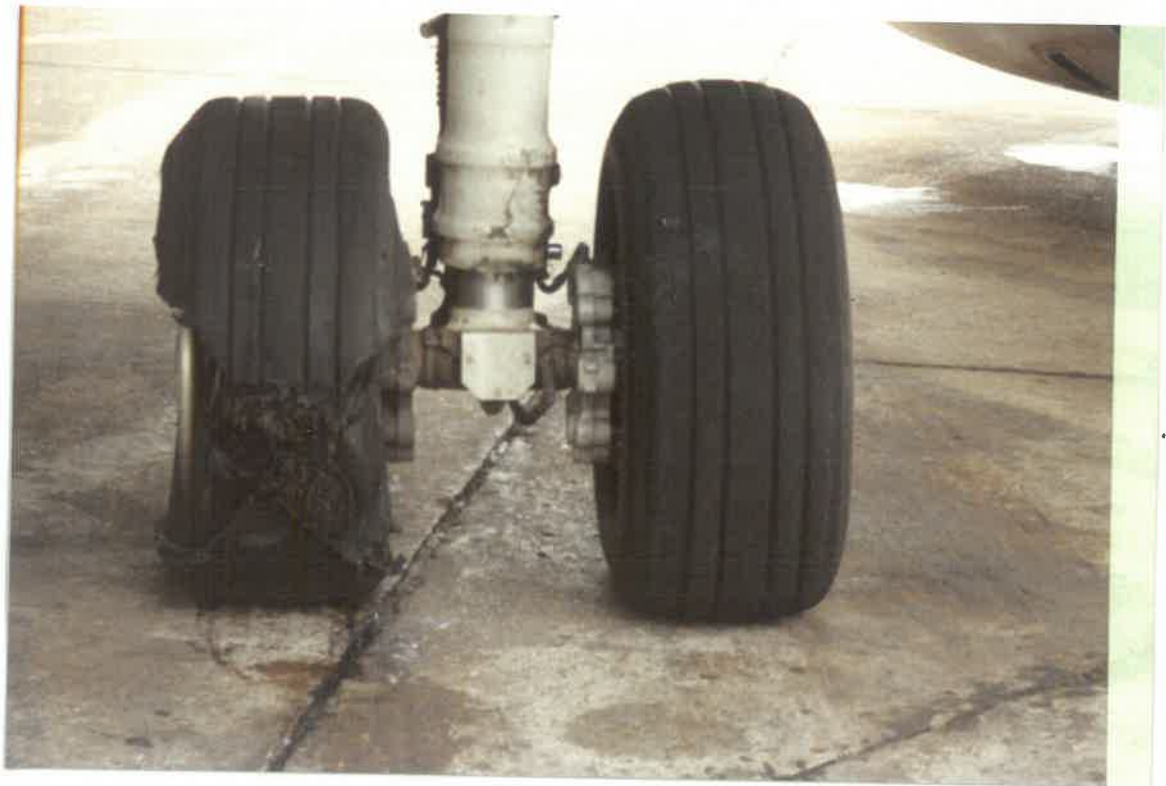
Right main landing gear wheels with inboard tyre burst and scuff.

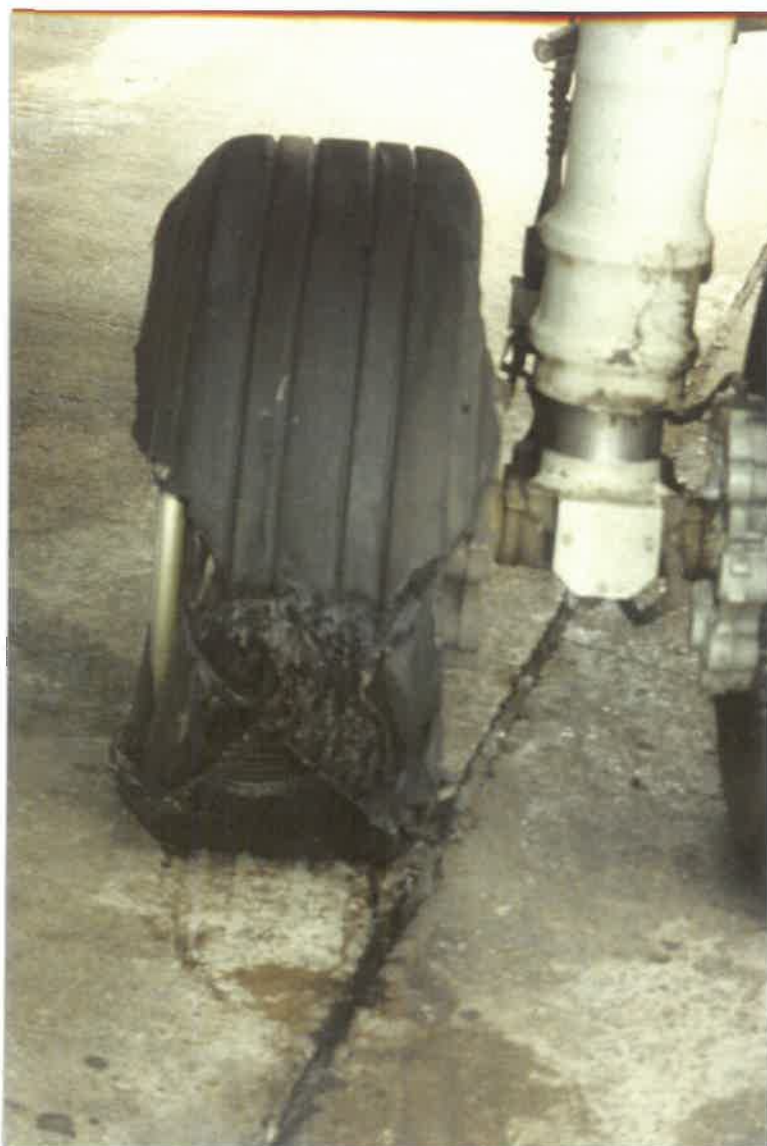
APP. 'c'  
6 of 6

Right main landing gear inboard tyre burst (close up).
