## AIRCRAFT INCIDENT INVESTIGATION REPORT PAKISTAN CIVIL AVIATION AUTHORITY

### TCAS-RA BETWEEN PIA A-310 & AIRBLUE A-320 ON 22 DECEMBER 2004

## FINAL REPORT

### TCAS RA BETWEEN PIA 309 AND AIR BLUE 406 ON 22 DECEMBER 2004

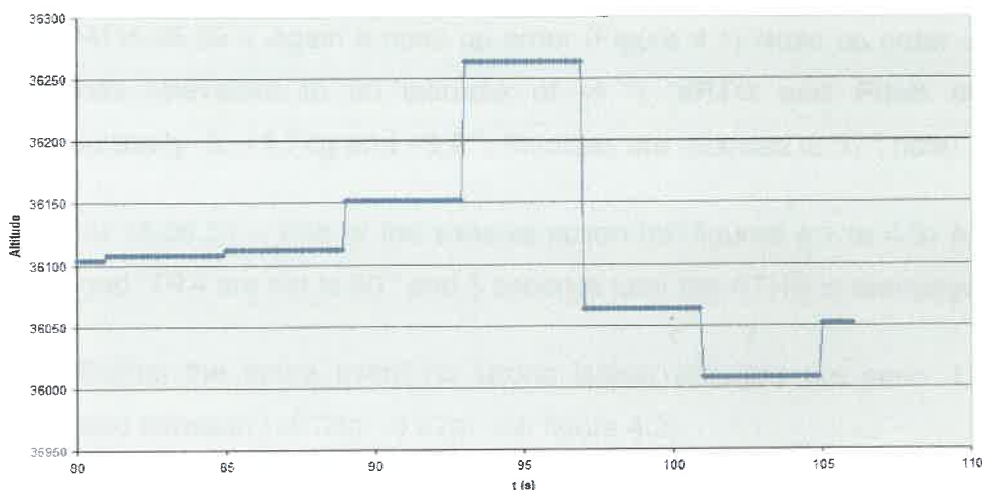
l. Chronological evolution of the situation according to recorded time: 15:06:24. The aircraft speed and altitude start slightly to increase. Around 15.06.29, TAOA1 increases to  $+6.5^{\circ}$  and the barometric altitude (ALT) increases to a maximum of 36260FT.

m. At this time the recorded elevators, pitch and VRTG value are constant.

n. Before and after the event some repetitive AOA1 jumps (cf. figures 4.5 and 4.6 Appendix G 11) are noticed. The recorded barometric altitude ALT comes from ADC1. ALT is corrected from AOA1.

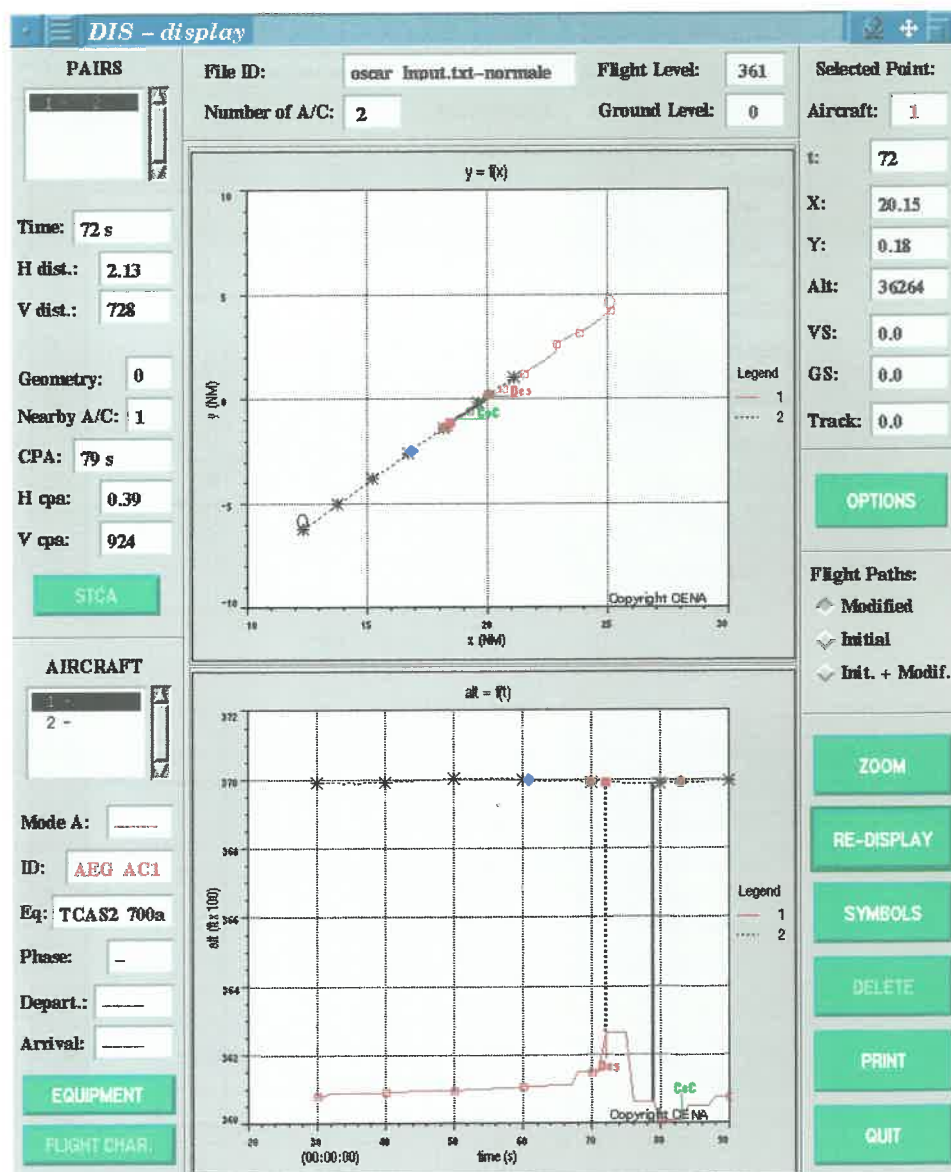
**Encounter simulated with TCAS II version 7.0  
onboard the A320 and the A310  
RAs onboard aircraft the A310 (Shown in full red line)**

2.7.3 The A310 receives a TA, and 2 s later a "Descend" RA, which lasts 11 s.

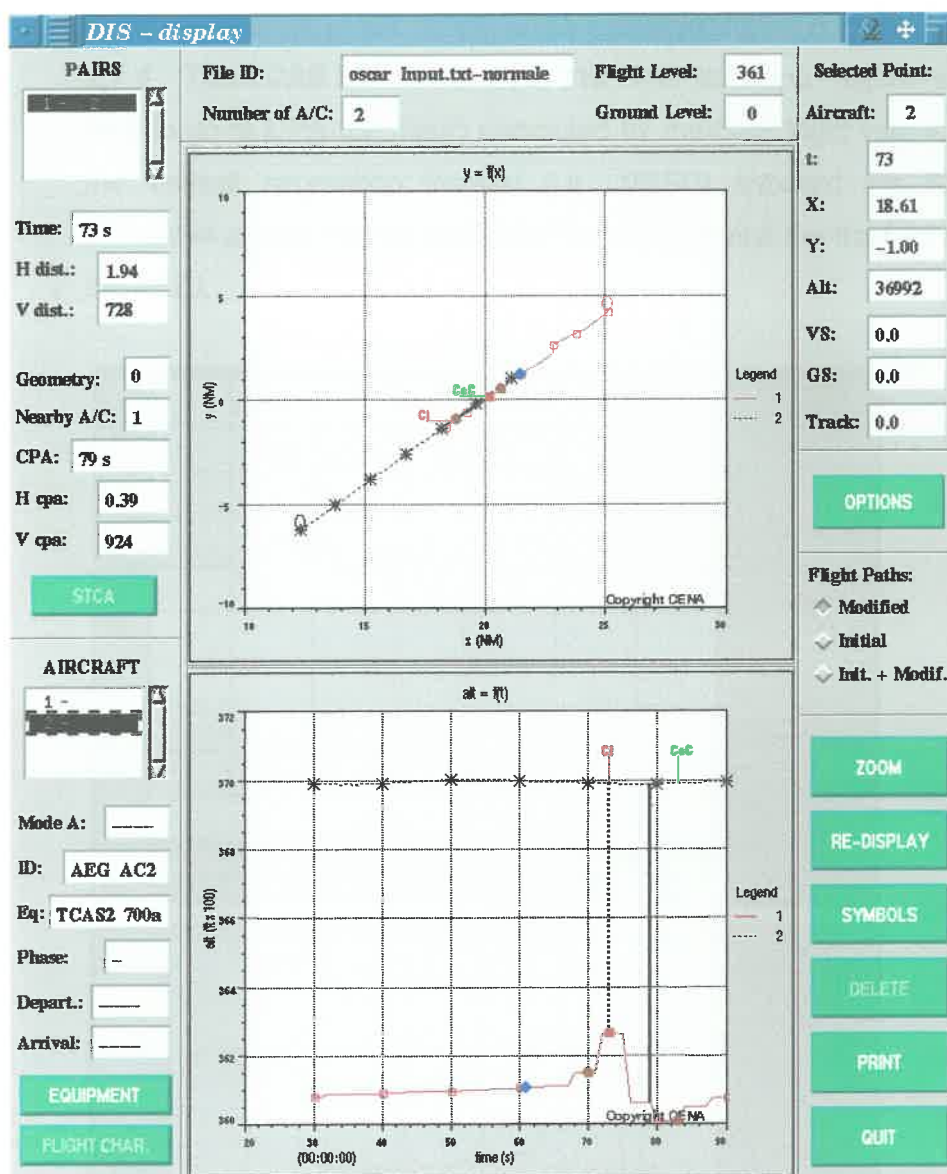
**Encounter simulated with TCAS II version 7.0  
onboard the A320 and the A310  
RAs onboard aircraft the A320 (Shown in black dotted line)**

The result of this simulation is in conformity to the TCAS data for the RA, for the A320. The simulations were performed with both aircraft reporting their altitudes in 25 ft or 100 ft, and with either 1 ft or 100 ft increments for own altitude, resulting in the same TA and RA sequences.

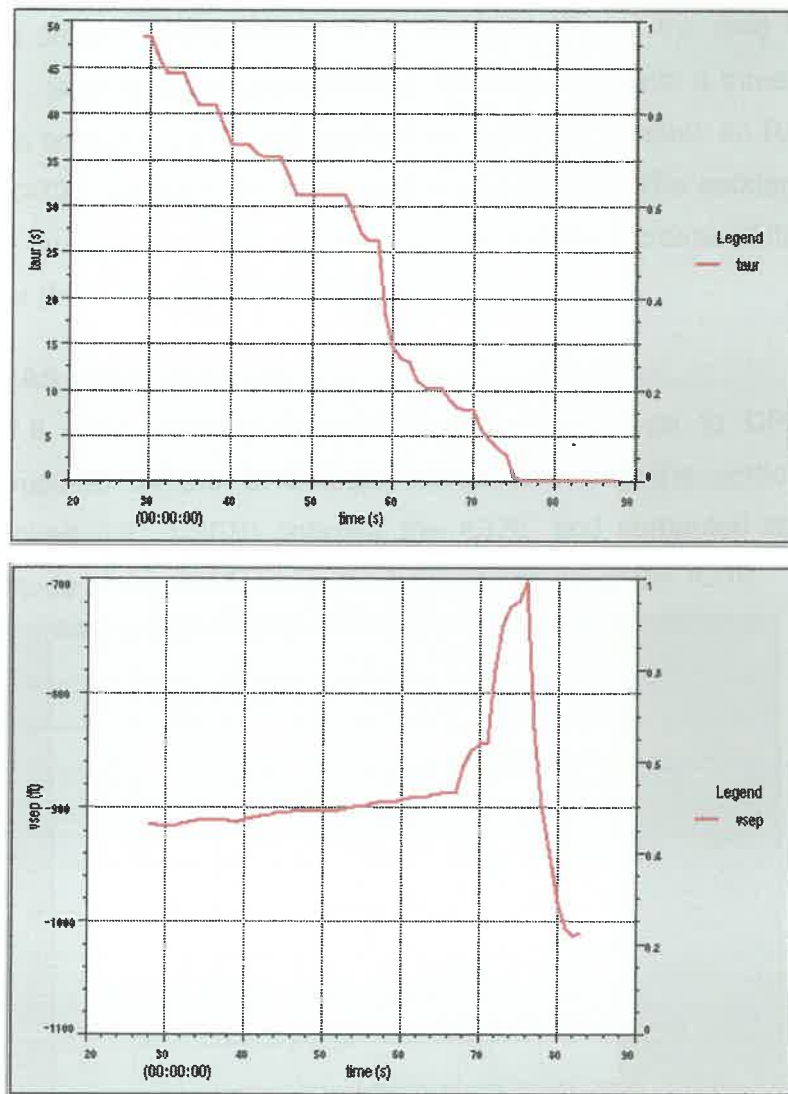
Time to CPA ( $t_{aur}$ ) and Vertical separation tracked on board the A310 (VSEP)

**2.7.4 The TCAS behaviour of A-310** The following figure shows the time-to-go to CPA (i.e.,  $t_{aur}$ ) computed by the CAS logic versus time and the vertical separation tracked (i.e., VSEP) onboard the A320, and computed as the tracked altitude of the A310 minus the tracked altitude of the A320.

$t=28$  s:  $t_{aur}<48$  s  $\Rightarrow$  range test passed for TA from this time on

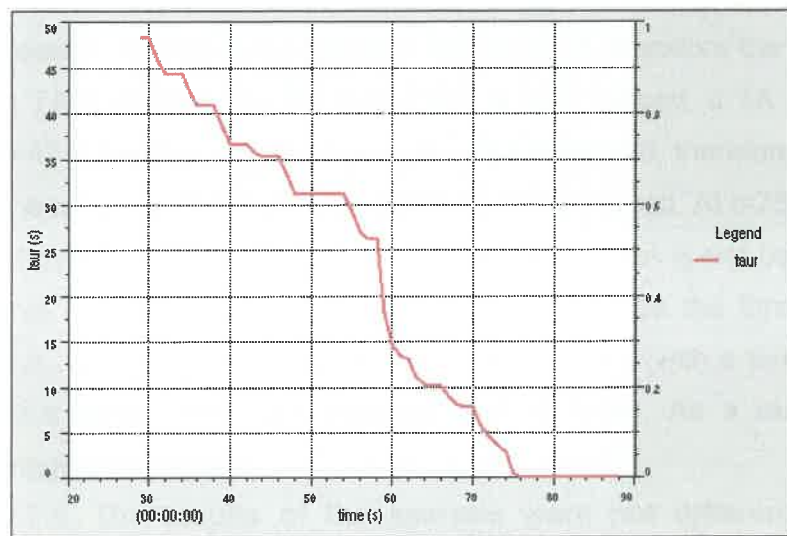
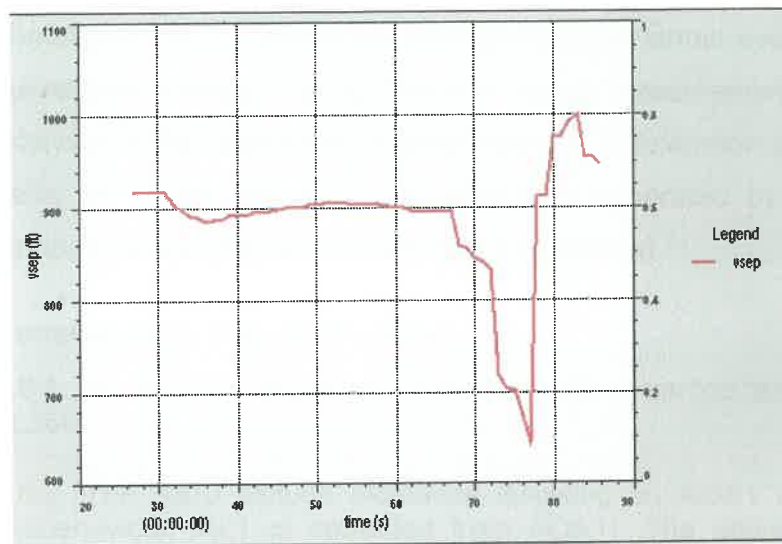
### Time-to-go to CPA (taur) and Vertical separation tracked on board the A320 (VSEP)

2.7.6 The following figure shows the time-to-go to CPA (i.e., taur) computed by the CAS logic versus time and the vertical separation tracked (i.e., VSEP) onboard the A320, and computed as the tracked altitude of the A320 minus the tracked altitude of the A310.

$t=31$  s:  $\text{taur} < 48$  s  $\Rightarrow$  range test passed for TA from this time on
