**CIVIL AVIATION AUTHORITY  
PAKISTAN**

**AIRCRAFT INCIDENT INVESTIGATION**

**BOEING -747 REG.NO,AP-AYW WHICH OCCURRED**

**ON 22ND DECEMBER, 1996**

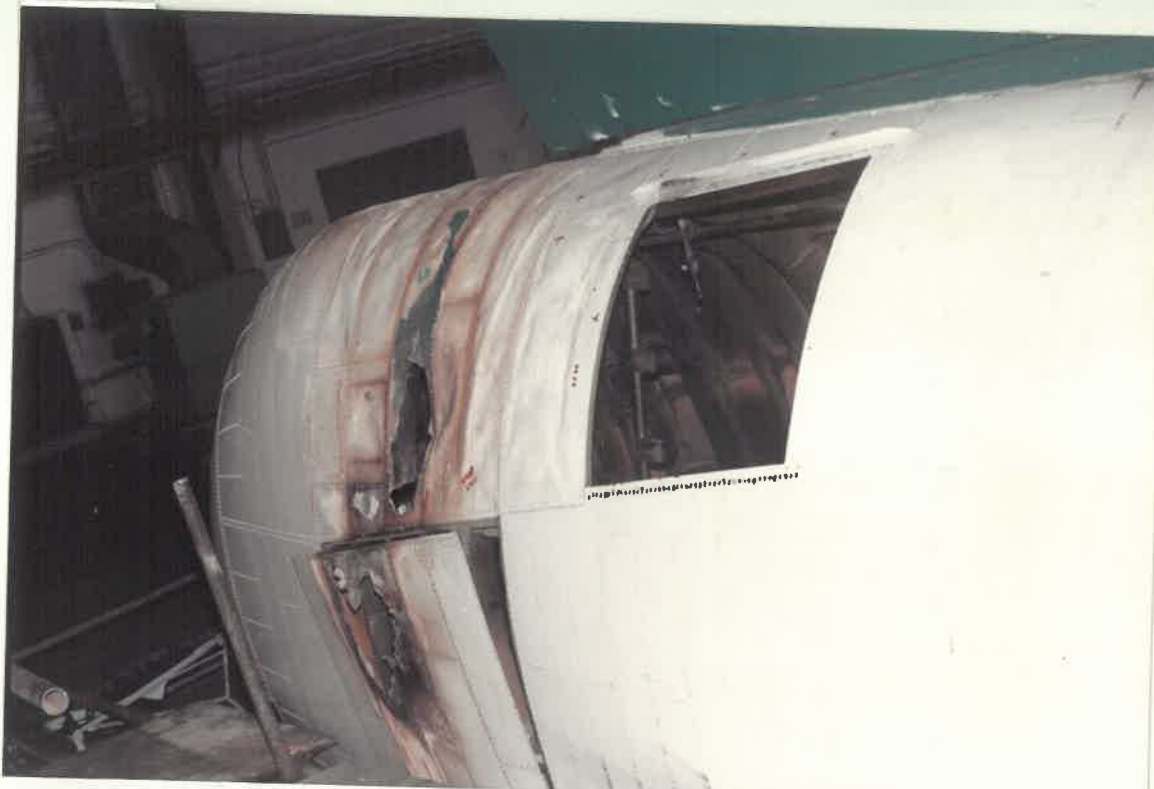
APP. B<sub>1</sub>

BURNT TAIL SECTION. BETWEEN 2 TO 3 O'CLOCK POSITION.

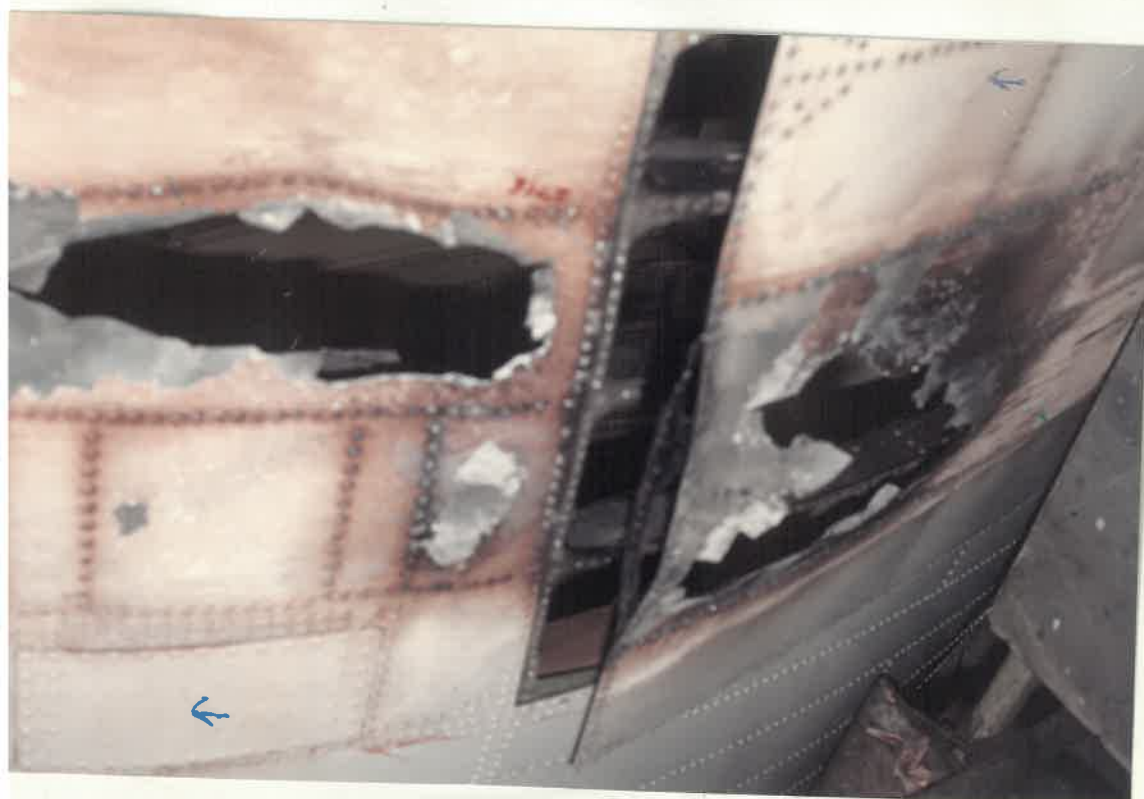
APP. 'B<sub>2</sub>'

BURNT SKIN CLOSE UP VIEW

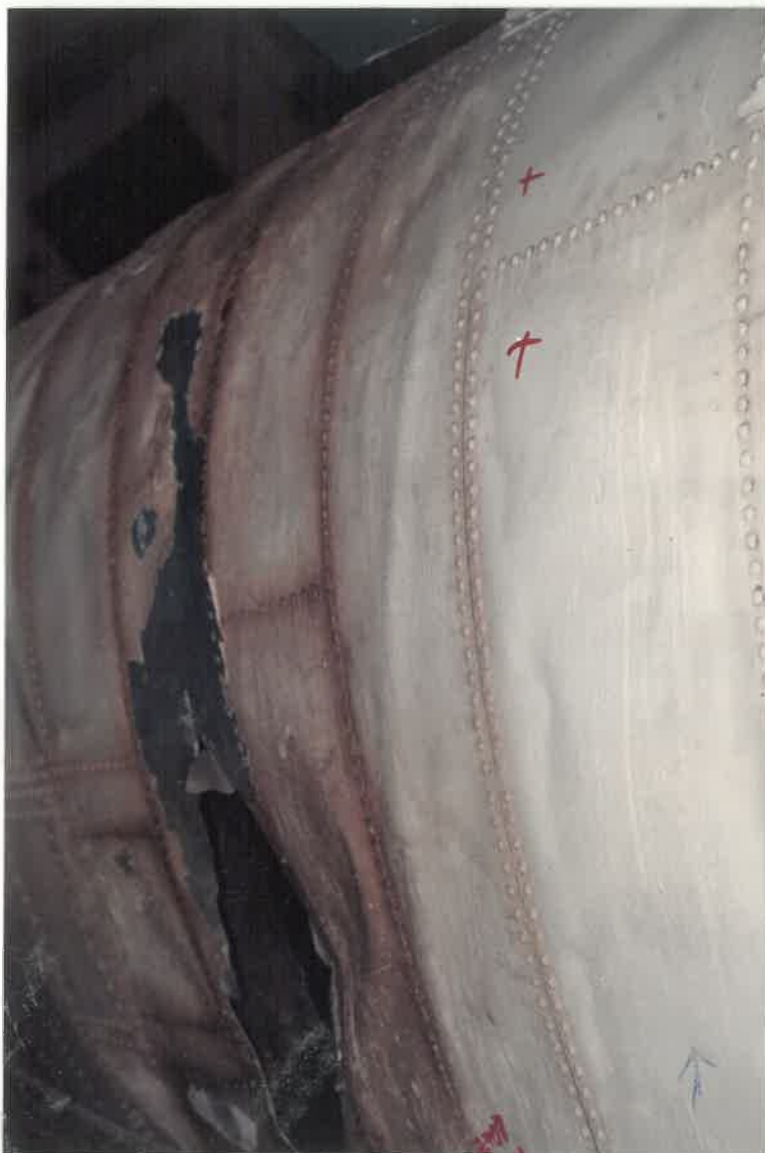
EVIDENCE OF BURNING AND BUCKLING OF TAIL SKIN

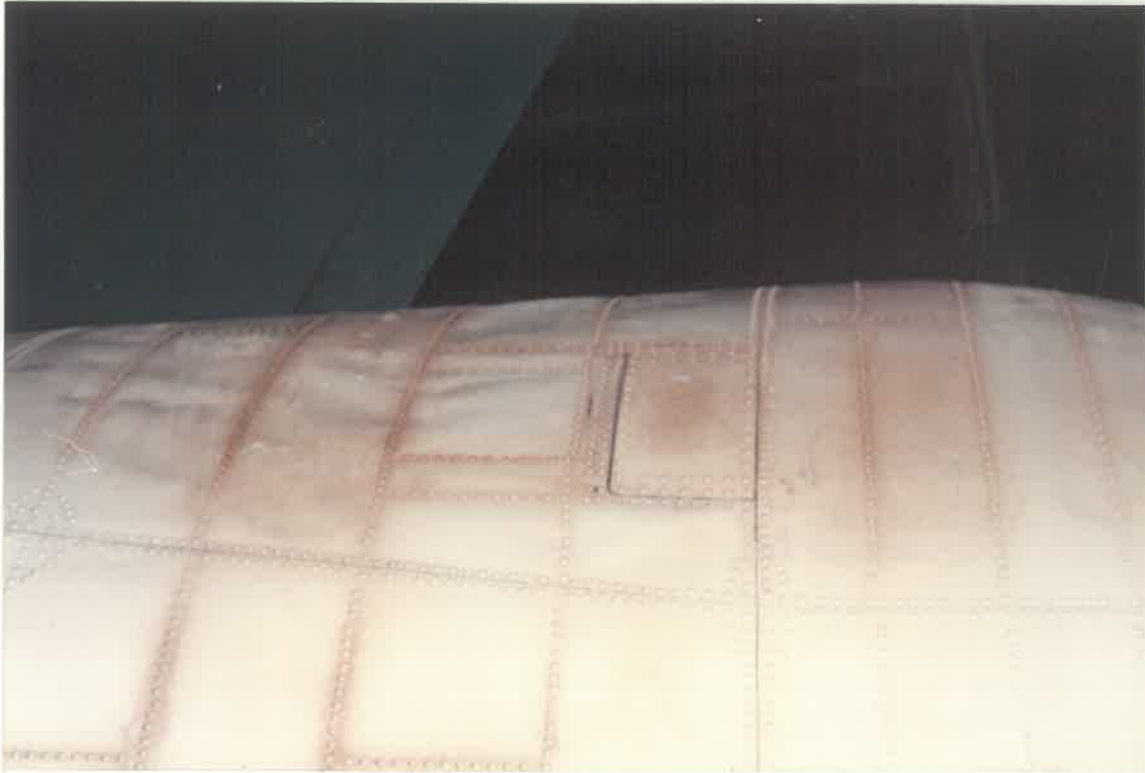
APP. 'B4'

EVIDENCE OF BUCKLED TAIL SKIN DUE TO HEAT

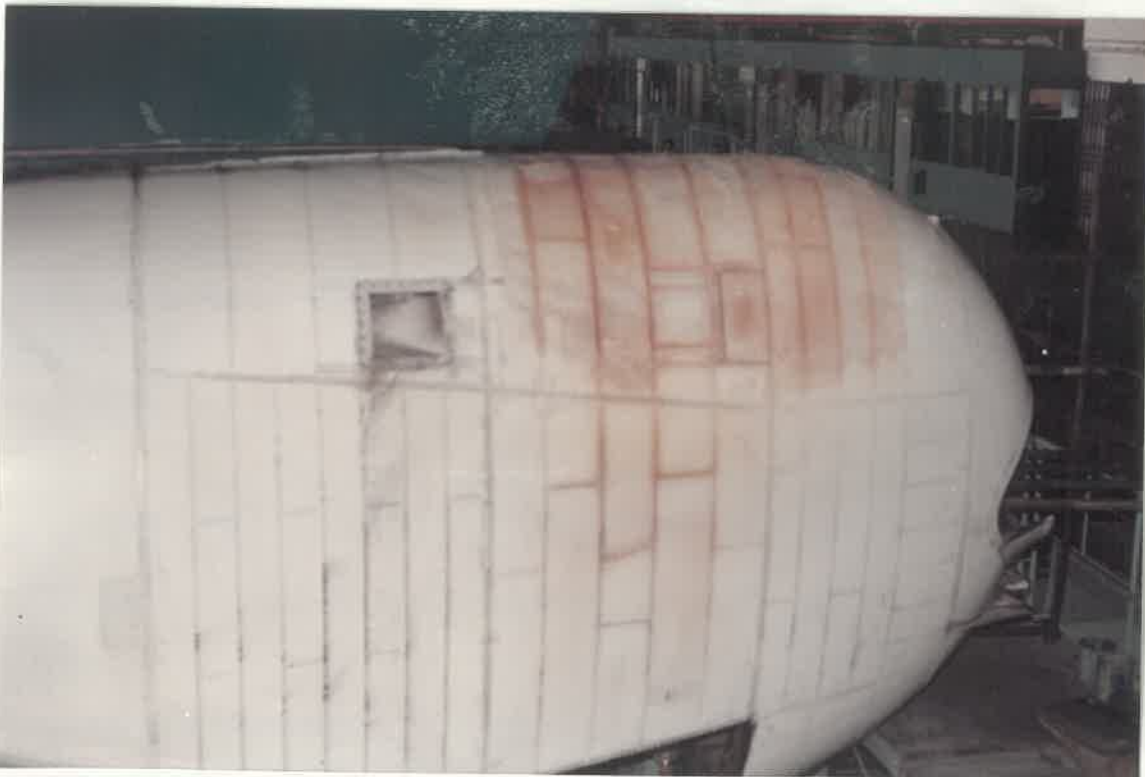
APP. 'B5'

EVIDENCE OF DISCOLORATION AND BUCKLING OF TAIL SKIN

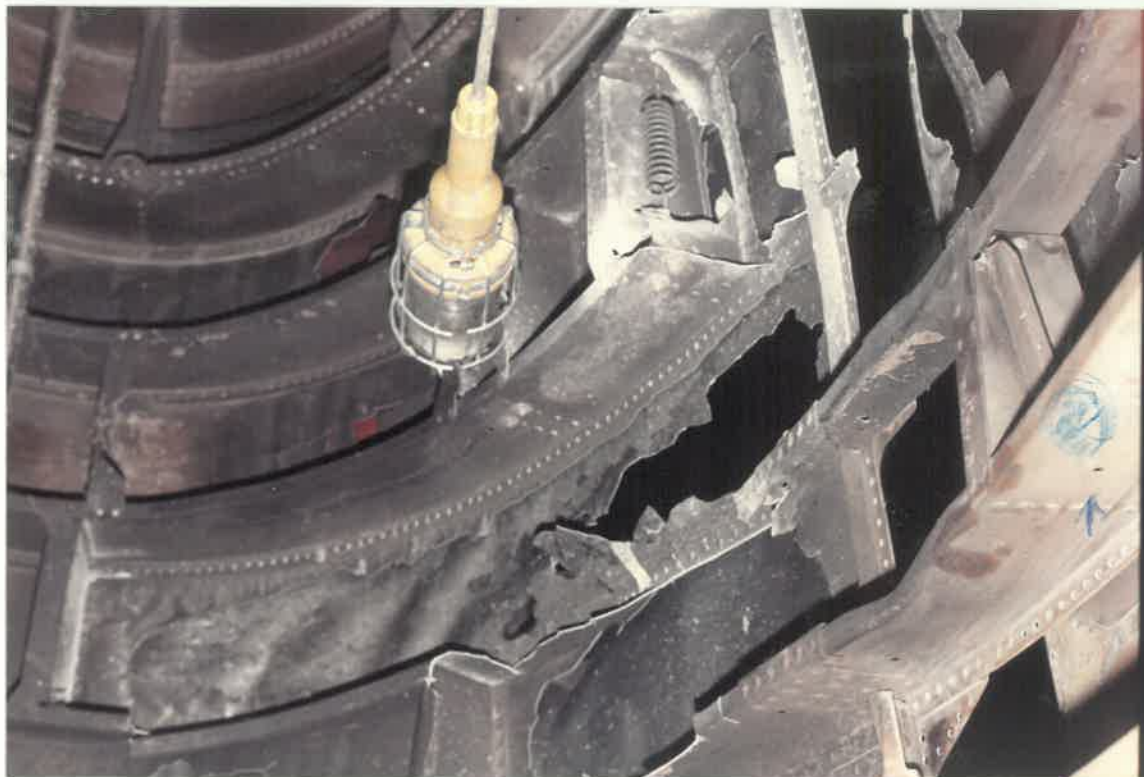
APR 'B6'

FIRE DAMAGE TO TAIL SECTION INSIDE VIEW

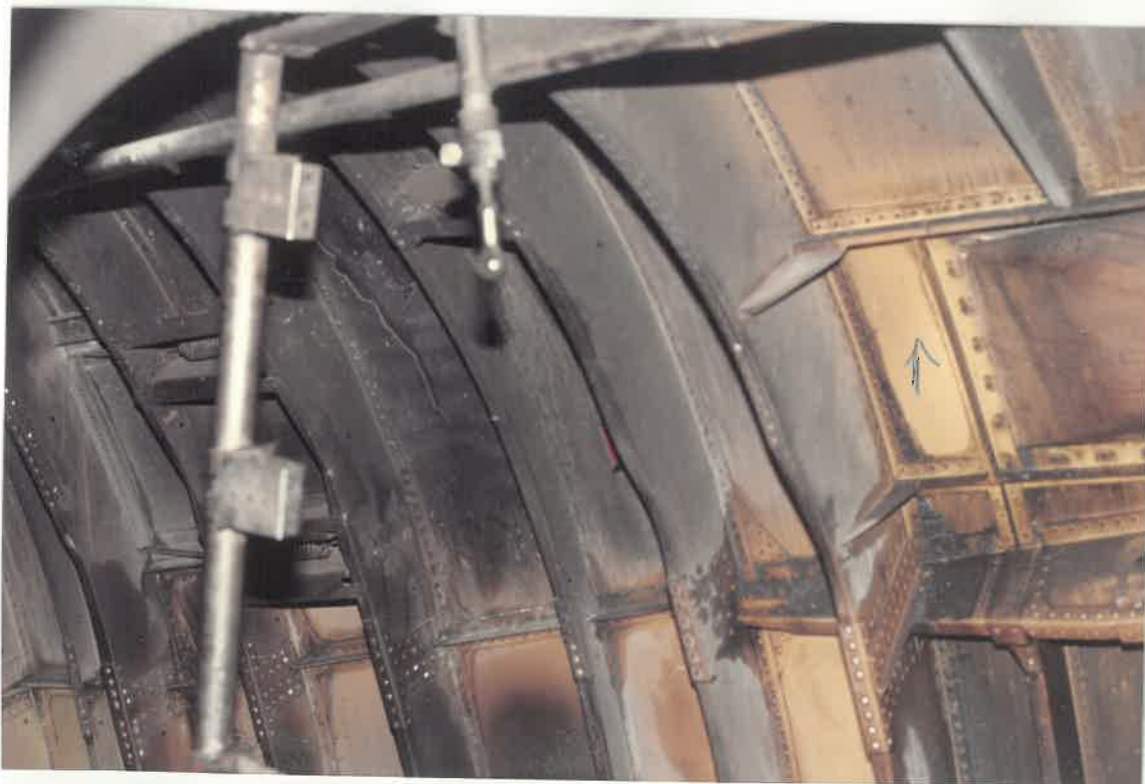
APR 'B7'

FIRE DAMAGE EVIDENCE INSIDE VIEW

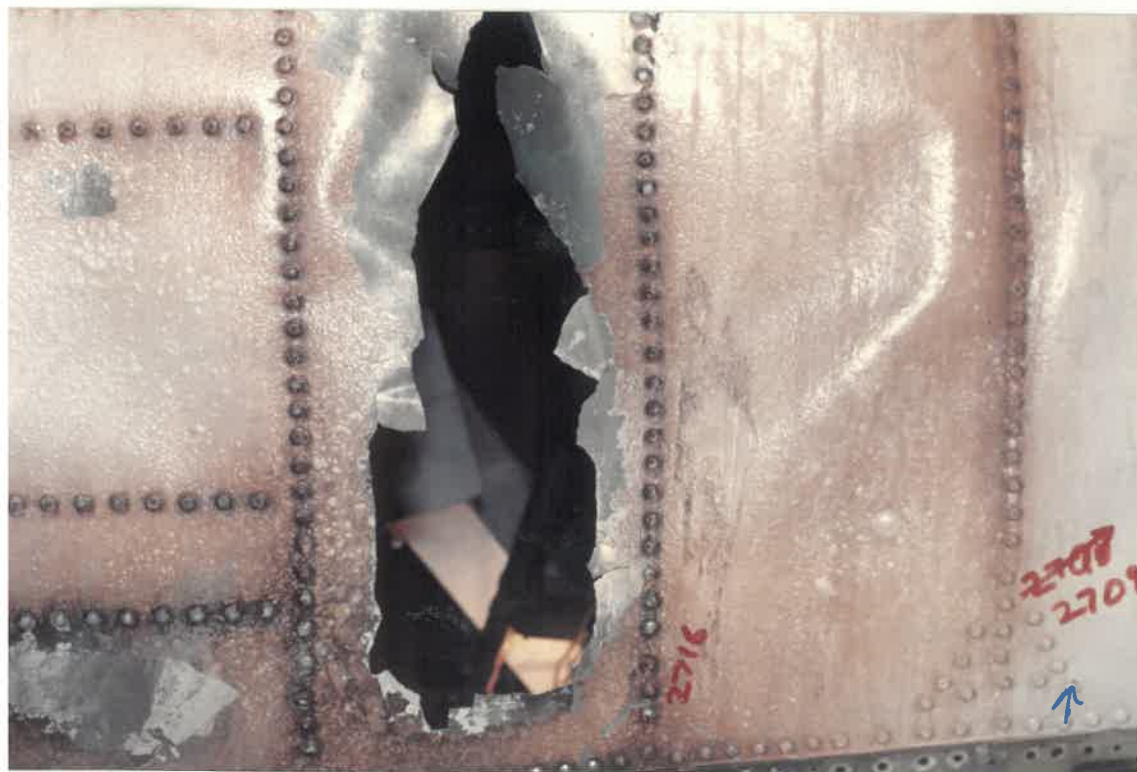
APP' B8'

EVIDENCE OF BURNING BUCKLING AND DISCOLORATION  
DUE TO HI-TEMP.

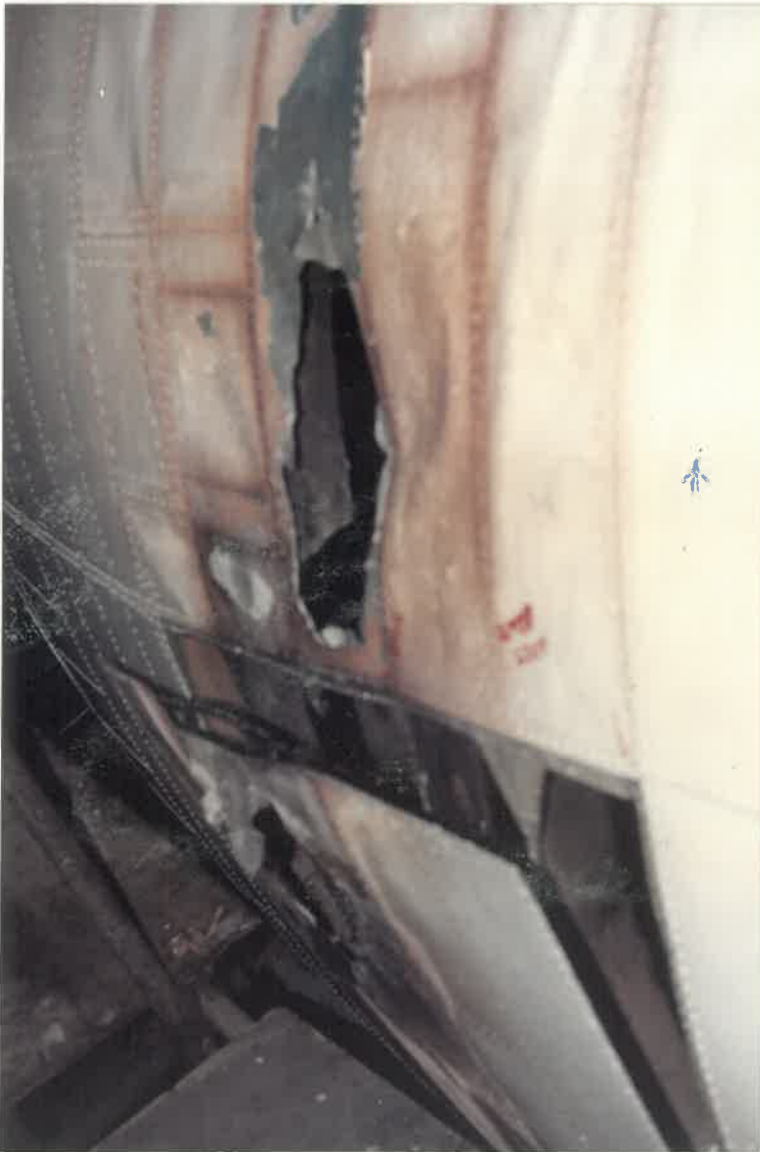
EVIDENCE OF BURNING AND BUCKLING OF TAIL SKIN - ANOTHER VIEW

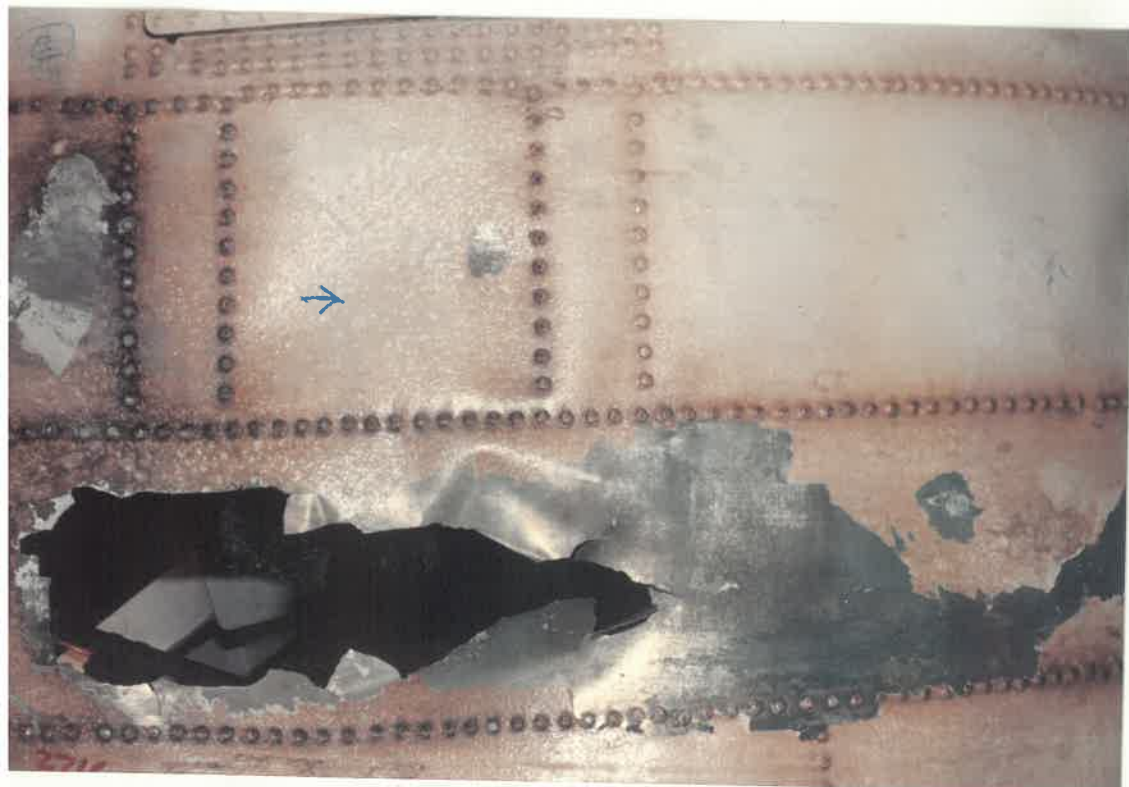
BURNT TAIL SECTION - ANOTHER EXTERNAL VIEW

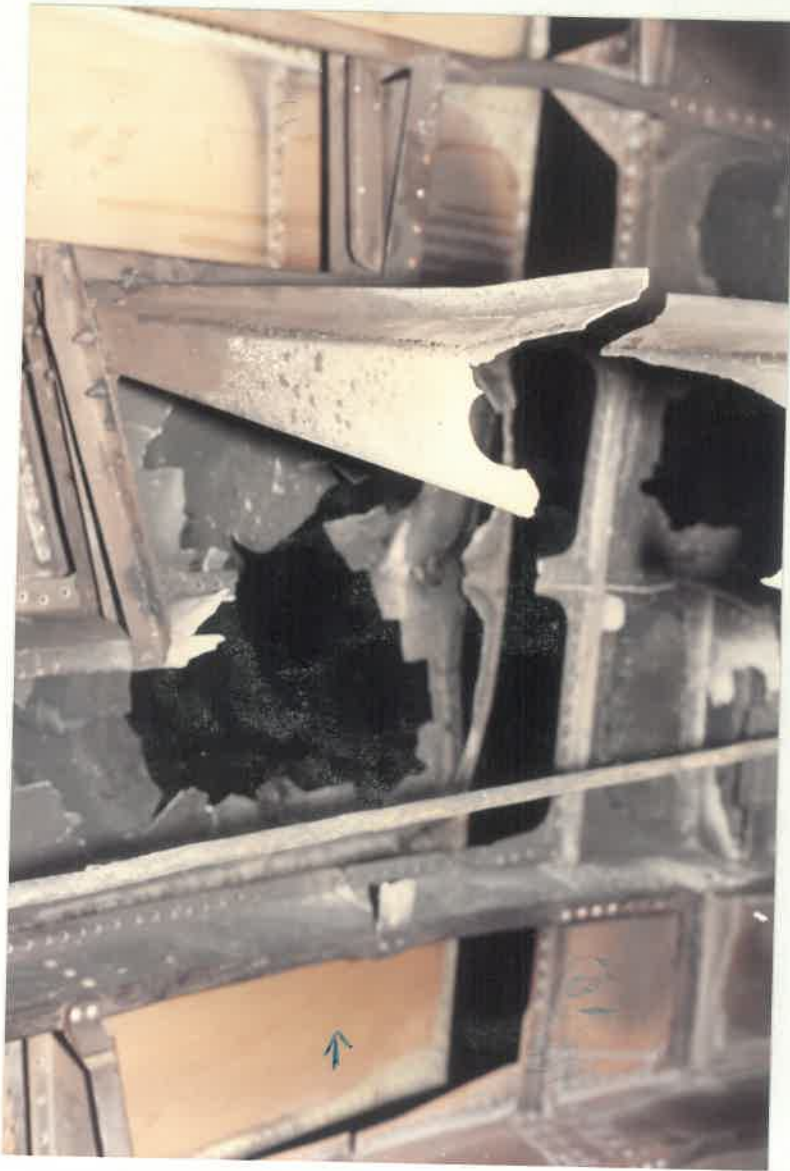
APP 'B11'

INTERNAL DAMAGE CAUSED DUE TO FIRE IN TAIL SECTION

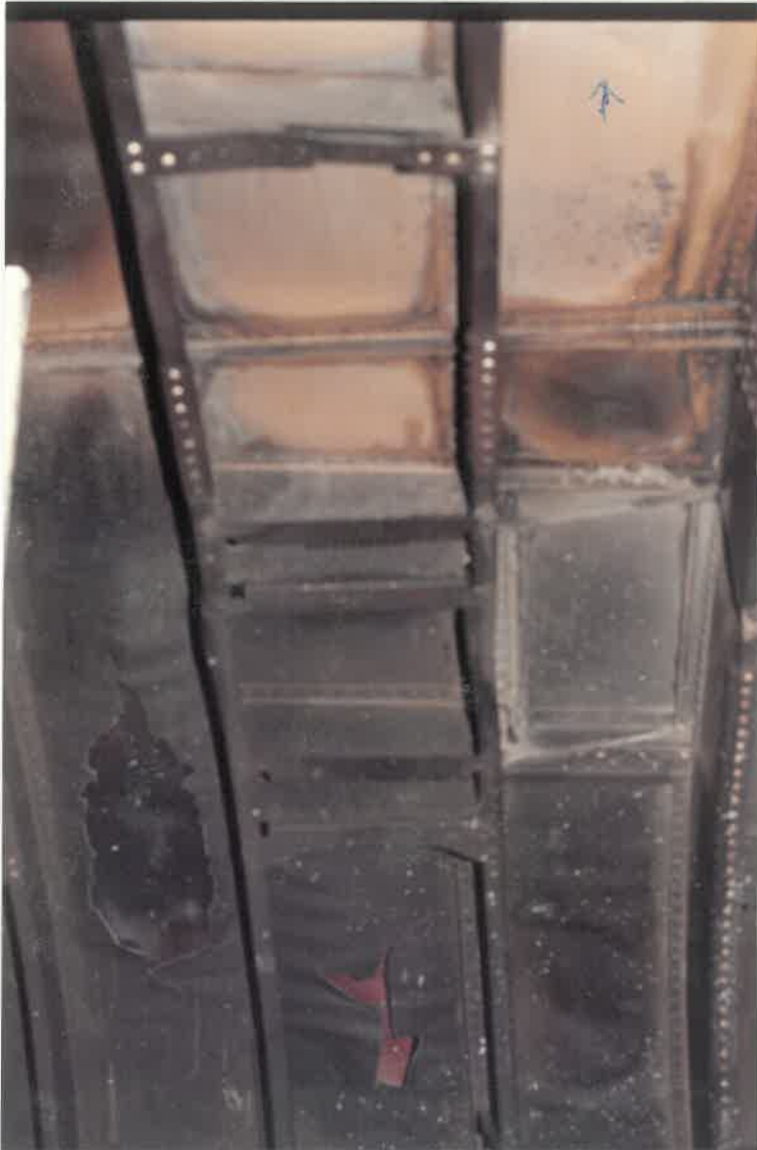
TAIL SECTION BURNING INSIDE VIEW

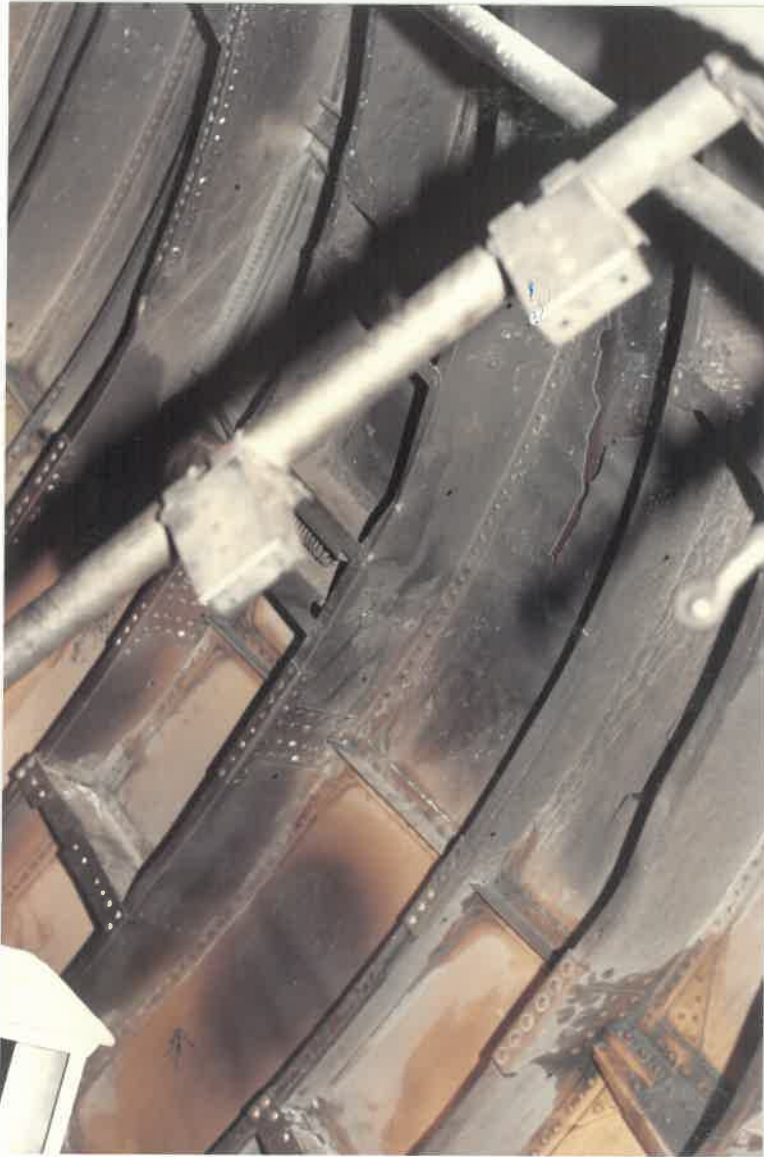
TAIL SECTION INTERNAL DAMAGE - ANOTHER VIEW

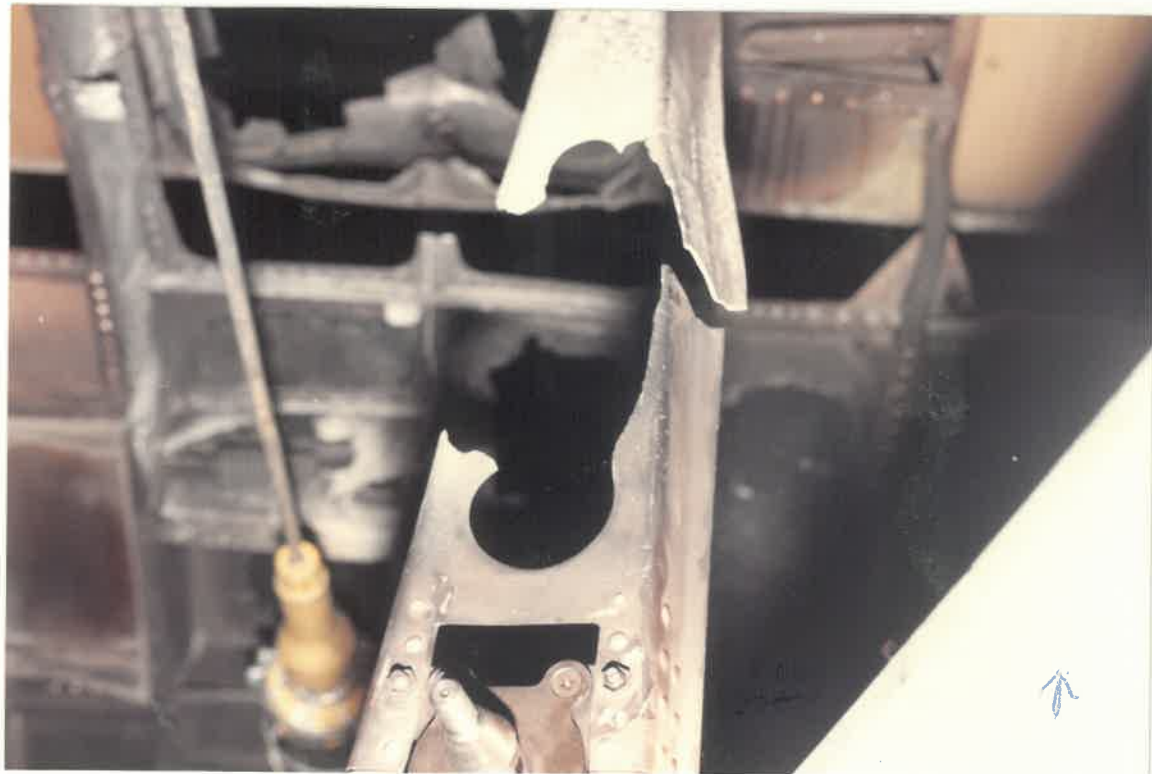
APP. 'B14'

INTERNAL DAMAGE IN THE TAIL SECTION

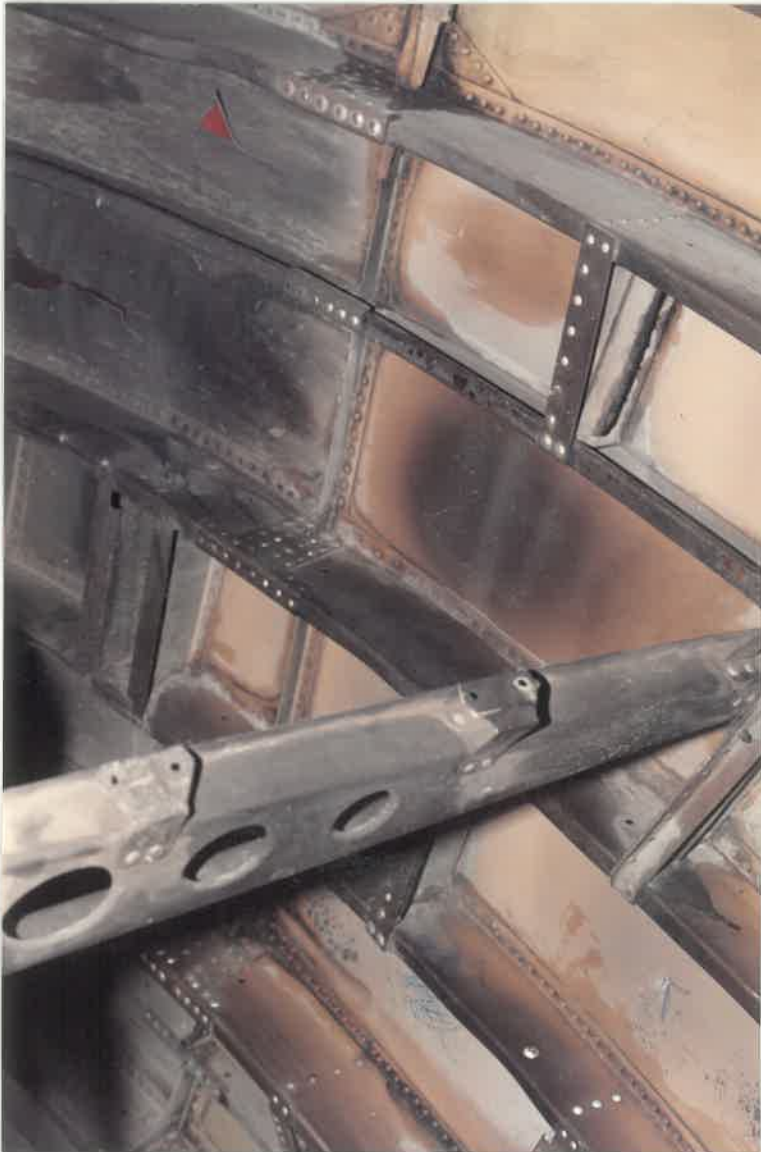
INSIDE VIEW OF DAMAGE CAUSED IN THE TAIL SECTION

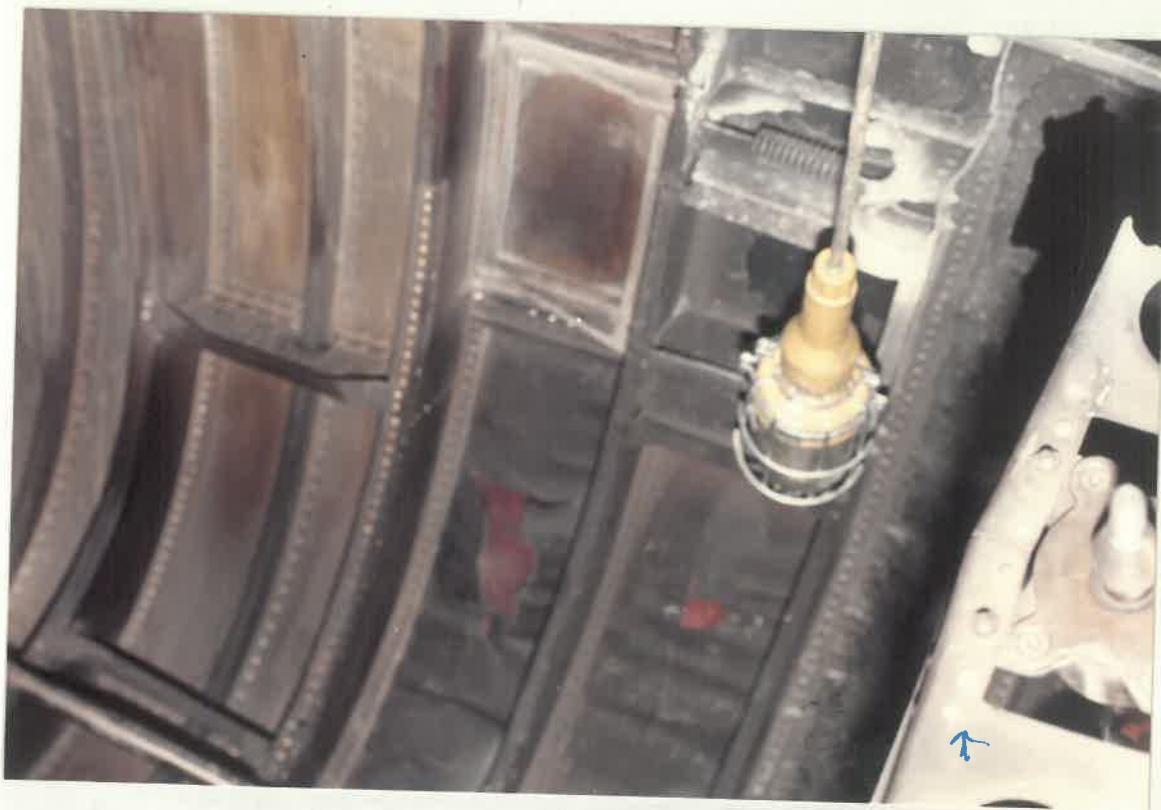
APR. 'B16'

INSIDE VIEW OF TAIL SECTION DAMAGE - ANOTHER VIEW

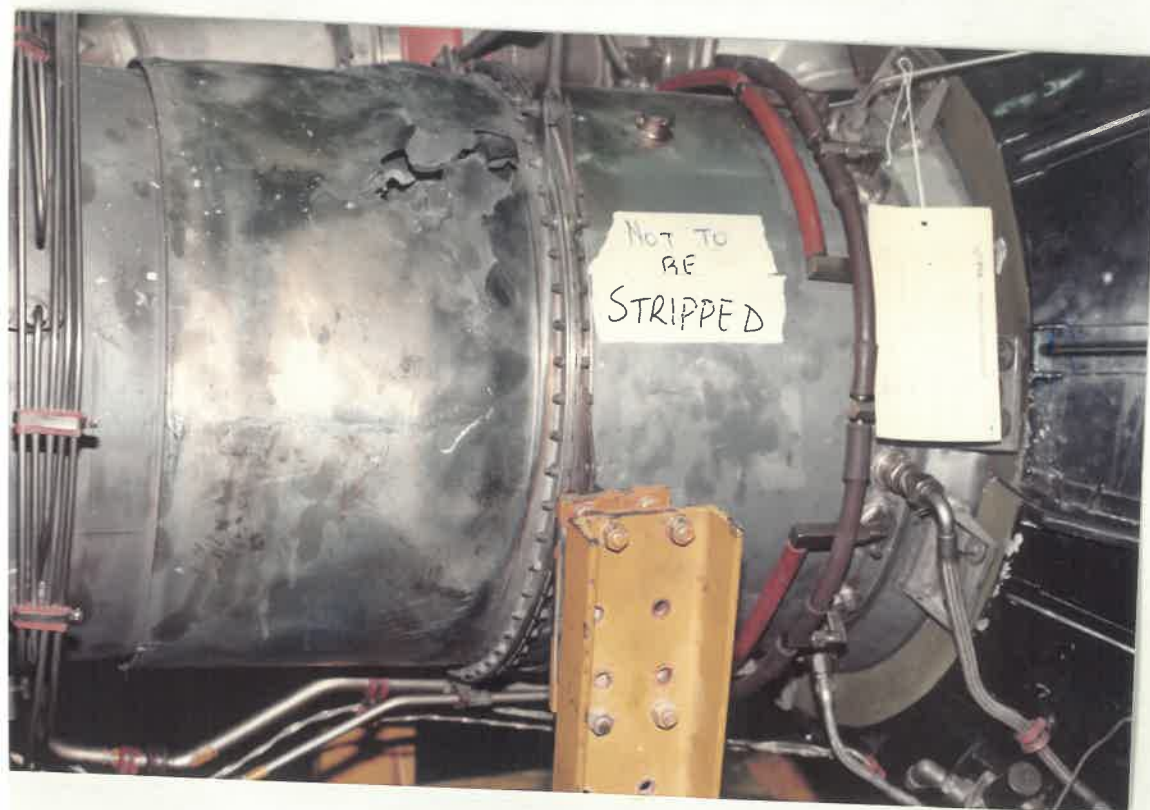
APR. 'B17'

20.1. Turbine Housing and Containment Ring was burnt through at about 2 O' Clock position, making an uneven hole measuring about 4 to 5 square inches (Ref. Appendix B17).

APU BURNT SKIN AT ABOUT 2 - 3 O'CLOCK POSITION

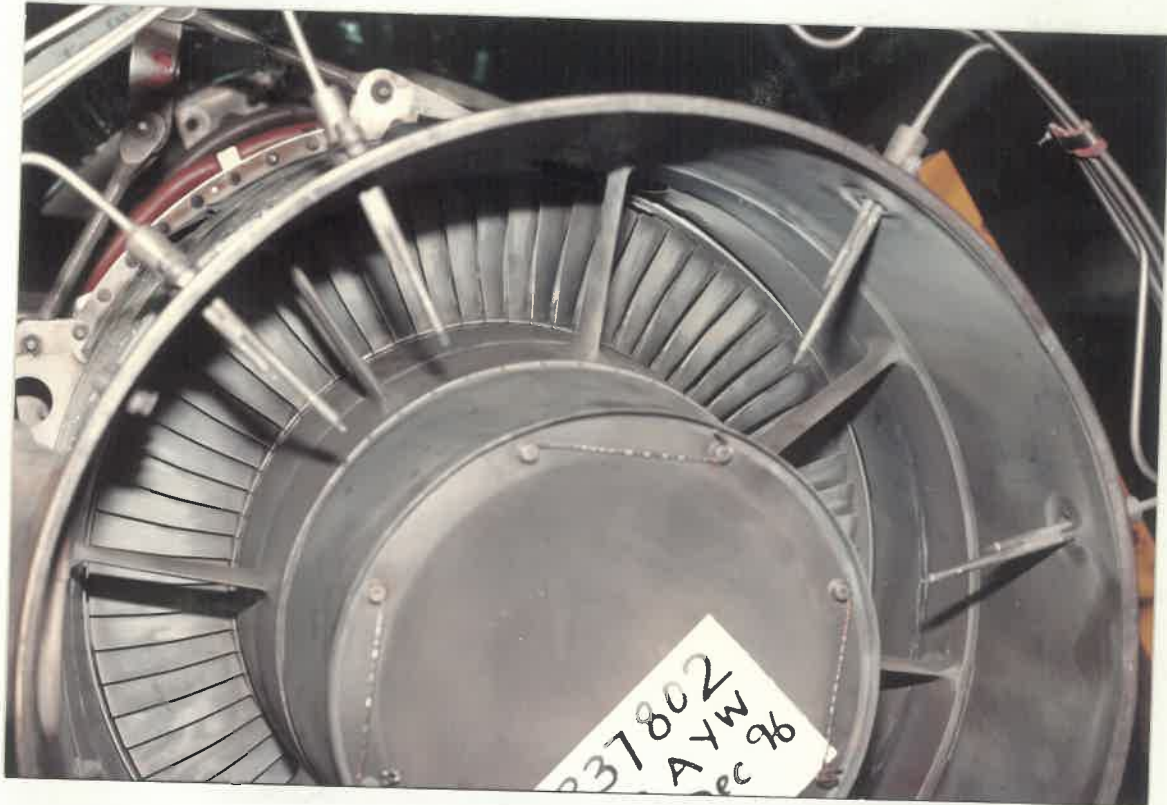
APP. B18

20.3. T1 Turbine Stator vanes were burnt more severely as compared to T2 turbine stator vanes. (Refer Appendix B18).

EVIDENCE OF OVERHEAT IN THE APU
