**CIVIL AVIATION AUTHORITY**

**AIRCRAFT INCIDENT INVESTIGATION**

**M/S S CHON AIR CESSNA-172 REG.NO.AP-BDV**

**14th. NOV 1994**

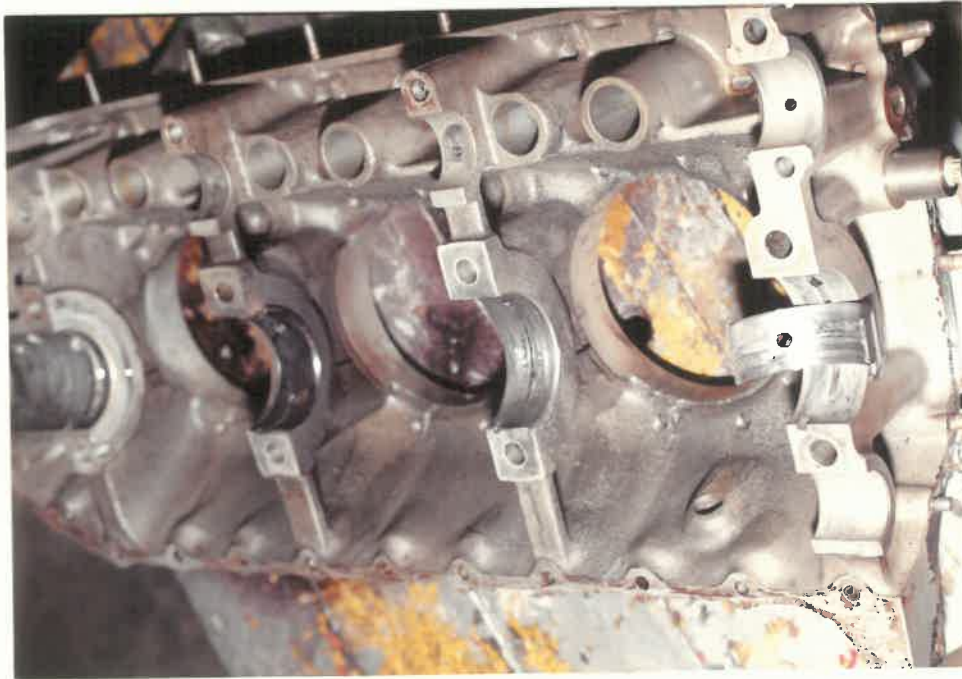
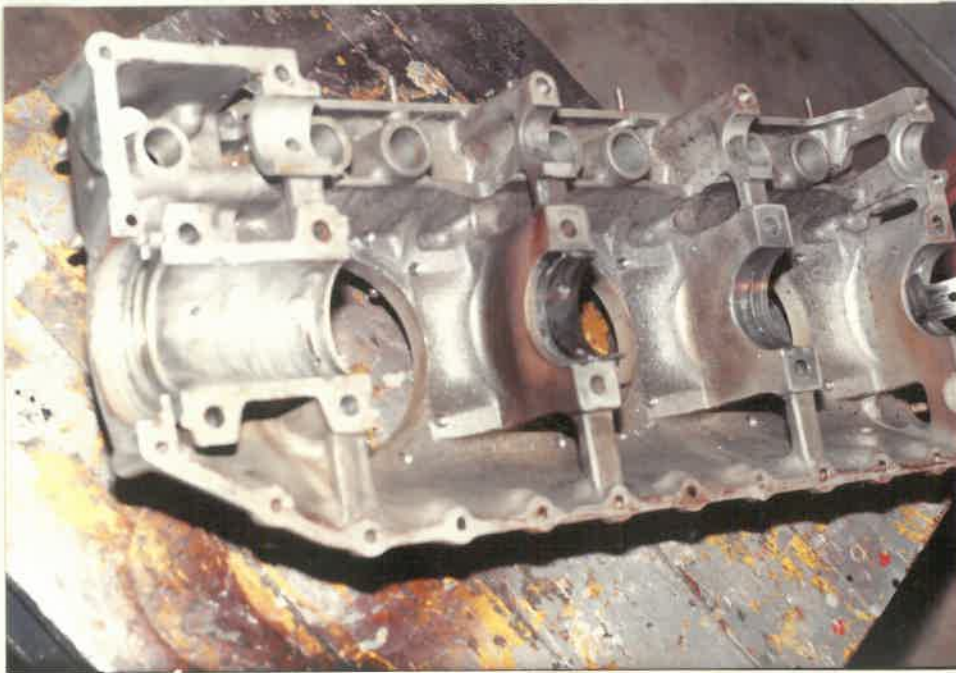
18.2.1 Main Bearings Heavy scoring was observed on No.1 main bearing and No.2/No.3 main bearings were broken. Additionally, the front main bearing had no evidence of deterioration (Ref. Exhibit 'A-1 to A-2').

MAIN BEARINGS.

NOTE:- HEAVY SCORINGS

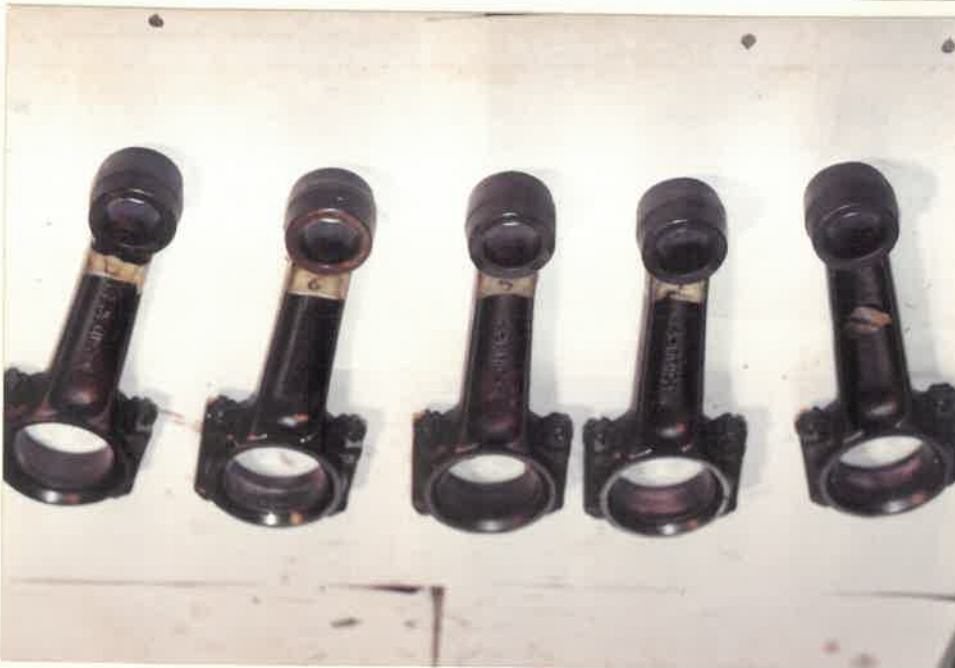
B-1

- 18.2.2 Connecting Rods Heavy scoring was observed on No.1,3,4,5 & 6 bearings; whereas, No.2 bearing was partially melted and welded with the connecting rod (Ref Exhibit 'B-1 to B-2').

CONNECTING RODS.

NOTE:- HEAVY SCORING.

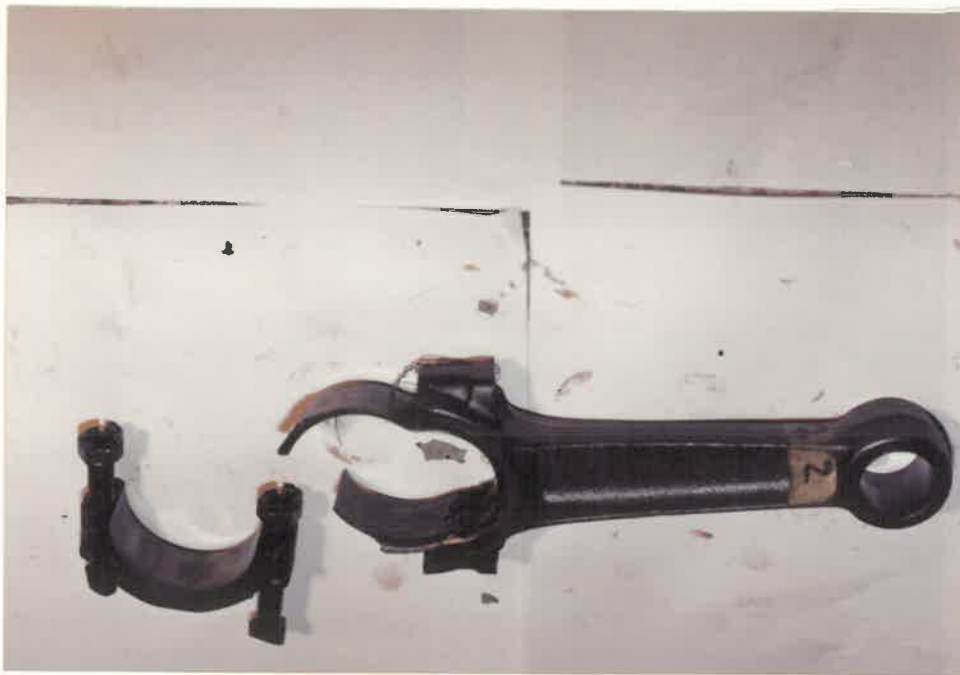
B-2

NO.2 CONNECTING ROD.      NOTE:- WELDED BEARING.

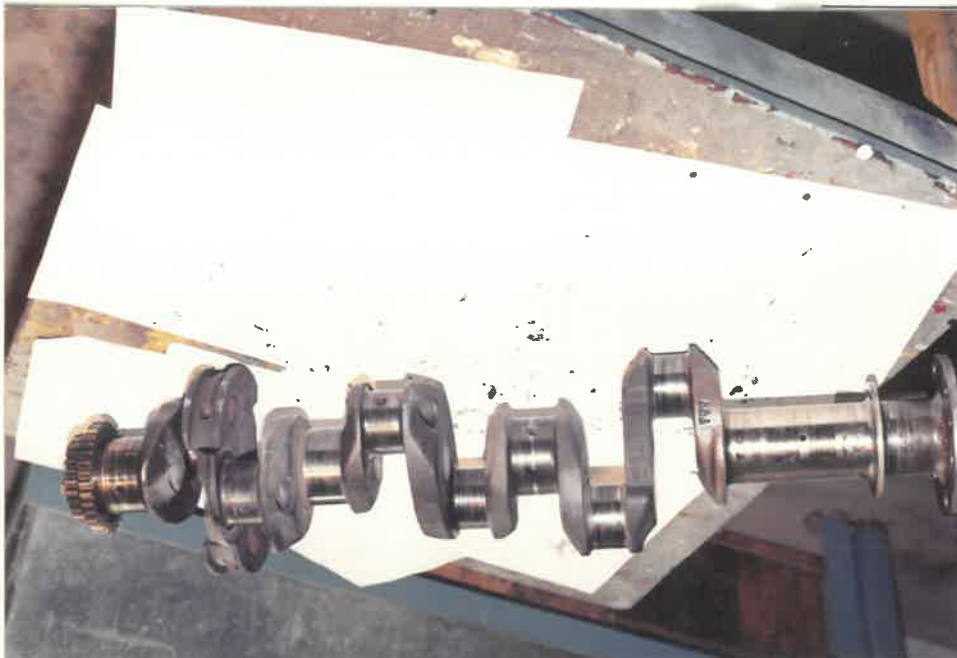
C-1

- 18.2.3 Crank Shaft The crank shaft main bearing had evidence of heavy scoring and overheating. Whereas, No.1,2,3 and 5 bearings were heat affected (Ref. Exhibit 'C-1 to C-2').

CRANK SHAFT.      NOTE:- SCORING ON THE SURFACE.

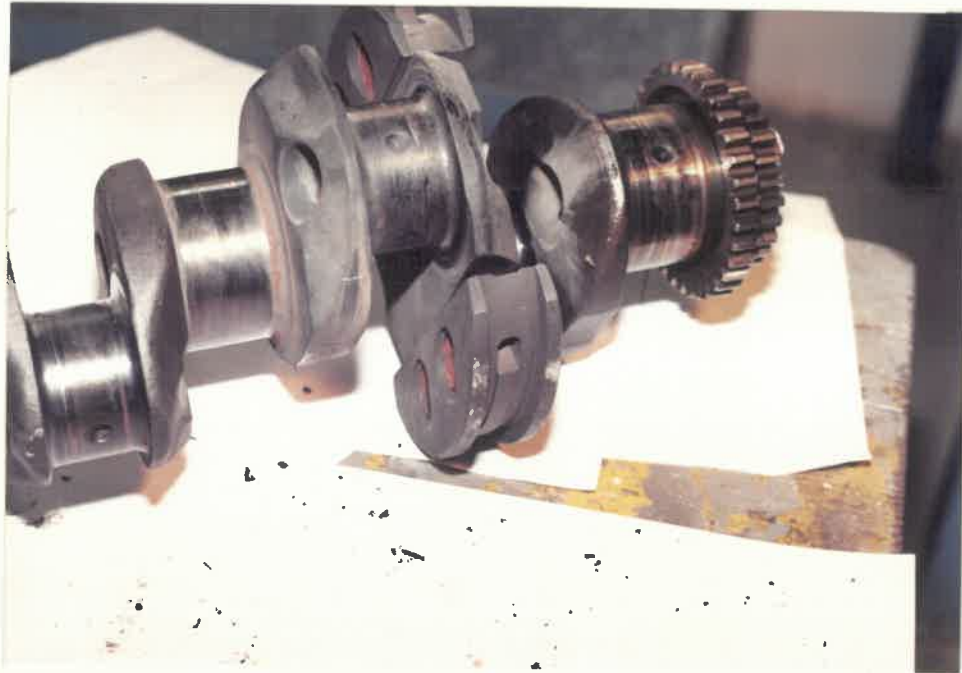
C - 2

CRANK SHAFT. NOTE: SCORING

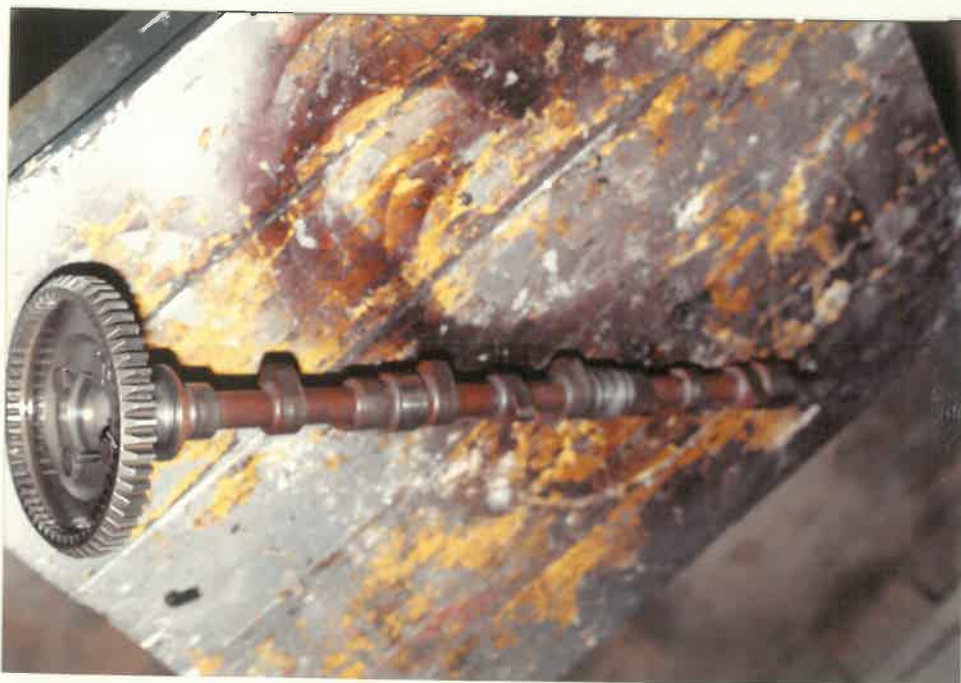
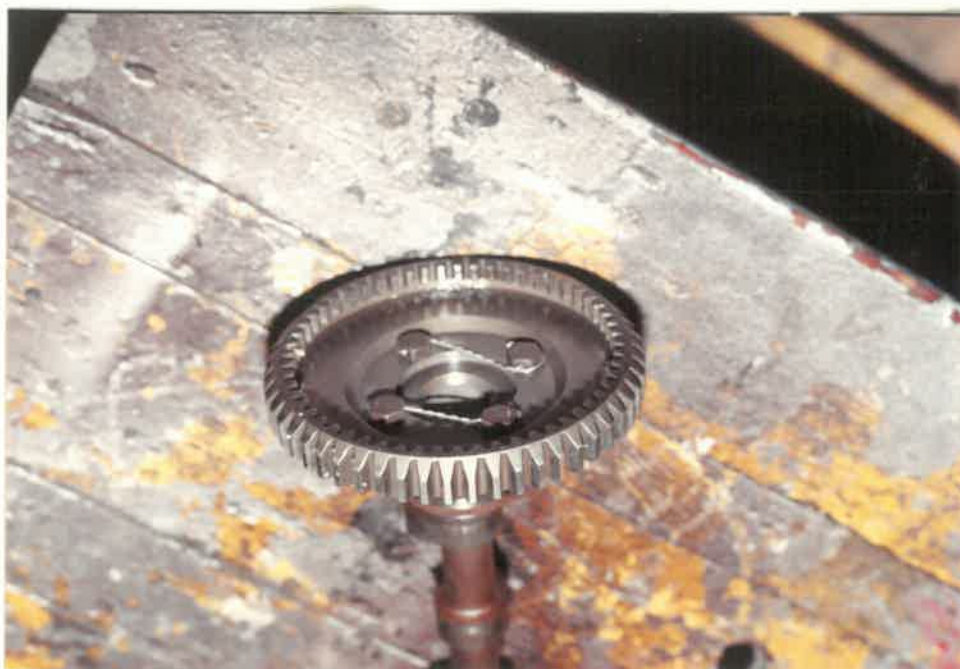
- 18.2.4 Cam Shaft The Cam Shaft gear teeth had no evidence of wear on the surface (Ref. Exhibit 'D').
- 18.2.5 Pressure Oil Filter Significant quantity of metal particles were observed in the oil filter element ( Ref Exhibit 'E').

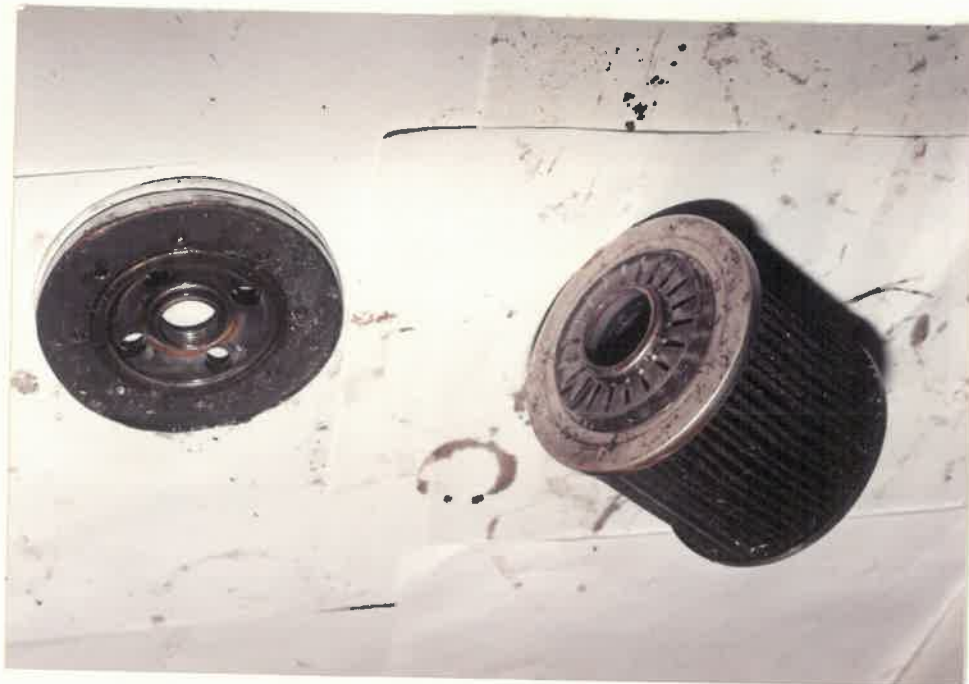
18.7 Engine Strip Examination. During strip examination of the engine large quantity of metal particles were observed both in the oil sump and pressure oil filter. logically, such a large amount of metal particles could not have accumulated in last few minutes of engine operation from start-up to the time when incident occurred. Additionally, the spectrometric oil analysis reports of sump and pressure filter oil samples indicate that concentration of iron, aluminum, copper, nickels and chromium was different in the two samples. While the concentration of iron was comparatively high in pressure oil filter sample the sump oil sample had the highest concentration of aluminum particles. It should be appreciated that oil after passing through the scavenge screen is transferred by oil pump into the pressure oil filter (Ref Exhibit 'P'). Logically the concentration of various metal particles in the two oil samples should be same. However, this was not true. The oil sample analysis reports (Ref Exhibit 'Q') indicate that there was negligible difference in the concentration of various metal particles like Magnesium, Copper, Nickel and Chromium except Iron and Aluminum. In the two samples metal particles concentration difference in parts per million was as follows:-

PRESSURE OIL FILTER. NOTE:- METAL DEPOSITS OF PARTICLES.

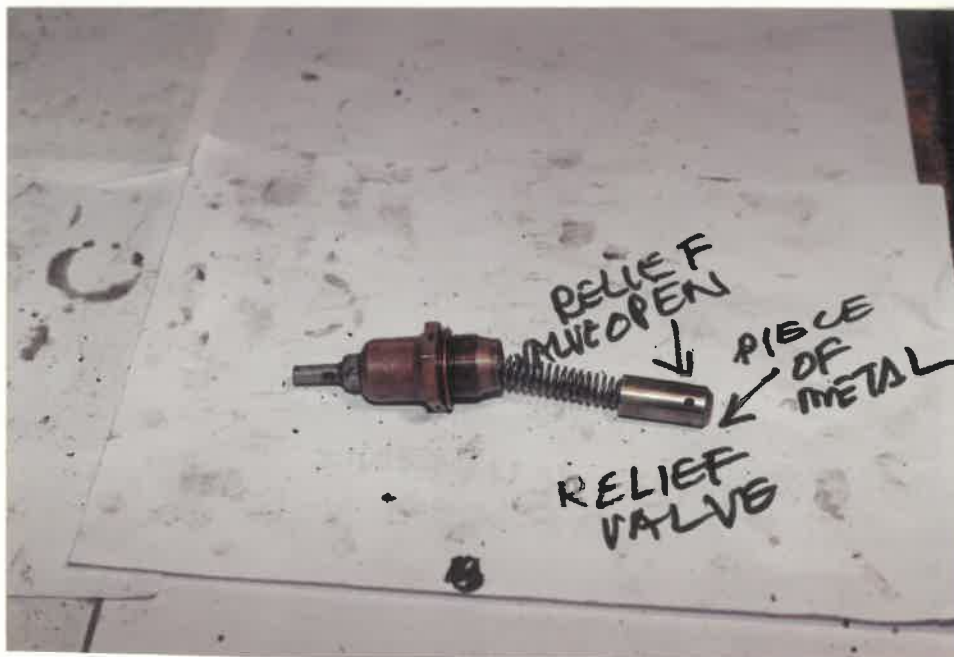
- 18.2.6 Oil Pressure Relief Valve. Metal particle was observed in between the spring and body due to which relief valve was stuck in the open position. (Ref. Exhibit 'F').

PRESSURE RELIEF VALVE. IT WAS FOUND STUCK IN OPEN POSITION.

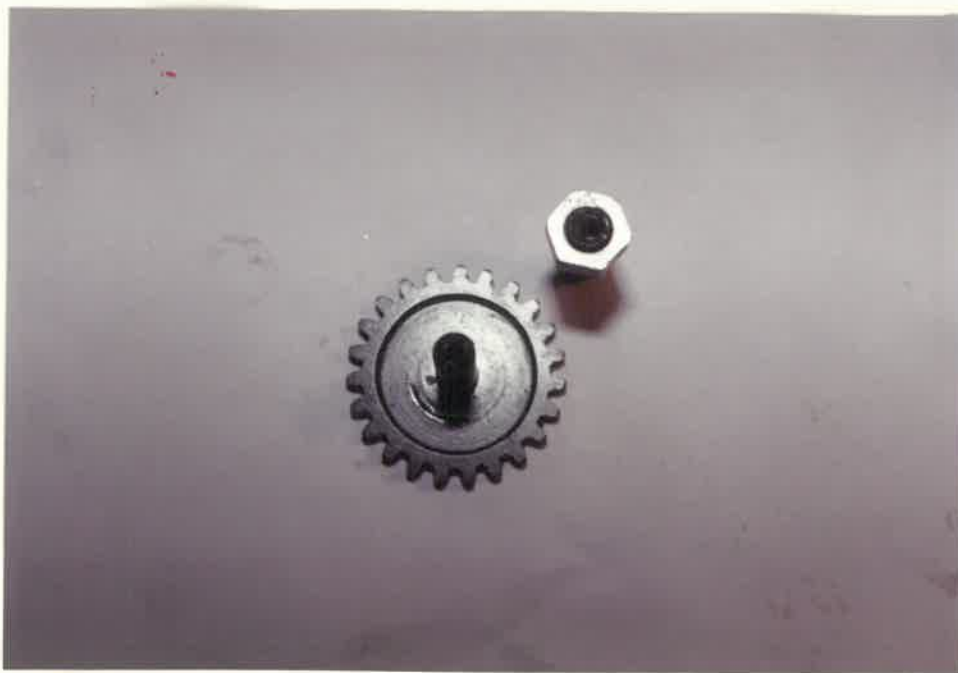
G-1

- 18.2.7 Oil Pump The woodruff key of the oil pump main gear drive was sheared off. Scoring marks were observed on the gear surface and the gear elements were hard to rotate. Additionally, bush of the pressure element was distorted and had evidence of scoring (Ref. Exhibit 'G-1 to G-3').

metal particles continued into the oil pump body, thereby restricting free movement of oil pump gear element. At one time the restriction went so high that the woodruff key (Ref Exhibit 'G-1') which provides drive to the oil pump was sheared off and the oil pressure dropped. After some time, the tachometer drive which is connected on the other side of the gear also sheared-off due to dry running of engine and the pilot observed drop in engine RPM after the oil pressure had dropped.

OIL PUMP GEARS. NOTE:- SCRATCH MARKS.

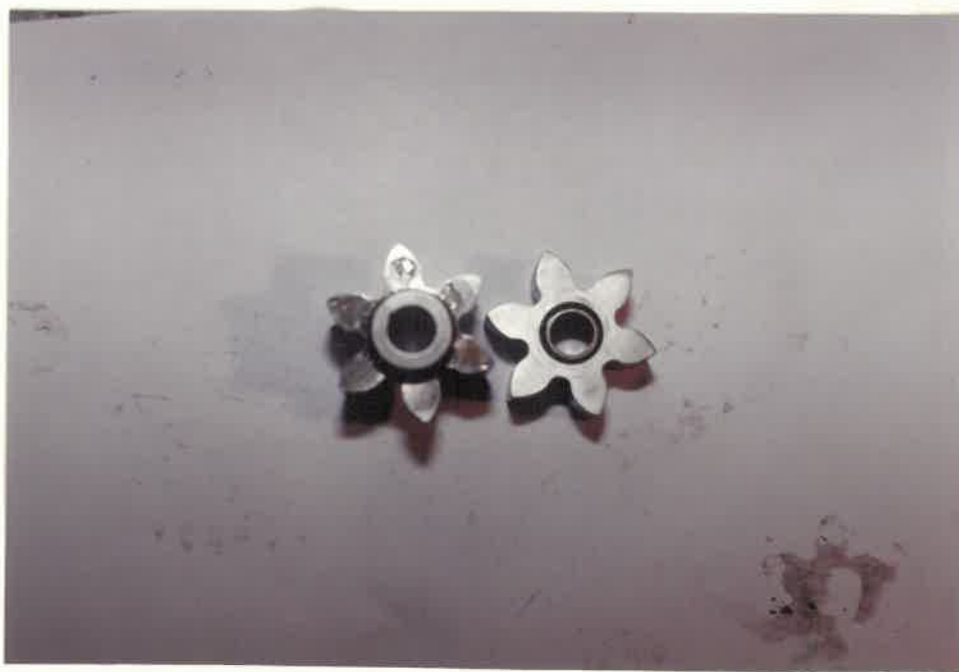
G-2

OIL PUMP GEARS. NOTE:- SCORING AND SCRATCH MARKS.

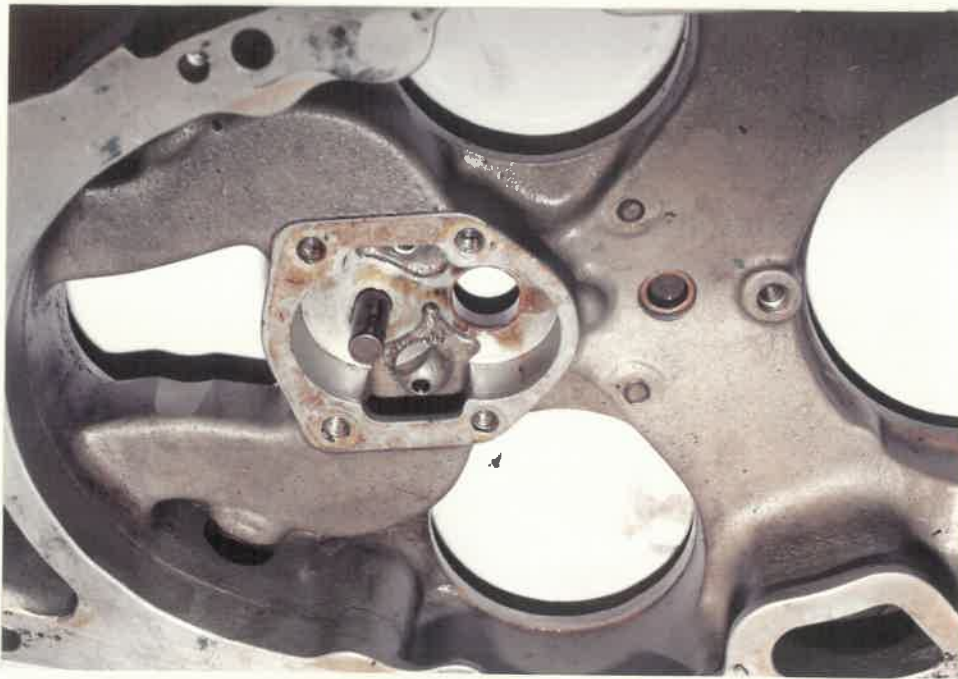
- 18.2.8 Oil Pump Body Metal particles were observed in the oil pump body and some particles were imbedded in the cavity wall due to stroke of the oil pump gear teeth (Ref. Exhibit 'H').

OIL PUMP BODY. NOTE:- SCRATCH MARKS.

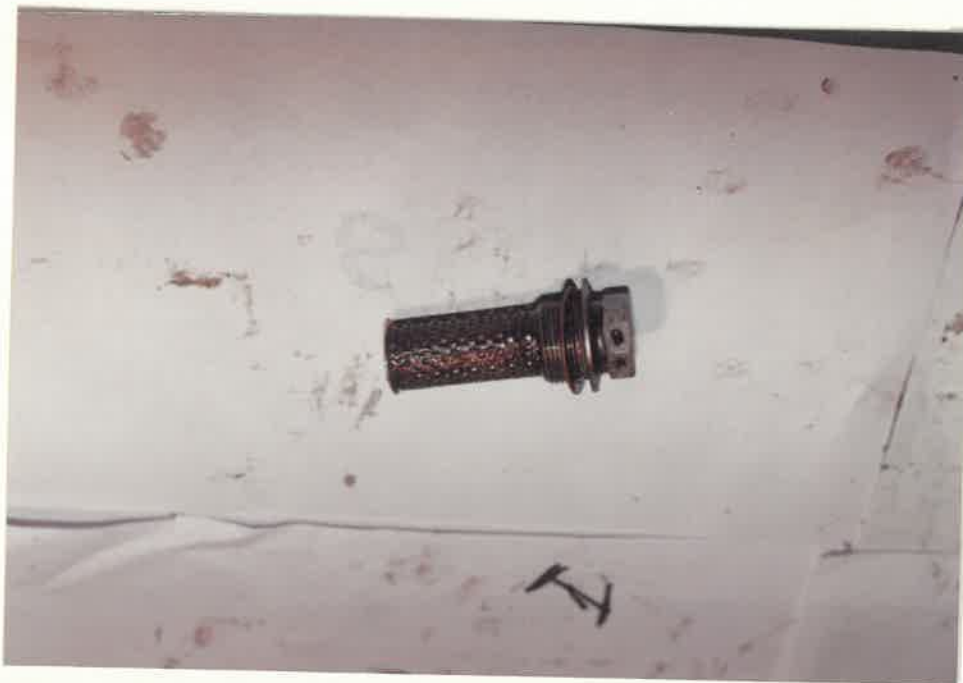
- 18.2.9 Scavenge Oil Filter The scavenge oil filter element was disintegrated / torn and had deposits of metal particles (Ref Exhibit 'J').
- 18.2.10 Tachometer Gen Drive The tachometer generator drive shaft was sheared off (Ref Exhibit 'K').

SCAVENGE OIL FILTER. NOTE:- DISINTEGRATED ELEMENT.

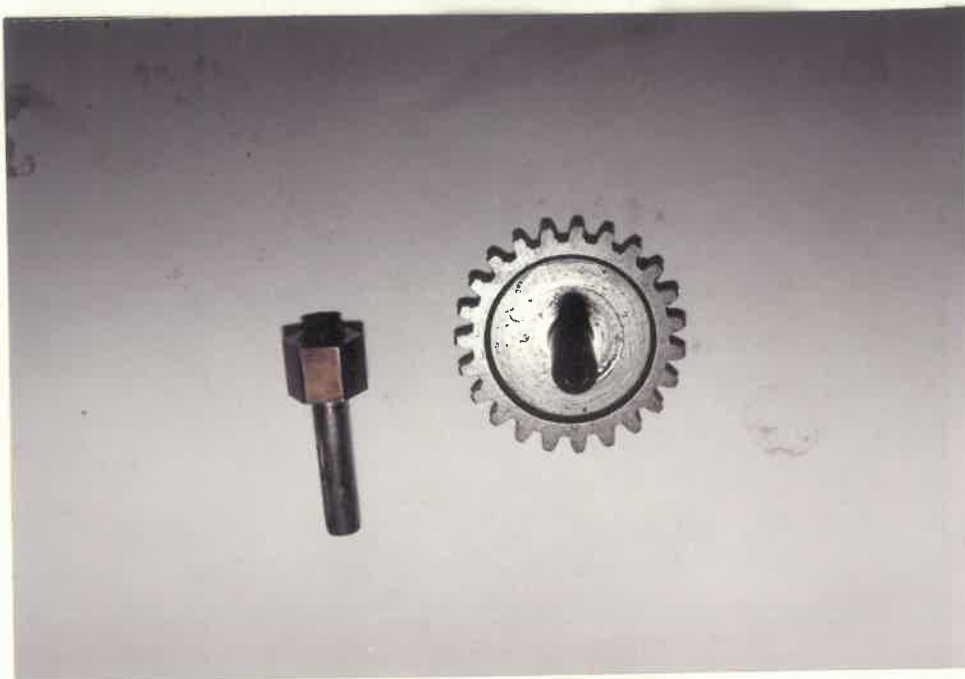
EXHIBIT - K

TACHOMETER GEN DRIVE. NOTE:- SHEARED SHAFT.

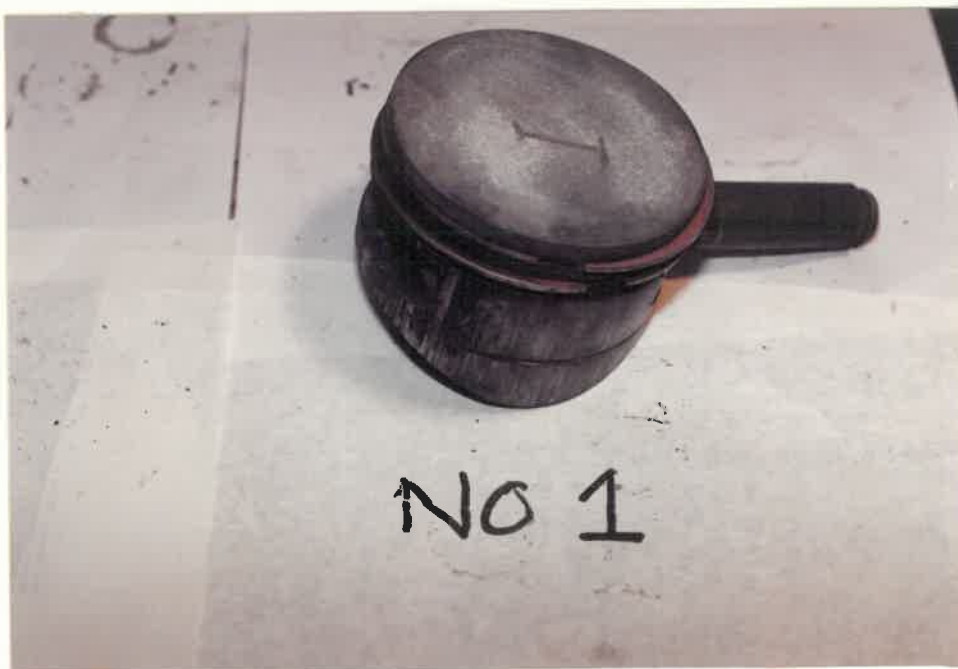
L-1

18.2.11 **Pistons:** No. 1,2,3,4 & 5 pistons had evidence of scoring and their scrapper oil rings were substantially worn-off and were imbedded in the piston body (Ref. Exhibit 'L-1 to L-11').

NO.1 PISTON

NOTE:- RUBBING MARKS.

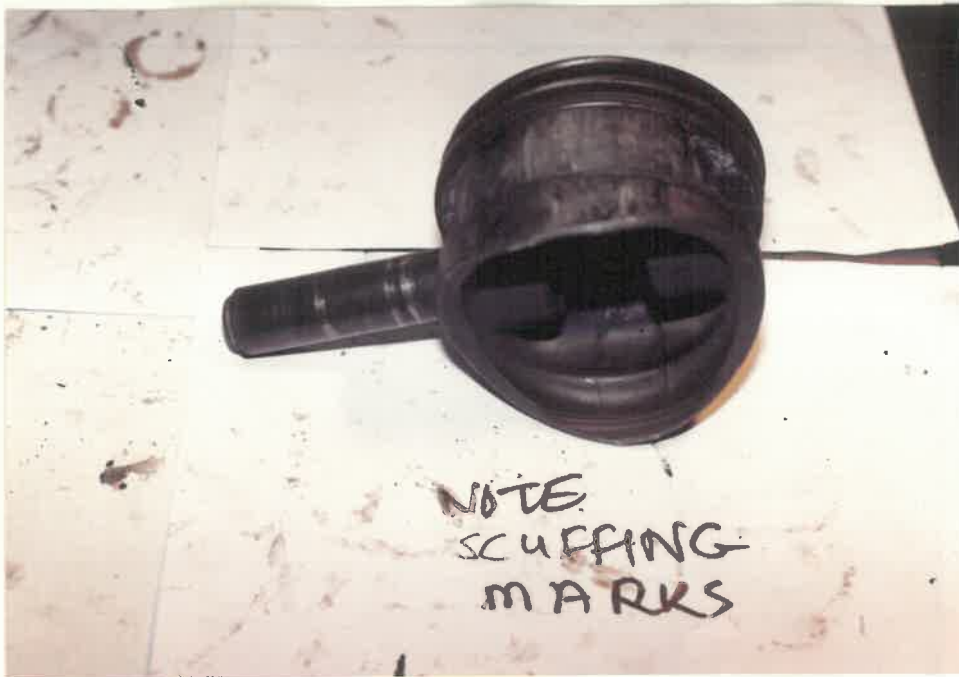
L-2

NO.1 PISTON NOTE:- SCORING MARKS.

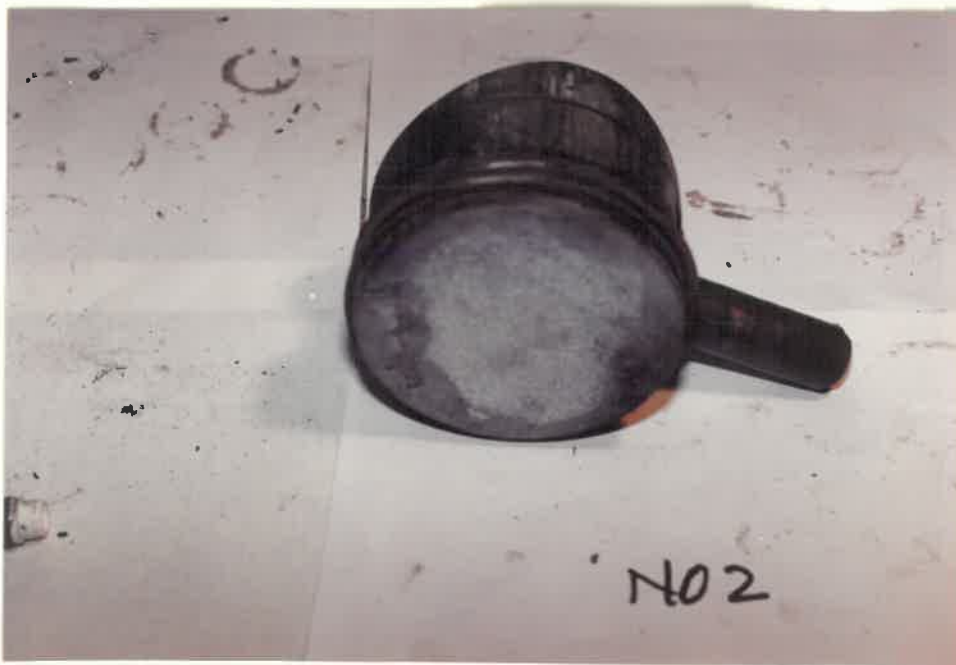
L-3

NO.2 PISTON. NOTE:- SCORING MARKS.

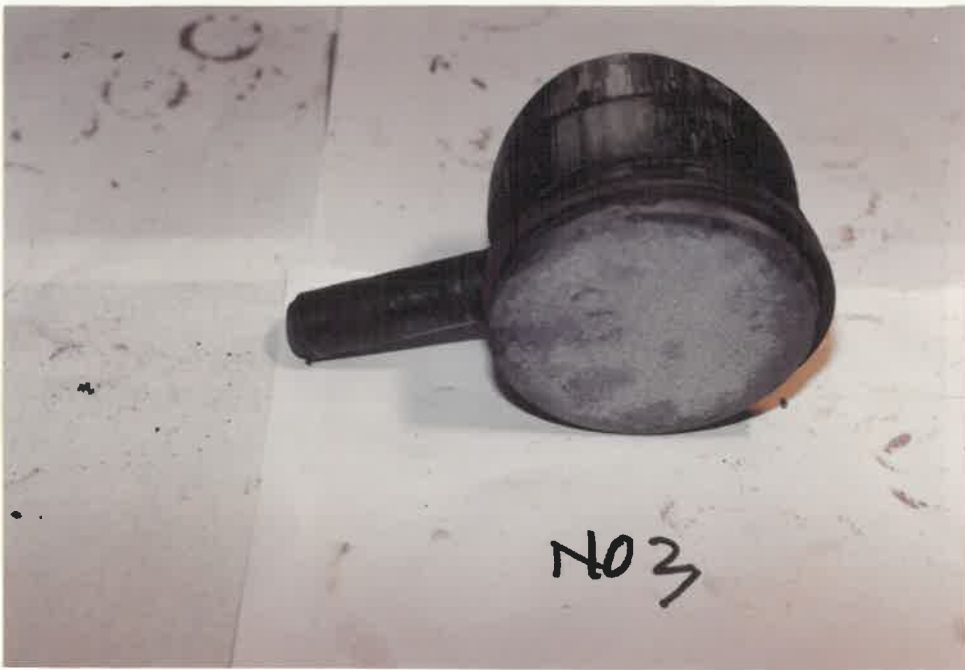
L-4

NO.3 PISTON. NOTE:- SCORING MARKS.

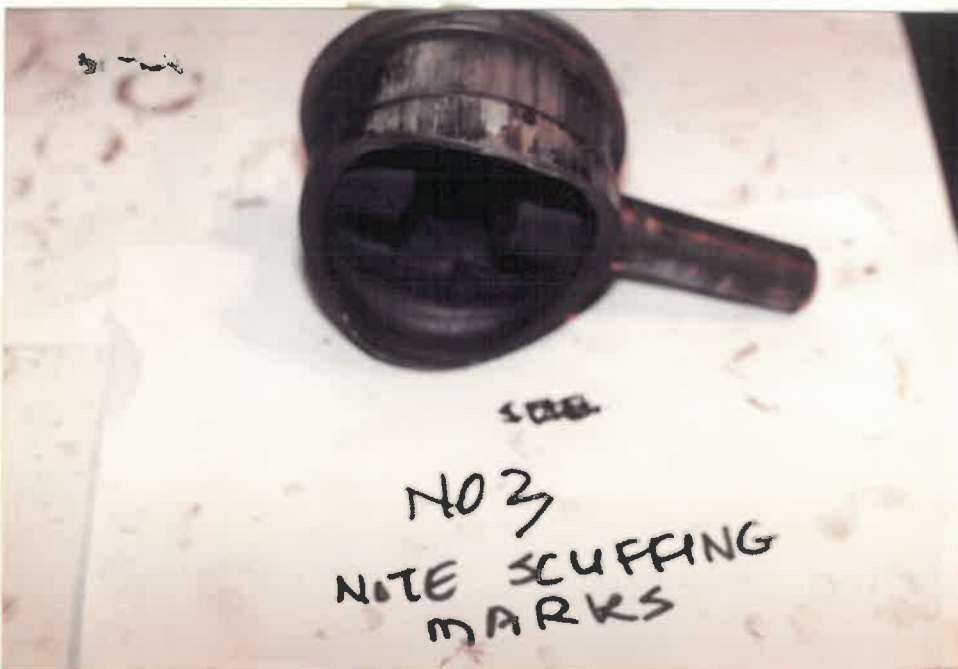
L-5

NO.3 PISTON. NOTE:- SCORING MARKS.

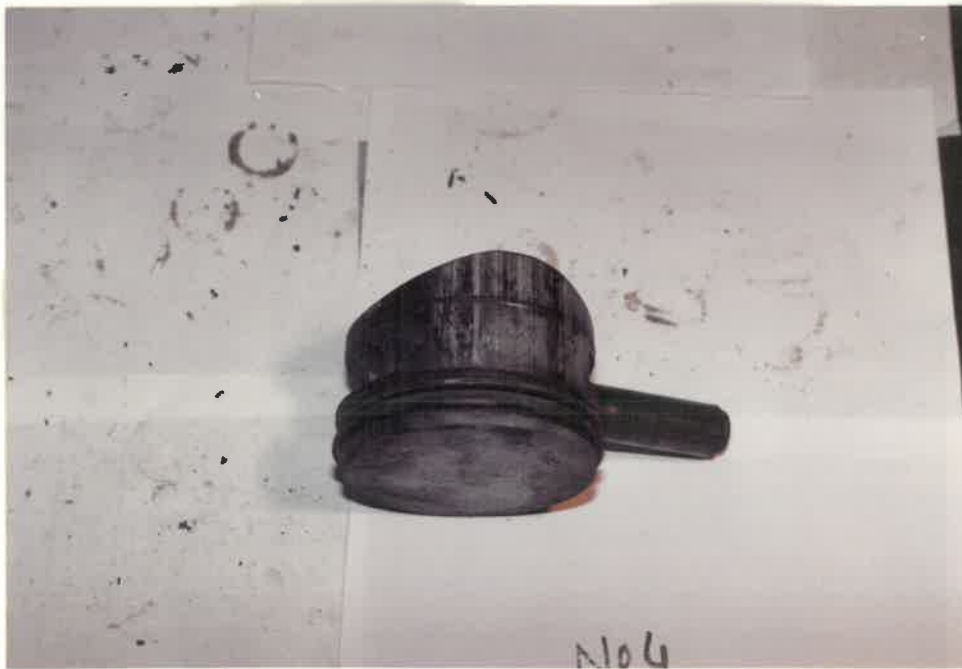
L-6

NO.4 PISTON. NOTE:- SCORING MARKS.

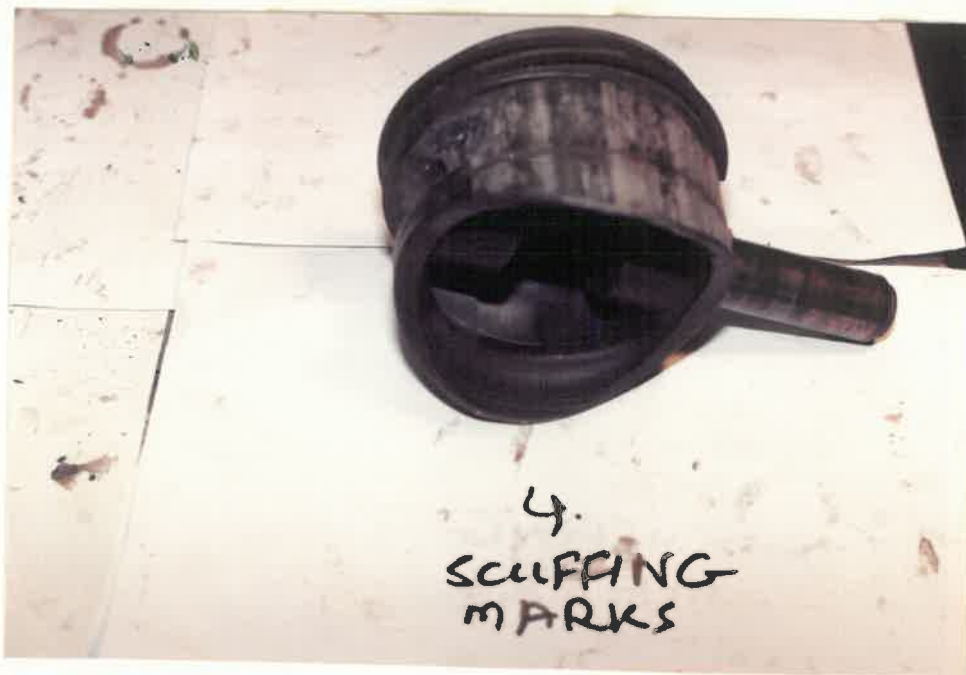
L-7

NO.4 PISTON. NOTE:- SCORING MARKS.

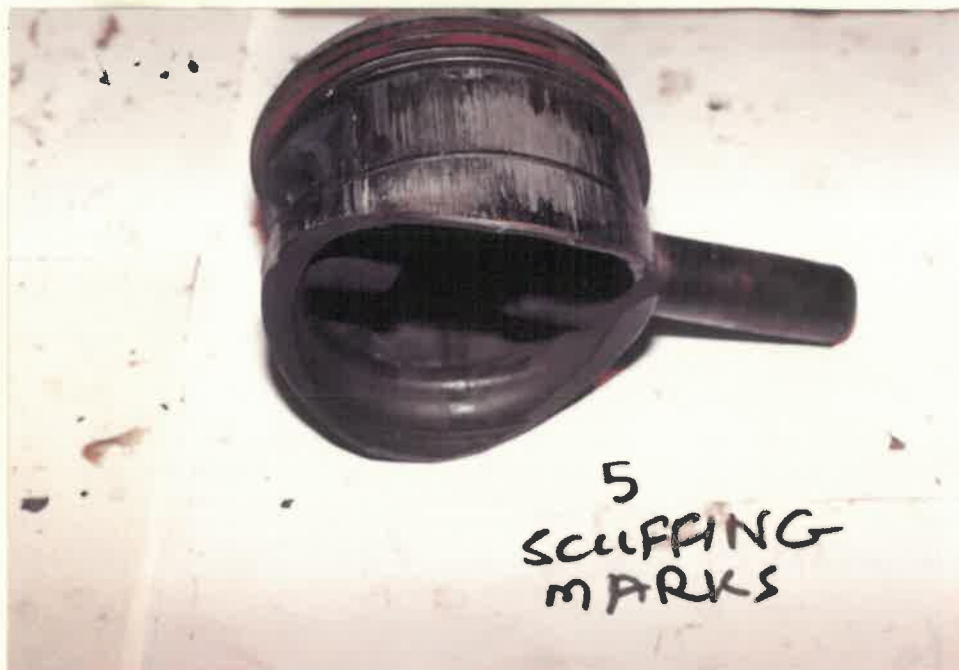
L-8

NO. 5 PISTON. NOTE:- SCORING MARKS.

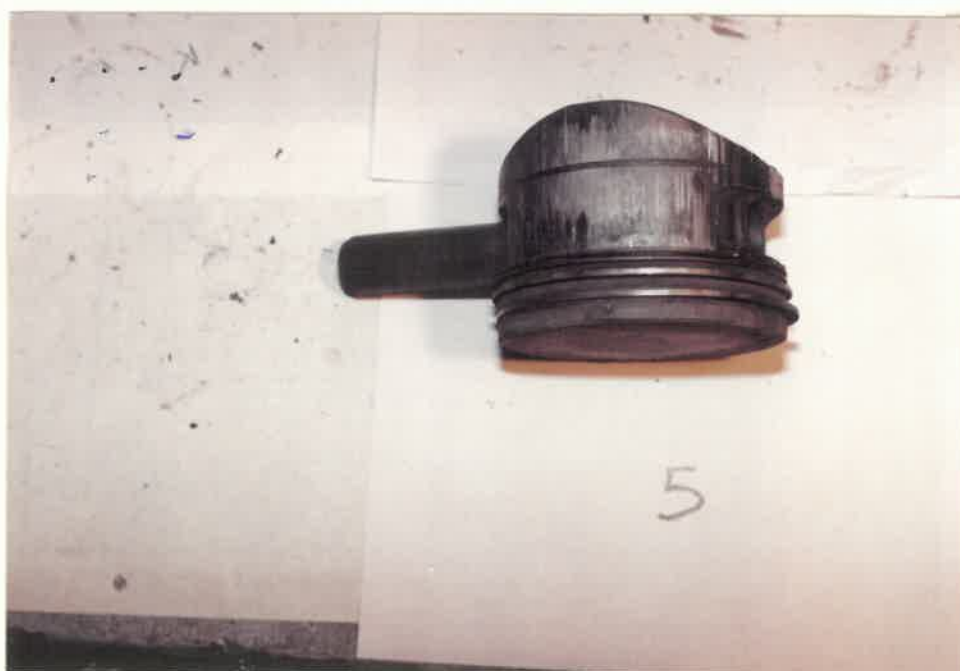
L-9

NO. 5 PISTON. NOTE:- SCORING MARKS.

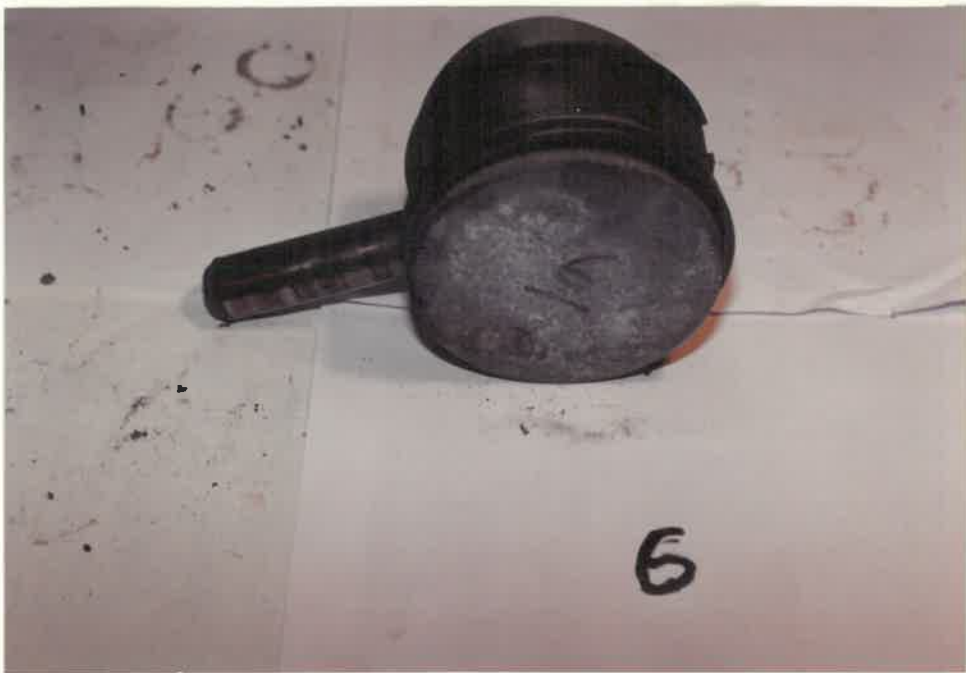
L-10

NO.6 PISTON. NOTE:- SCORING MARKS.

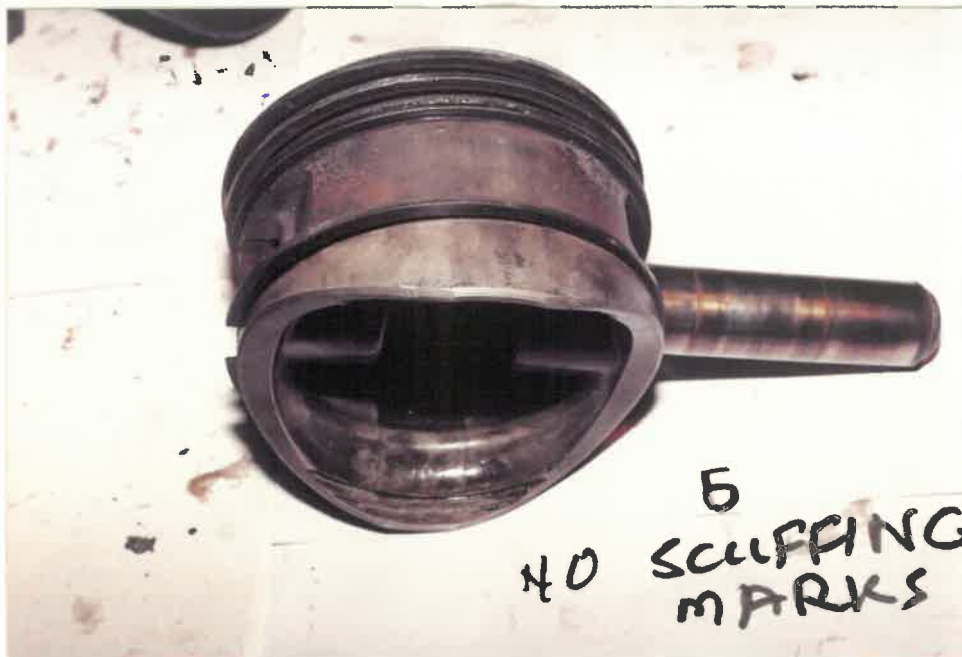
L-11

NO.6 PISTON. NOTE:- SCORING MARKS.

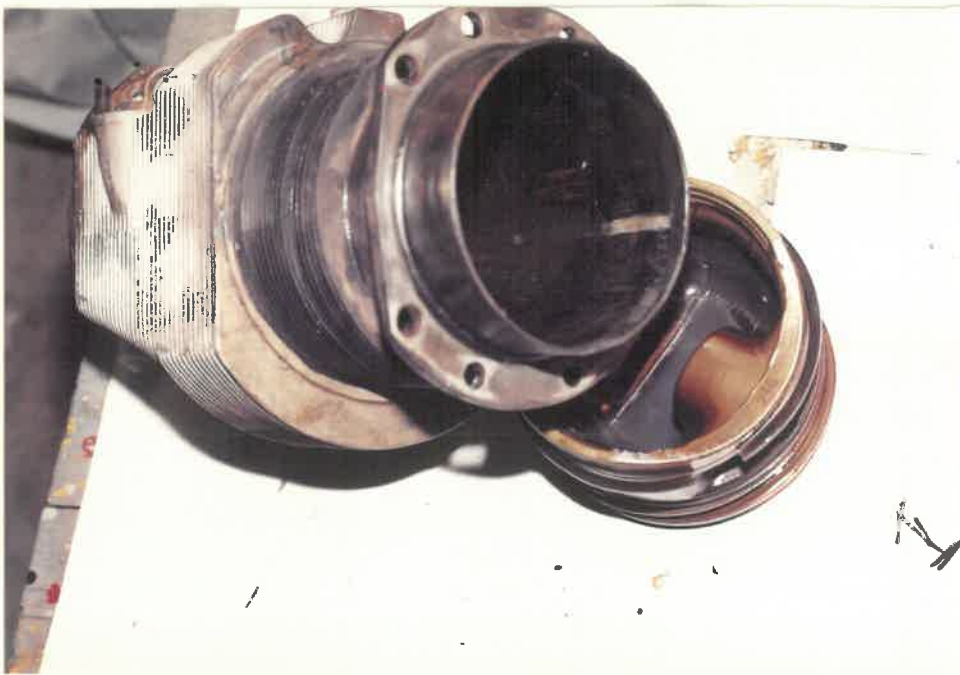
M-1

18.2.12 **Cylinder Sleeves.** All Cylinder Sleeves except of No 6 cylinder had evidence of scoring on the inner wall at the initial length of the Sleeve (Ref Exhibit 'M-1 to M-2') .

NO.1 CYLINDER. NOTE:- INTERNAL SCORING.

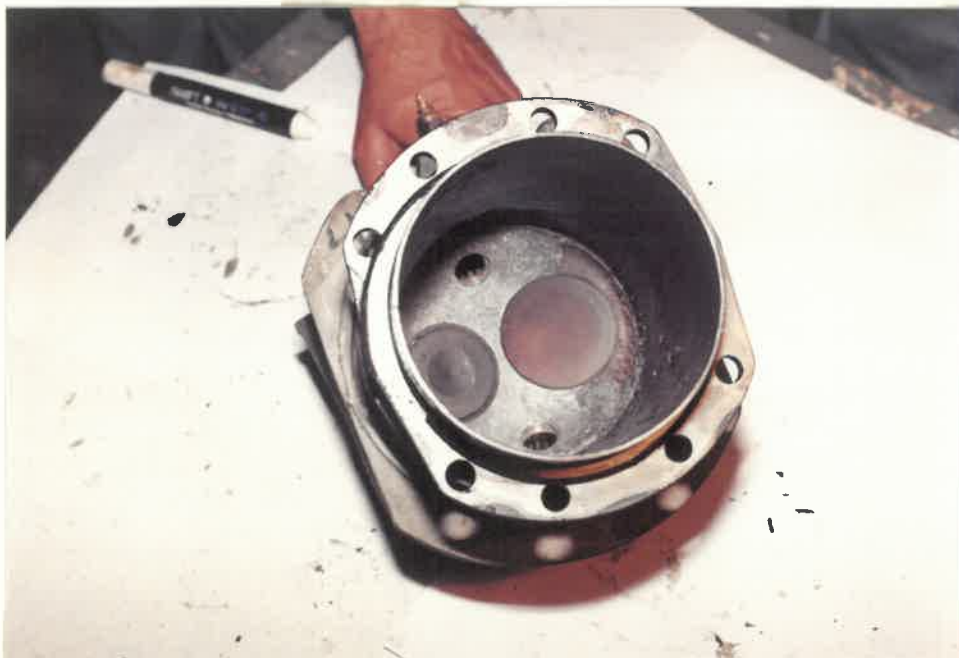
M-2

CYLINDER SLEEVE. NOTE:- INTERNAL SCORING.

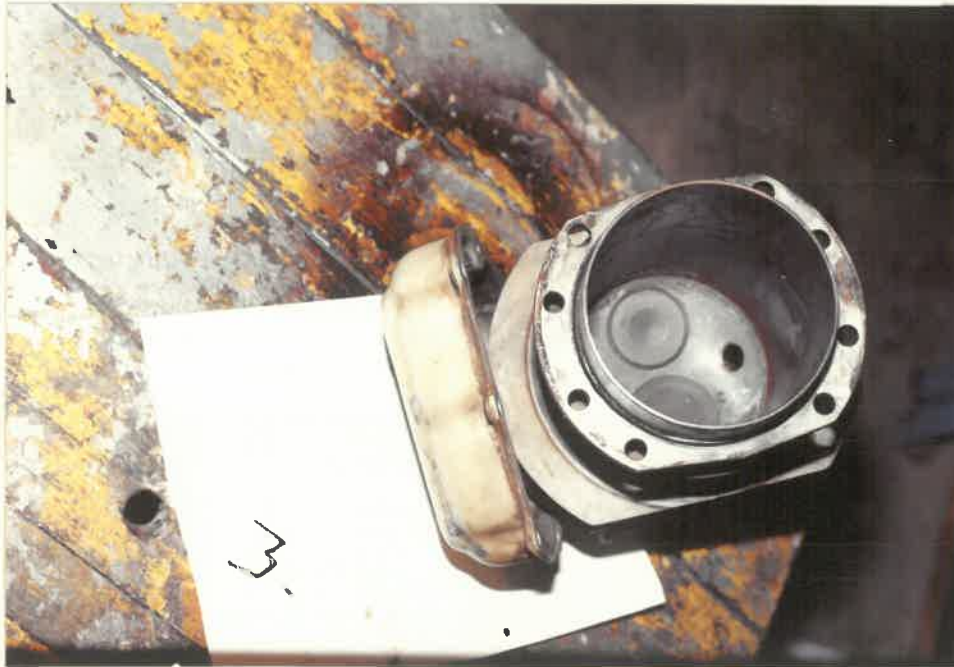
M-3

CYLINDER SLEEVE. NOTE: INNER WALL SCORING

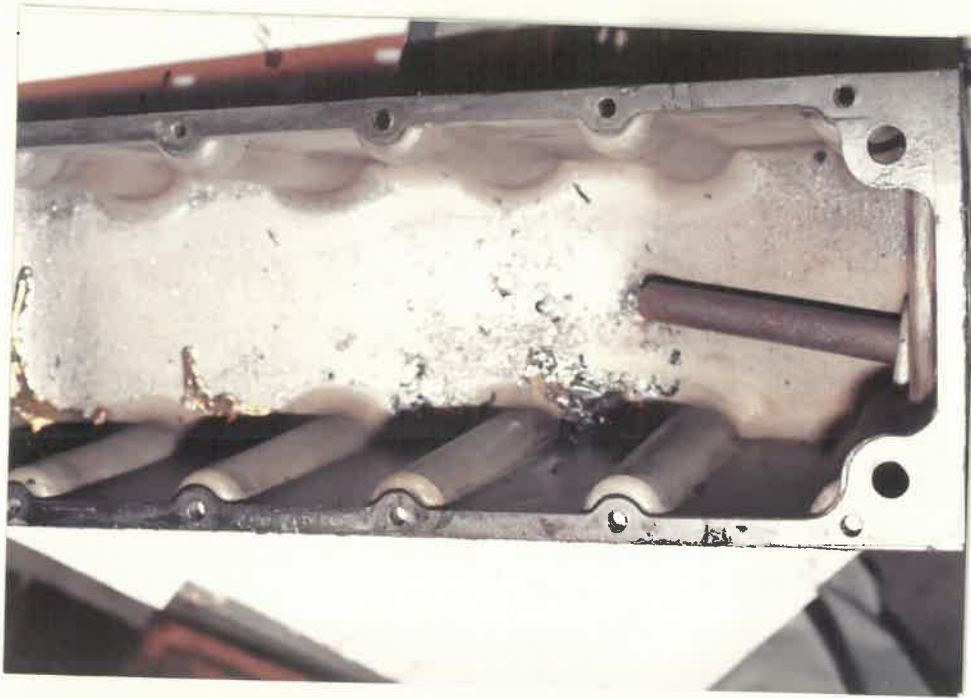
18.2.14 **Oil Sump.** Large deposits of metal particles were observed in the oil sump (Ref Exhibit 'N').

OIL SUMP. NOTE:- METAL DEPOSITS.
